### RESEARCH MEMORANDUM

STALL CHARACTERISTICS OBTAINED FROM FLIGHT 10 OF

NORTHROP X-4 NO. 2 AIRPLANE (USAF NO. 46-677)

NACA RM A50A04

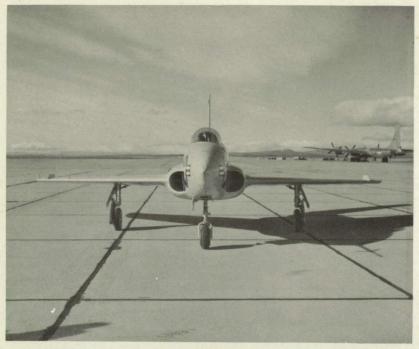
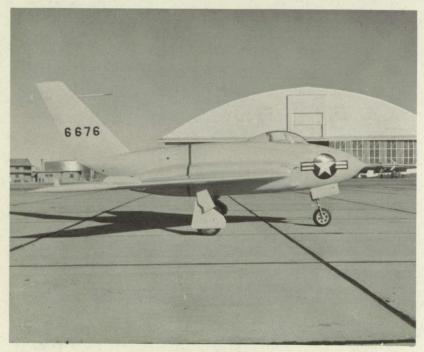
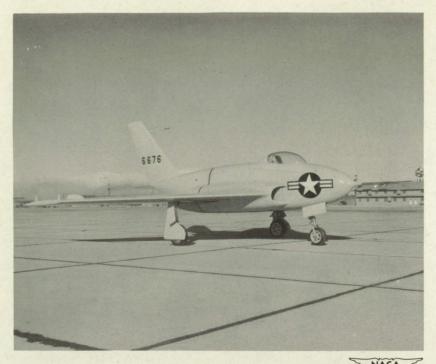
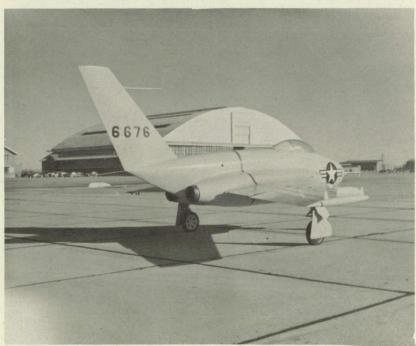
(a) Front view.

(b) Side view.

Figure 1.- The Northrop X-4 Airplane.

(c) Quarter front view.

(d) Three-quarter rear view.

The Northrop  $X_{-}^{-}$  research airplane has a vertical tail but no horizontal tail. It is powered by two modified Westinghouse J-30-WE-7-9 engines and is designed for flight research in the high subsonic speed range. Photographs of the  $X_{-}^{-}$  No. 1 airplane, which is identical to the test airplane, are presented in figure 1 and a
