FLIGHT MEASUREMENTS OF THE FLYING QUALITIES

OF AN F6F-3 AIRPLANE (BUAER NO. 04776)

III - STALLING CHARACTERISTICS

By Walter C. Williams and John P. Reeder

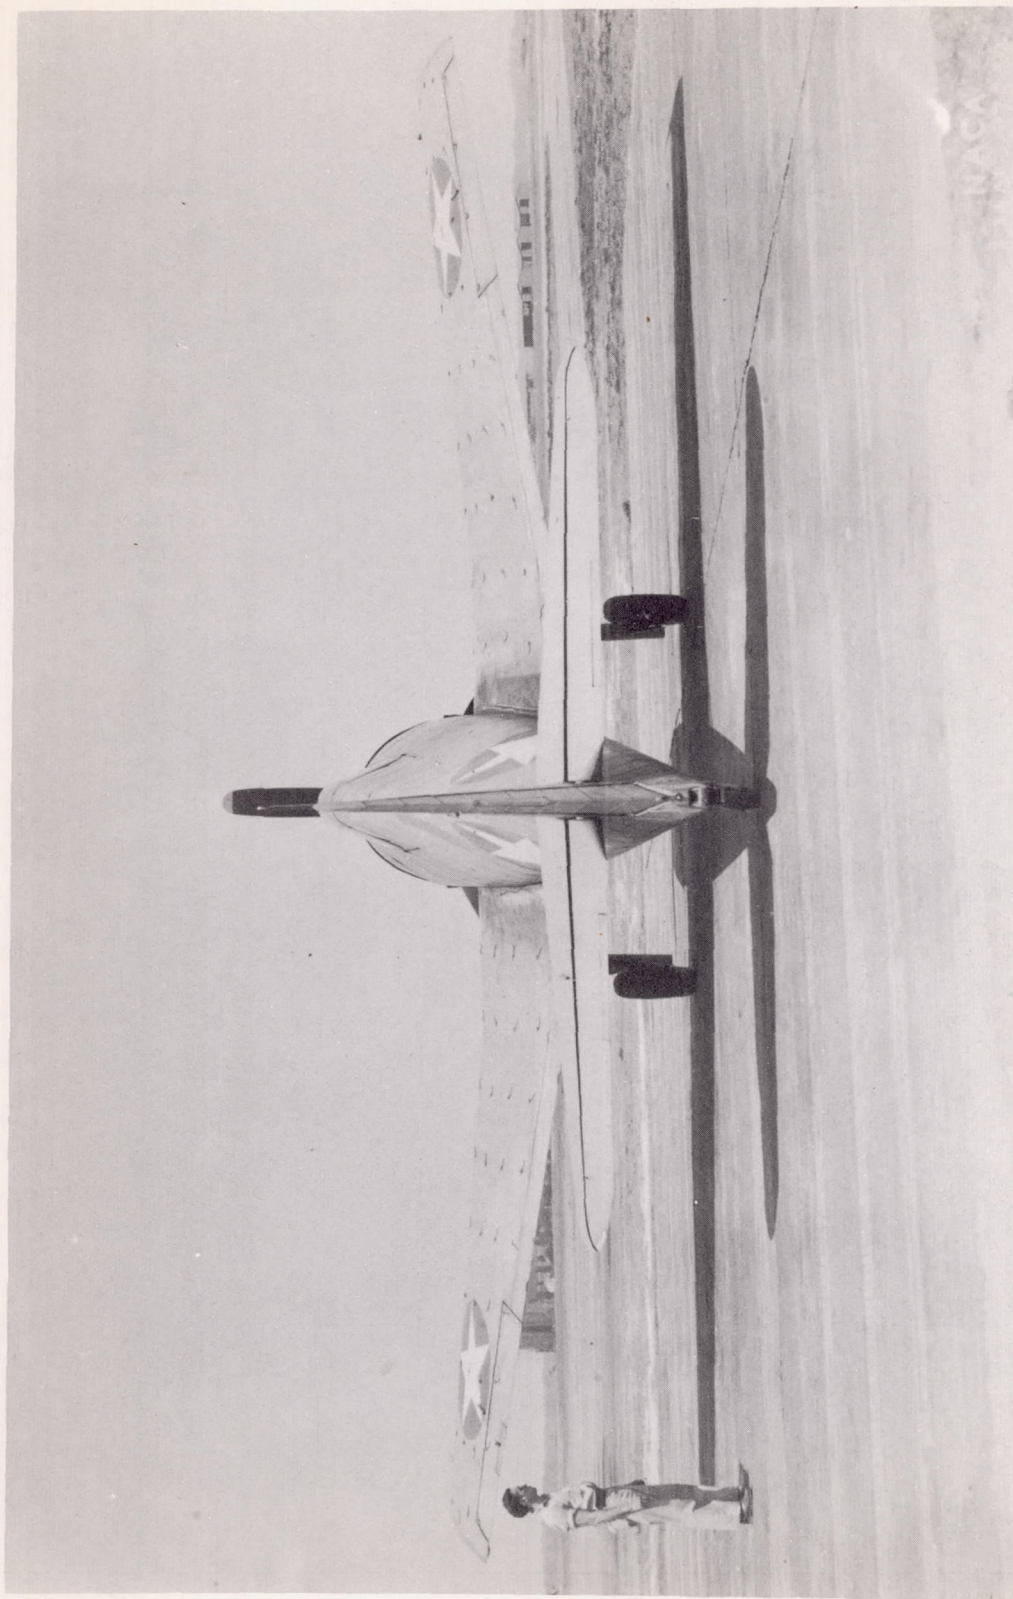
Figure 1.- Rear view of the F6F-3 airplane.

General views of the F6F-3 airplane are shown in figures 1 and 2. Figure 3 is a three-view layout of the subject airplane. Pertinent details and dimensions of the F6F-3 are given in reference 1.

The stalling characteristics of the F6F-3 airplane in steady flight were determined in stalls made by gradually decreasing the speed in straight flight. The motions of the airplane and of the controls were recorded during the stall approach and in some cases after the stall. The stability characteristics and the maximum lift coefficients during the stall approaches were determined. A camera had been installed in the airplane in order to check the rate of roll during low-speed aileron rolls. The camera installation was then used to make some tuft studies of the left wing. These tuft studies are rather limited and no particular effort was made to obtain a complete series of tuft pictures. Figure 1 shows the tufts on the wing.

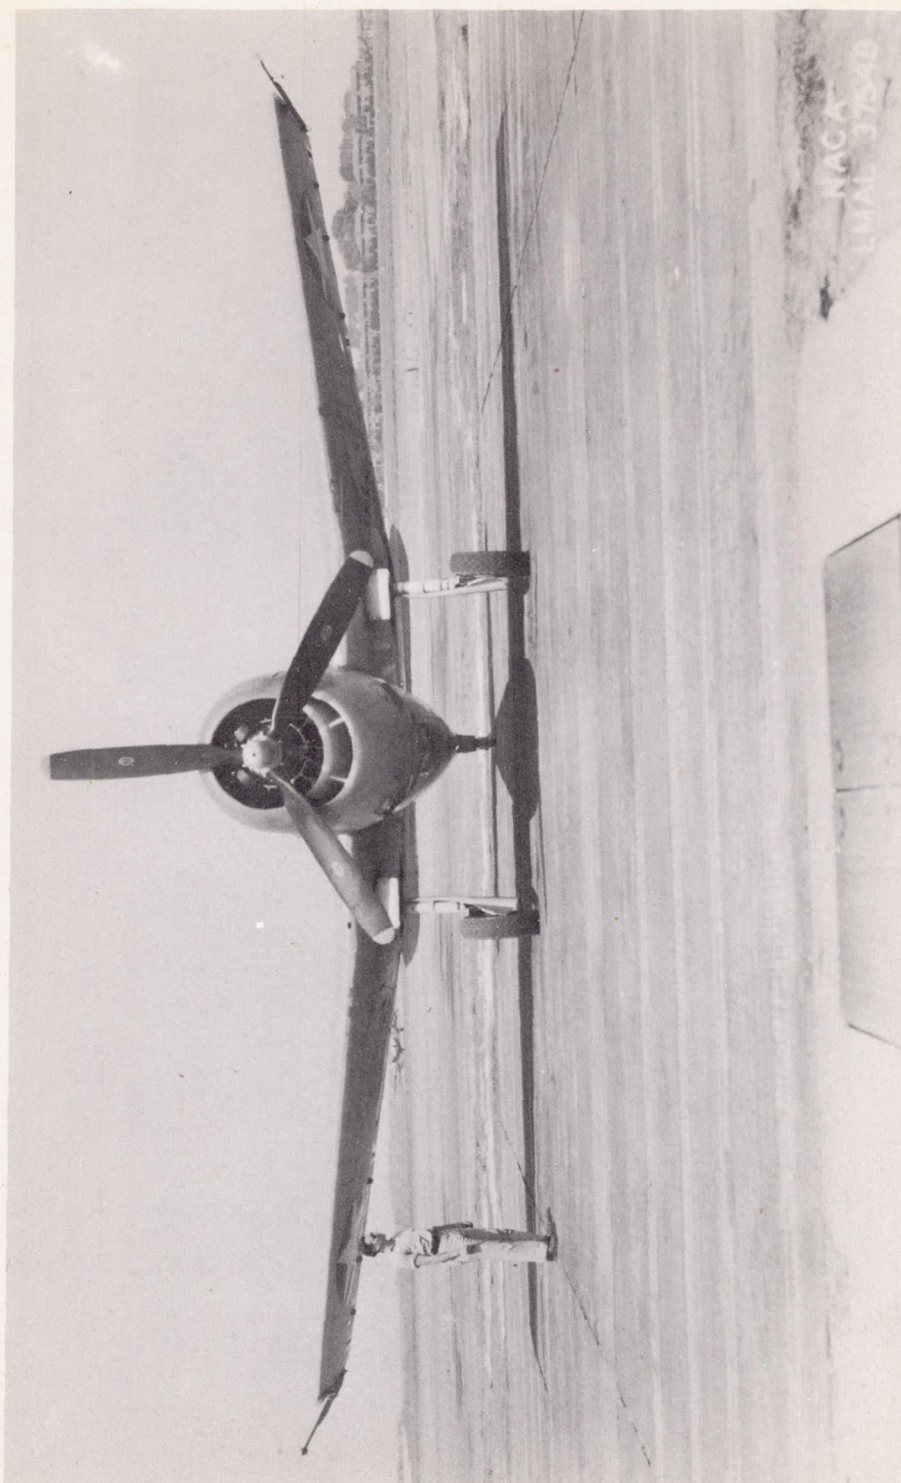
Figure 2.- Front view of the F6F-3 airplane.

(a) In the gliding condition (figs. 4 and 5) stall warning was afforded by a howl in the duct on the underside of the engine cowl (see fig. 2) beginning about 18 miles per hour above the stall and by an increased general vibration of the airplane felt in the stick and rudder pedals about 5 miles per hour above the stall. In addition, there was a very mild buffeting beginning 1 to 2 miles per hour above the stall and increasing in intensity as the initial roll off to the left occurred. This buffeting preceding the roll-off cannot be relied upon as a stall warning since it was obtained only with very slow approaches to the stall. In the stall, where the pilot attempted to hold the rudder and ailerons fixed after the initial roll-off (fig. 4), a rolling and mild pitching oscillation set in which increased in amplitude until the complete stall. Tuft pictures of the left wing taken during this run (fig. 14) show that the wing alternately stalled and unstalled during the oscillation. Use of the rudder and ailerons after the initial roll-off (fig. 5) resulted in diminished motion of the airplane up to the final stall. Maximum lift coefficient in the gliding condition varied from 1.35 to 1.45.

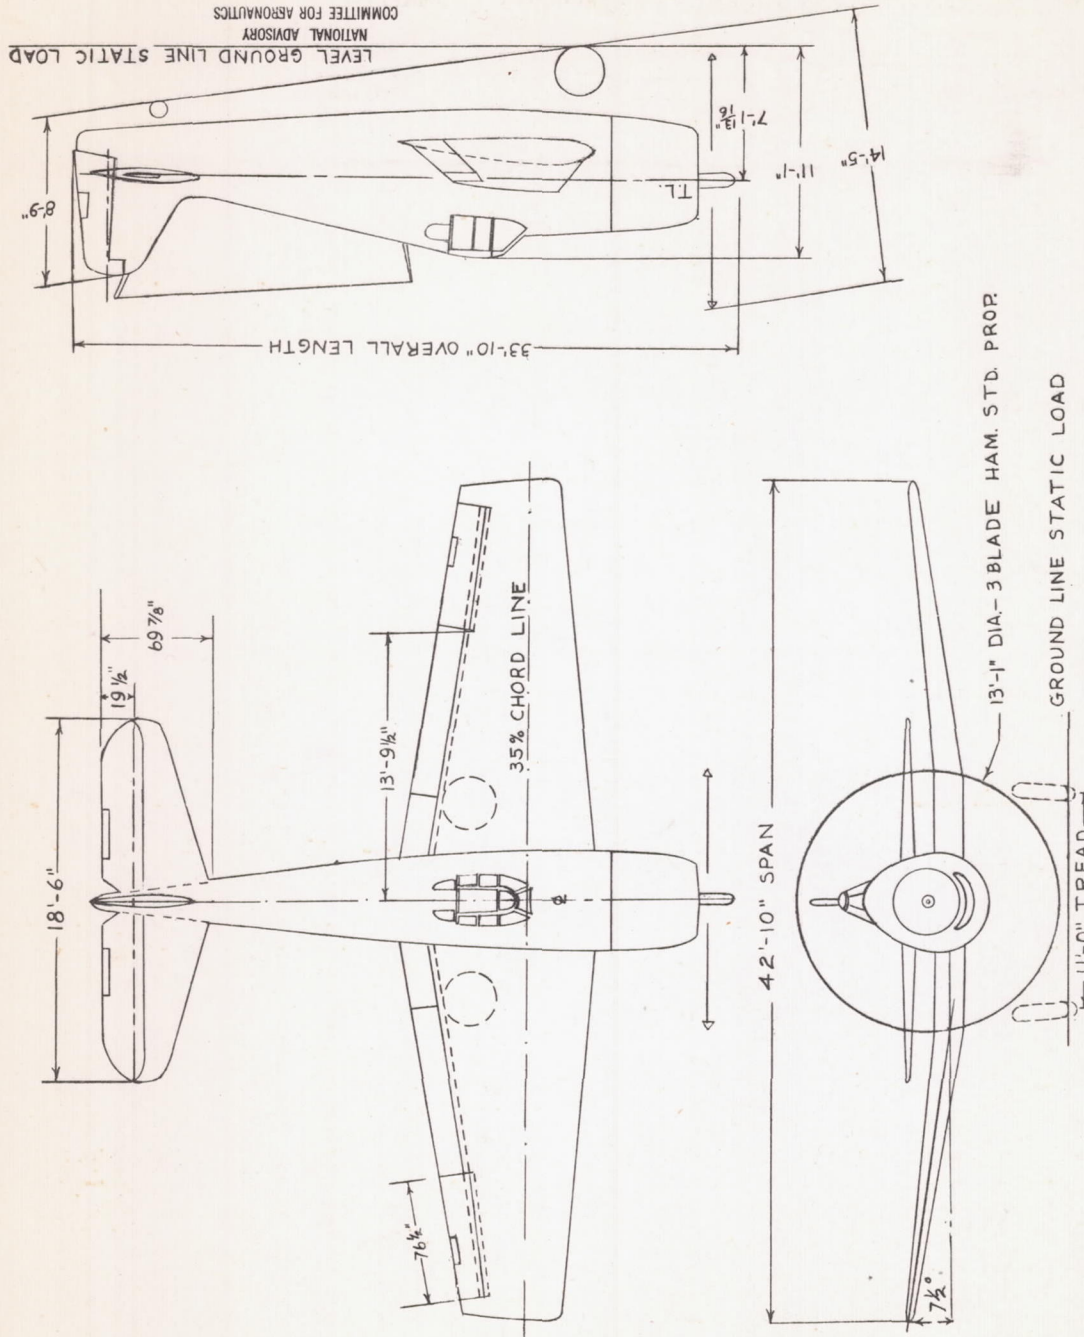
Figure 3. - Three-view layout of the F6F-3 airplane.

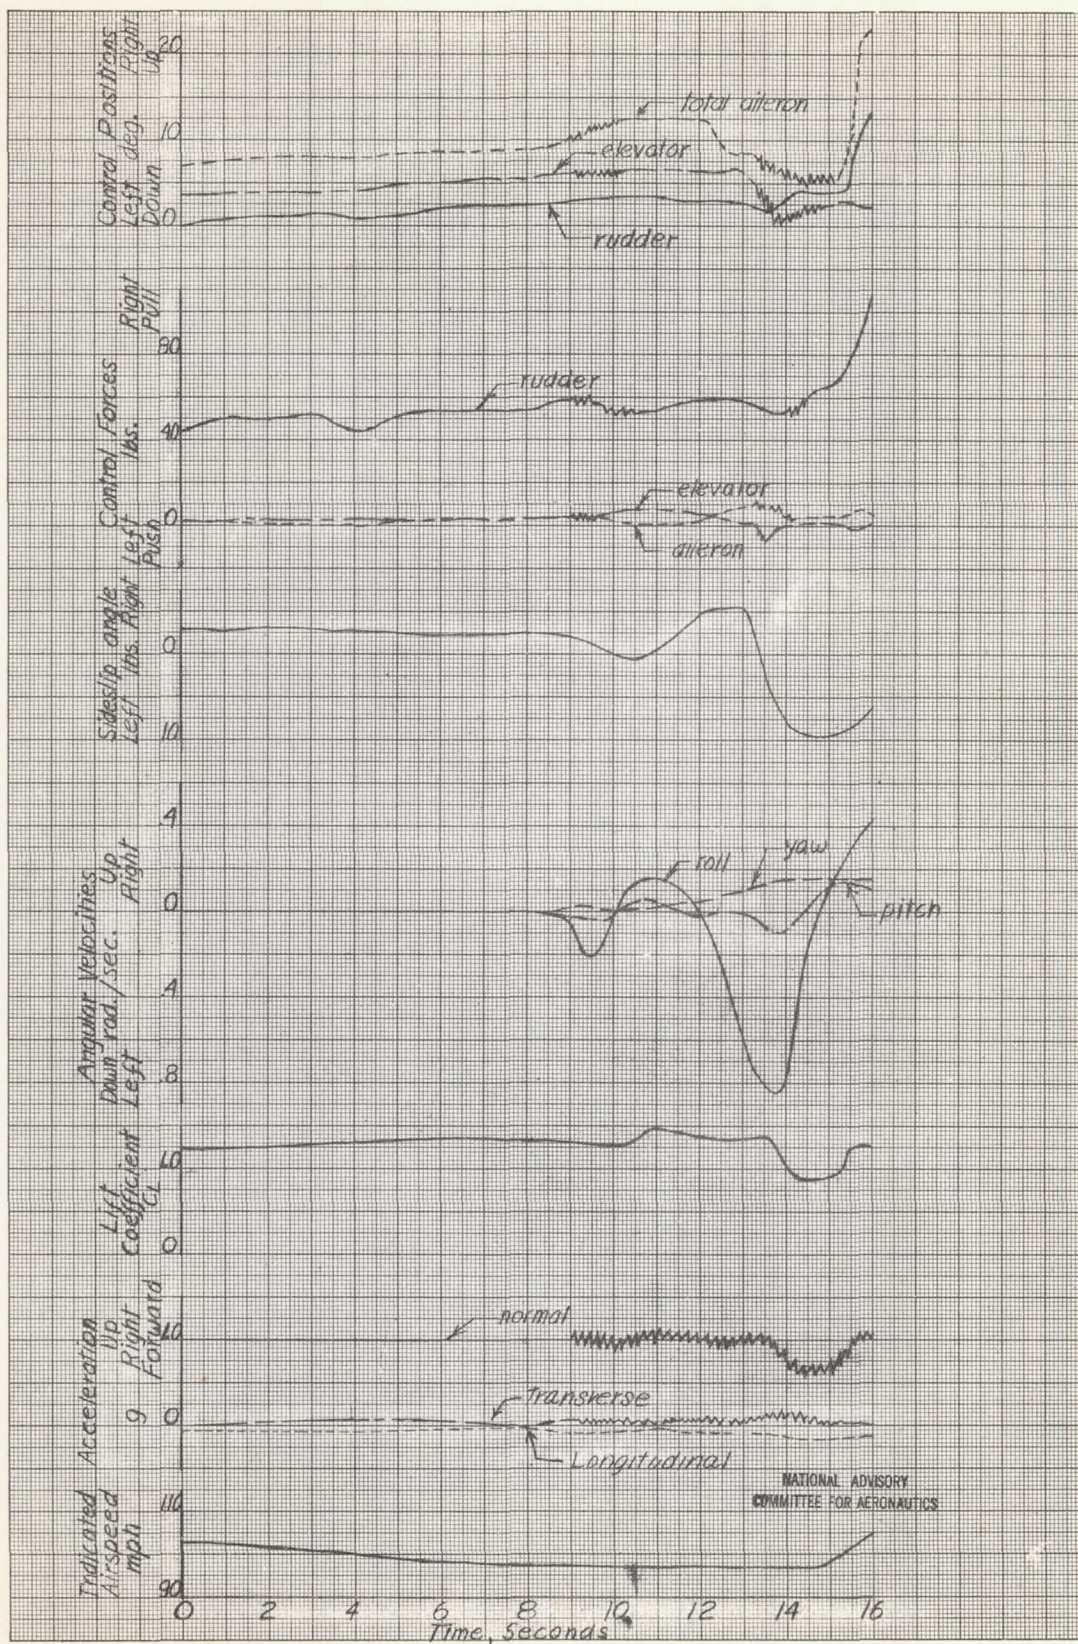
Figure 4. - Time history of a stall in gliding condition in which the pilot attempted to hold the aileron and rudder controls fixed after the initial roll-off. F6F-3 airplane.

Time histories of stall approaches in the various conditions of flight are given in figures 4 to 13. Tuft studies corresponding to figures 4 and 12 are given in figures 14 and 15. The stalling characteristics may be summarized as follows:

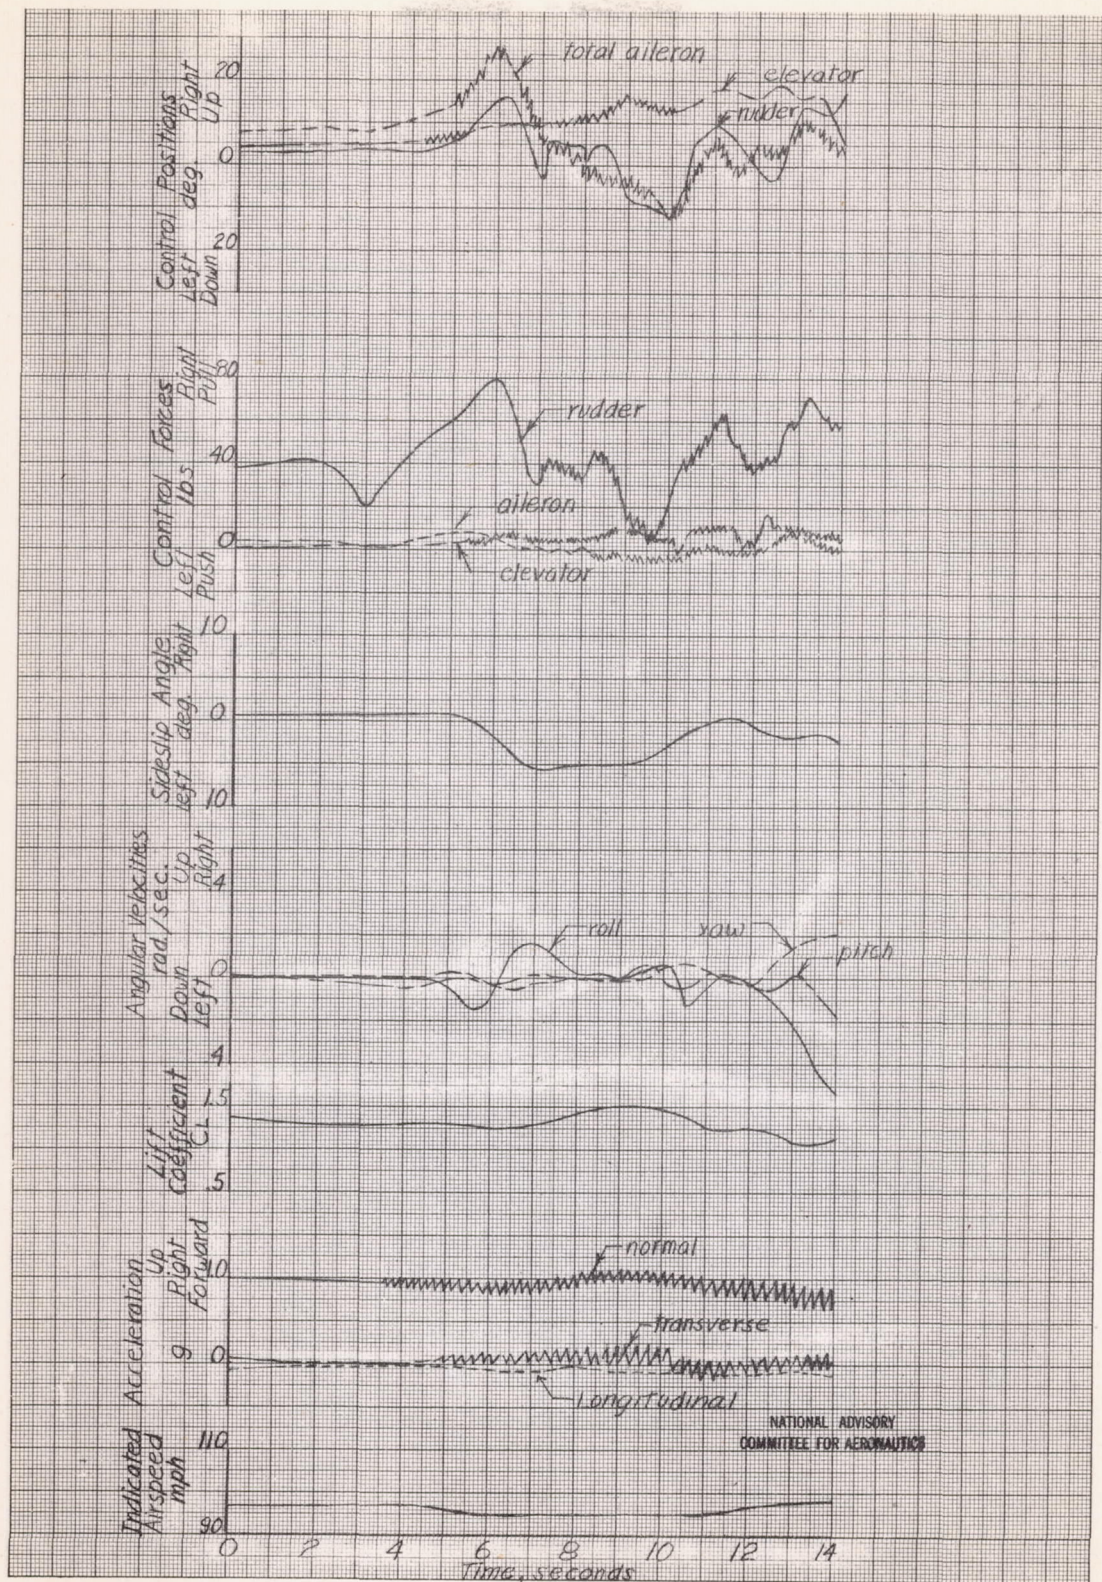
Figure 5. - Time history of a stall in the gliding condition in which the pilot attempted to control the airplane through the stall. FoF-3 airplane.

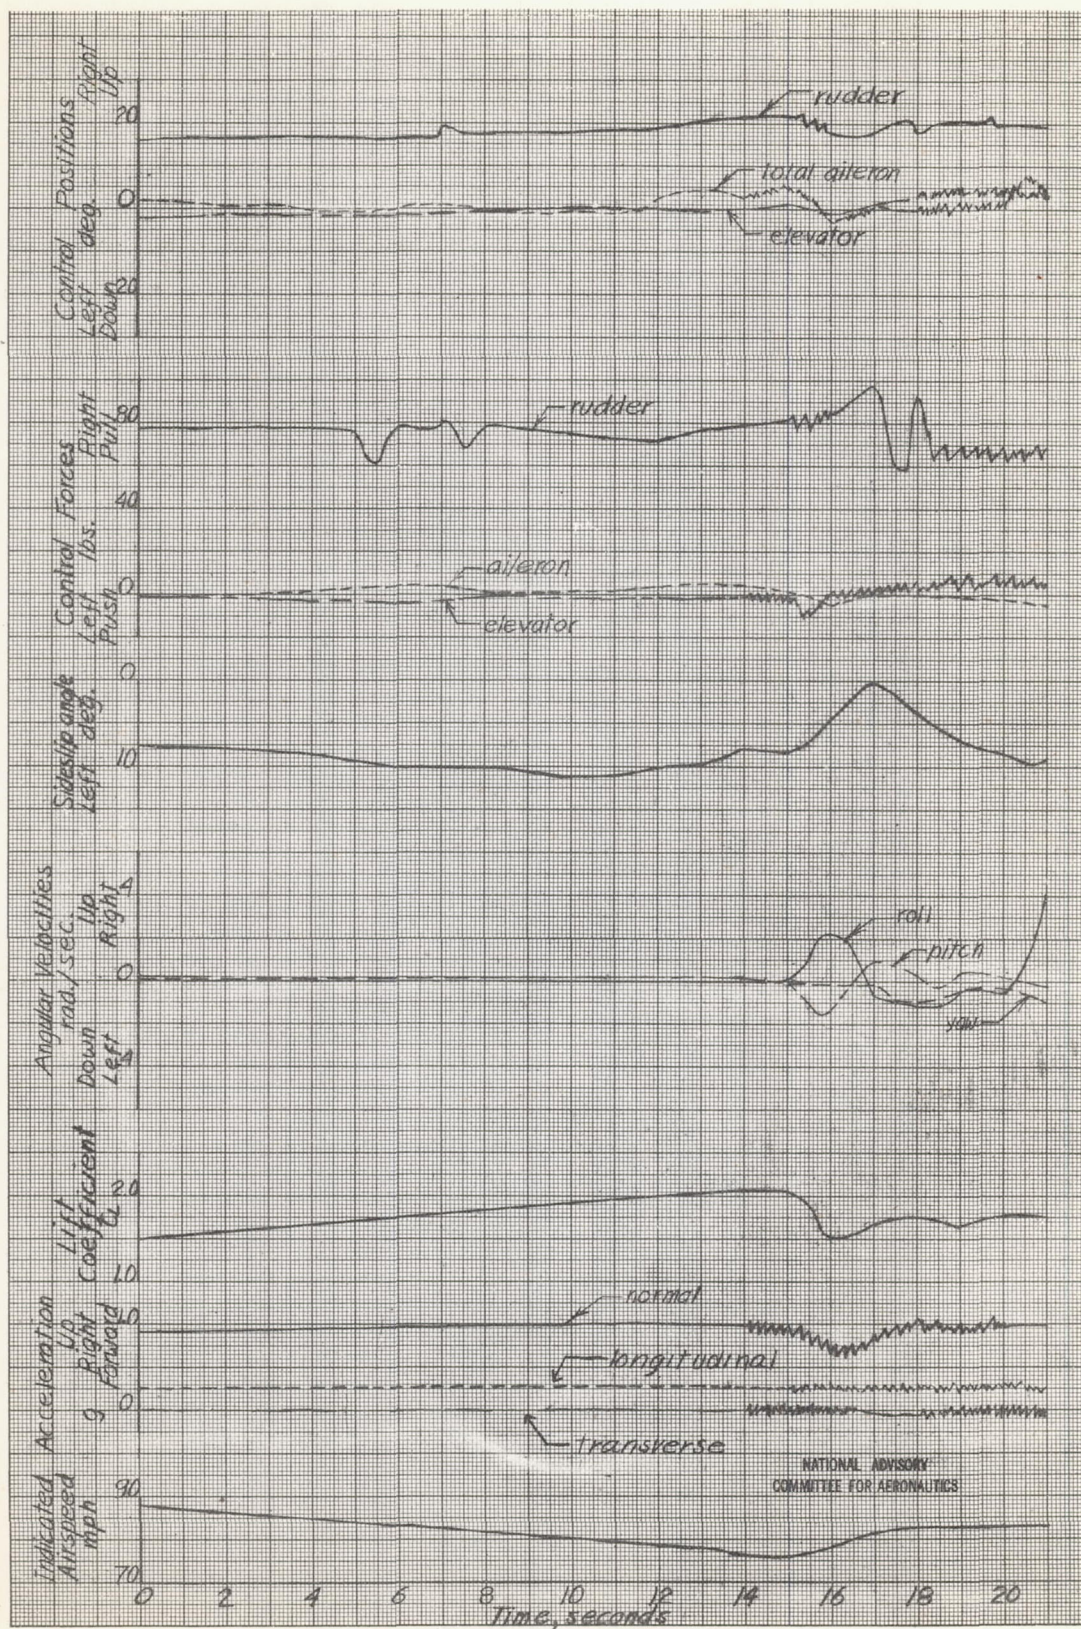
Figure 6. - Time history of a stall in the climbing condition in which the pilot attempted to hold the rudder and ailerons fixed after the initial roll-off. F6F-3 airplane.

(b) In the climbing condition (figs. 6 and 7), general vibration of the airplane increased noticeably about 7 miles per hour above the stall. About 2 miles per hour above the stall a very mild buffeting set in. The intensity of this buffeting increased as roll-off to the right occurred. In the control-fixed stall (fig. 6), there was mild rolling and pitching up to the final roll-off. Use of the controls (fig. 7) resulted in rather violent motions of the airplane as the pilot overcontrolled. Maximum lift coefficient in the climbing condition varied from about 2.1 to 2.2.

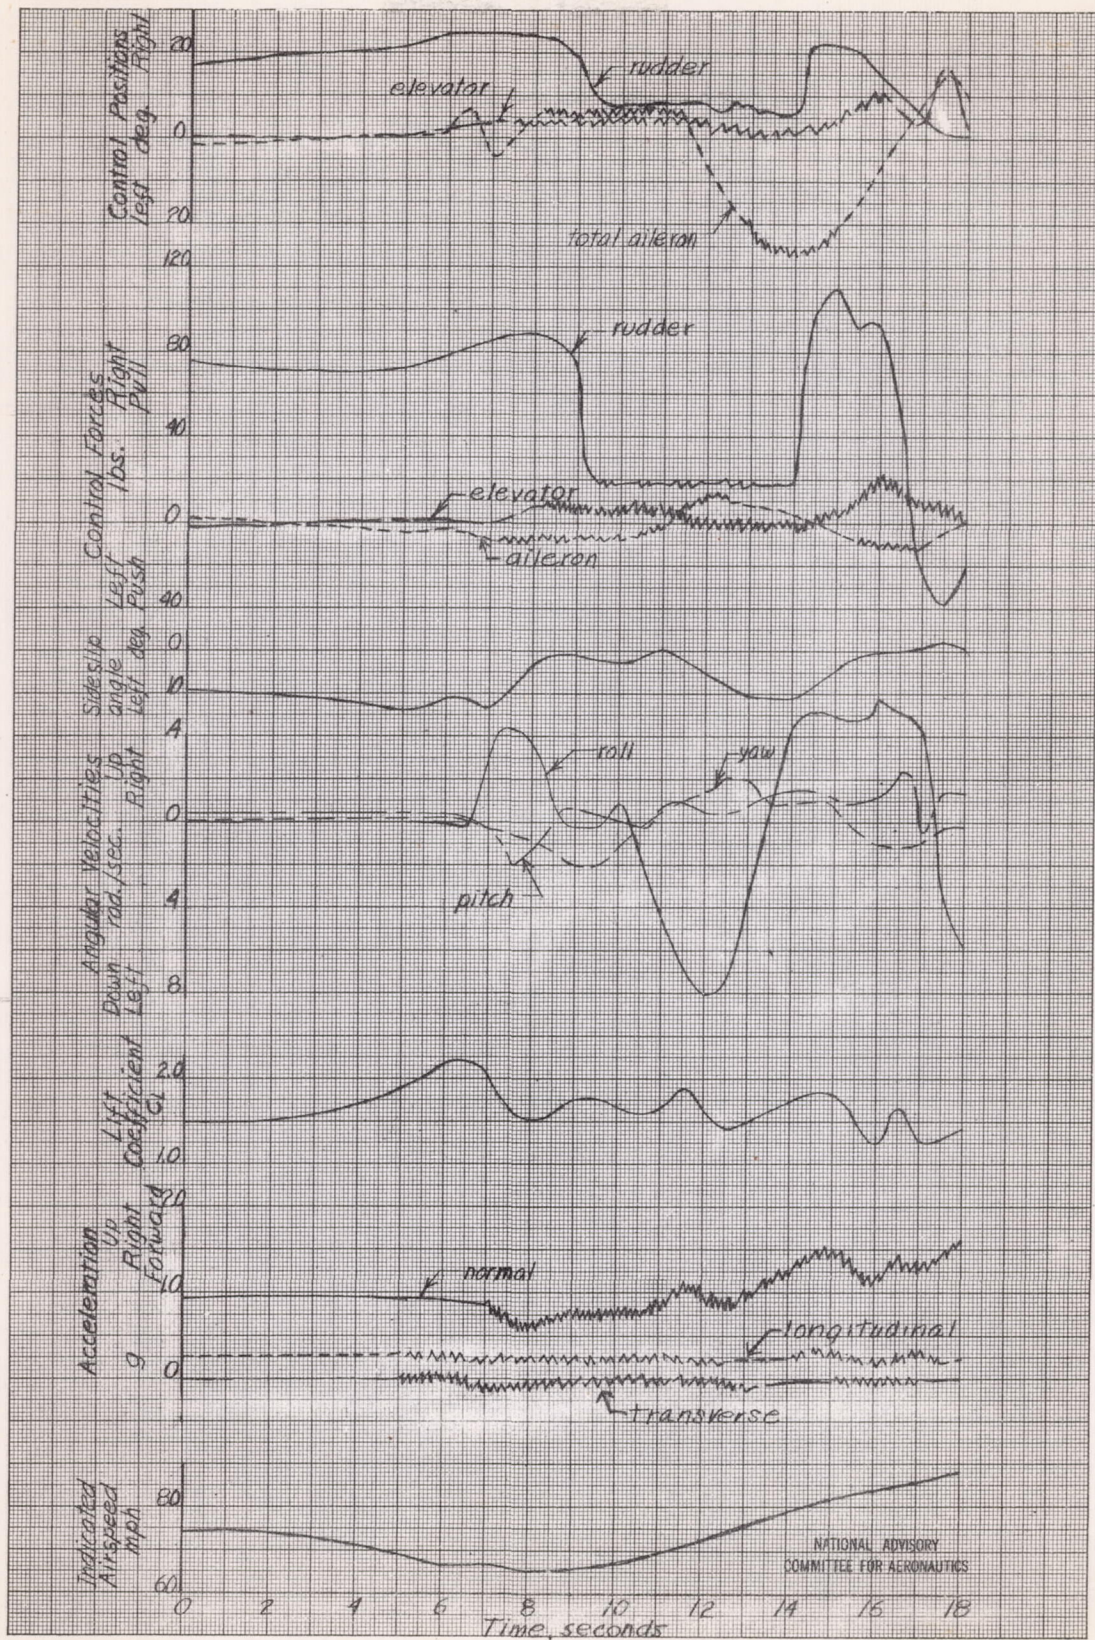
Figure 7. - Time history of a stall in the climbing condition in which the pilot attempted to control the airplane through the stall. F6F-3 airplane.

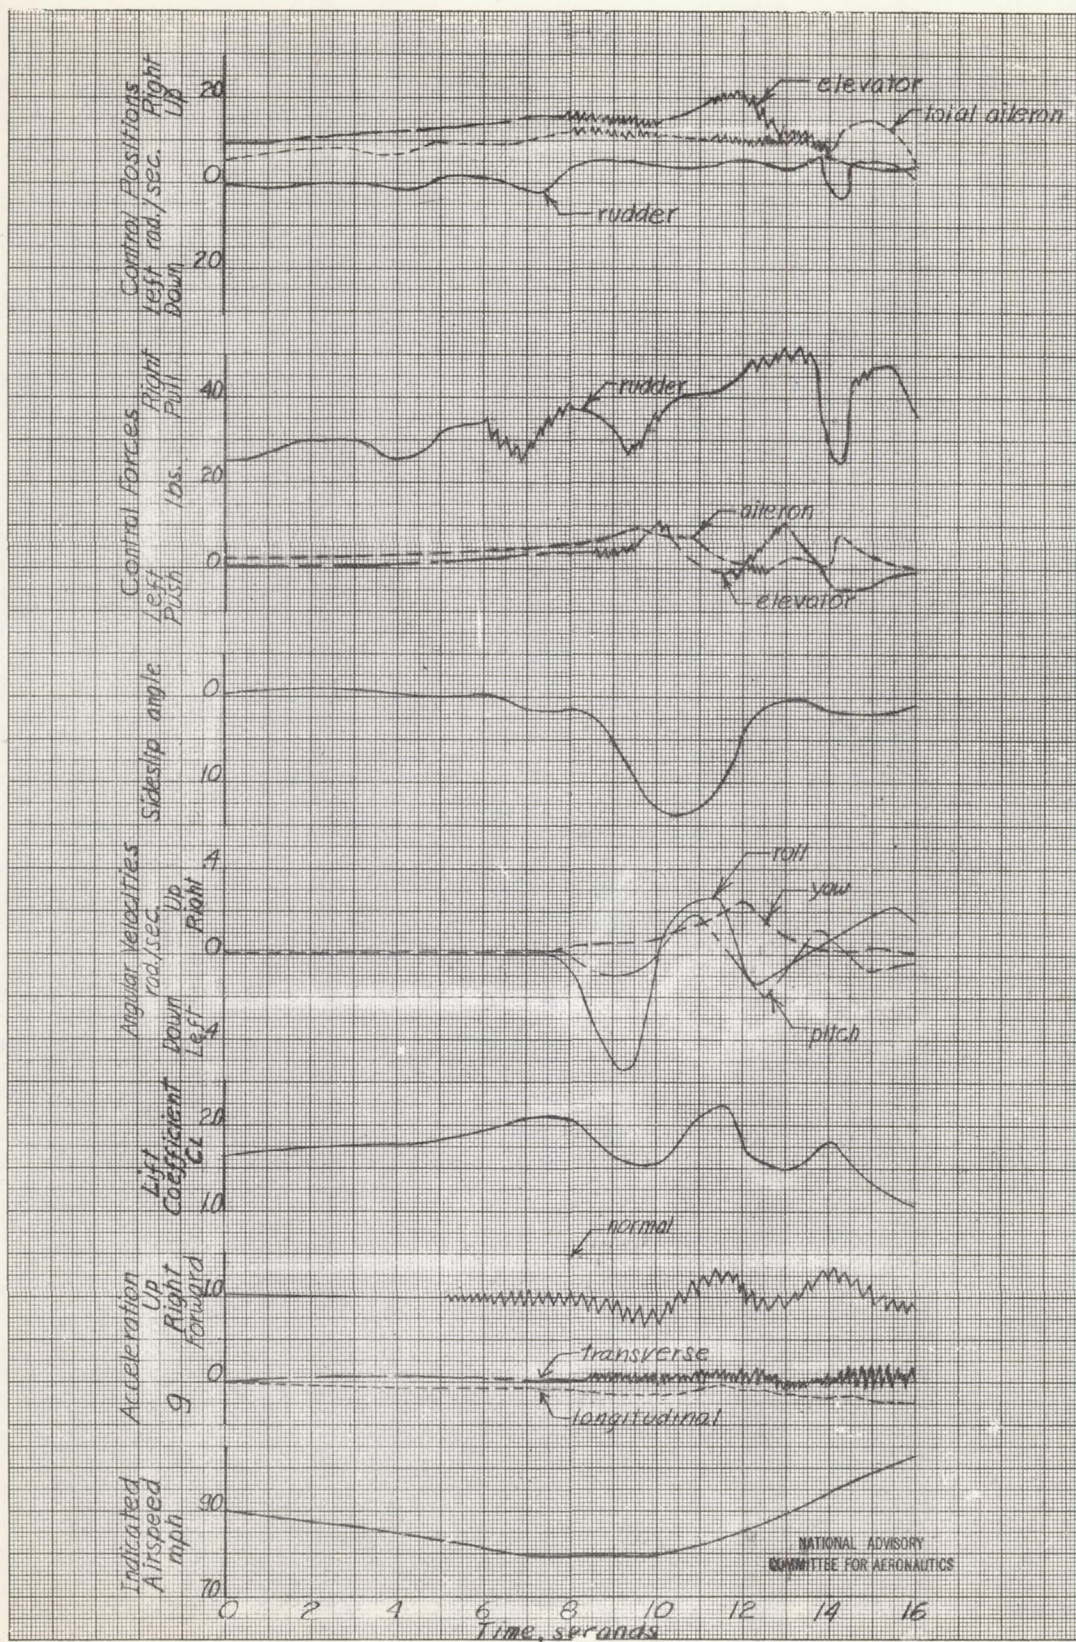
Figure 8. - Time history of a stall in the landing condition in which the pilot attempted to hold the rudder and ailerons fixed after the initial roll-off. F-3 airplane.

(c) In the landing condition (figs. 8 and 9), a duct howl preceded the stall as in the gliding condition and a very mild buffet set in 1 or 2 miles per hour above the stall. As in the gliding and climbing conditions the buffet preceding the stall is noticeable only in a very slow stall approach. The stick-fixed stability was high for this condition and the stick was well back at the stall. The initial roll-off in all cases was to the left. In the control-fixed stall (fig. 8) the initial roll-off was followed by a rolling and pitching oscillation. Figure 9 shows that the pilot in attempting to control the airplane through the stall overcontrolled

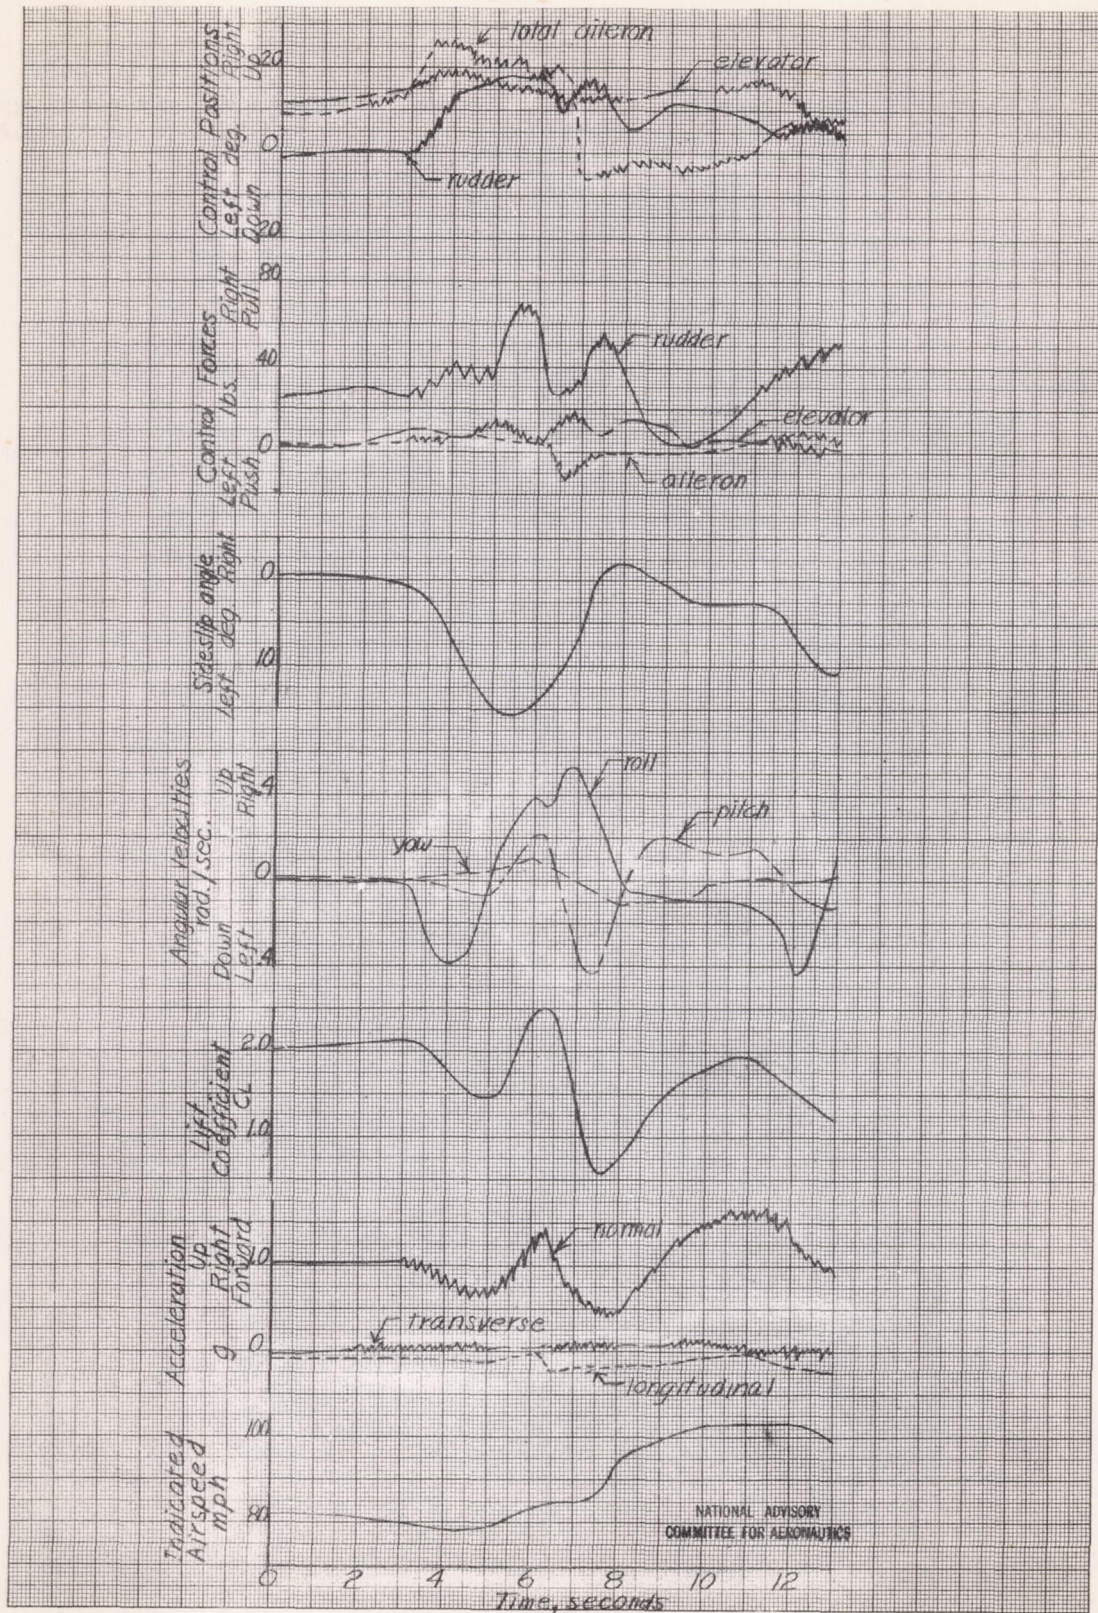
Figure 9. - Time history of a stall in the landing condition in which the pilot attempted to control the airplane through the stall. F6F-3 airplane.

which resulted in more violent motions of the airplane than with control fixed. Maximum lift coefficient varied from 2.15 to 2.25.

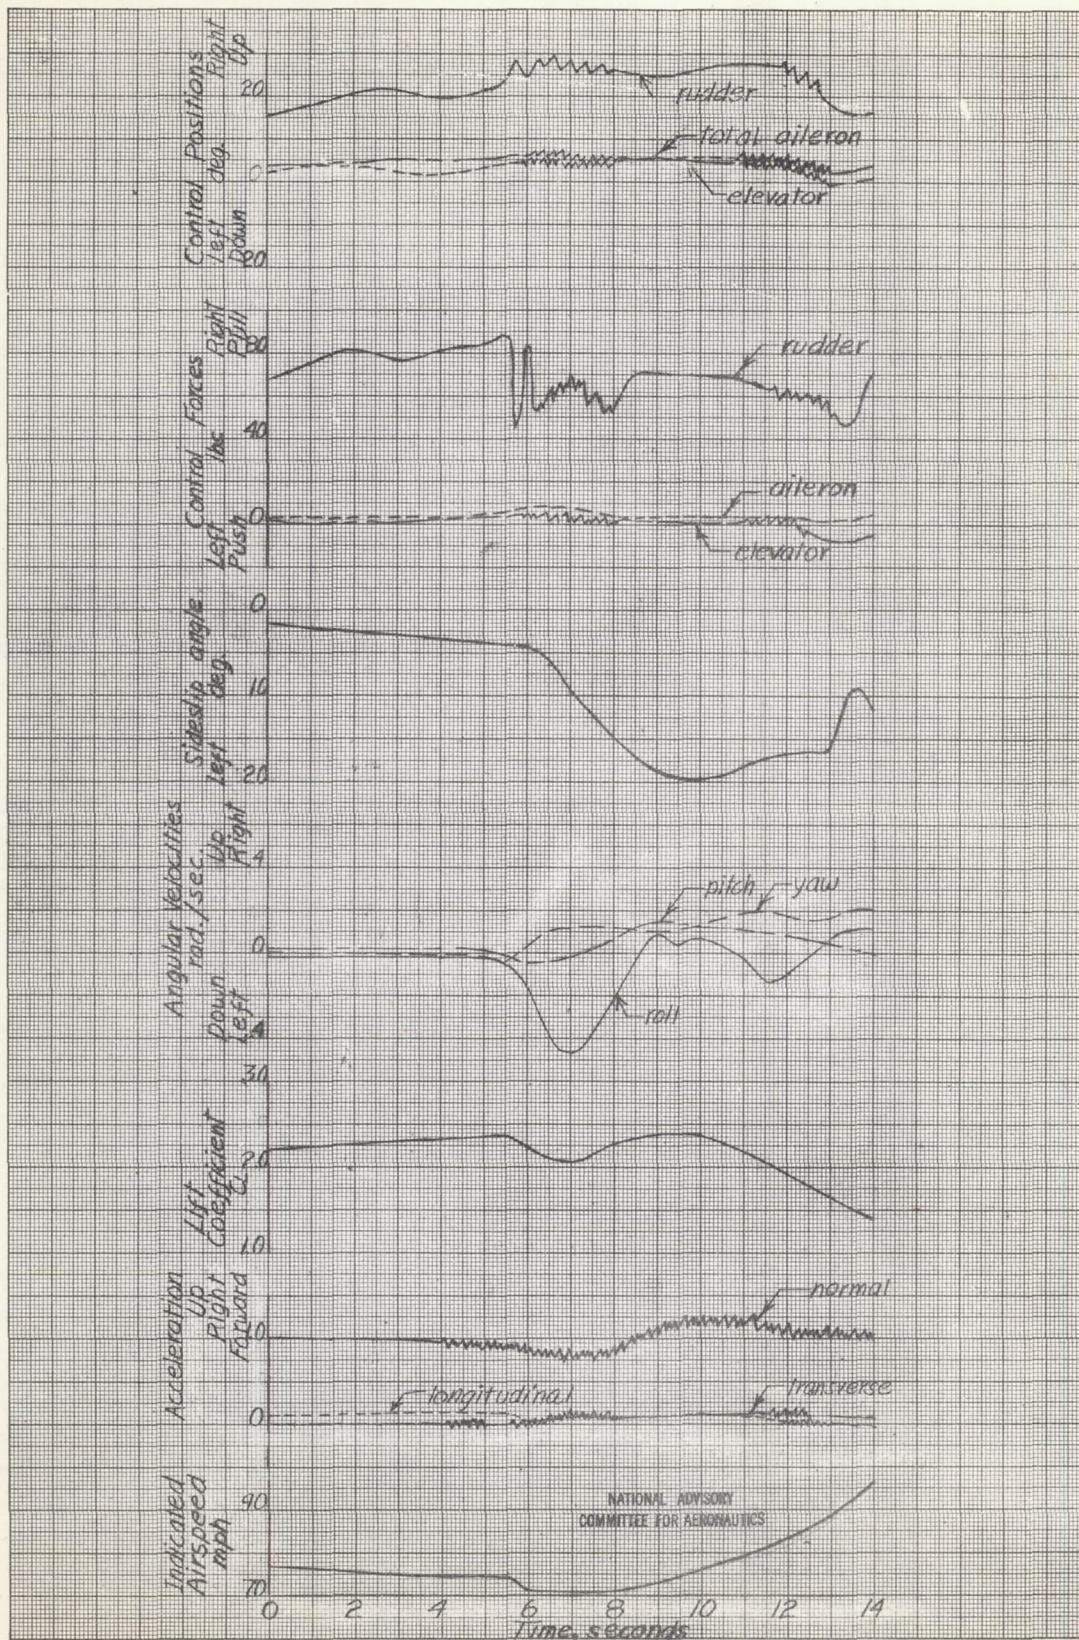
Figure 10. - Time history of a stall in the approach condition in which the pilot attempted to hold the rudder and ailerons fixed after the initial roll-off. P6F-3 airplane.

(d) In the approach condition (figs. 10 and 11) there was no stall warning. The initial roll-off was to the left. After the initial roll-off there was some buffeting of the airplane. A control-fixed stall is shown in figure 10. As shown in figure 11 the initial roll-off could be checked by use of the ailerons. Maximum lift coefficient in the approach condition varied from 2.35 to 2.45.

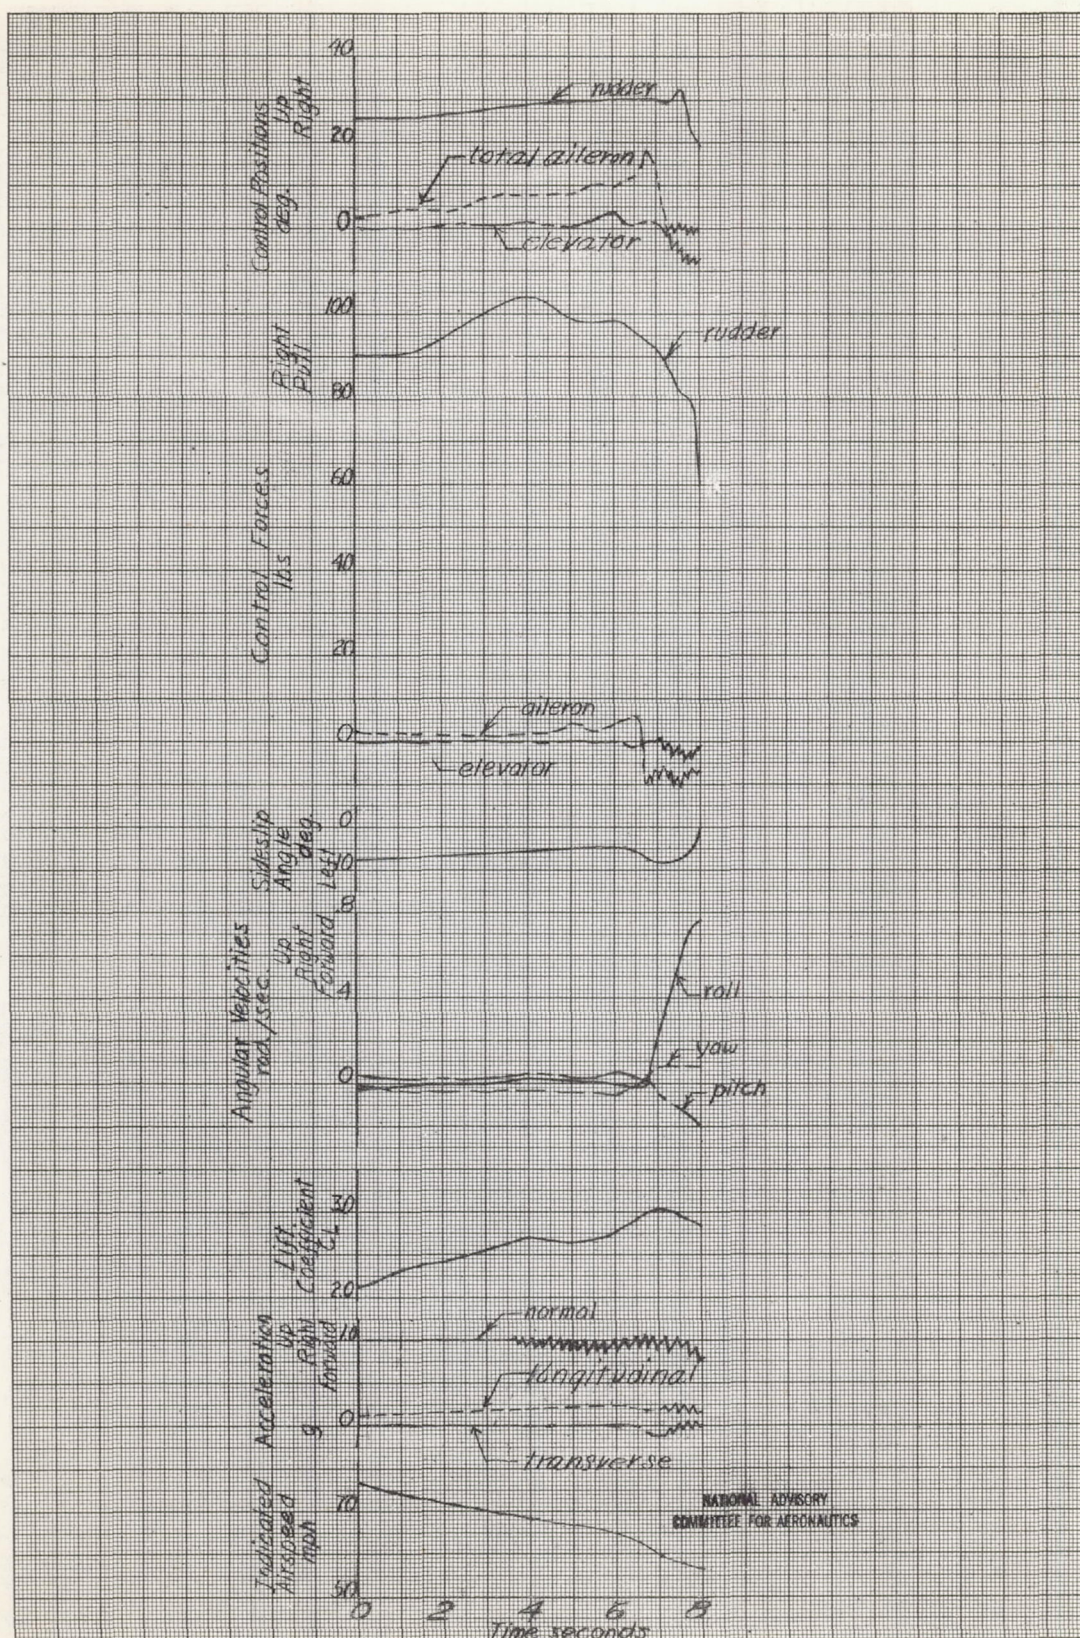
Figure 12. - Time history of a stall in the wave-off conditions. (Recording instruments were turned off after initial roll-off.) F6F-3 airplane.

(e) In the wave-off condition (figs. 12 and 13), there was no stall warning whatsoever. The initial roll-off was to the right and was more severe than in any of the other conditions tested. This roll-off could be checked, however, by use of ailerons and rudder as shown in figure 13. Tuft pictures of the left wing made during the run shown on figure 12 show in figure 15 that the stall begins at the root and progresses outward. It should be noted, however, that the airplane rolled to the right in this run; and, therefore, the stall will be more extensive than that shown in figure 15 for the left wing. Maximum lift coefficient was approximately 3.0 in the wave-off condition.

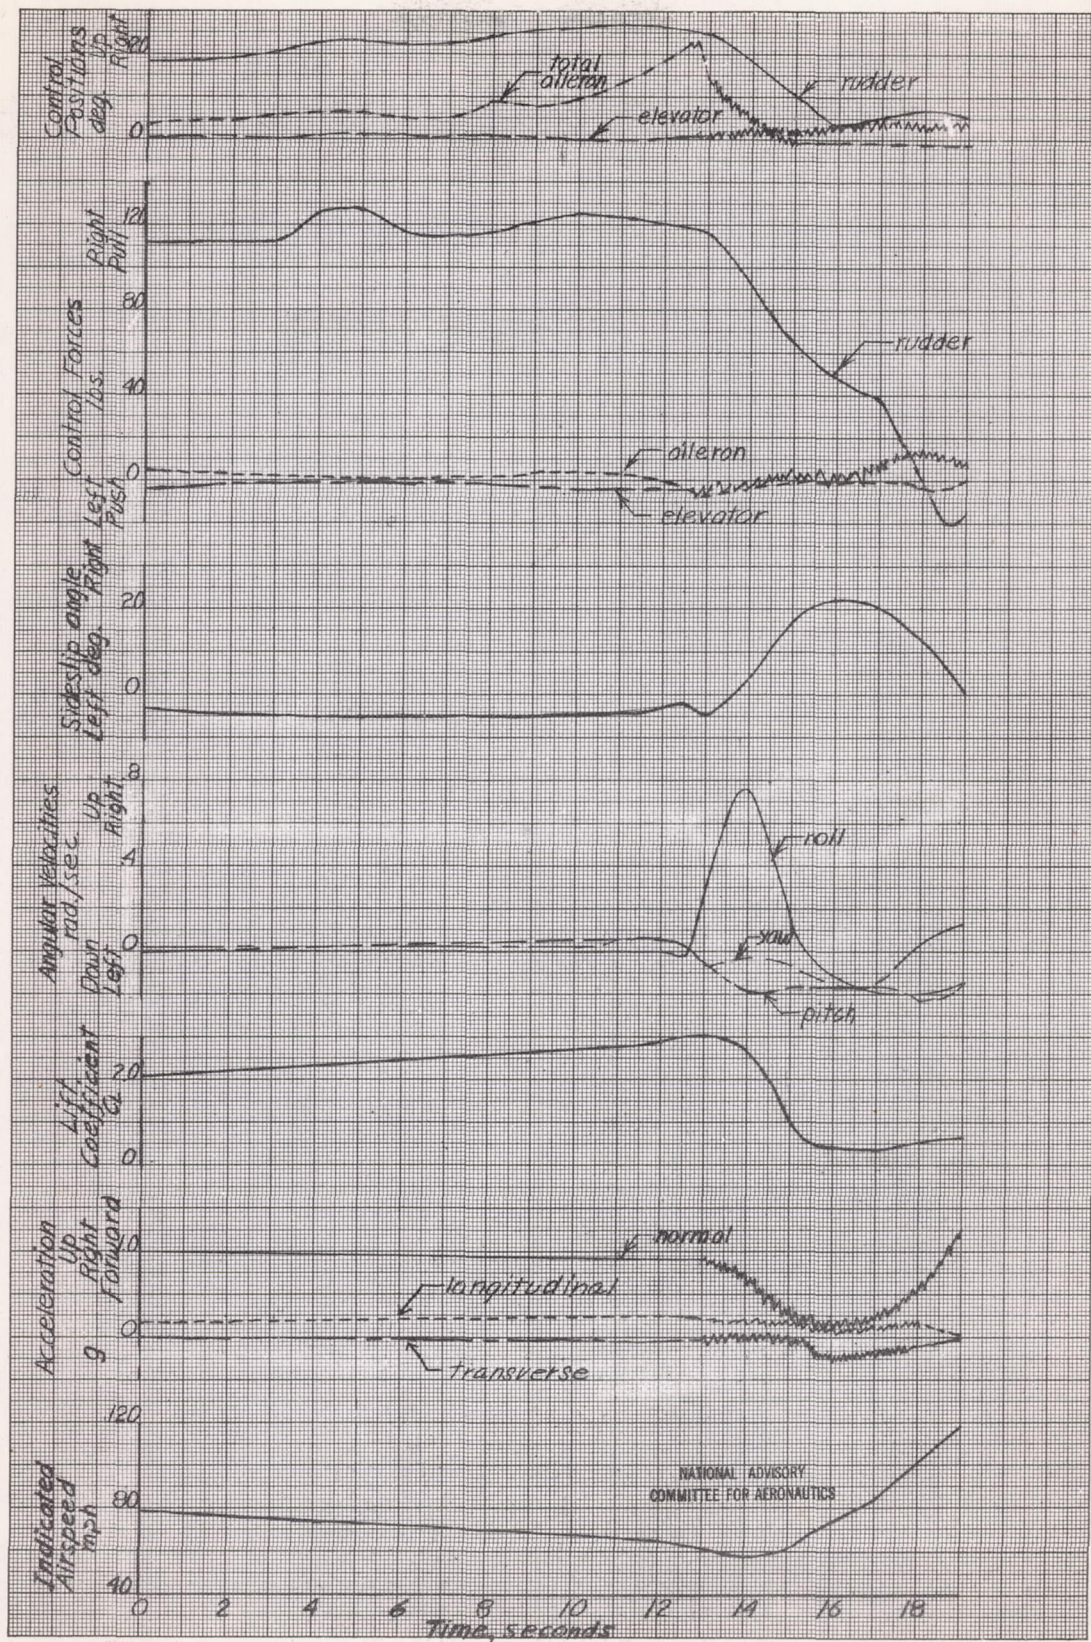
Figure 13. - Time history of a stall in the wave-off condition in which the pilot attempted to control the airplane through the stall. F6F-3 airplane.
