FLIGHT MEASUREMENTS OF THE FLYING QUALITIES

OF AN F6F-3 AIRPLANE (BUAER NO. 04776)

III - STALLING CHARACTERISTICS

By Walter C. Williams and John P. Reeder

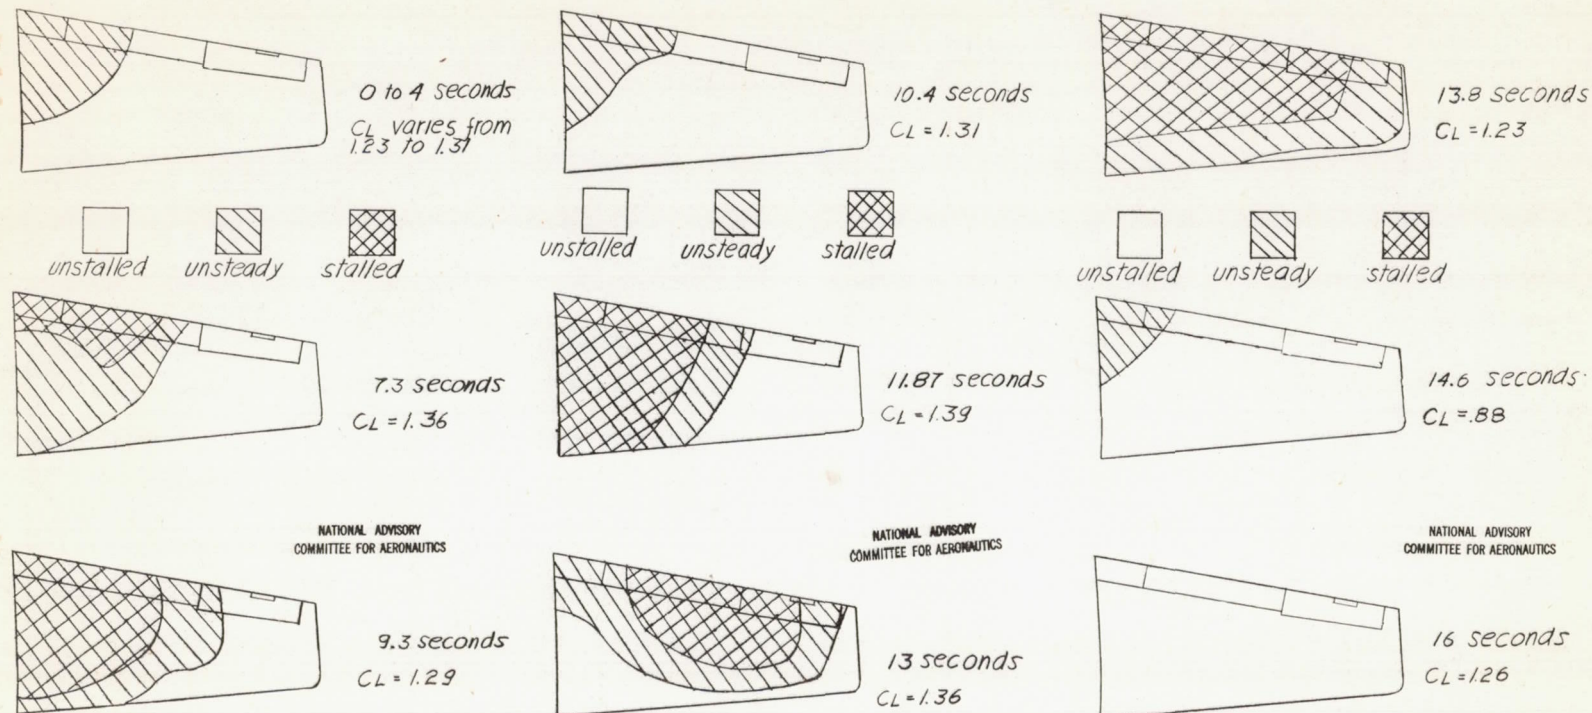
Figure 14.- Tuft studies of left wing during the stall in the gliding condition shown in figure 4. F6F-3 airplane.

Time histories of stall approaches in the various conditions of flight are given in figures 4 to 13. Tuft studies corresponding to figures 4 and 12 are given in figures 14 and 15. The stalling characteristics may be summarized as follows:

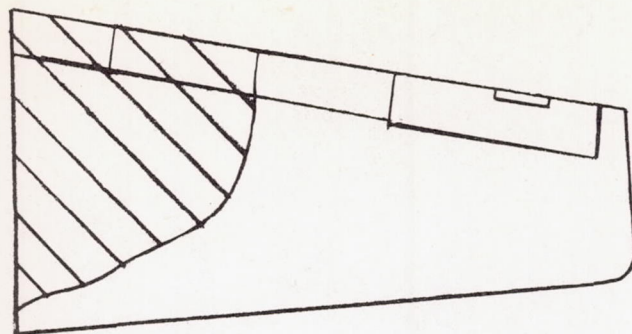
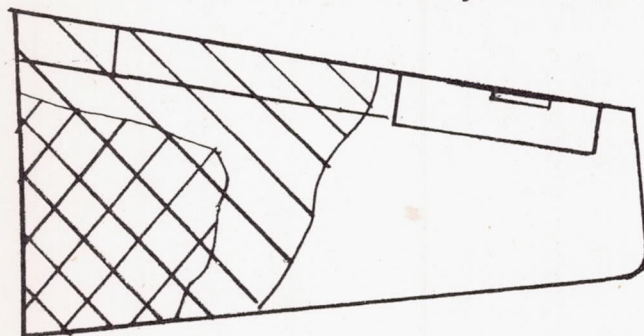
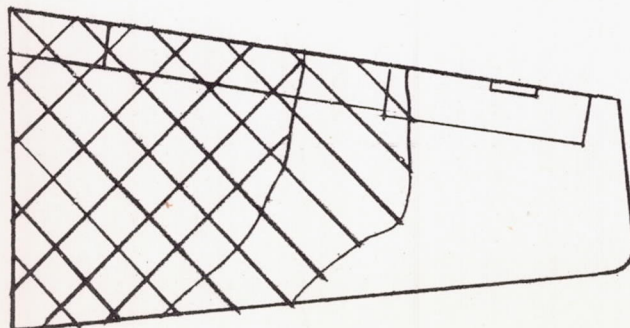
*3 seconds* *$CL = 2.55$*

*unstalled*

*unsteady*

*stalled*

*5.75 seconds* *$CL = 2.70$*

*6.5 - 8 seconds* *CL varies from
2.85 to 3.04*

Figure 15.- Tuft studies of left wing during stall in wave-off condition shown in figure 12. F6F-3 airplane.

(e) In the wave-off condition (figs. 12 and 13), there was no stall warning whatsoever. The initial roll-off was to the right and was more severe than in any of the other conditions tested. This roll-off could be checked, however, by use of ailerons and rudder as shown in figure 13. Tuft pictures of the left wing made during the run shown on figure 12 show in figure 15 that the stall begins at the root and progresses outward. It should be noted, however, that the airplane rolled to the right in this run; and, therefore, the stall will be more extensive than that shown in figure 15 for the left wing. Maximum lift coefficient was approximately 3.0 in the wave-off condition.
