WARTIME REPORT

April 1946 as
Memorandum Report E6C07

TESTS OF CAST ALUMINUM-ALLOY MIXED-FLOW IMPELLERS

By John E. Douglas and Irving R. Schwartz

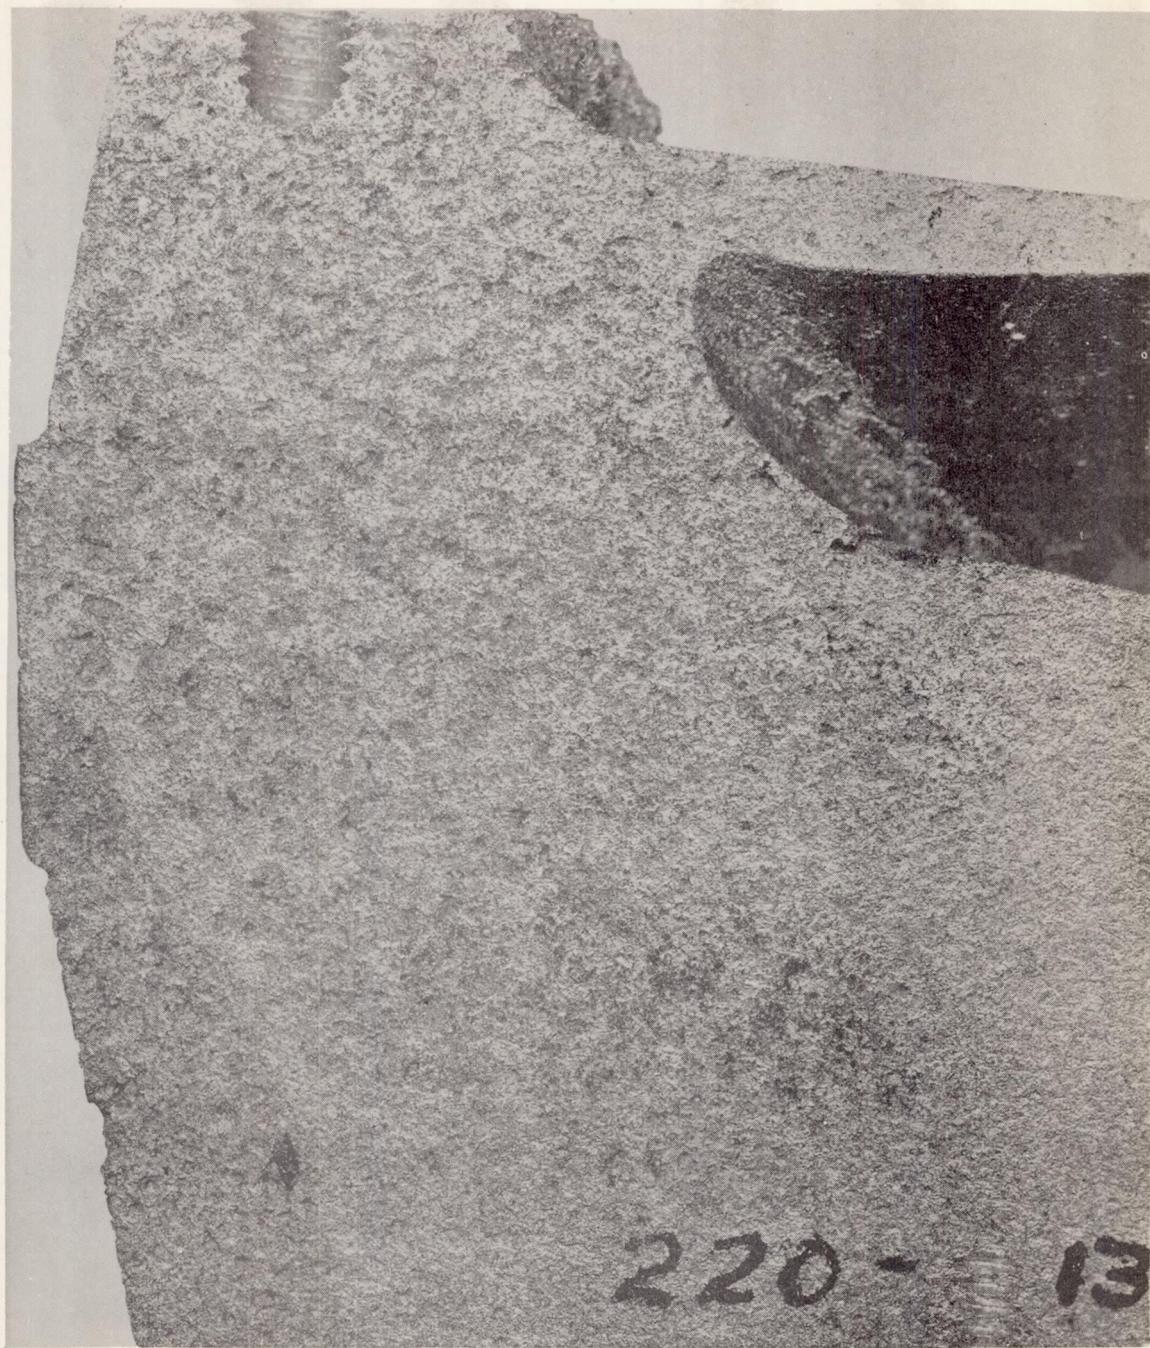
(a) Impeller 1-13.

Figure 6. - Specimens cut from the cast mixed-flow impellers macroetched to show grain structure. X2.25.

Metallurgical examination. - Specimens similar to those used for the internal Brinell hardness determinations were macroetched to examine the grain structure of the cast impellers. The macroetched specimens from typical impellers (1-13 and 2-9) are shown in figure 6. The specimen from impeller 1-13 shows a granular grain structure, porosity, and evidence of segregation, all of which would reduce the physical strength of the impeller. (The tensile strength was less than 70 percent of Navy specifications.) The specimen from impeller 2-9 shows porosity, blowholes, and shrinkage cracks and the grain structure was somewhat dendritic.

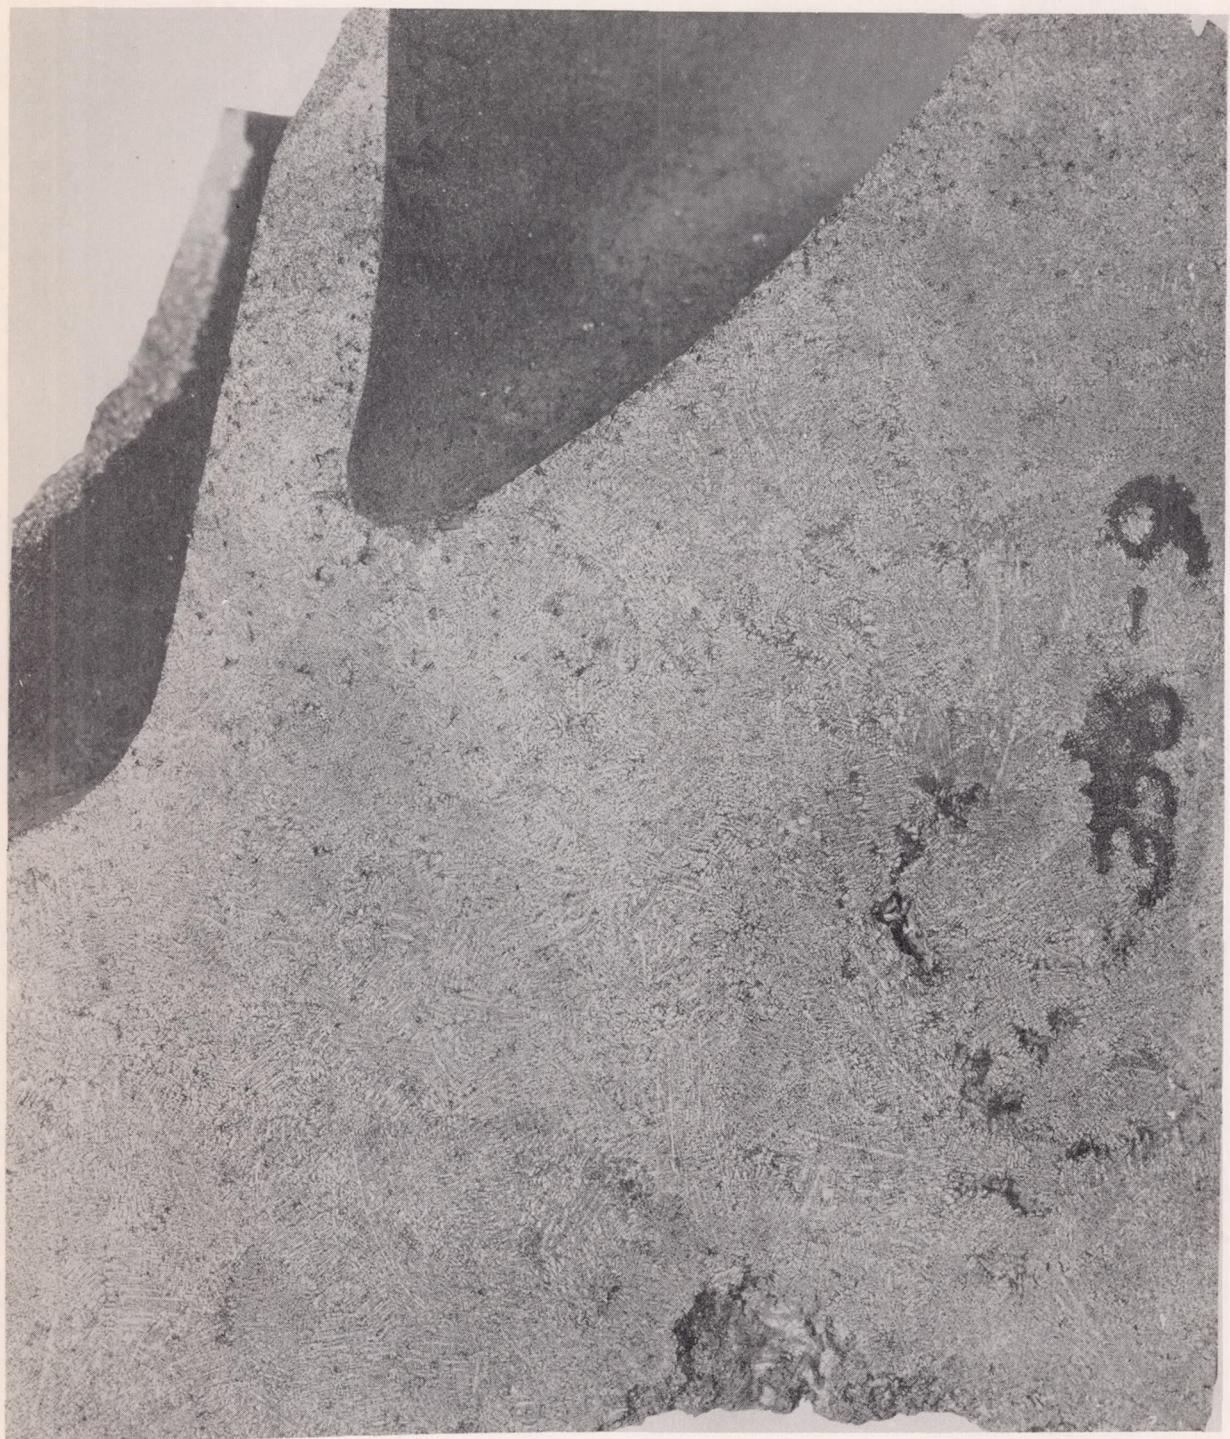
Figure 6. - Concluded.

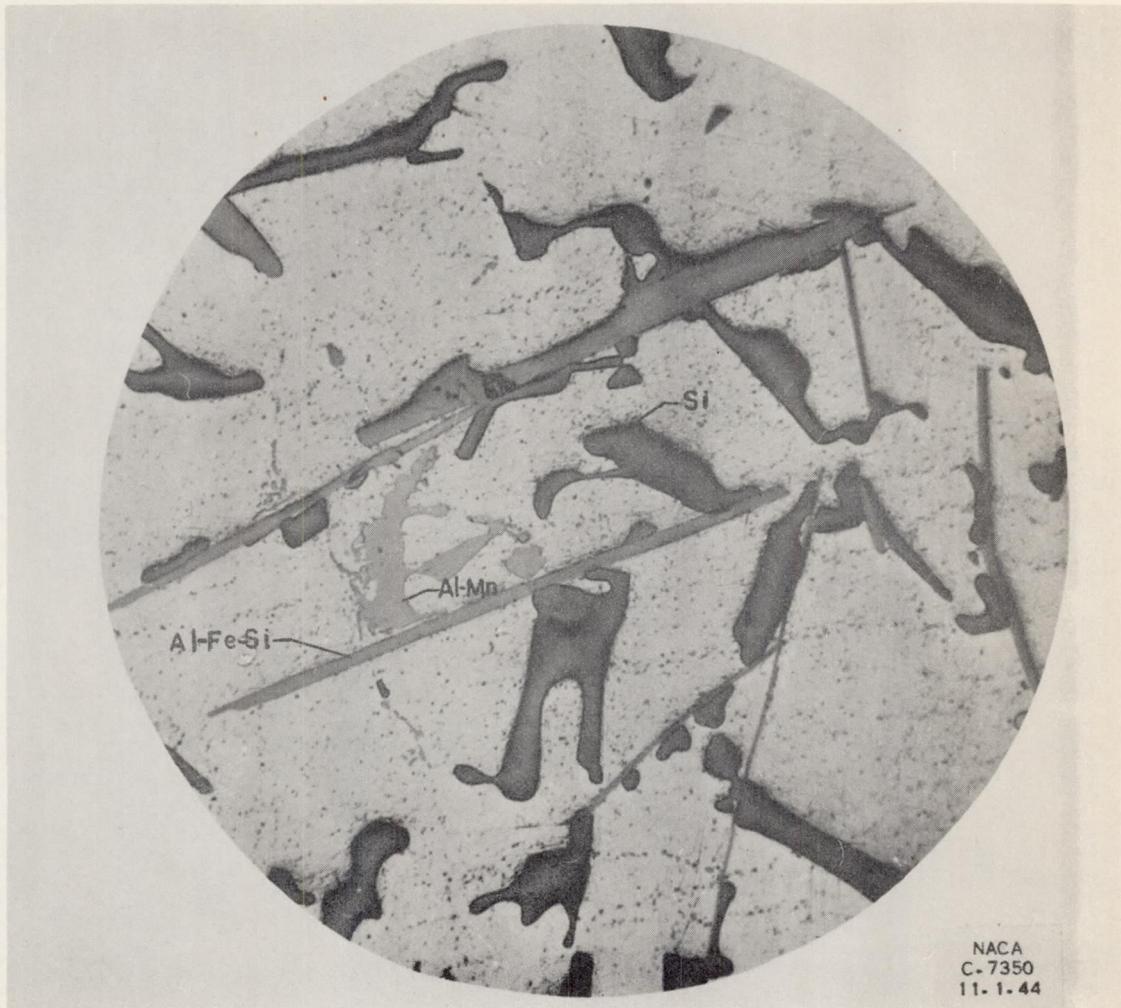
(a) From top of impeller 2-23. Etched in hydrofluoric acid.

Figure 7. - Etched specimens cut from various impellers showing porosity. X500.

The structure of the alloys was further examined from photomicrographs of specimens cut from various portions of the cast impellers. A typical photomicrograph of a specimen of alloy 2 is shown in figure 7(a). The photomicrograph of the specimen showed that aluminum combined with impurities to form Al-Mn and complex compounds of Al-Fe-Si. The free silicon that came out of solution on cooling appears to be fairly uniformly distributed. The photomicrograph in figure 7(b) is of a specimen taken from the top of impeller 1-11 and shows complex compounds of Al-Fe-Mn-Co-Si and Mg₂Si and Al₂O₃. The fine porosity characteristic of this alloy is shown for impeller 1-11 at a magnification of 500 diameters in figure 7(b) and for impeller 1-15 at a magnification of 100 diameters in figure 8. The solid black areas indicate porosity. In general, the photomicrographs show that the impellers are of the normal structure with the maximum permissible amount of impurities.
