FLIGHT TESTS OF THERMAL ICE-PREVENTION

EQUIPMENT IN THE XB-24F AIRPLANE

By Carr B. Neel and Alun R. Jones

MEMORANDUM REPORT

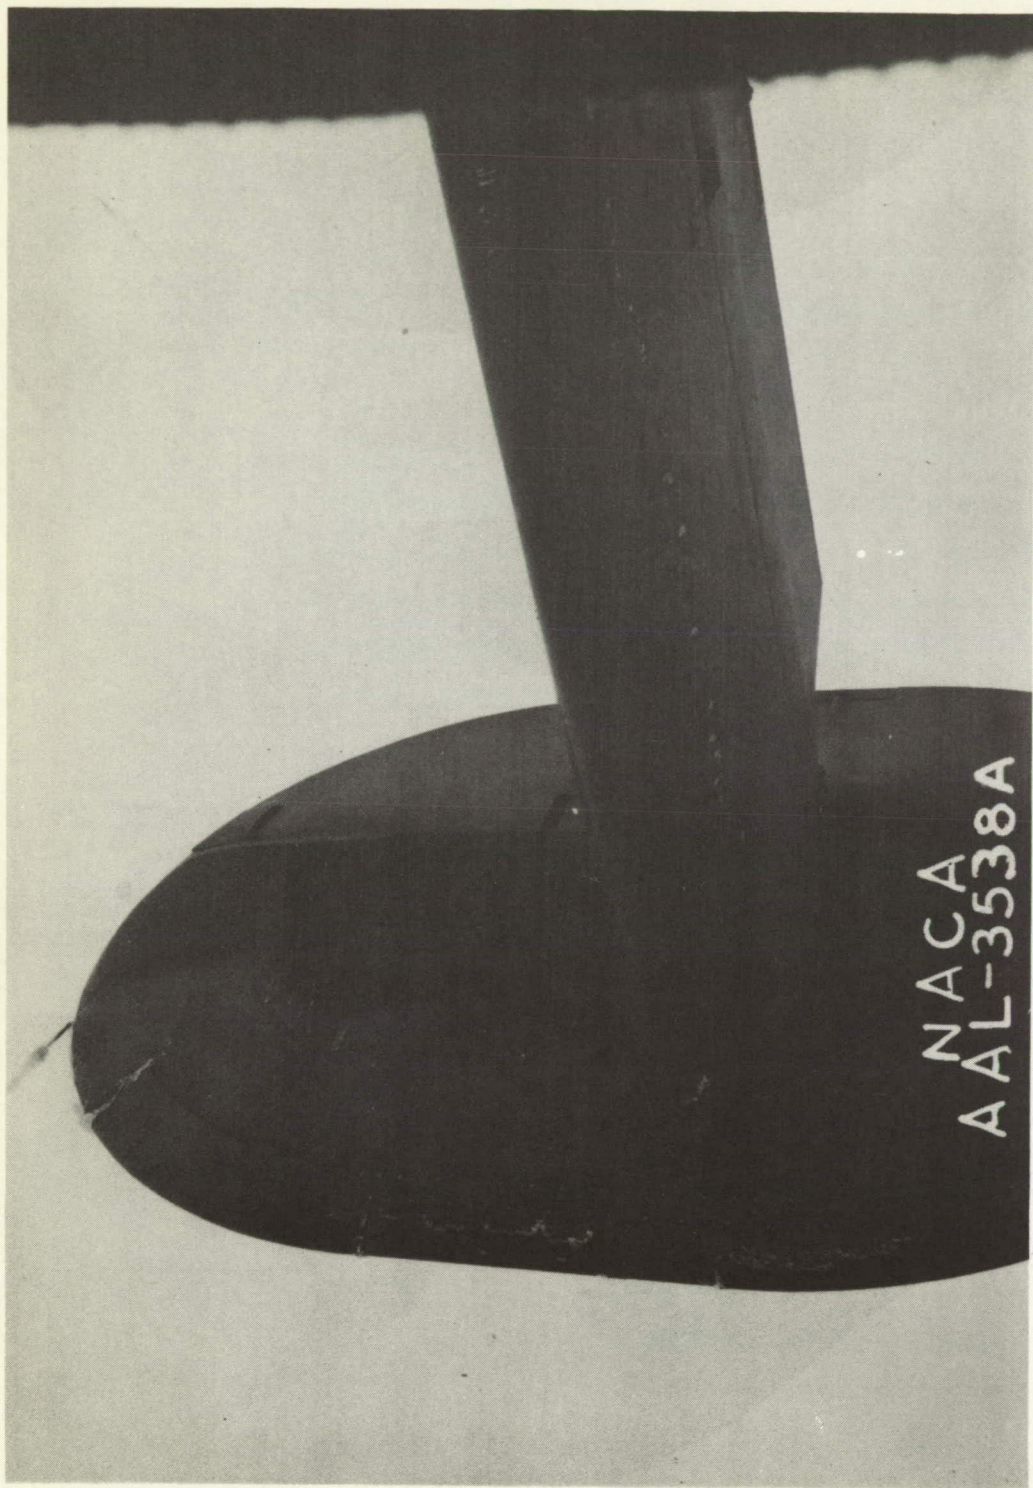
Figure 14.- Right horizontal stabilizer and vertical fin during flight in glaze icing conditions. Test 9.

Ice formations aft of the leading edge on the under surface of the horizontal stabilizer were observed in some flights and are shown in figures 14 and 15. Ice was not observed to form at any time in the vicinity of the elevator hinges or on the elevator surfaces, which were not heated. In most of the flights ice formed on the central portion of the fin leading edge, the top and bottom sections remaining clear (figs. 15 and 16). An attempt was made to improve the heating of the central region by reducing the internal obstruction to air flow in that vicinity, but only slight improvement was obtained. In the test flight at an air temperature of -3° F, ice formed along the entire fin leading edge as shown in figure 11. In test 12 the central portion of the leading edge (shown covered with an ice formation during flight at cruising power in fig. 15) was maintained in an intermittently cleared

In some of the test flights, slight ice formations were observed on the sides of the fins aft of the leading edge, as shown in figures 14 and 17. The rudder hinges and surfaces, which were not heated, were observed to be clear of ice at all times.

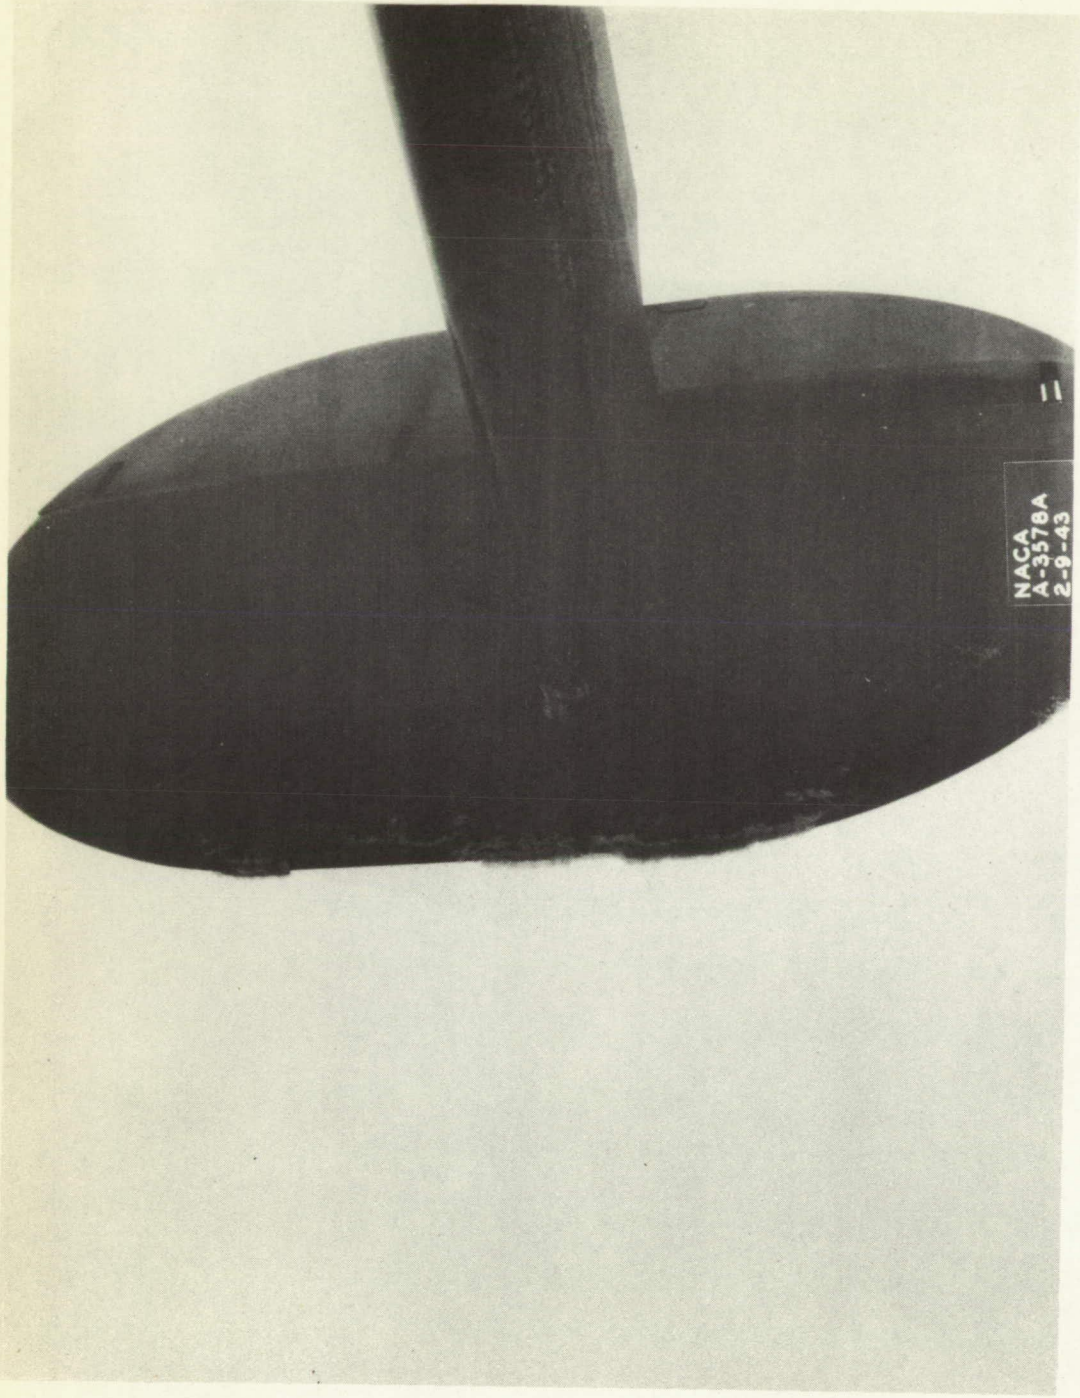
Figure 16. - Right horizontal stabilizer and vertical fin during a flight in rime icing conditions.
Test 12.

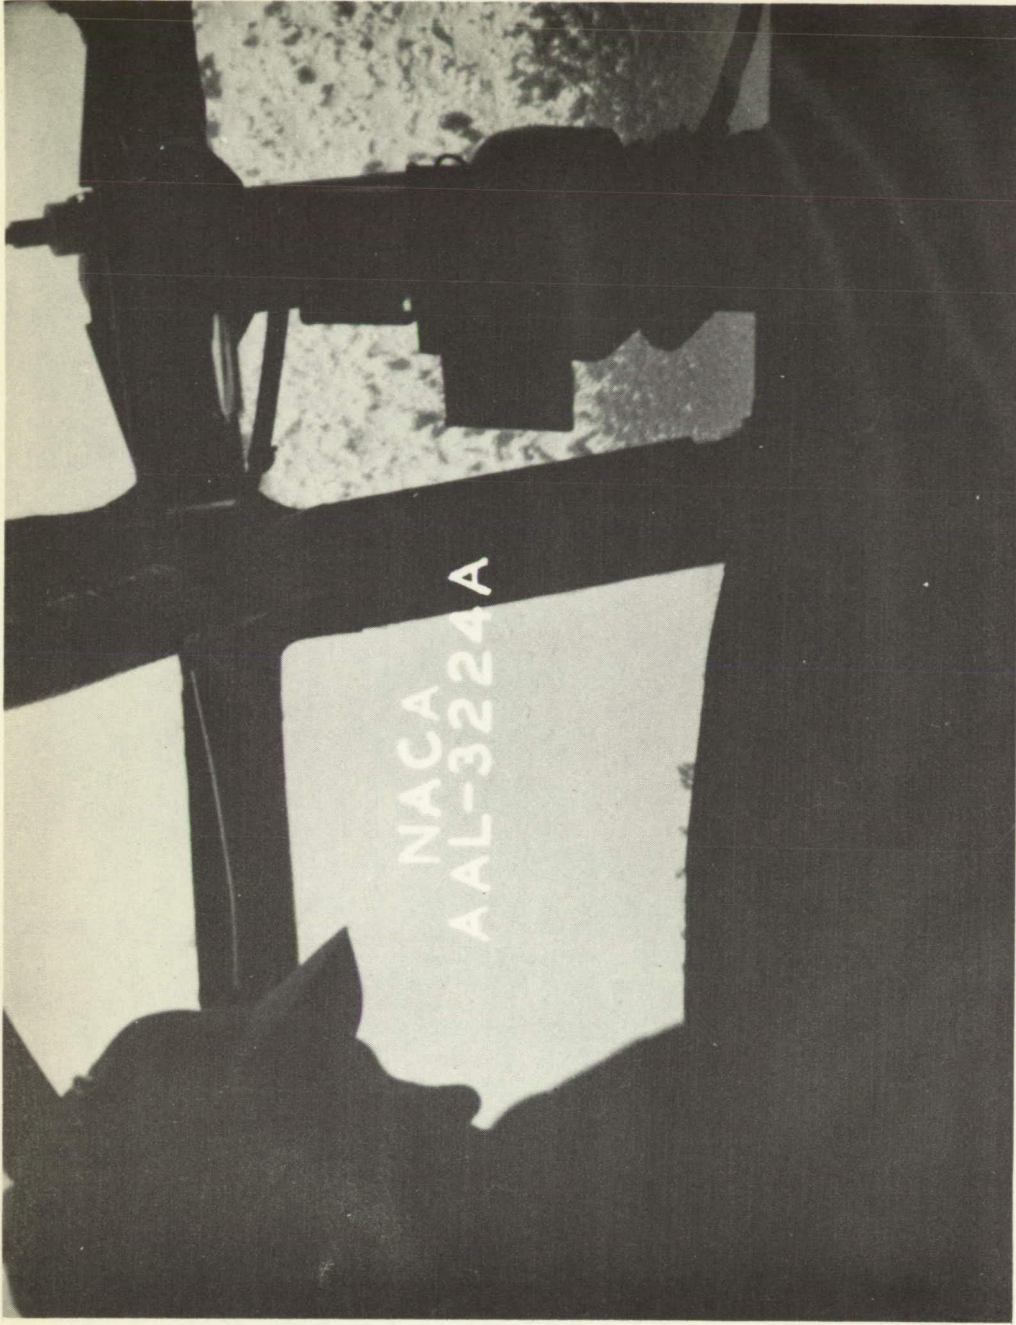
Figure 18.- Pilot's and center windshields during a flight in icing conditions. Note ice formations on unheated center pane. Test 15.

With the final windshield arrangement (glass inner panel, blower in the windshield supply duct, and shut-off valve in copilot's supply duct) ice was prevented from forming on the pilot's windshield during all icing conditions encountered. For the copilot's windshield the degree of protection afforded varied during the tests, being dependent upon the heated air available after the pilot's windshield had been supplied. Figures 18 and 19 show the pilot's and copilot's windshields during a typical icing flight. Frost on the exterior and interior of the pilot's and copilot's windshields, which had formed with the airplane at rest, was readily removed by the heated-air system during ground warm-up.

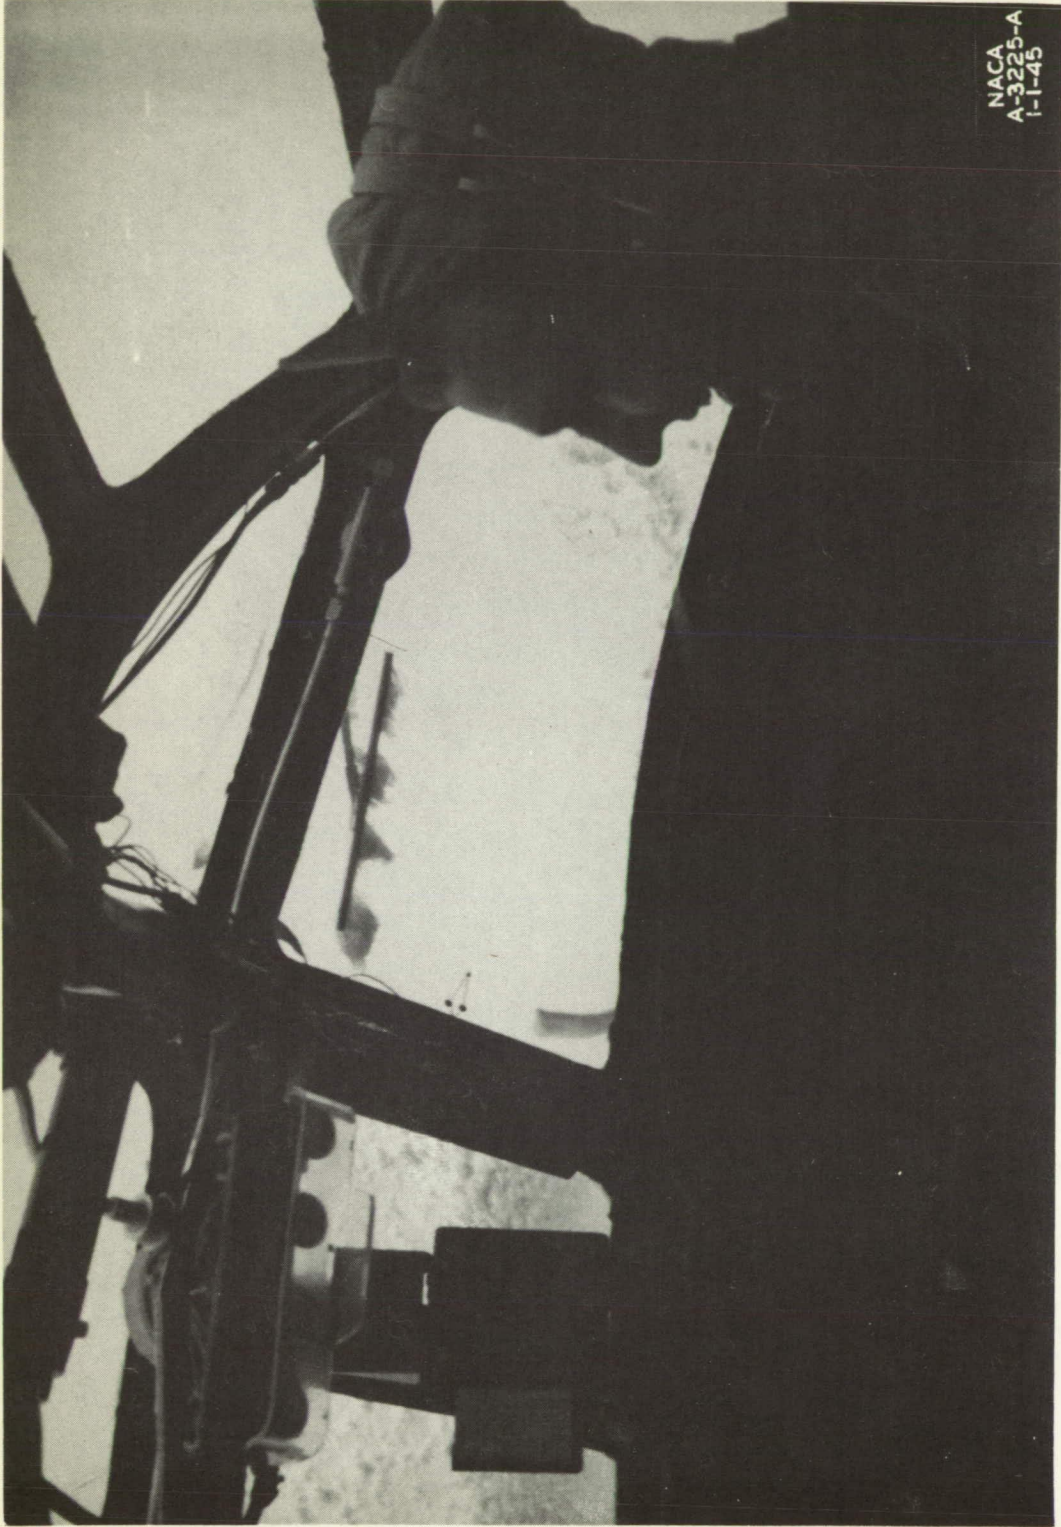
Figure 19. - Copilot's and center windshields during a flight in icing conditions. Test 15.

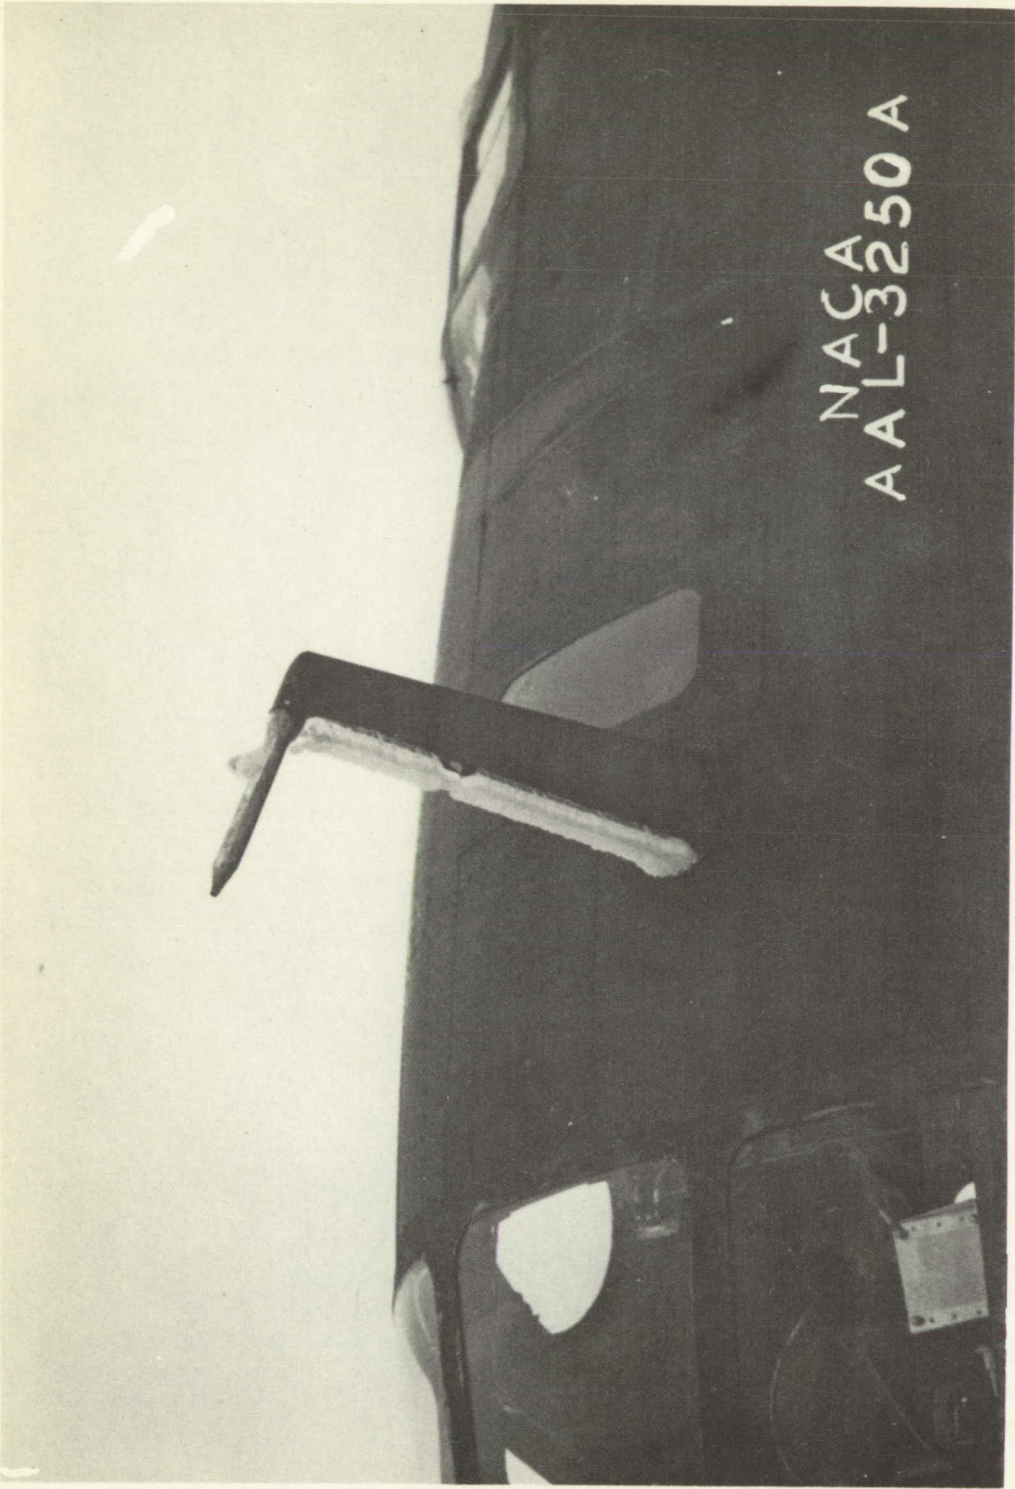
Figure 20.- A rime-ice formation on the left airspeed
mast after test 16.

During all of the icing conditions encountered, the electrically heated pitot-static airspeed head was maintained free from ice accumulations. Formations occurred on the airspeed mast, however, which may have been of sufficient magnitude to

affect the airspeed indicator and altimeter readings. (See fig. 20.) Accordingly, a second source of static-pressure reference was established, which consisted of two interconnected static orifices flush-mounted on opposite sides of the fuselage about midway between the trailing edge of the wing and the leading edge of the stabilizer. An airspeed indicator was connected to the static pressure from these fuselage vents and to an electrically heated total head located at the nose of the airplane. This installation gave reliable airspeed readings under all conditions encountered.

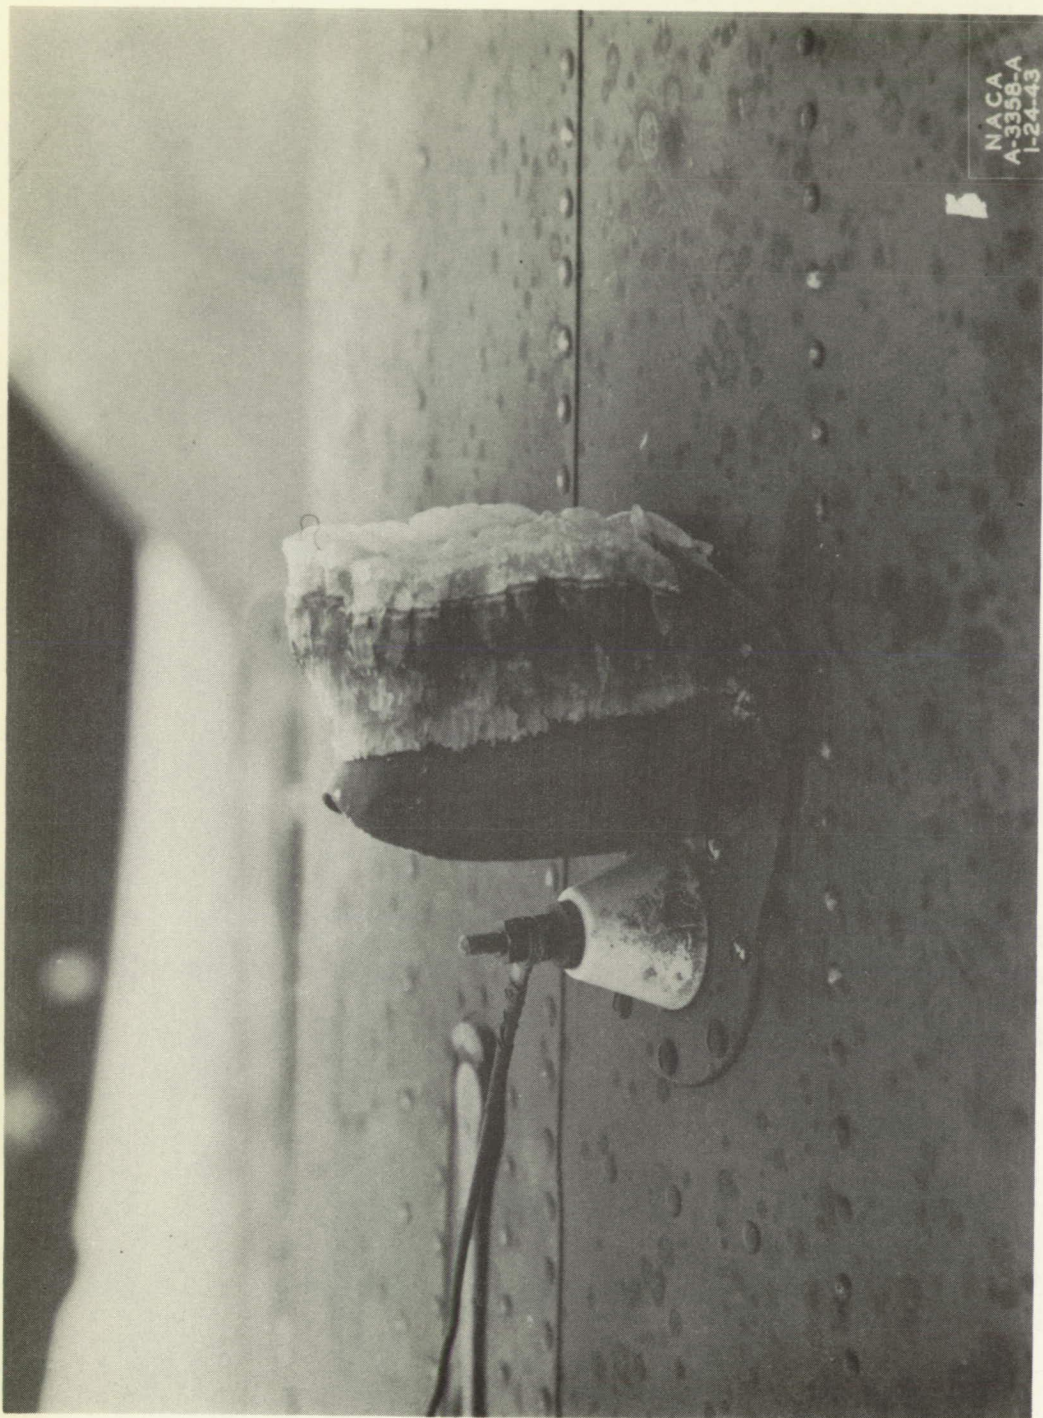
Figure 22. - A rime-ice formation on the antenna insulator shield. The black streaks through the ice are caused by smoke particles. Tests 7 and 8.

For the flights in icing conditions the service radio antenna was replaced with a 1/16-inch steel cable which was rubber-covered to reduce radio static interference. With the exception of occasional precipitation static interference, radio reception was maintained during all of the flights in icing conditions irrespective of heavy ice formations on the antenna wire. The steel cable had sufficient strength to carry ice formations on the wire as large as 2 inches in diameter. Figure 17 shows the radio antenna successfully carrying a very heavy ice formation. Ice also formed on the antenna anchor insulators, as shown in figure 21. Aluminum shields were placed in front of the antenna lead-in insulators to prevent ice formations from providing an electrical connection between the antenna and the airplane structure. An ice formation on one of the insulator shields is shown in figure 22.

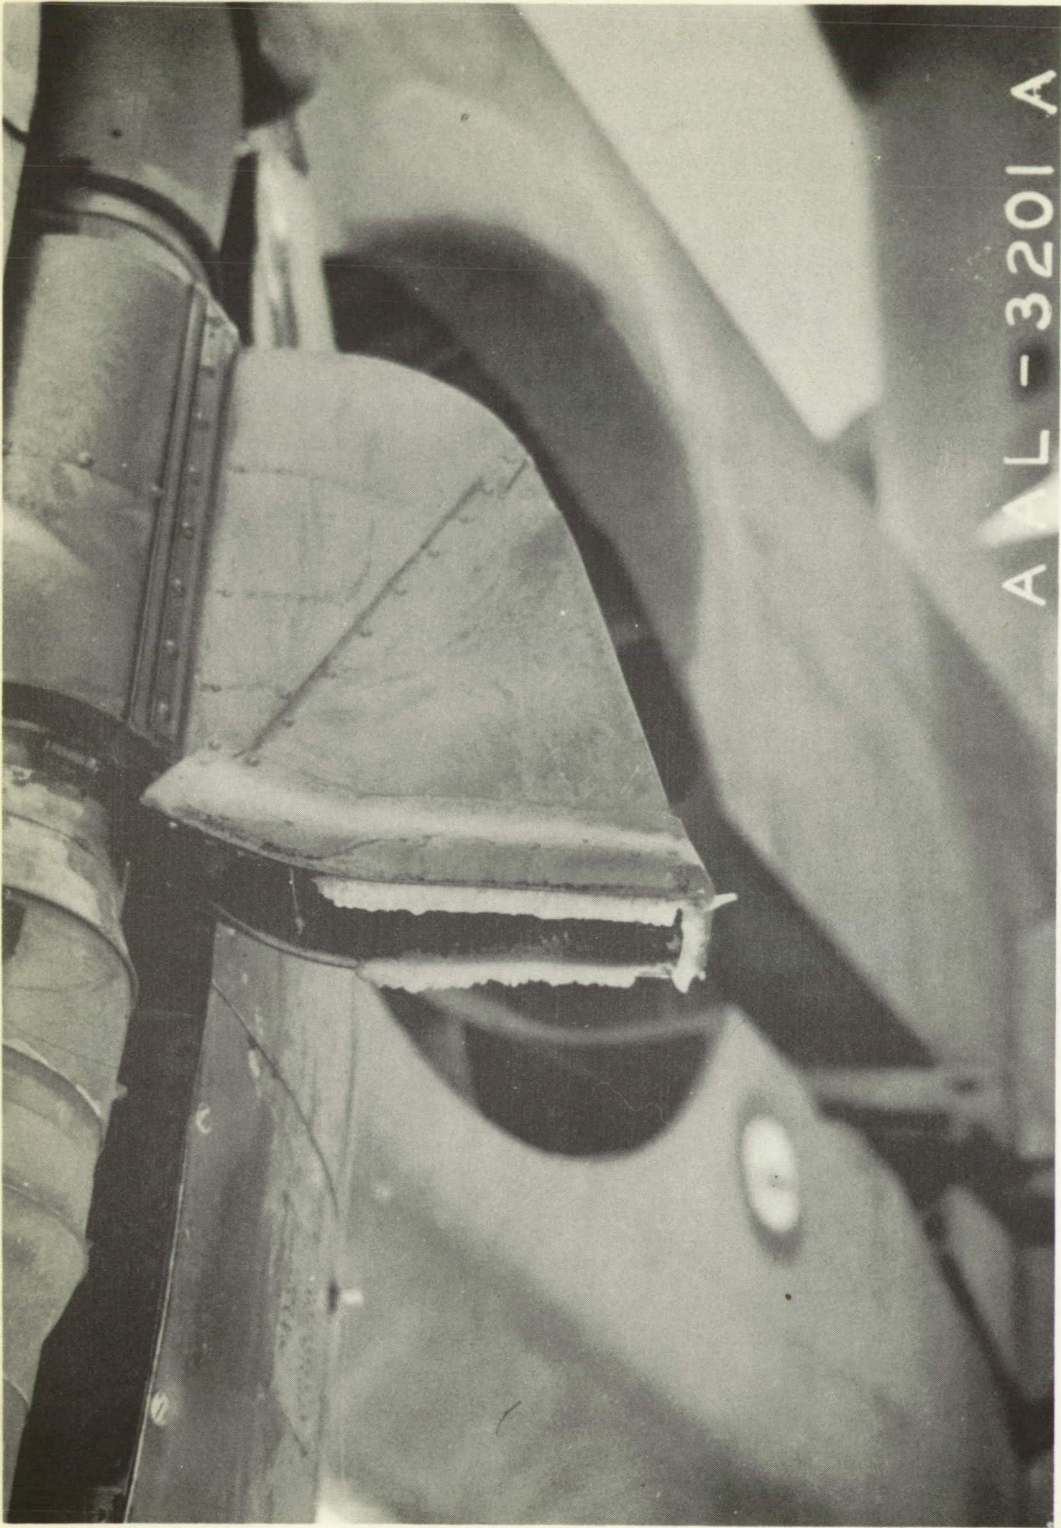
Figure 23.- Rime-ice formations on the heated lips of an
air-intake scoop. Test 13.

Ice formed on the heated lips of the heat-exchanger air-intake scoops in all of the tests, as shown in figure 23.

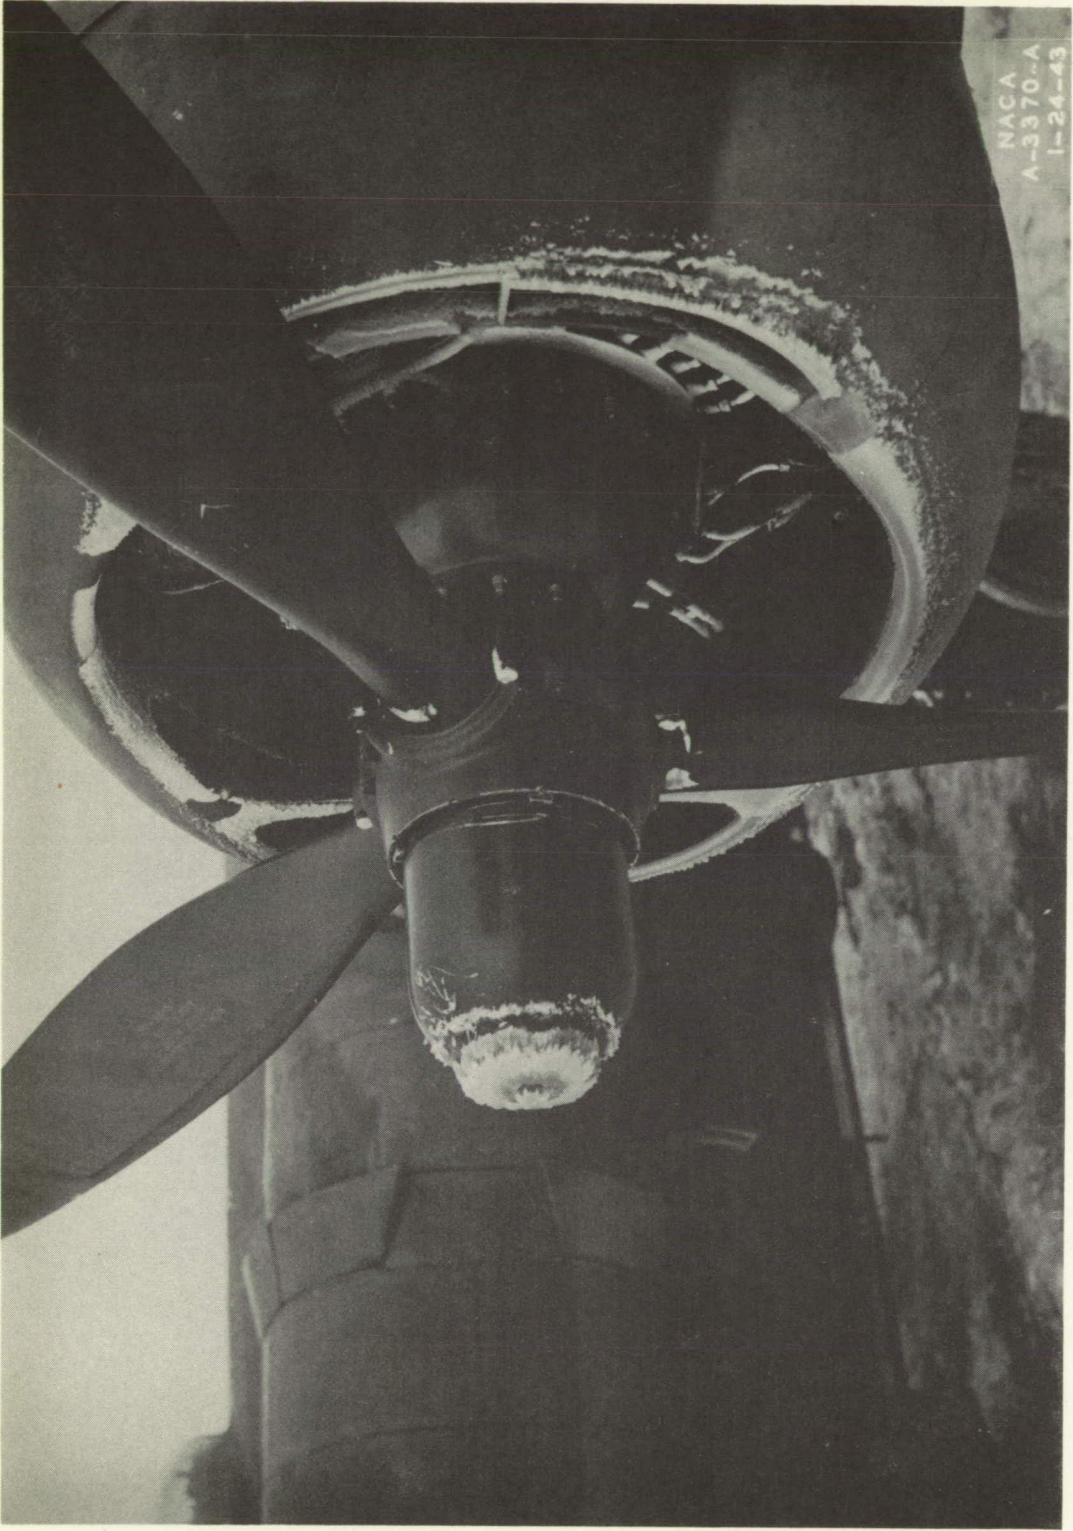
Figure 24. - Rime-ice formations on the propeller spinner and engine-cowl leading edges. Test 7 and 8.

The need for further extension of the ice-prevention equipment is evident from a consideration of figures 24, 25, and 27. In the case of the leading edges of the engine cowls (fig. 24) continuous flight in icing conditions resulted in an area reduction of the carburetor, oil cooler, and intercooler air intakes of approximately 50 percent. Obviously stoppage of these openings would terminate the flight irrespective of the satisfactory operation of other parts of the ice-prevention equipment. The protection of the air inlet to the heat exchanger should also be given considerable attention in the design.

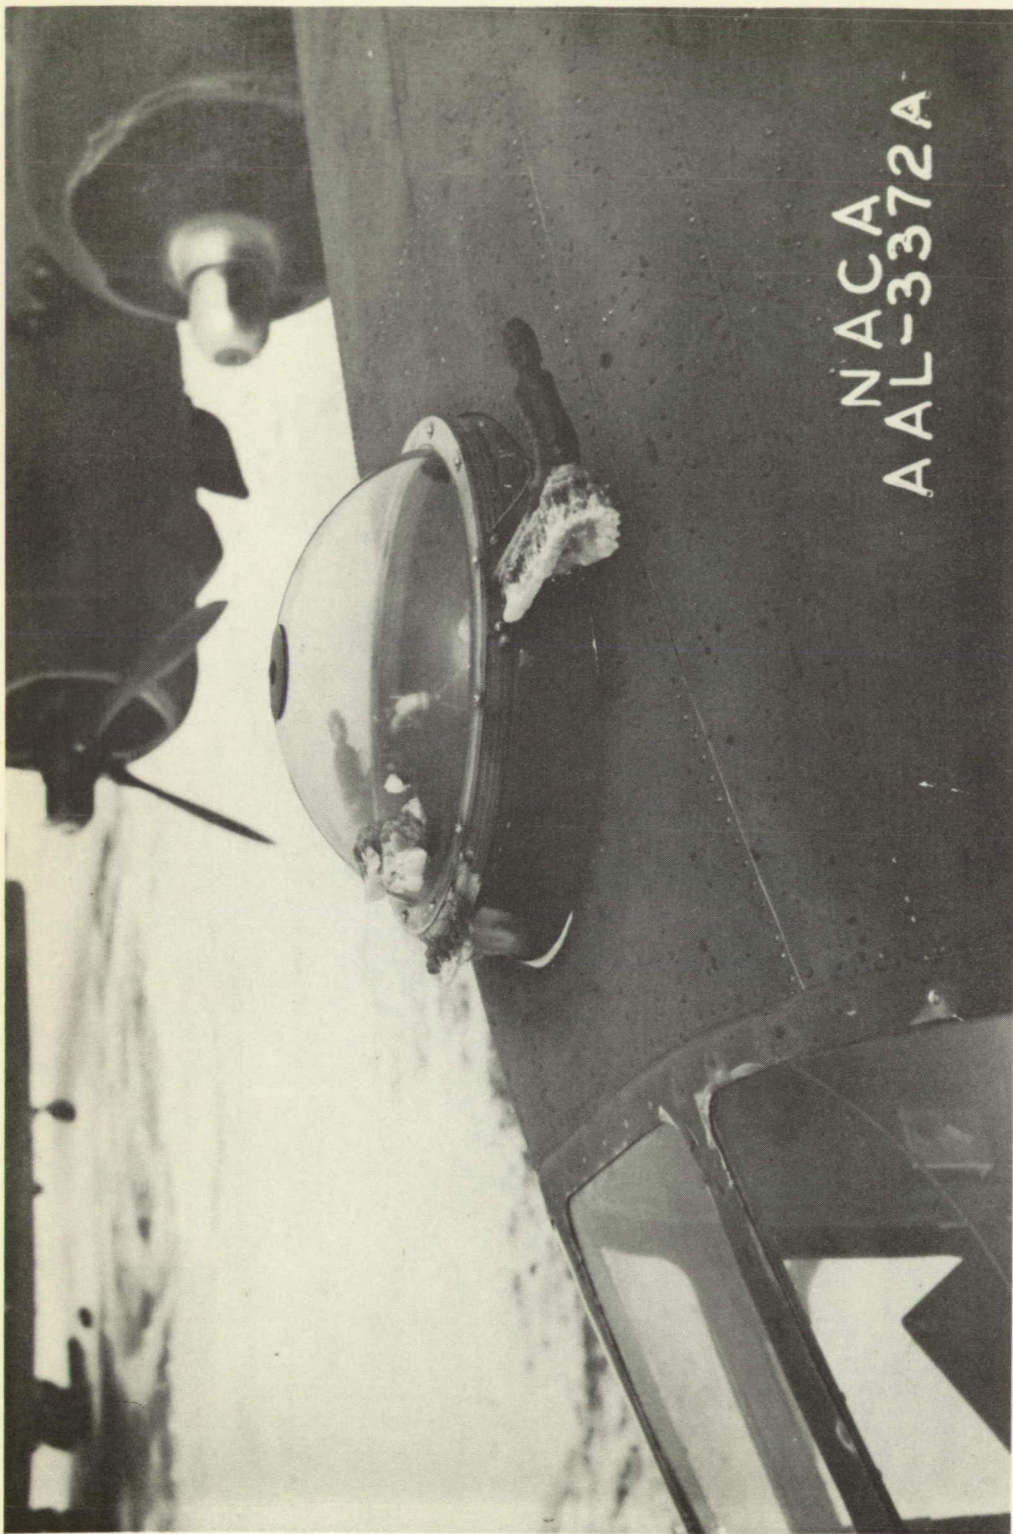
Figure 26.- Rime-ice formations on the astrorodome and a protuberance from it. These accretions were about 3 inches thick. Tests 7 and 8.

Ice accumulations on the unheated surfaces and protuberances of the airplane are shown in figures 20, 21, 22, and 24 to 28.
