**ADVANCED TURBINE TECHNOLOGY
APPLICATIONS PROJECT (ATTAP)
1992 ANNUAL REPORT**

Engineering Staff of
Garrett Auxiliary Power Division
A Unit of AlliedSignal Aerospace Company

March 1993

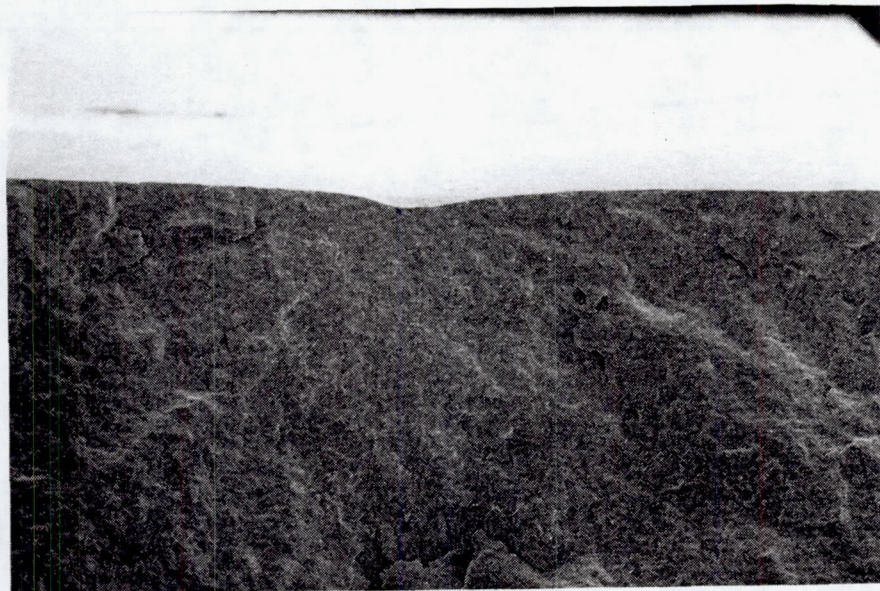
Figure 26. As-Processed SN-88 Specimen Failure Originating From Surface Pit.

The SN-88 specimen fractures originated predominately from the as-processed surface. The primary fracture-originating flaws were pits in the as-processed surface (Figure 26). Several surface failures from large silicon nitride grains, usually associated with a surface pit, were also noted (Figure 27). A few specimens exhibited internal failure origins. In these instances, the fracture-originating flaws were either silicon nitride grains or porous areas, similar to the internal failure origins documented previously for the machined SN-88 flexural strength specimens.
