SPACE ENVIRONMENT DURABILITY OF BETA CLOTH IN LDEF
THERMAL BLANKETS

Roger C. Linton, Ann F. Whitaker, and Miria M. Finckenor
NASA George C. Marshall Space Flight Center
Marshall Space Flight Center, AL 35812

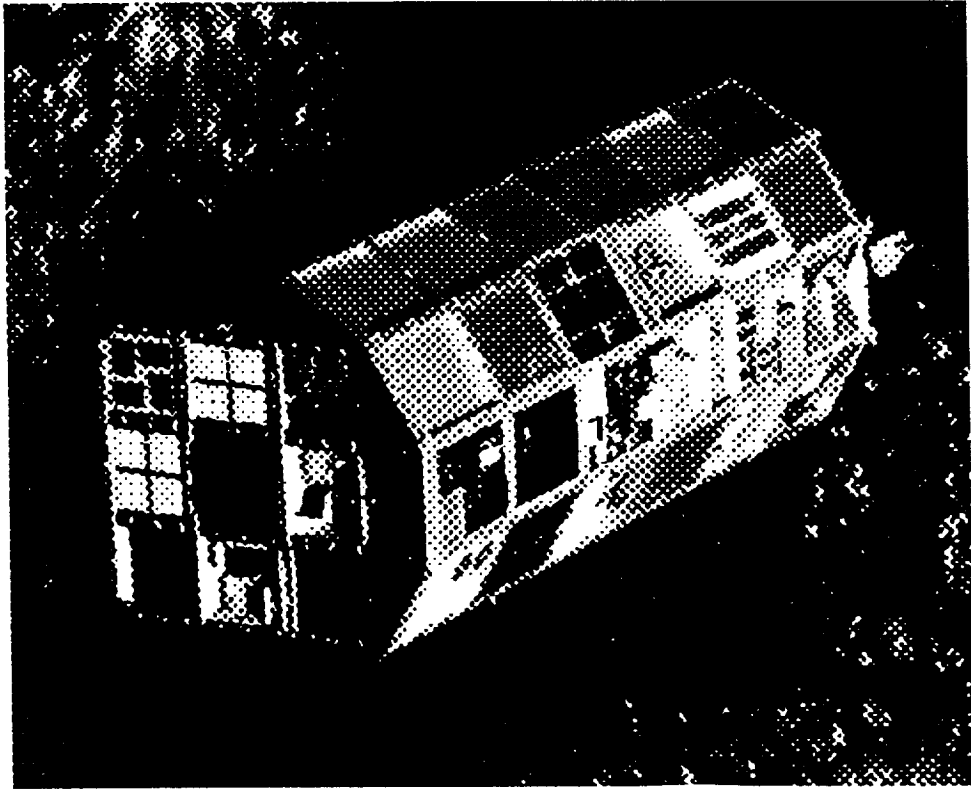
Figure 1. The LDEF.

The beta cloth analyzed in this report came from the MSFC Experiment S1005 (Transverse Flat-Plate Heat Pipe) tray oriented approximately 22° from the leading edge vector of the LDEF satellite (ref. 1). Figure 1 shows the location of the tray on LDEF and the placement of the beta cloth thermal blankets. The specific space environment exposure conditions for this material are listed in table 1.

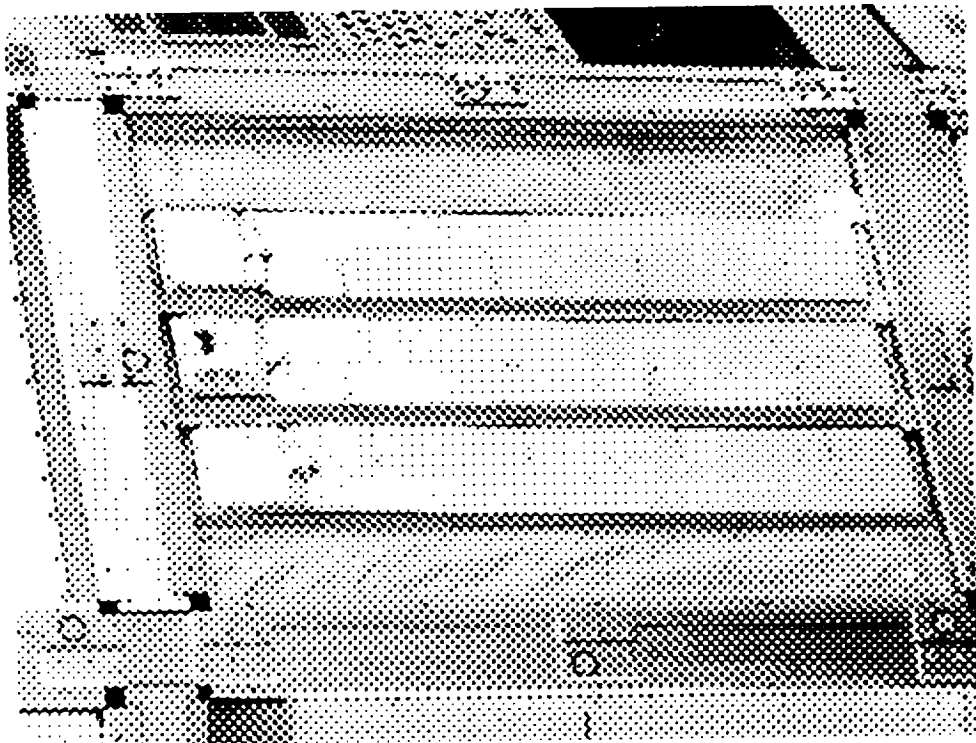
S1005 experiment, Tray B10, transverse flat plate heat pipe experiment.

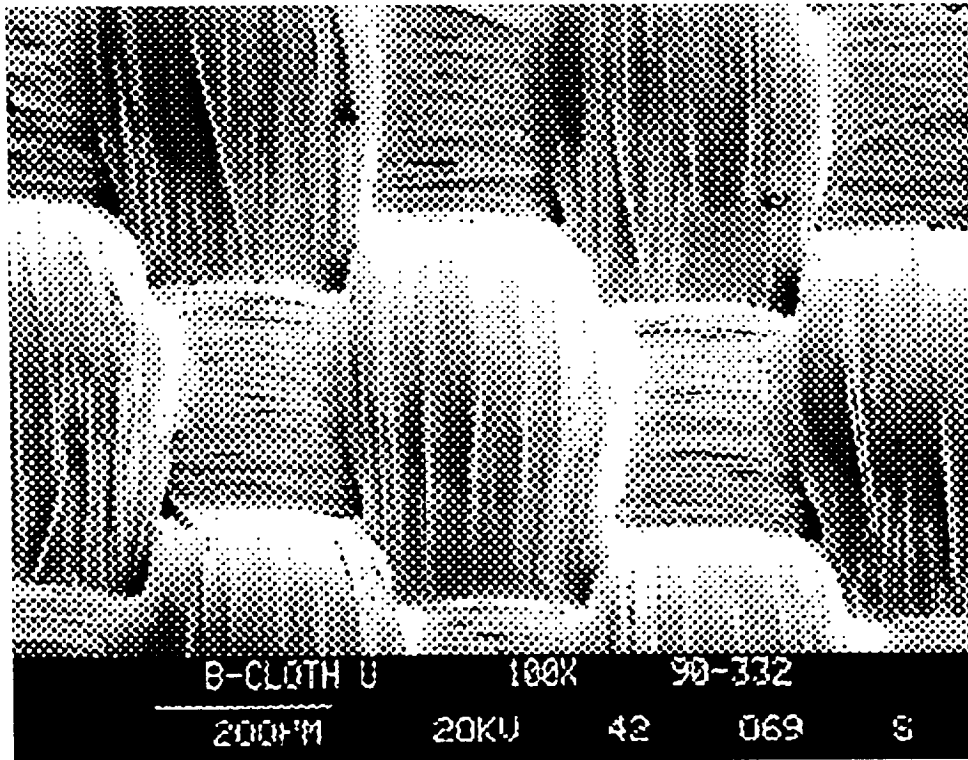
Figure 2. Beta cloth from folded underside of thermal blanket, protected from AO erosion.

Photographs taken with a scanning electron microscope indicate the change in beta cloth caused by space environment exposure. Figure 2 is of beta cloth removed from the folded underside of the blanket, protected from AO, radiation, and thermal cycling. The sample is intact. For comparison, Figure 3 is of beta cloth exposed to the leading edge environment, where Teflon™ erosion by impinging AO was most severe. However, the Teflon™ erosion did not release the embedded glass fibers. Teflon™ is visible between the fibers in areas shielded from direct impingement of AO. Erosion is evident to the extent seen. Figure 4 shows the fine erosion peaks typical of AO-eroded polymeric material at high magnification. Figure 5 is a still higher magnification SEM photo showing the remaining Teflon™ in the glass fiber weave. The AO erosion seemed to be limited to the first layer of glass fibers. The glass fibers prevented further erosion by staying in place and protecting the remaining Teflon™. Also, areas impacted by meteoroid and debris particles have pulled-up fibers, but these fibers remained in the matrix (Figures 6, 7).

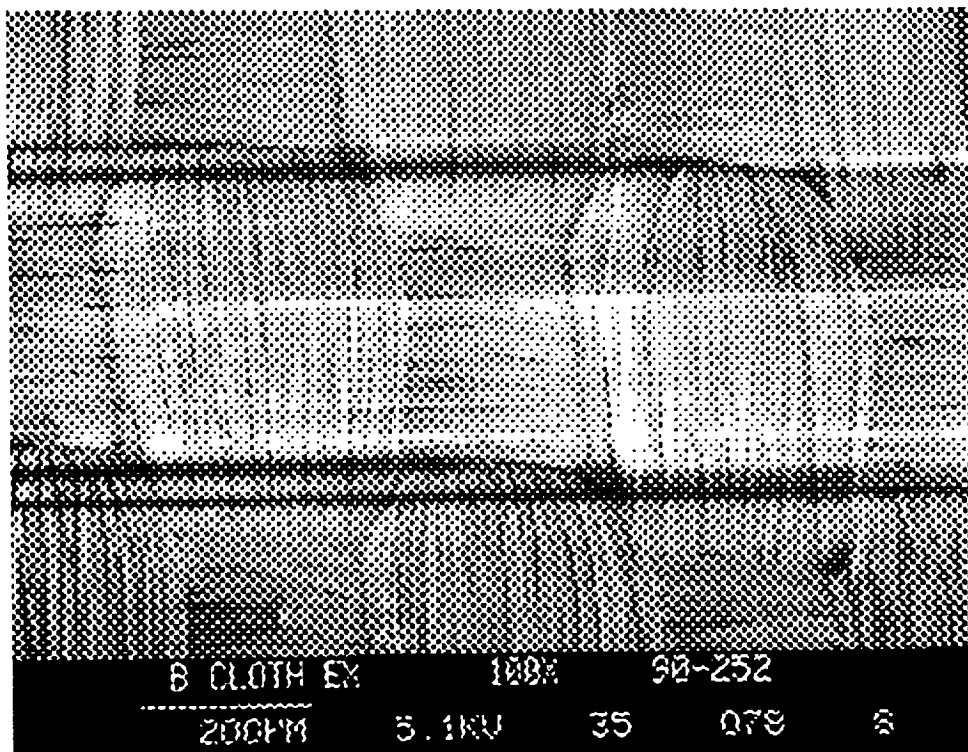
Figure 3. Beta cloth exposed to RAM environment.

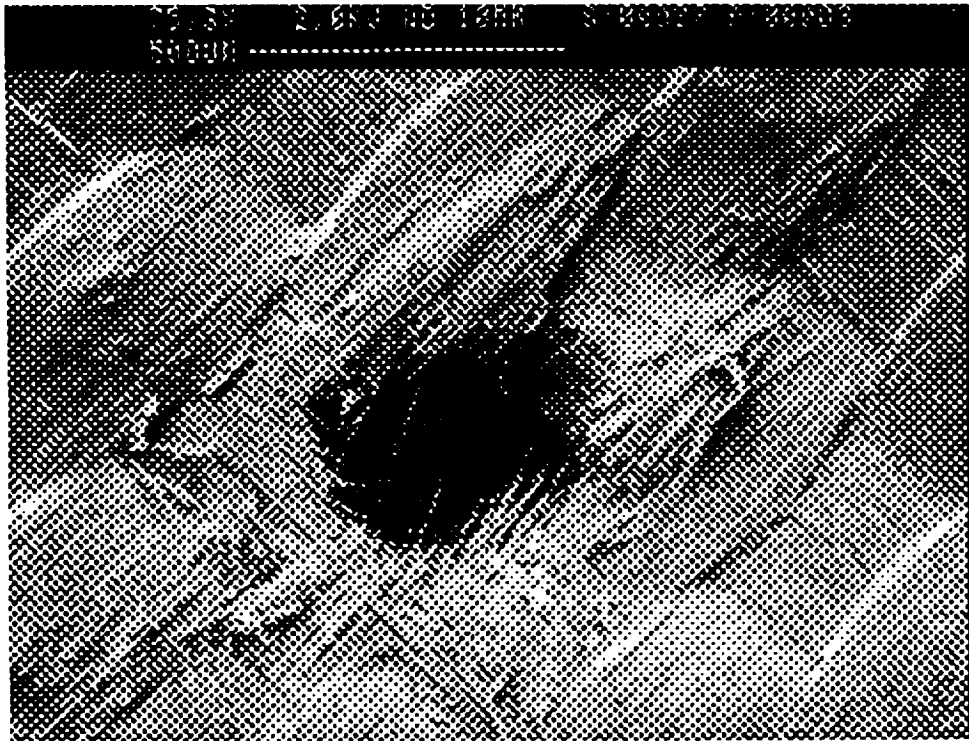
Figure 6. Meteoroid/debris impact in beta cloth.

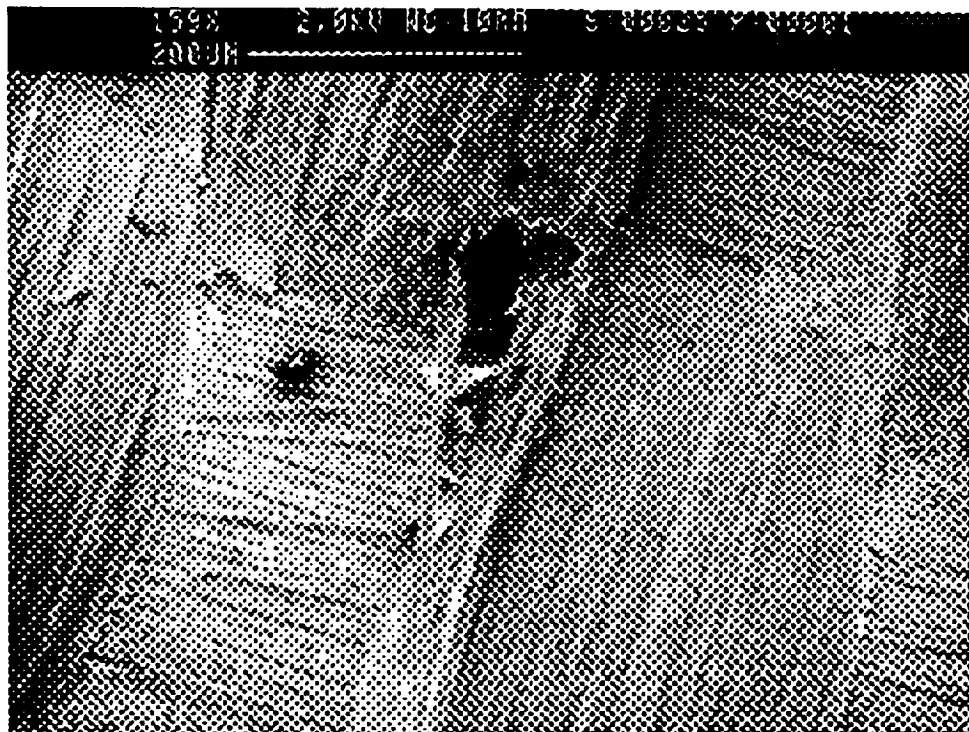
Figure 7. Meteoroid/debris impact.

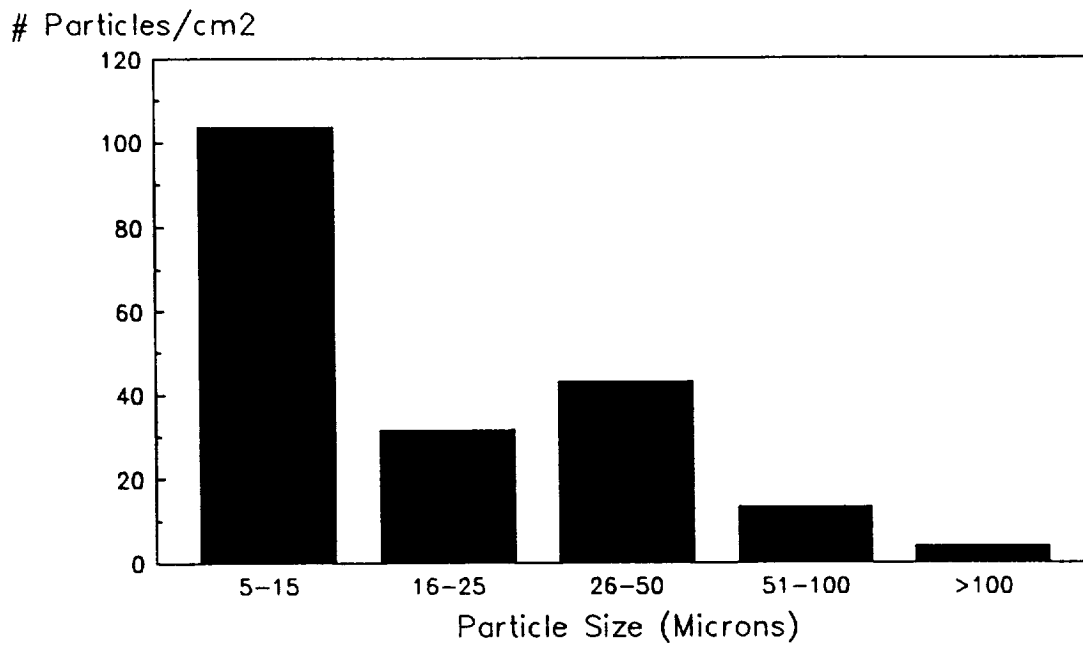
Figure 9. Beta cloth sloughing evaluation, AO and UV exposure.

The beta cloth was also evaluated for sloughing. The samples were flushed with Freon™ over a Millipore filter collector. A soft brush was then used to wipe the beta cloth surface directly above another collector. The results from the sloughing are presented in Figures 9 to 12. These graphs show the number of particles of a particular size collected after the Freon™ flush and brushing. The largest dimension of the particle is counted. Control material from the manufacturer, beta cloth from the folded underside of the thermal blanket, and beta cloth fully exposed to AO and UV radiation were evaluated. SEM photos of similar samples with particulate contamination (Figures 2 and 3) agree with the sloughing results. The beta cloth exposed to AO had the least amount of particulate contamination, most likely due to erosion. The beta cloth from the folded underside of the thermal blanket was cleaner than the control sample, presumably as a result of preflight preparation.

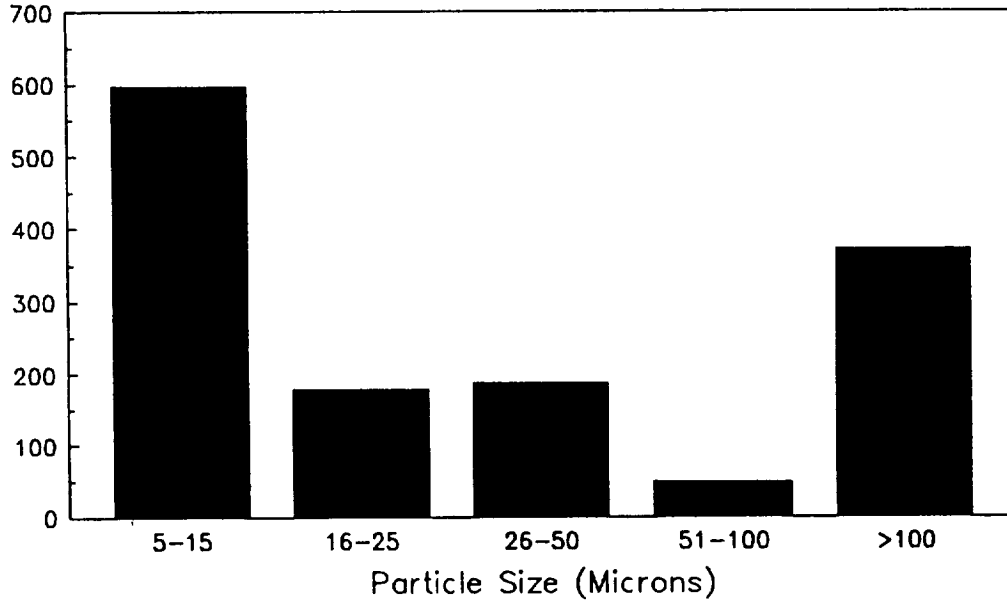
Figure 10. Beta cloth sloughing evaluation, flight beta cloth, not exposed.

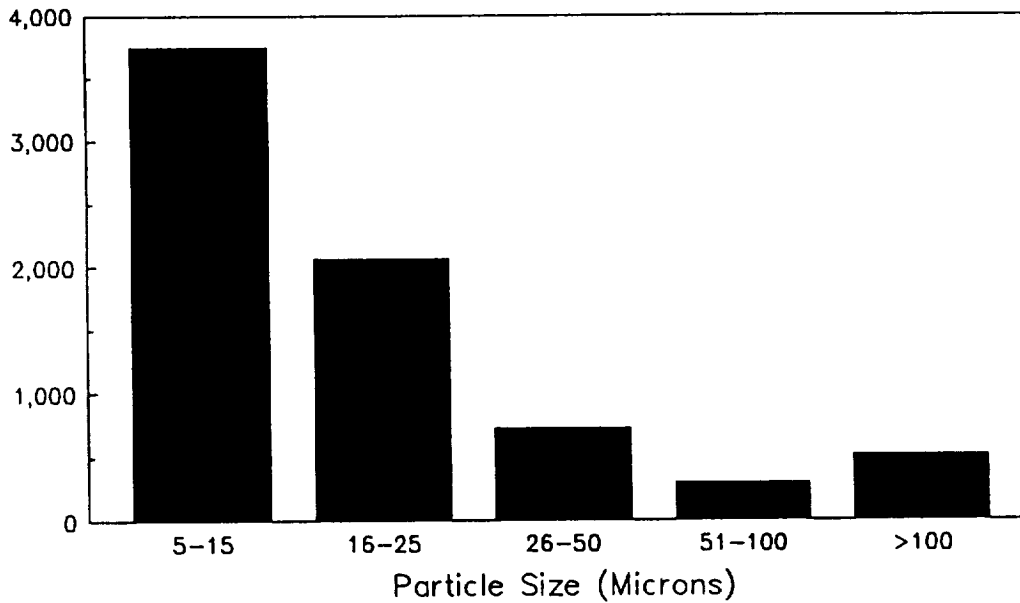
Figure 11. Beta cloth sloughing evaluation, nonflight beta cloth.

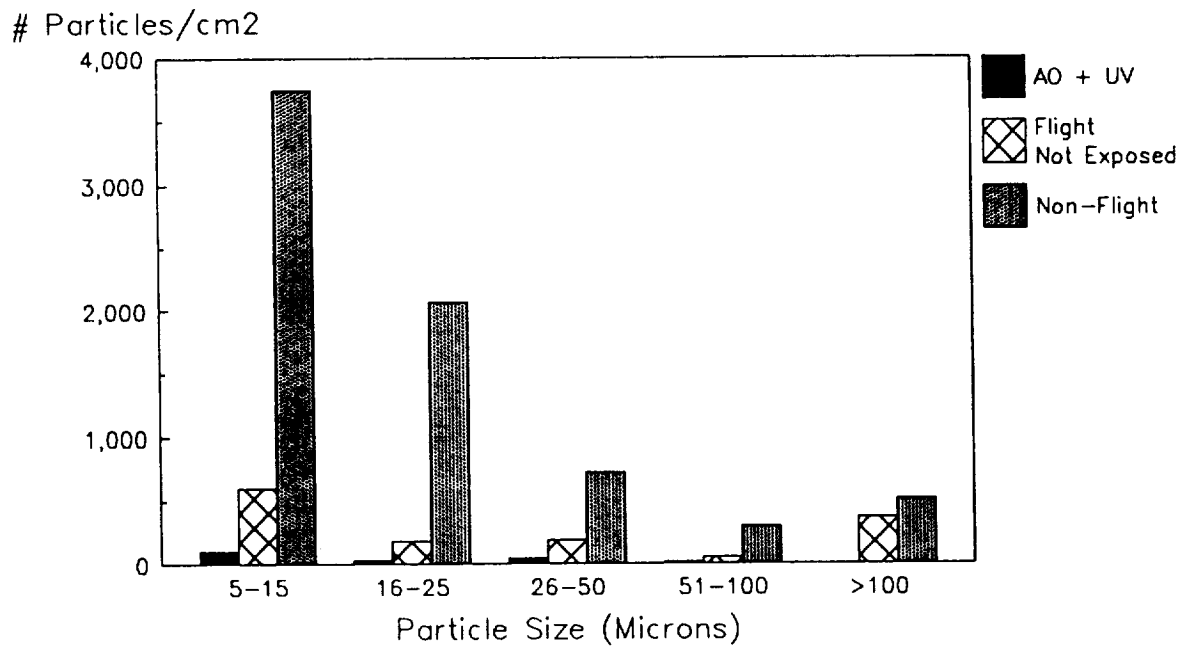
Figure 12. Beta cloth sloughing evaluation, comparison chart.

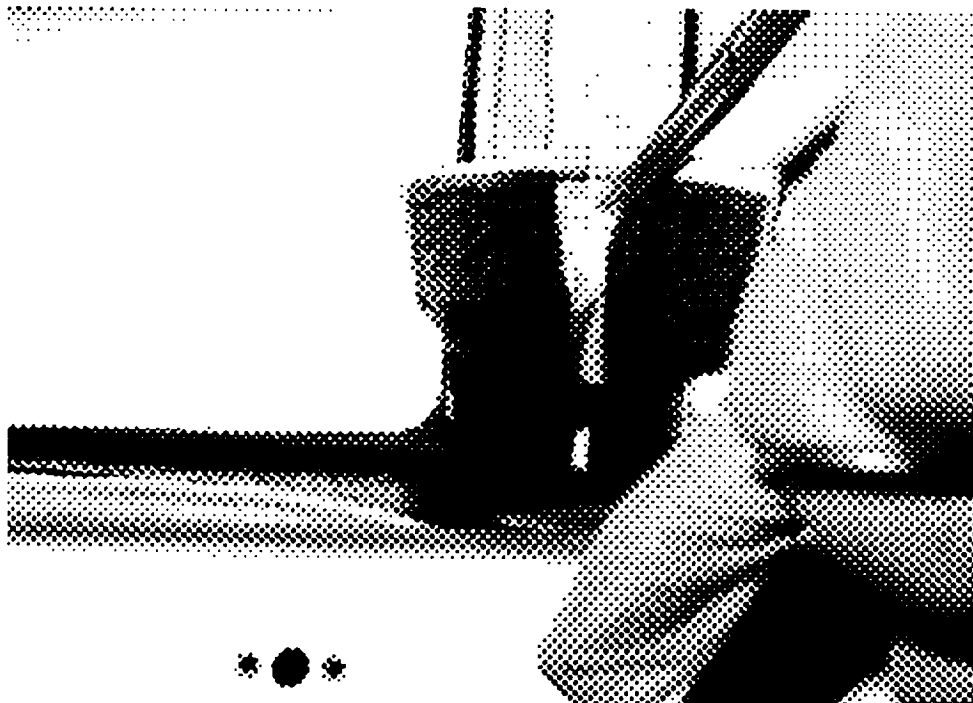
Figure 15 is of the observed bleaching effect of AO on the Velcro™. SEM photos of unexposed and exposed Velcro™ hooks (Figures 16 and 17) show the AO erosion. In some places, only nubs of nylon were left (Figure 18). The loops were similarly affected. In addition, the mechanical strength of the Velcro™ was degraded by space exposure. Peel tests on uneroded Velcro™ indicated a peel strength of 2.0 to 2.5 lb/in. Velcro™ that had been eroded and bleached had a peel strength of 1.2 to 1.7 lb/in.

Figure 15. AO bleaching of Velcro™.

While beta cloth's performance over a 30-year S.S. *Freedom* mission remains unqualified, beta cloth's performance in the near 6-year exposure on the LDEF provides the evidence for satisfactory retention of properties for extended space exposure. Beta cloth overlap of the Velcro™ is being recommended, and new materials and configurations are under consideration for replacement of Dacron™ as a result of degradation of these blanket elements. It is anticipated that with these changes, beta cloth thermal blankets will endure space environment exposure well beyond 6 years.

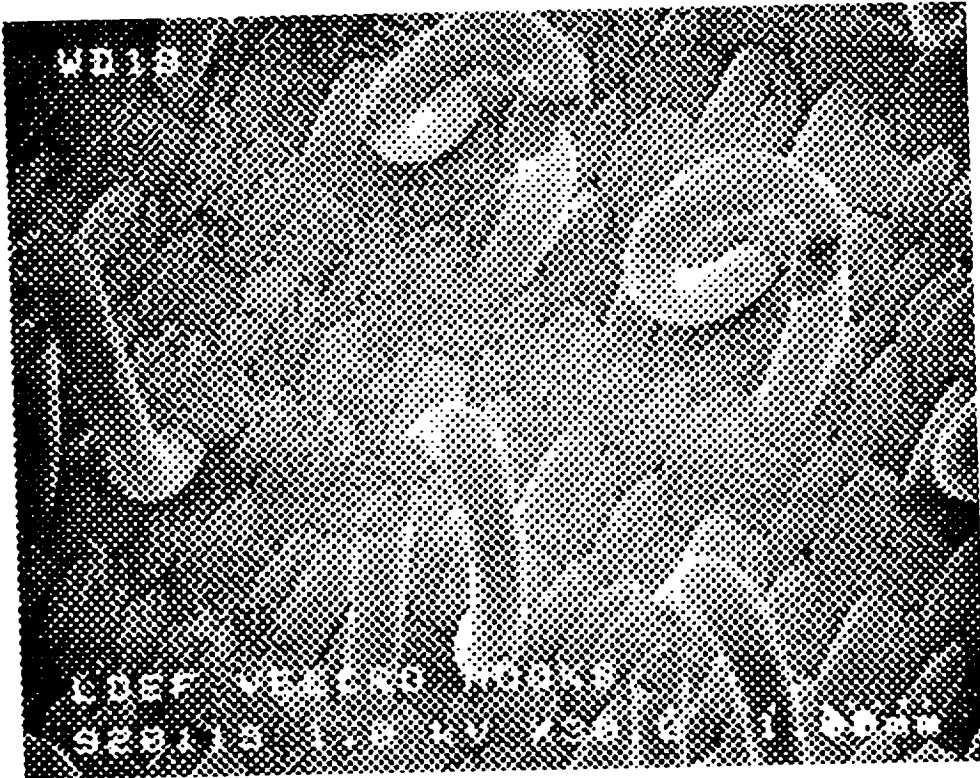
Figure 16. Unexposed Velcro™ hooks.
