A REVIEW OF VIBRATION PROBLEMS IN POWER STATION BOILER FEED PUMPS

David France
Weir Pumps Limited
Glasgow, Scotland

SYNOPSIS

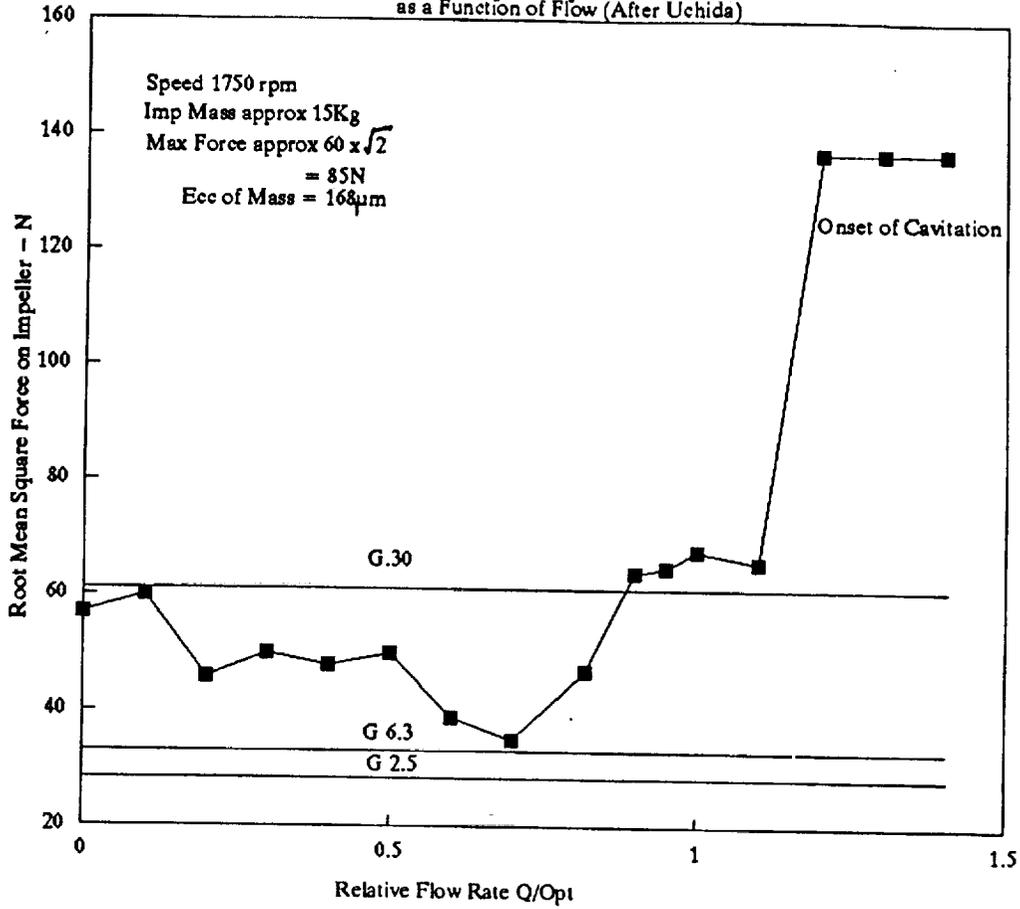
Fig.1. Shaft Speed Hydraulic Unbalance as a Function of Flow (After Uchida)

blockage of impeller passageways by, for example, ingress of foreign matter. Generally speaking the magnitude of hydraulic unbalance generated by an impeller is greater than the residual mass unbalance component. A Japanese investigator, ref.1, measured the hydraulic force as a function of flowrate, fig.1. The maximum value of unbalance qualities of G2.5 - G6.3. Practical experience suggests that precision castings for the impellers of high speed feed pumps could offer a hydraulic reduction of possibly an order of magnitude. Nonsynchronous forced responses usually arise at part load operations where hydraulic forces, generated by recirculating flows within the impeller or diffuser, may give rise to irregular or cyclic low frequency excitations. These have been discussed previously by a number of authors, ref.2, 3. A typical example of this can be seen in fig.2, where the shaft displacement increased threefold between the design flowrate and the recirculation flow quantity.

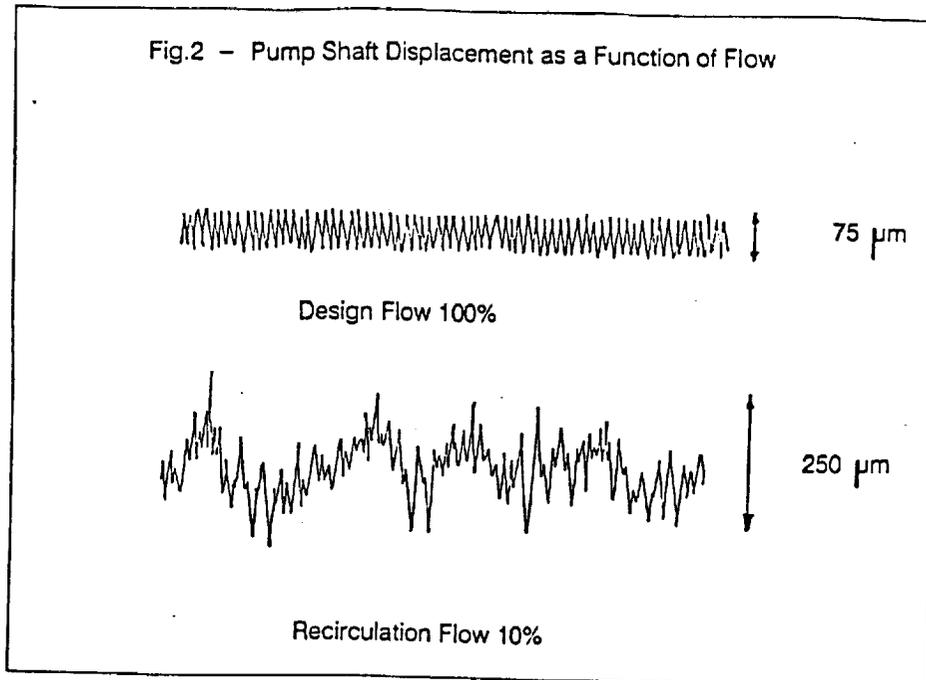
Fig.2 - Pump Shaft Displacement as a Function of Flow

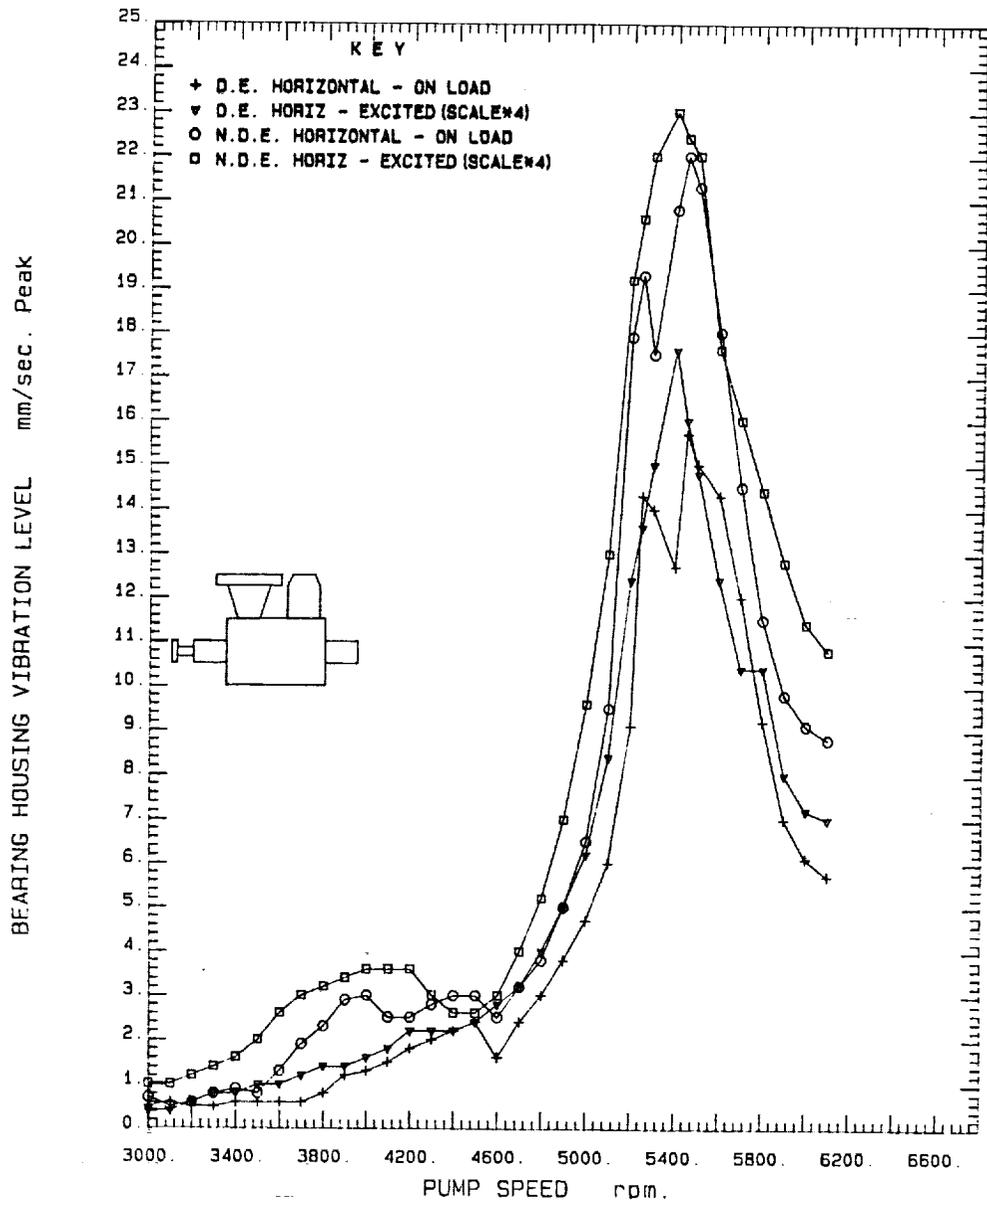
FIG6a ON LOAD VIBRATION OF PUMP COMPARED WITH VIBRATION OF PUMP
EXCITED BY AIR DRIVEN ROTARY OUT OF BALANCE DEVICE

In 1982 a resonance problem was experienced on a four turbine driven variable speed boiler feed pump, installed at Huntly Power Station, (4 x 250MW), New Zealand. The area is seismically active and the design of the pump and turbine support structure reflected the seismic requirements. The pump was centre line mounted on a baseplate which was secured to a large steel table onto which the turbine was also mounted. The steel table was supported from the floor level by a number of tall vertical metal columns, ensuring a low frequency mounting system for the equipment. A schematic is shown in fig.5. High vibration levels, in excess of 20mm/sec peak, at pump shaft frequency, were obtained at generator loading of 200-220MW, corresponding to a pump speed in the range 5300 rpm-5500rpm. Examination of the amplitude phase relationship suggested a resonance was responsible. Excitation tests were carried out with the pump stationary using an air driven rotary out of balance exciter to stimulate the structure into vibration and to examine the mode shape. These tests confirmed there was a natural frequency of the pump, but the mode shape was complex showing motion involving the pump and turbine support structure. Surprisingly, there was little or no deformation of the pump casing and pump supporting baseplate, the whole body appeared to be moving on the flexibility of the steel supports beneath the base plate. A comparison of the on load vibration characteristic compared with the vibration obtained from the air driven exciter is shown in fig.6a. Exciter tests were then carried out with one of the pumps and its baseplate secured to a concrete foundation. No evidence of any natural frequencies in the range 3000cmp - 6000cpm were found indicating that the steel support structure was important in terms of the mode of vibration of concern. A comparison of the responses on the steelwork and on the concrete floor are shown in fig.6b. The next stage of this investigation was to consider how detuning the resonant frequency could be achieved on site. Clearly a solid support for the pump bedplate would have solved the problem but it was impractical to stiffen the support steelwork sufficiently. It was decided to introduce compliance between the pump casing and the bedplate at the pump support feet. As designed the support feed slide relative to the pump baseplate on greased brass pads to accommodate thermal expansion. A modification was made as shown in fig.7, this introduced horizontal flexibility but still allowed the pump support feet to slide. On site a series of exciter experiments was carried out to optimise the flexibility of the detuning element. Once an optimum was found the pump was run up to full load to demonstrate the modification. The vibration levels were found to be a maximum of 5mm/sec peak. A comparison before and after modification is shown in fig.8.

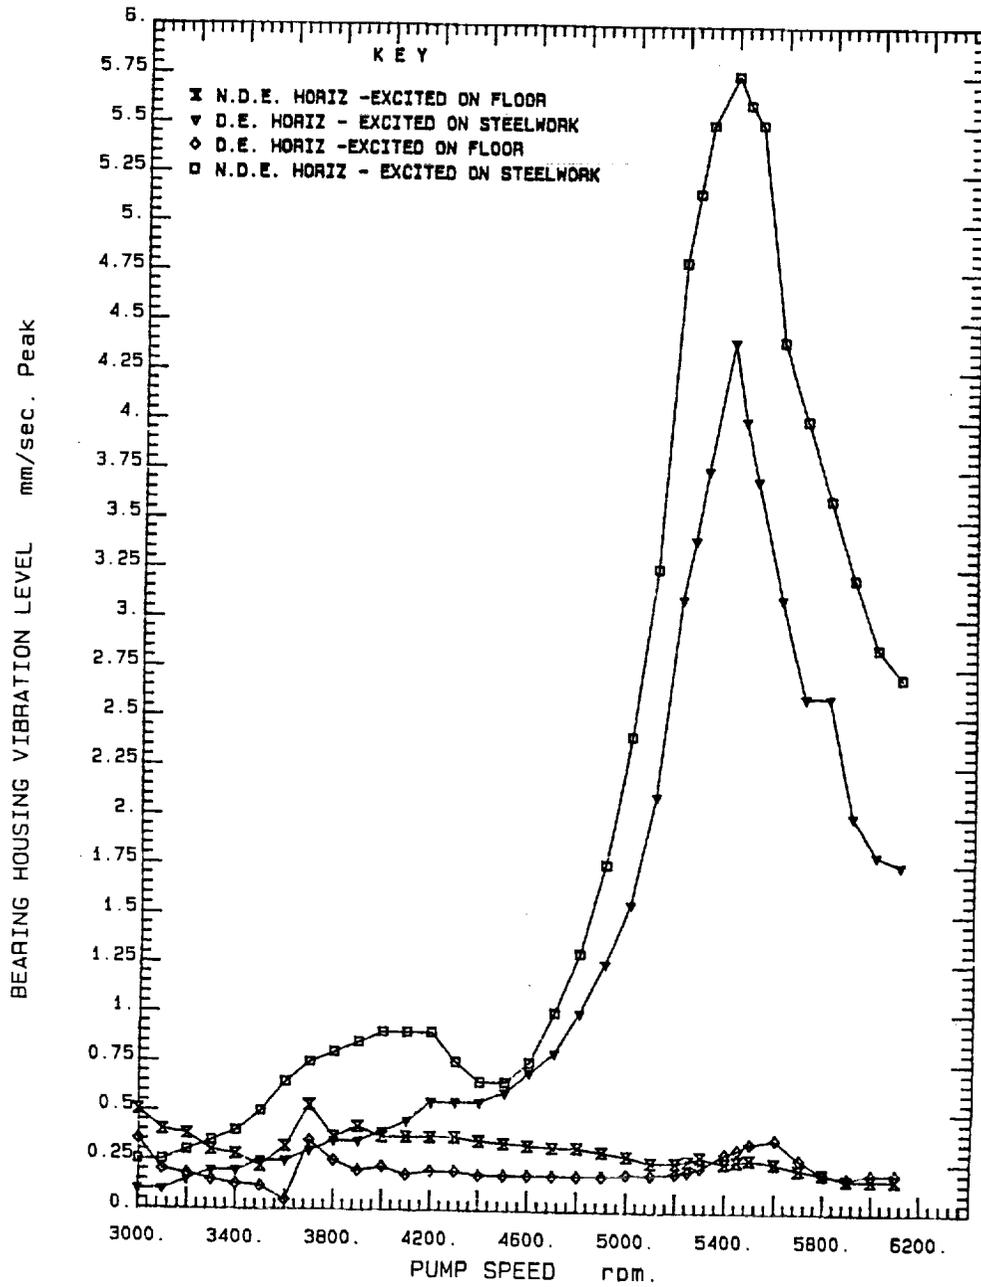
FIG 6b RESPONSE OF PUMP ON STEELWORK COMPARED WITH PUMP ON CONCRETE FLOOR - EXCITED BY ROTARY DEVICE

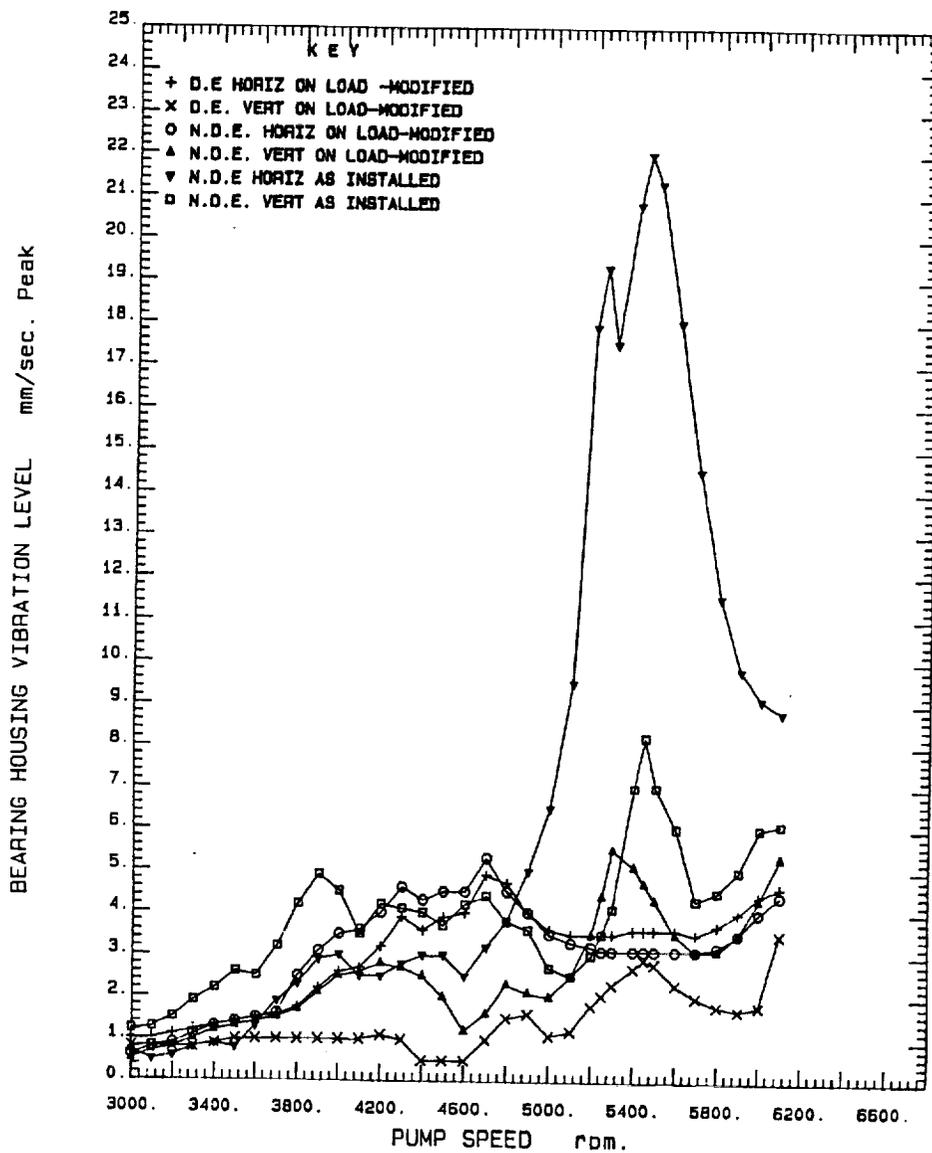
FIG 8 ON LOAD VIBRATION RESPONSE OF PUMP FITTED WITH FLEXIBLE DETUNING ELEMENT COMPARED WITH PUMP AS ORIGINALLY INSTALLED

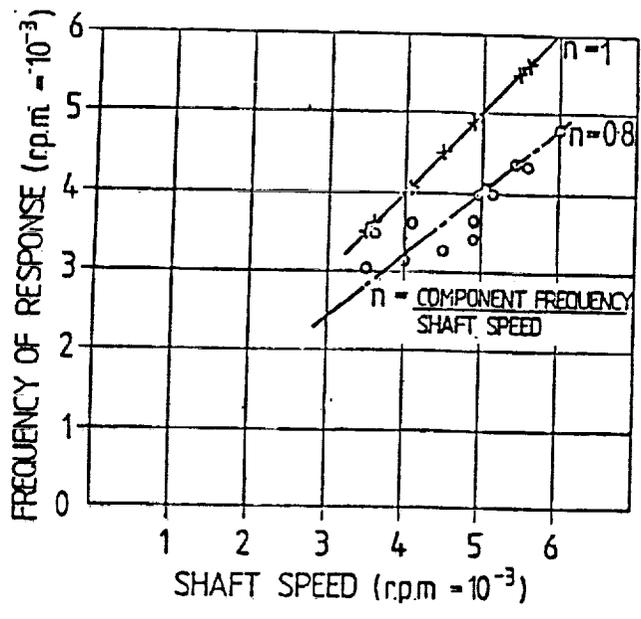
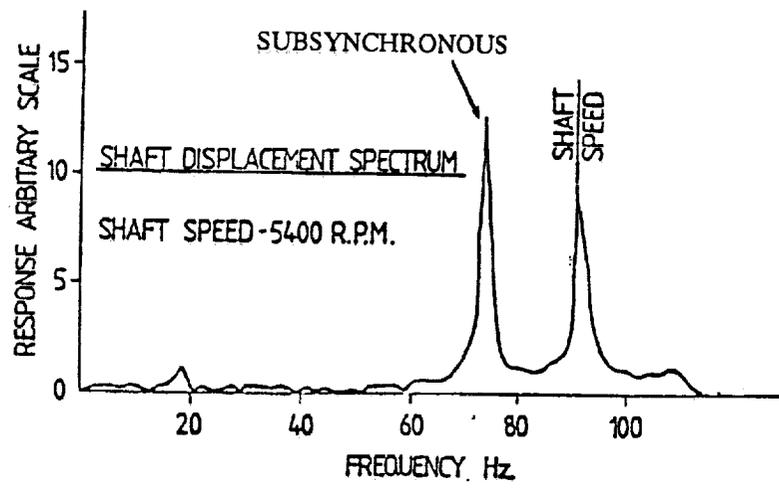
Fig.9. Whirl Frequency Ratio and Frequency Spectrum From 4 Stage Boiler Feed Pump

In the late sixties a 0.8 x running speed vibration problem was found on starting and standby boiler feed pumps at Longannet Power Station, Scotland. The high vibrations were seen over a range of operating speed from 3500 rpm - 6000 rpm as shown in fig.9. The pump was found to undergo an almost instantaneous progression from low level synchronous vibration to "foundation shaking" nonsynchronous vibration as pump speed was increased; typical of a classical self excited vibration phenomenon. The problem was related to premature wear out of the pumps internal clearances caused by intermittent low flow operation and consequential reduction in rotor stiffness. The problem was eliminated by increasing the minimum recirculating flow to eliminate the wear out problem; no further research was done at this time on what was believed to a "one off" phenomenon.

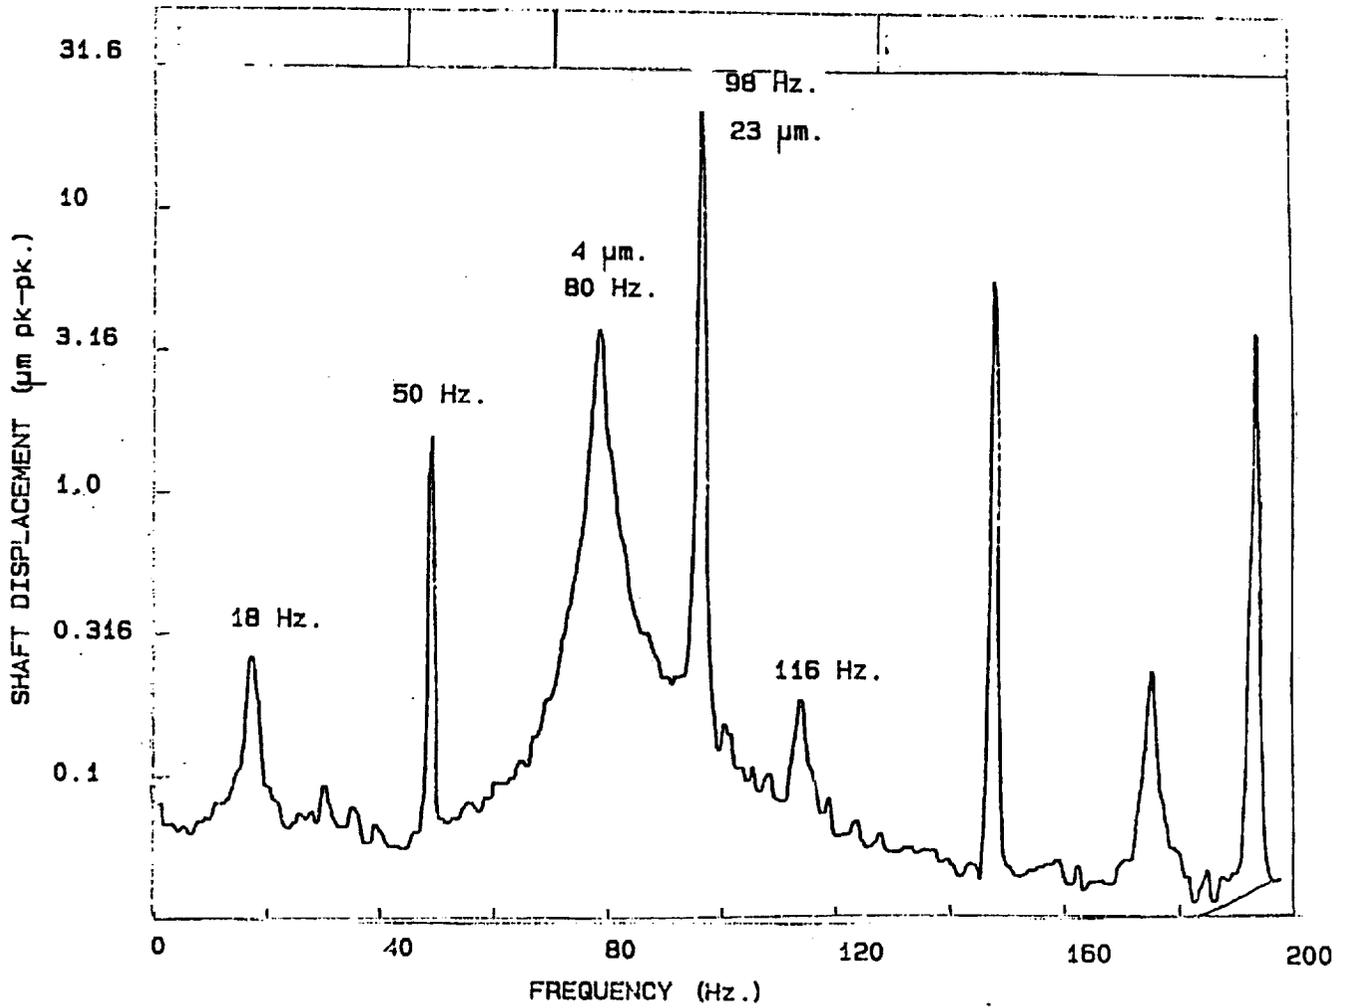
FIG.10 - Frequency Spectrum taken at Drive End Bearing for 7 Stage Pump with 2 x Design Clearances at 5850 r.p.m.(975 Hz)

In 1978 serious problems were experienced during works testing of three pumps. Performance tests were conducted at full power and fixed speed and near running speed subsynchronous vibration was experienced. These pumps were 7 stage pumps absorbing 2230Kw at 5850 rpm. The problem was first noticed as flowrate was increased from the minimum recirculation quantity to the design flow. Shaft probes were fitted as standard and the transition from synchronous to nonsynchronous vibration was abrupt. It was also established that reducing flowrate could once again stabilise the pump. Shaft displacement levels were $75\mu\text{m}$ pk-pk at a frequency of 80Hz-84Hz giving a whirl frequency ratio of 0.82-0.86. A typical average spectrum is shown in fig.10. A 24 hour endurance test on the test bed confirmed the severity of the problem when balance drum leakage flowrates doubled and bearing housing vibrations increased fourfold. Initially it was assumed that the problem was a classical rotor instability, i.e. unstable eigenvalue. It was believed that negative stiffness and forward driving cross coupling could arise due to an impeller/diffuser interaction of the type described in (11). However, it seemed unlikely that the problem was due to an unstable eigenvalue as rotordynamic analysis predicted well damped eigenvalues even with generous allowances for impeller/diffuser interaction forces. Nevertheless, both aspects of the problem were examined, the former by a specially instrumented single stage test rig and the latter by conducting variable speed tests on one of the pumps with clearances set at design values (0.5mm) and then twice design (1mm). To assist the problem diagnosis a pair of displacement probes were installed to view the shaft motion at the balance drum as well as the bearings of the pump. The results of these tests are summarised in fig.11a and fig.11b. Tracking of the amplitude and phase of the synchronous component of shaft vibration over a speed range from 4000 rpm - 6500 rpm showed no significant phase or amplitude change which would indicate even a near proximity to a natural frequency. A similar result was obtained for both the design and twice design clearances build configurations. Rotordynamic calculations confirmed the shaft motion and phase measurements at the balance drum and bearings and absence of unstable eigenvalues. Of enormous significance was the fact that the subsynchronous component of vibration bore an almost fixed ratio with respect to speed (.85) for both clearance cases tested. The subsynchronous component was discernible down to the minimum speed tested. The test rig

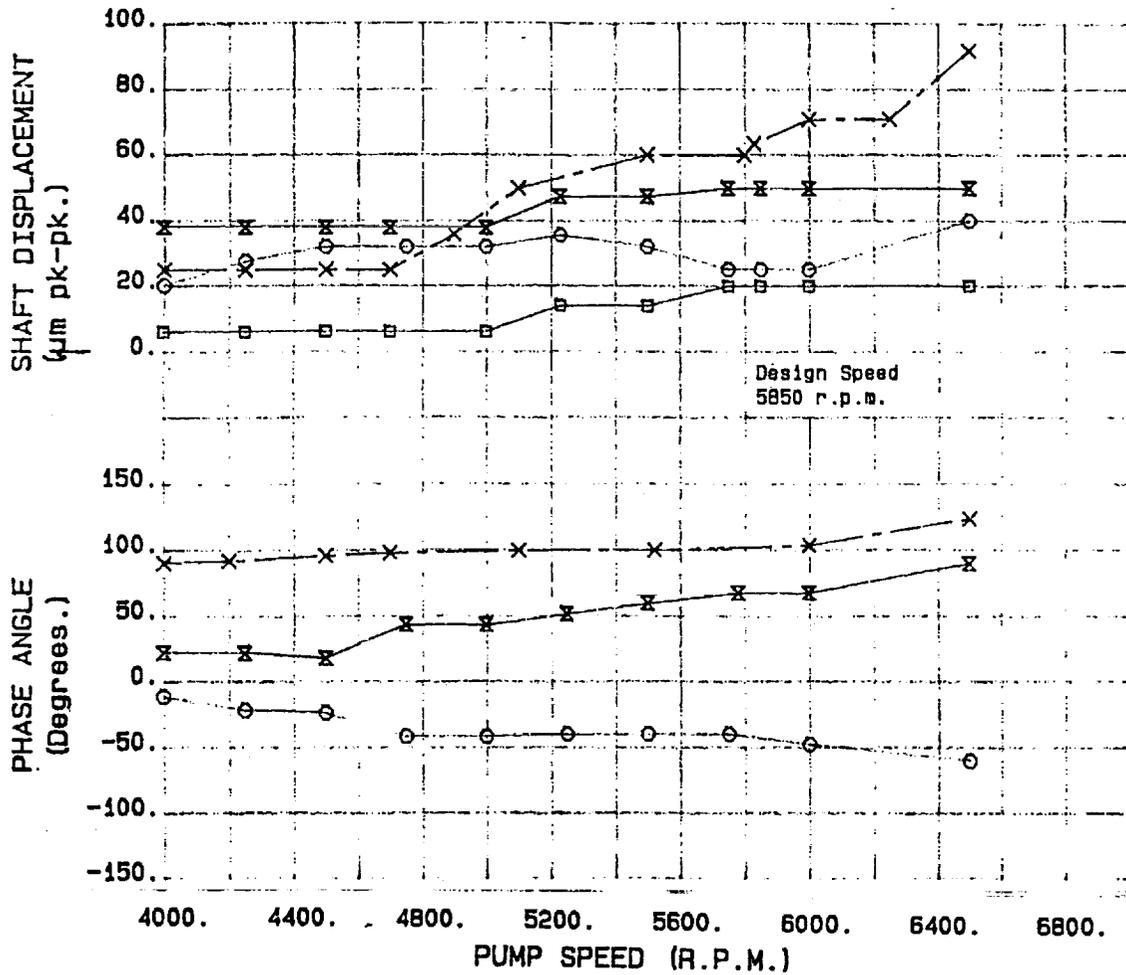
FIG. 11a.- Amplitude and Phase for Design and Twice Design Clearances for a 7 Stage Pump

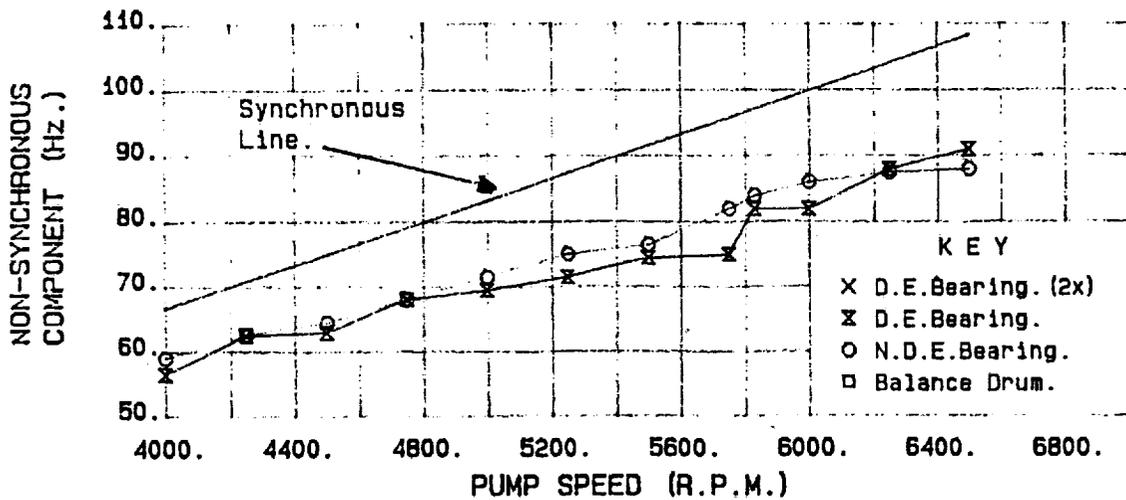
FIG. 11b.- Frequency of Non-synchronous Vibration versus Pump Speed for a 7 Stage Pump

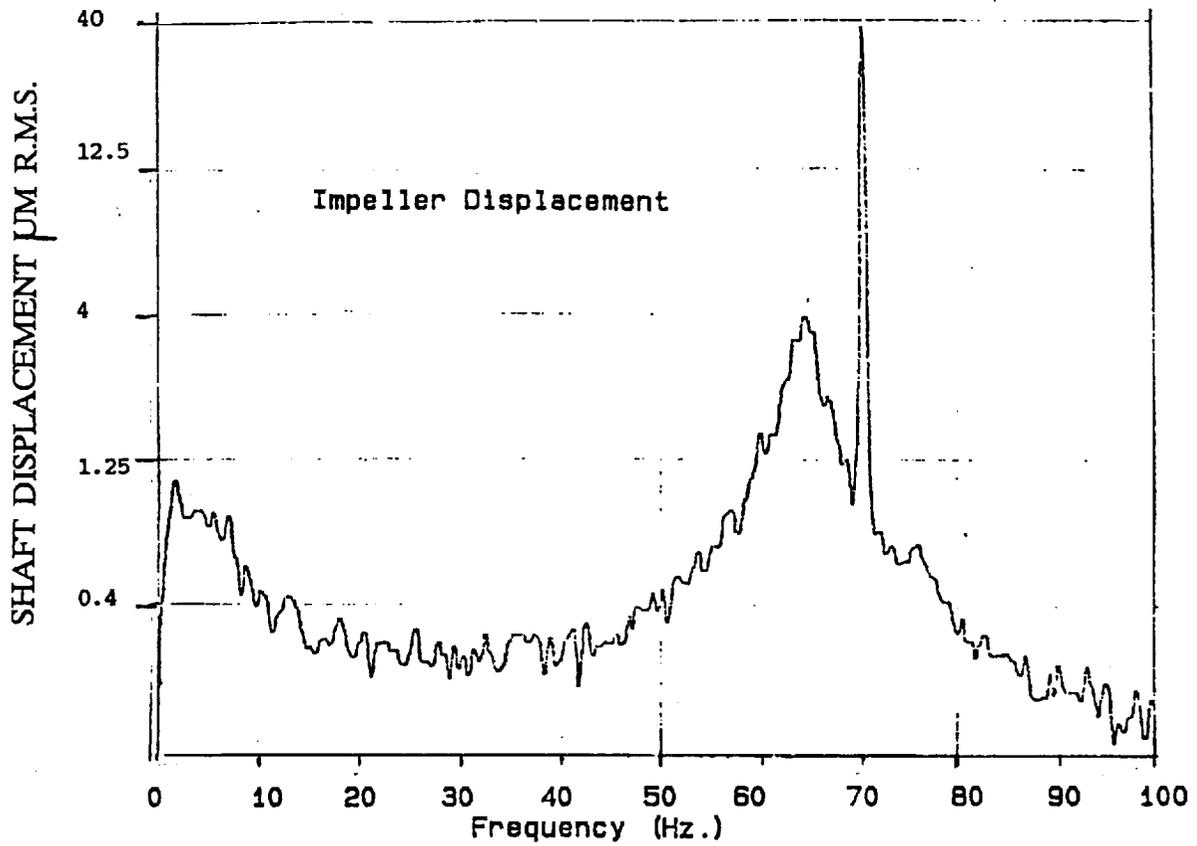
FIG12a - Impeller Displacement From Single Stage Test Rig at 4250 r.p.m. and 65% Best Efficiency Point Flow

comprised a single impeller and diffuser stage and was instrumented with shaft motion probes and dynamic pressure transducers to examine distributions of pressure in the diffuser inlet, impeller shroud to casing gaps and near to the impeller eye. Tests were carried out to approximately 80% pump design speed. Sum and difference measurements of two pressures at 180° at impeller eye showed a nonsynchronous frequency component which was out of phase implying a net resultant force on the impeller. This correlated extremely well with the resultant shaft motion as shown in fig.12a and fig.12b and was very similar to that obtained from the pump, fig.10. Tests subsequently confirmed that this was an impeller inlet stall which appeared to rotate relative to the impeller at a frequency equal to the difference of the synchronous and subsynchronous frequencies. The forces involved were quite small and the feedback element which was evidently present with the 7 stage pump was never reproduced on the test rig. In the final event no design changes were made to the pumps, although an impeller with revised inlet geometry had been tested successfully in the single stage test rig. There were however, significant improvements made to the build concentricity of the pump cartridge and a change to the shaft material. Tests confirmed that subsynchronous vibrations were still present but a factor of ten below synchronous amplitude levels. No change in vibration was obtained over a 48 hour endurance test at full load. The pumps have been in service for over twelve years and have given trouble free operation.

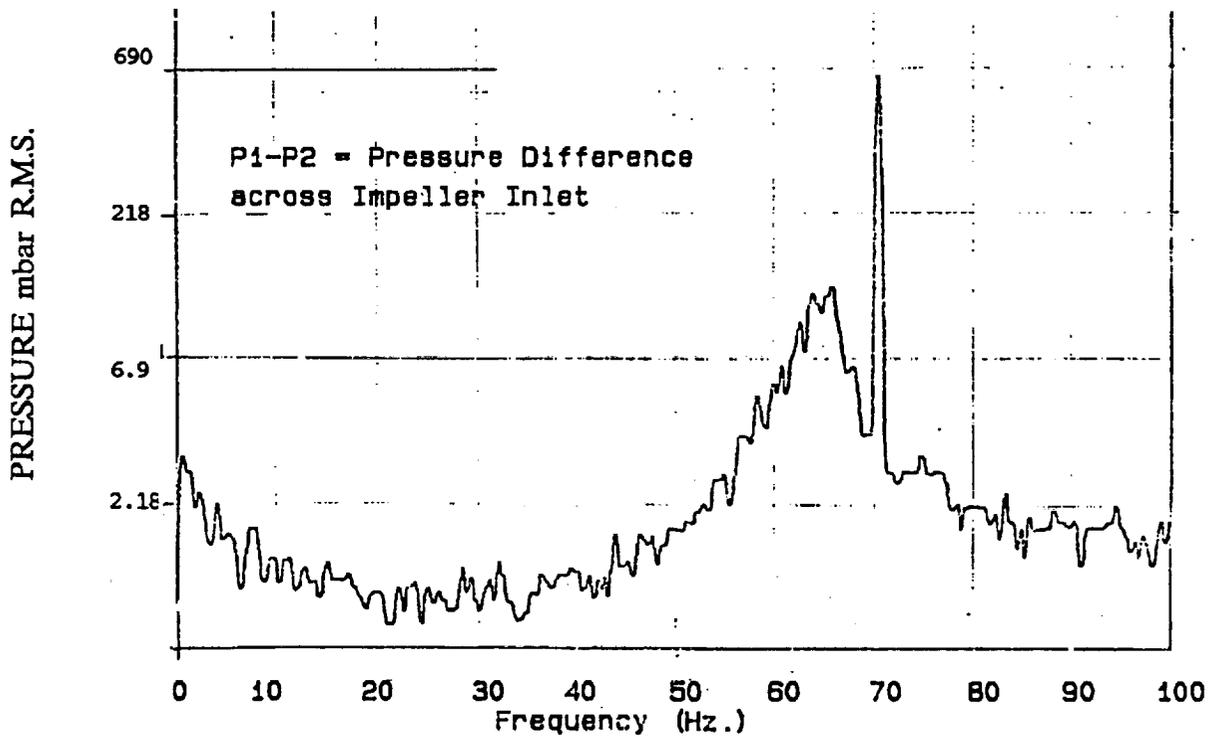
Fig12b - Dynamic Pressure across Impeller Inlet from Single Stage Test Rig at 4250 r.p.m. and 65% Best Efficiency Flow.

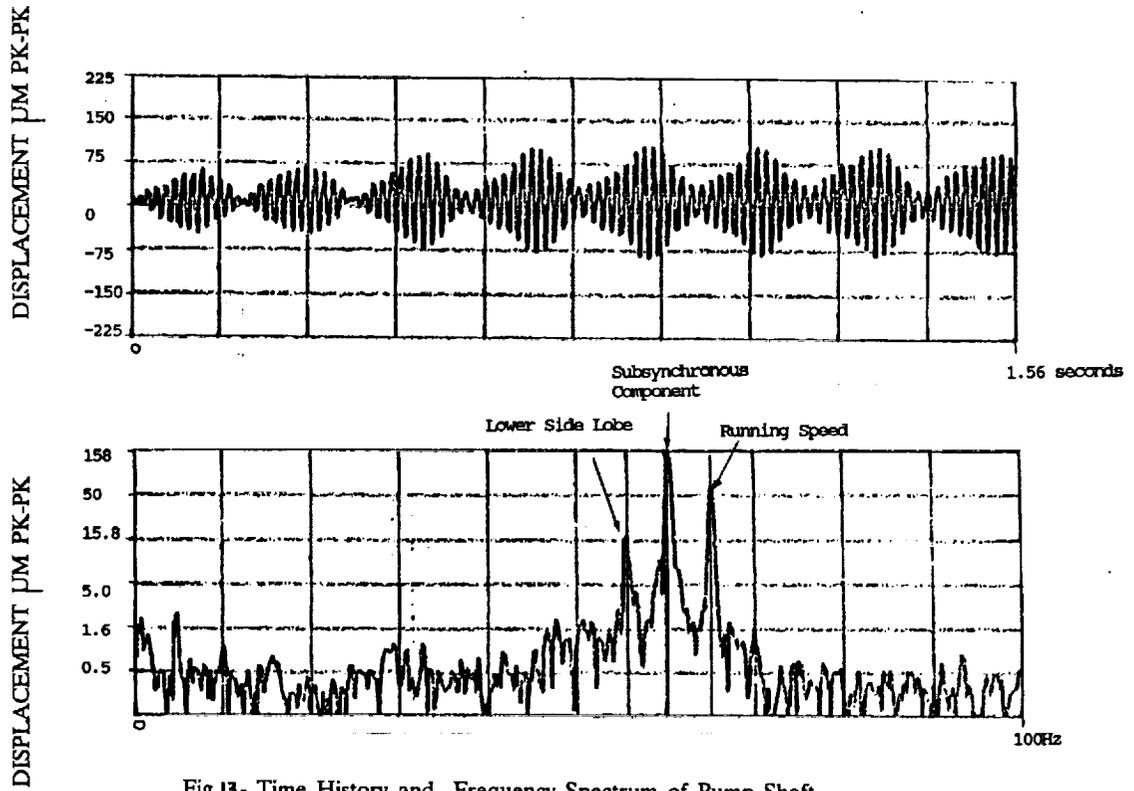
Fig.13- Time History and Frequency Spectrum of Pump Shaft Displacement (Pump Clearances at Twice Design Values - Refer Test 3)

During proving tests on the prototype of a new frame size of barrel casing pump in 1987, the opportunity was taken for an in-depth examination of the effects of annular clearance wear and the influence of inlet swirl at the balance drum upon rotor dynamics and, in particular, subsynchronous vibration. The device used to control inlet swirl was similar to that described in (7). The prototype was a six stage pump with radial diffusers and a balance drum with a design maximum running speed of 5000 rpm. The design parameters of this barrel casing pump are set out in Appendix I. The materials chosen for the renewable wearing rings were chosen for their high wear resistance and freedom from galling. To maintain optimum efficiency the recommended renewal clearances are set at 1.5 times the new design clearances. It was decided to study the effects of wear up to a maximum of twice the renewable limits. The tests were carried out in the production test facilities and the pump was installed on a temporary, but substantial, support structure. The prime mover gave a variable speed capability from 3600-5500 rpm, representing 10% above pump design speed. Instrumentation was fitted to the pump to measure, head, flow, speed, loop temperature, bearing metal and oil temperatures, axial thrust, balance return line flow. Dynamic measurements taken were bearing housing vibration, (seismic), shaft to casing radial displacement and pressure fluctuations in the suction, and discharge and balance return lines. The dynamic signals were taped recorded for subsequent analysis off line. During each test discrete points were taken over the performance envelope of the pump together with data from controlled runs varying one parameter at a time and keeping others constant, e.g. varying speed at constant discharge control valve setting. The tests carried out are summarised in Table II and the incidence of subsynchronous vibration during the tests is summarised in Table III. The pump was stable when clearances were within the recommended limits, but became unstable with 2 x design clearances. In contrast inlet flow swirl control delayed unstable behaviour until clearances approached twice the renewable values. When the subsynchronous vibration occurred it had a well defined character. Figure 13 shows a time history and a spectrum of the shaft motion taken during Test 3. The time history shows the typical beating resulting from the presence of two strong vibration signals with frequencies close together. The spectrum shows not only the running speed vibration and the subsynchronous vibration but also the sidebands associated with these frequencies. This spectrum with its strong difference frequency, (running speed - subsynchronous speed), and the similarly displaced sidebands is typical of this phenomenon.

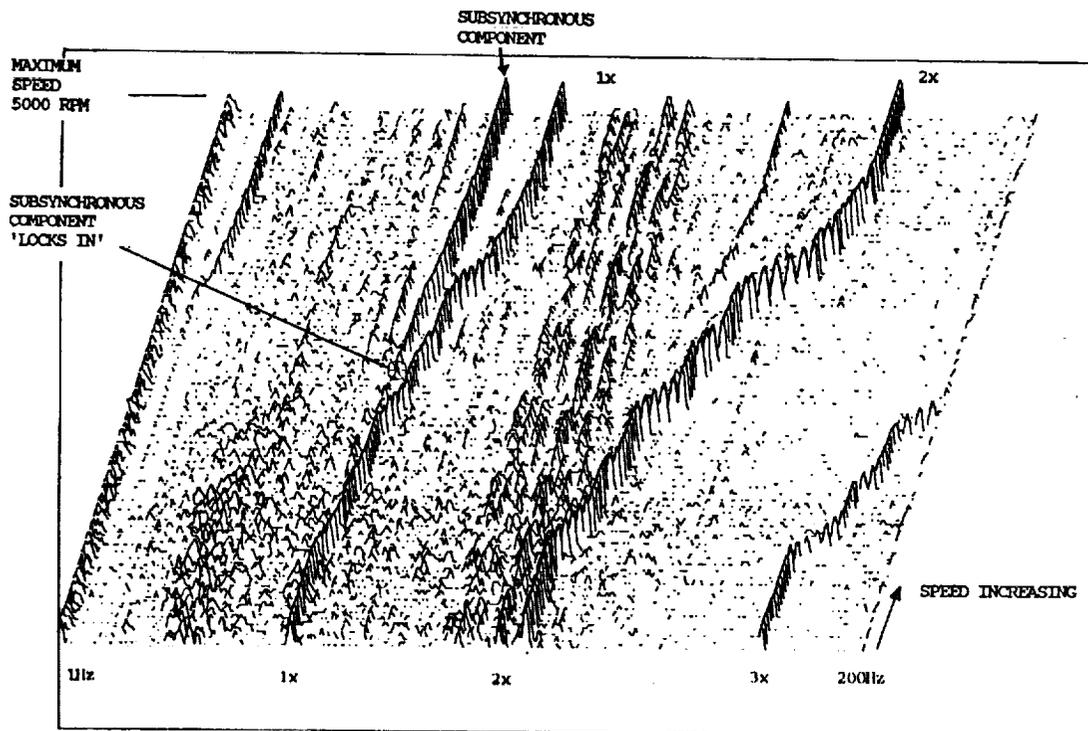
Fig.14- Waterfall Plot of Shaft Motion during controlled speed increase. (Pump Clearances at Twice Design Values)

The vibration locked in and dropped out as the speed was varied. On fig. 14 a waterfall plot of the shaft vibration on a run up highlights this characteristic. The waterfall was taken by varying the speed against a constant throttle valve setting, approximately equivalent to the best efficiency point at any speed. At this setting the subsynchronous vibration drops out at 3600 rpm. On fig. 15 a waterfall plot of shaft vibration on a run down shows that the subsynchronous vibration dropped out at 3600 rpm. The waterfall plots also show that the subsynchronous vibration did not occur at a fixed frequency but varied as a constant proportion of running speed. In Test 3 the subsynchronous whirl frequency ratio 0.84 irrespective of the actual running speed of the pump. This is particularly well illustrated on the run down characteristic. At speeds, where the subsynchronous vibration was well established, the variation of flow had little effect on the character of the vibration. However, at speeds around the stability boundary of the subsynchronous vibration a change of flow caused the phenomenon to 'lock in' or 'drop out'. In general reducing the flow brought on the onset subsynchronous vibration. The effect of flow on the subsynchronous was noticeably less powerful than the effect of speed. Throttling the balance return line to increase the back pressure on the balance drum also delayed the onset of the subsynchronous vibration. Where the subsynchronous motion was well established the shaft vibration appeared to take up virtually the full bearing clearance. Not unsurprisingly this imposed an upper bound to the amplitude of the vibration. The general character of the bearing housing vibration was the same as the character of the shaft vibration. The vibration levels in the frequency range 10-200Hz, were of order 2mm/sec when running normally and up to 7mm/sec when the subsynchronous vibration was present. The vibration at blade rate and twice blade rate showed some modulation at the difference frequency. The pressure fluctuations in the suction and discharge were largely random in character with some contribution at blade rate and twice blade rate but nothing evident at the subsynchronous frequency. The balance return line pressure pulsed strongly at shaft rate and, when present, at the subsynchronous frequency. Impulse tests on the bearing housings showed that the natural frequencies were well away from running speed. The pump rigid body natural frequencies, (on the temporary supports), were about 2500 cpm whilst the characteristics natural frequencies of the pump body and bearing housings were much higher, above 500Hz. The dynamic characteristics obtained during Test 5, i.e. with swirl control, showed stable operation over the complete range of flow and speed available. With clearance opened out to 3x, Test 6, the pump became unstable at a speed of about 4800 rpm and the whirl ratio remained the same as before at 0.84, fig. 16. The frequency of the subsynchronous vibration maintained the same relationship to speed up to the test maximum of 5500rpm as had been obtained before (Test 3).

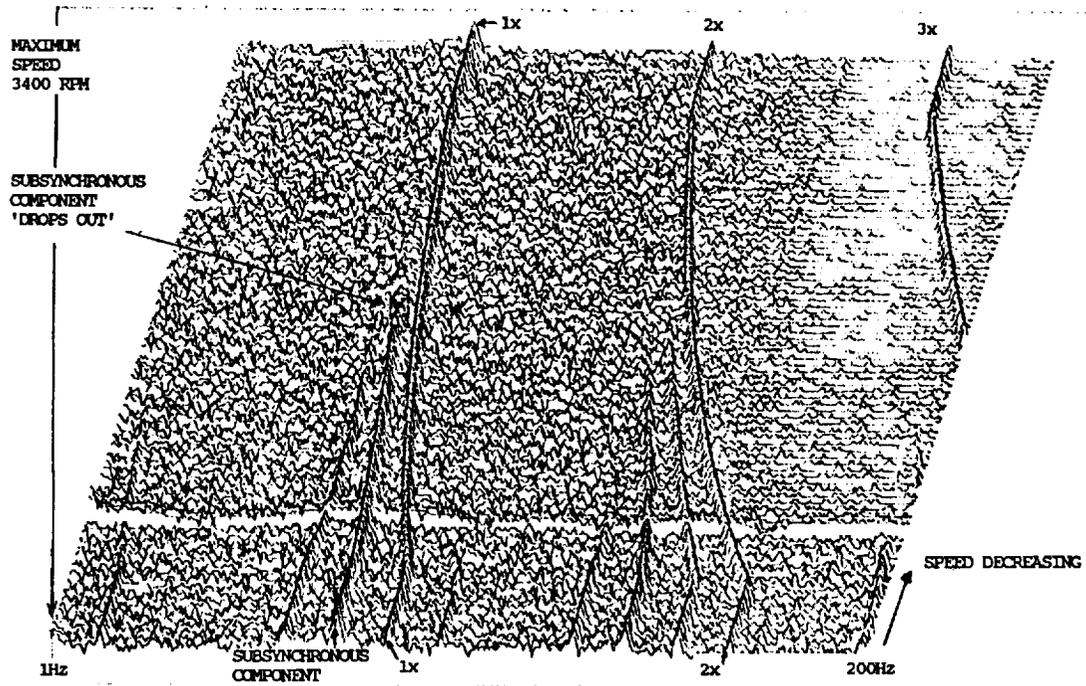
Fig.15 - Waterfall Plot of Shaft Motion during controlled speed reduction. (Pump Clearances at Twice Design Values)

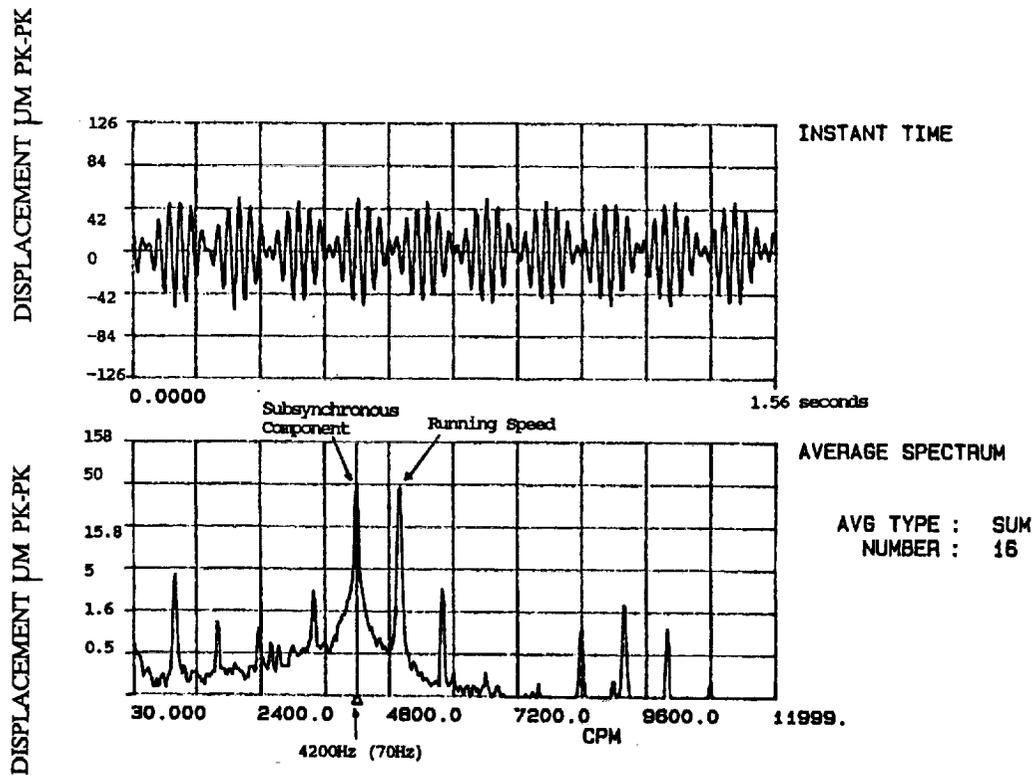
Fig.16 - Time History and Frequency Spectrum of Pump Shaft Displacement [Pump Clearances at 3 x Design, with Swirl Control Test 6]

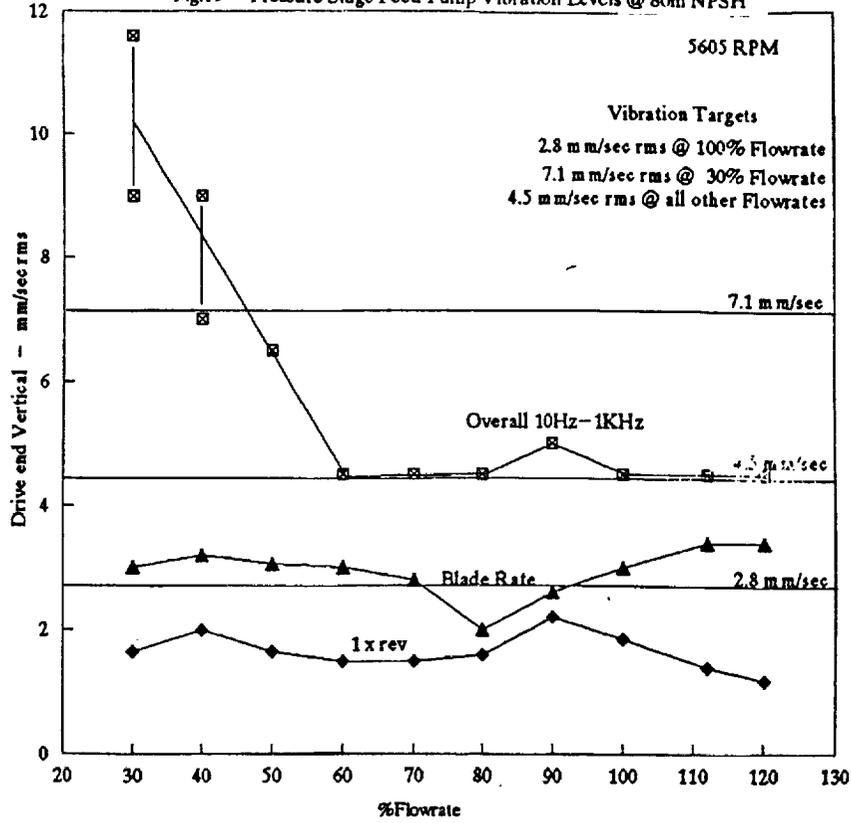
Fig.20 - Scale Model of Cavitation Performance in Cavitation Visualisation Rig vs Site available NPSH

In 1988 a cavitation related problem was seen during works testing of pressure stage feed pumps for a Nuclear Power Station. These tests were carried out at rated speed of 5610 rpm and over the full range of flow. Tests however, were carried out without the booster stage pump and the NPSH was less than a half of the site NPSH at rated duty falling to less than a third of the site NPSH at 40% rated flow. Although this was considered acceptable for the hydraulic performance measurements it was found to give unsatisfactory vibration levels as measured on the pump bearing housings compared with the vibration targets. On site the pumps were to meet a vibration level of 2.8mm/sec rms (10Hz-1KHz) at duty flow, 4.5mm/sec rms down to 40% flow and 7.1mm/sec rms at 30%, the recirculation flow quantity. It was desirable to demonstrate these levels during the works test. The measured vibrations were higher than target as characterised in terms of broad band excitation, impeller blade frequency excitation and general unsteady/erratic readings. Figure 19 shows the highest vibration recorded during test at 80m NPSH in terms of the overall level, once per revolution and blade rate frequency components compared with the target. It was suspected that cavitation was responsible for the problem. A review of some visual cavitation tests done on a 1/2 scale model impeller in our Research Laboratory indicated that sizeable bubble formation could exist 80m NPSH despite the fact that no loss in head had occurred. Typical bubble size data are shown in fig.20 where it can be seen that bubble size in excess of 30mm would be expected at the NPSH used during the test. The NPSH was increased to 145m, still only 50% of the site NPSH at duty flow and 50% at 40% rated flow. The vibration levels were found to be very close to the vibration targets as can be seen in fig.21. Clearly this underlines the need to consider carefully before agreeing to meet tight vibration limits during tests designed primarily to demonstrate hydraulic performance.
