Brush Seal Performance and Durability Issues Based on T-700 Engine Test Results

R.C. Hendricks
*Lewis Research Center
Cleveland, Ohio*

March 1994

National Aeronautics and
Space Administration

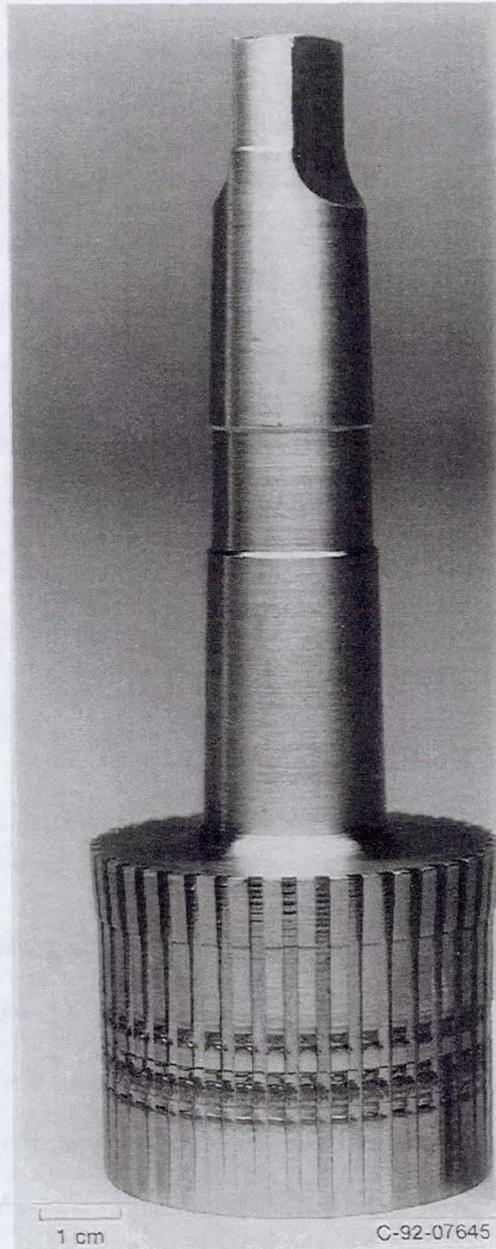
Figure 1.—Geometry of tapered, 40-tooth rotor.

In a rather harsh test at low surface speeds, brush seals were subjected to hard rubs by engaging the bristles into a 40-gear-tooth rotor (Fig. 1). The bristles withstood over 1×10^9 cycles without pullout, fracture, or massive debris generation. Under conditions of severe rotor-stator interface damage, the seal leakage performance degraded some 30 percent, but the brush seal did not fail (Hendricks et al. [1993a]).

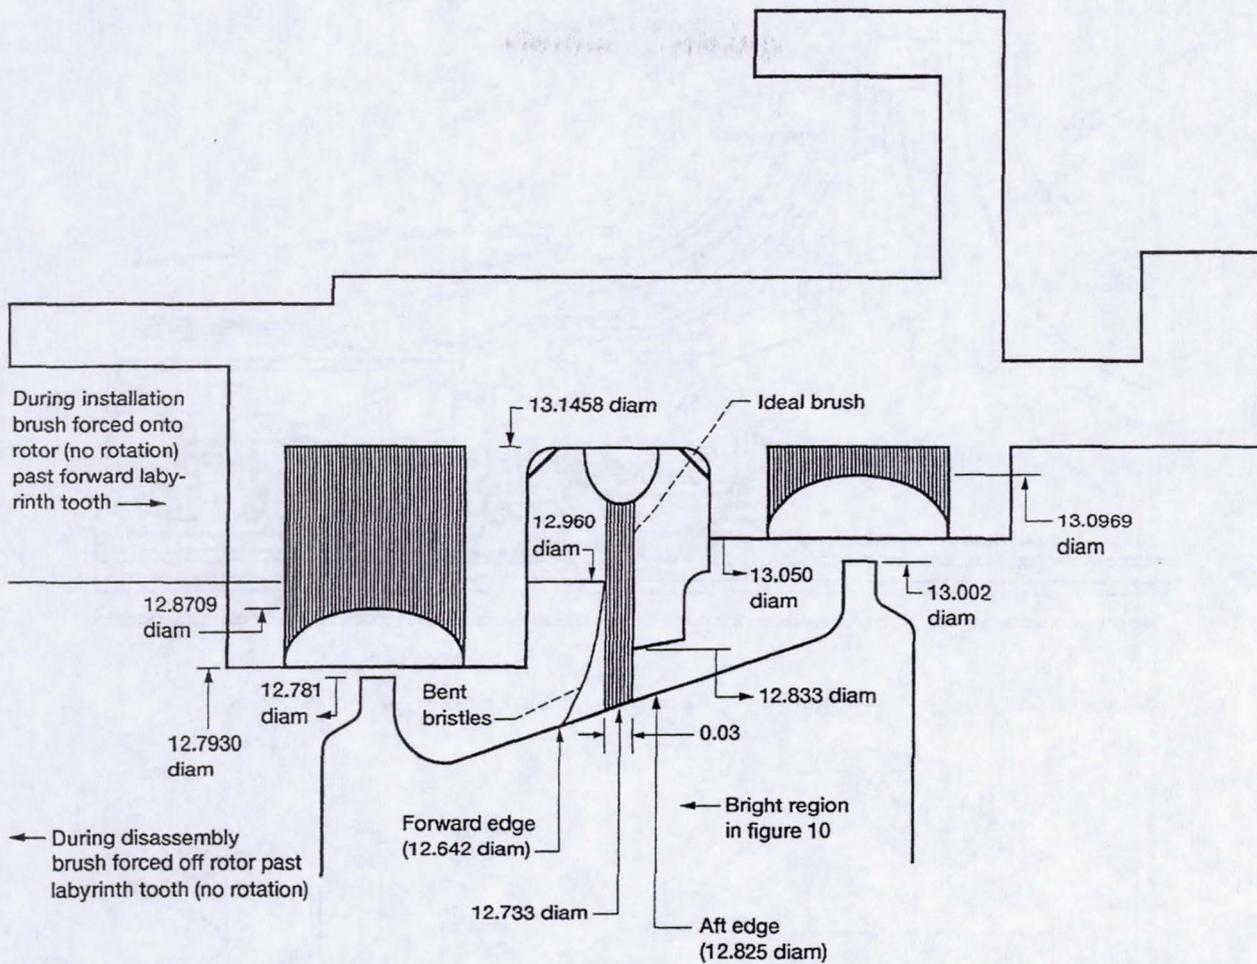
Figure 2.—Cross-sectional view of split-ring brush seal configuration. (Brush design with -0.020 in. interference. Dimensions are in inches.)

Testing of a brush seal between two honeycomb-labyrinth shroud seals (Figs. 2 and 3) in the fourth-stage turbine of a T-700 experimental engine revealed the following (Hendricks et al. [1993b]):

The integrity testing of a brush seal in a T-700 experimental engine (Hendricks et al. [1993b]) (Figs. 2 and 3) led to bristle clipping, excessive shear smearing of bristle material at the interface, and irregular bristle wear patterns (Fig. 9). Wear was assumed to be initially rapid, then steady, and subsequently decreasing with time of engine operation. Cyclic operations cause more rapid wear because excessive bristle debris forms upon initial engine startup. As anticipated, little material transfer or wear was noted on the fourth-stage turbine rotor, but the high points of the blade joints were polished (Fig. 10). The Haynes 25 bristles were sacrificed to the hard René 80 of the rotor, leading to loss of brush performance while maintaining the integrity of the fourth-stage turbine; this is very important. One metallographic sample of a bristle cut from the brush wear track showed material smearing and a potential redistribution of the tungsten (Fig. 11). Such a nonuniformity of tungsten could indicate bristle melting at the interface. Multiple polished micrographs showed bristle tip distortions but no redistribution of the tungsten to within 1 μm of the interface (Fig. 12). Even though the surface speeds and loads were high enough to produce a melt, melting is questionable; however, shear smearing (forming mudflat cracks) was prevalent (Fig. 13) as was oxide scale formation on the bristle (Fig. 14) with various color gradations noted. Integrity testing in bench and engine experiments demonstrated significant wear, tribological problems, and short life but no seal failures or engine failures due to seal malfunctions.

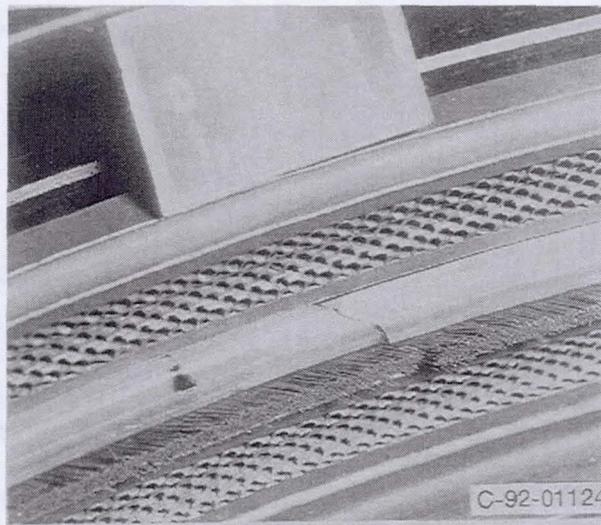
Figure 3.—View of installed brush seal.

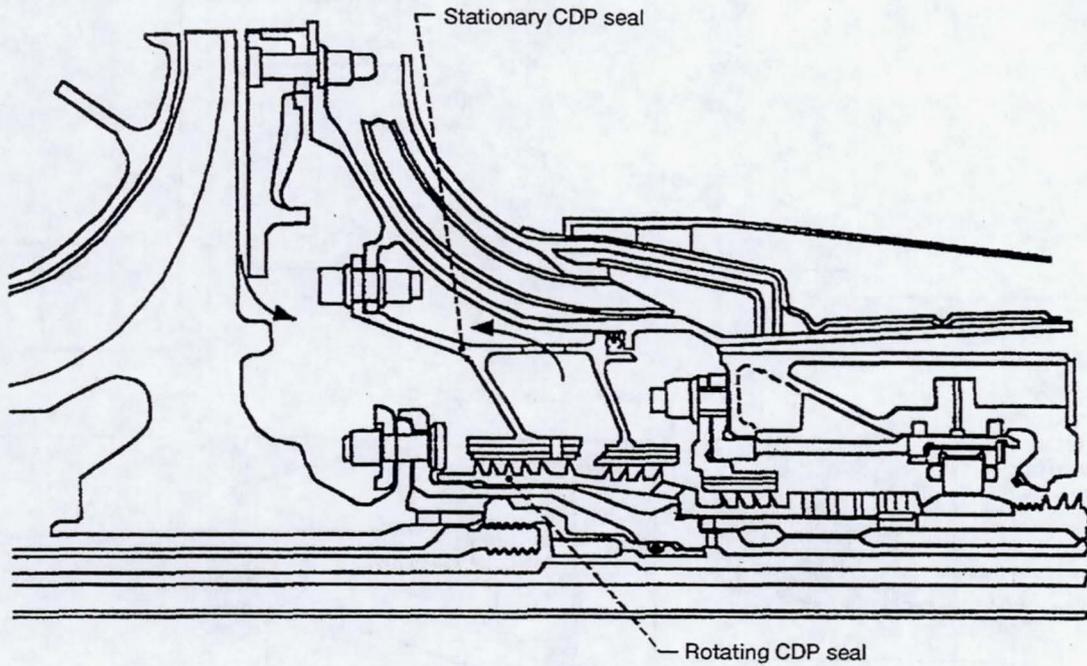
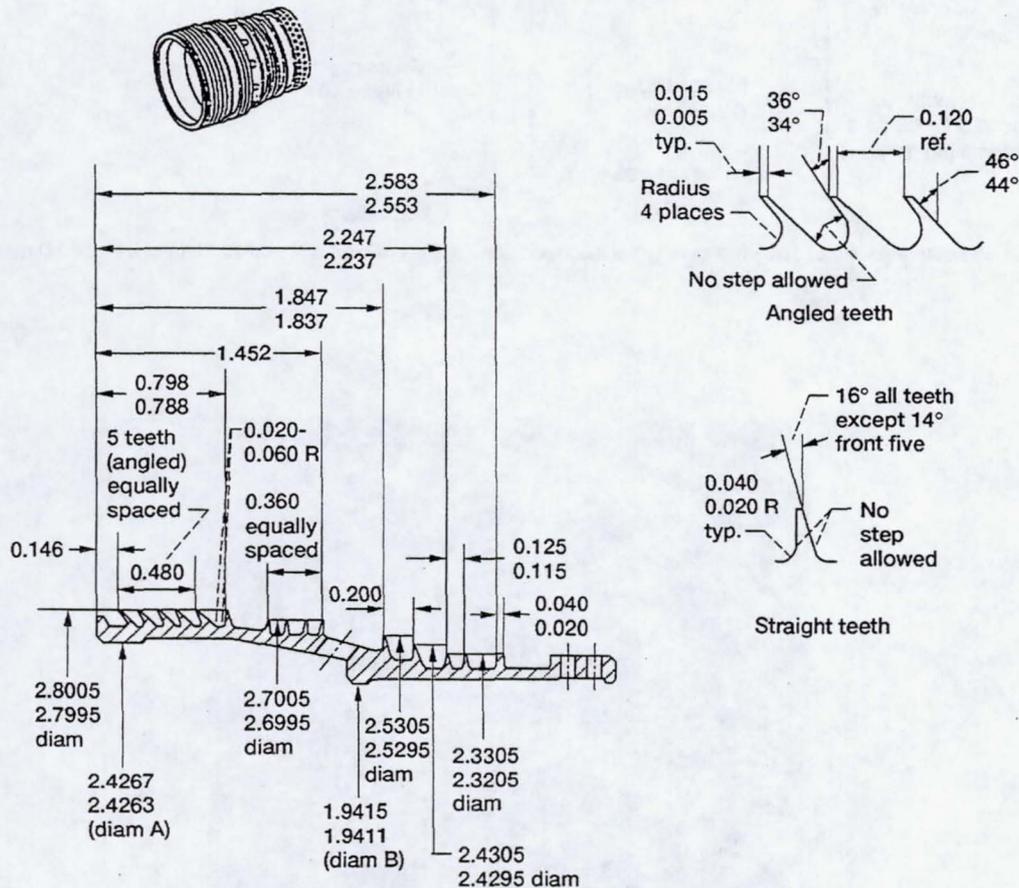
Figure 4.—Labyrinth compressor discharge seal system.

(a) Labyrinth seal package and airflow.

(b) Schematic of labyrinth compressor discharge seal. (Seal teeth and axis established by diameters A and B to be concentric within 0.003 full indicator reading. No steps allowed on tooth face or at fillet radius. All dimensions are in inches.)

The relative performance of a labyrinth and a dual-brush compressor discharge seal in a later T-700 experimental engine test provided conclusive evidence of a performance gain (Hendricks et al. [1994]). The labyrinth and dual-brush seal configurations are illustrated in Figs. 4 and 5, respectively. The seal had a nominal diameter of 71 mm (2.8 in.) and was tested for 46 hr of engine operations. Test conditions included compressor discharge pressures to 1 MPa (145 psi), temperatures to 407 °C (765 °F), and operating speeds to 160 m/s (530 ft/s), with the working fluid being normally dry ambient air. To within the uncertainty of the data and short engine hours (46 hr), experimental engine specific fuel consumption for the brush seal was reduced over 1 percent relative to the labyrinth seal performance (Fig. 6). These high gains in performance may be partially lost as the brush wears line to line within the rotordynamic and static eccentricity envelope. Nevertheless, brush seals are anticipated to be at least 20 percent more efficient than labyrinth seals over the life of a commercial engine (Anon. [1993]).

The dual-brush compressor discharge seal configuration and engine testing (Hendricks et al. [1994]) were designed to provide performance data for both the engine and the dual-brush and labyrinth seals (Figs. 4 and 5).

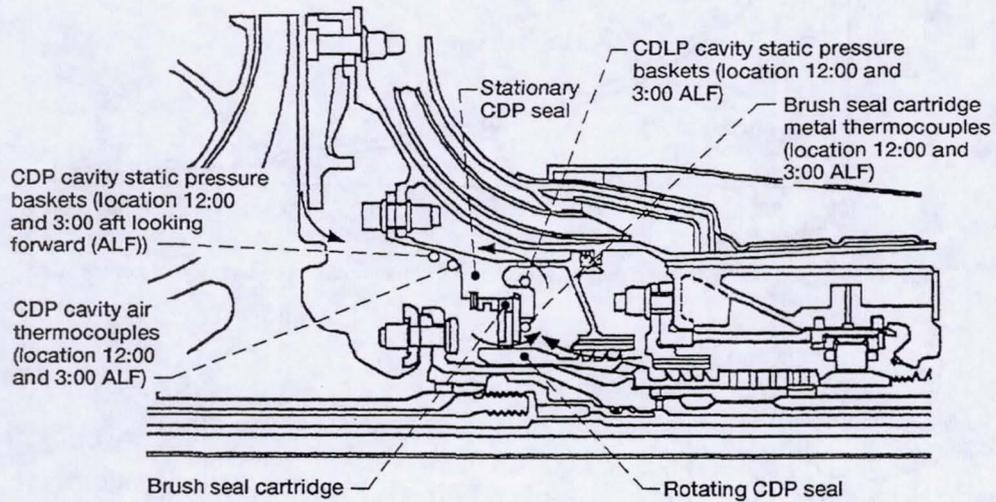
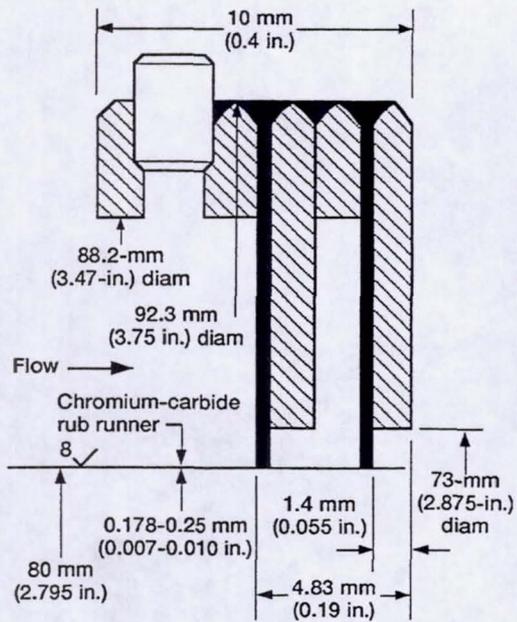
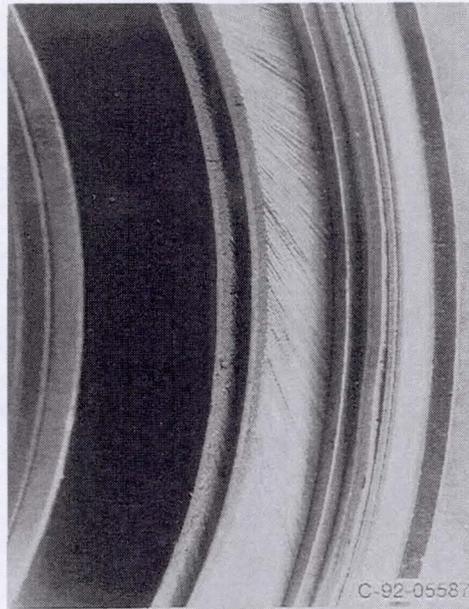
Figure 5.—Dual-brush compressor discharge seal system and schematic of airflow.

(a) Brush seal package and airflow.

(b) Illustration of dual-brush compressor discharge seal system.

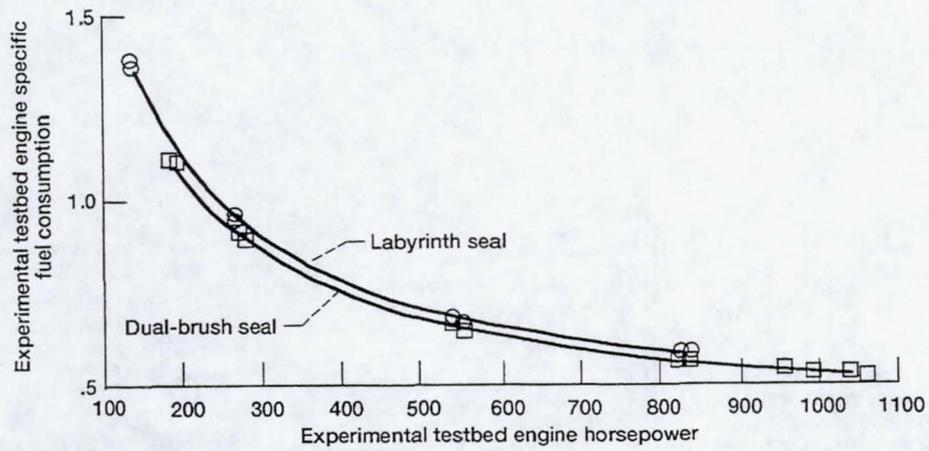
Figure 6.—Experimental testbed engine specific fuel consumption as a function of horsepower.

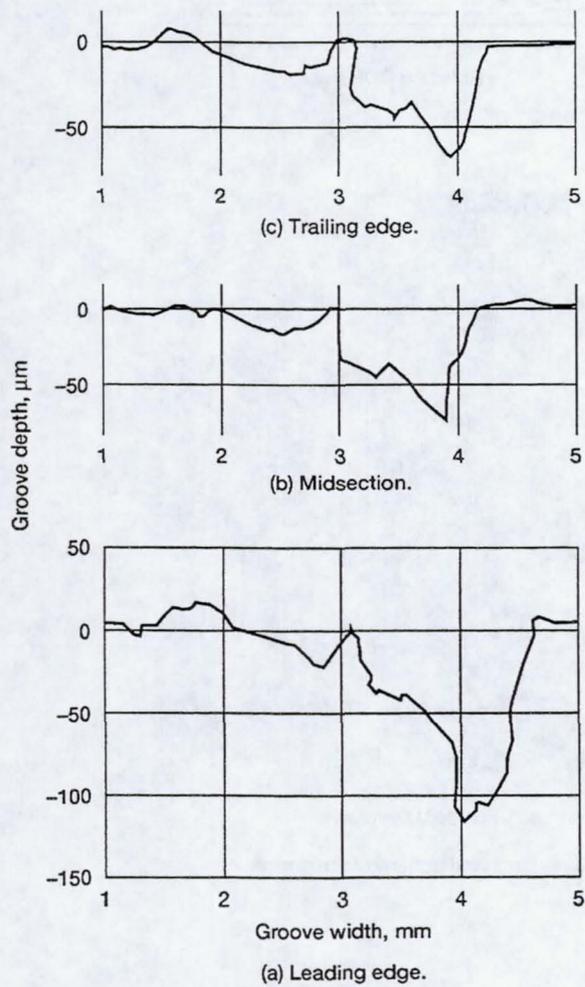
Figure 7.—Profilometer traces for 40-tooth rotor.

The low-speed, hard-rub test results (Hendricks et al. [1993a]) showed stainless steel rotor grooving by the Haynes 25 bristles that was 0.076 mm (0.003 in.) in depth (Fig. 7) with erratic "whipped" leading-edge surfaces followed by convergent grooving to a clean-cut trailing edge (Fig. 8). Bristle losses were even more significant, up to 0.2 mm (0.008 in.). The generated debris was a fine black powder and rust-colored materials. The black powder appeared to be amorphous, but the rust-colored materials were magnetic and iron-rich, implying Fe_3O_4 . Such fines could lodge within the brush, disrupting flexure characteristics and thermal heat sinking and ultimately rendering the brush incapable of sealing.

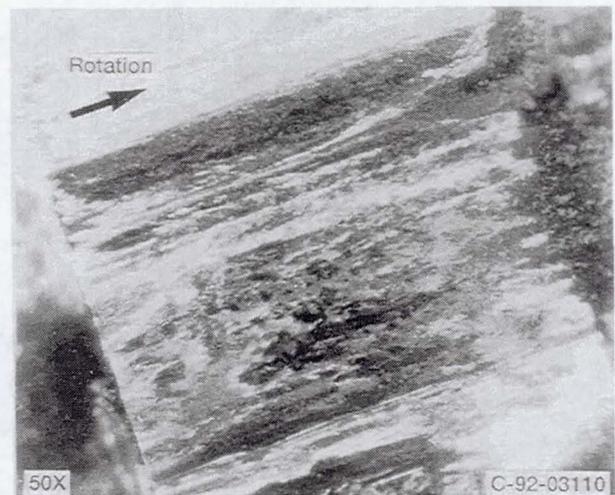
Figure 8.—Rotor land with debris and rub scars (40-tooth rotor).

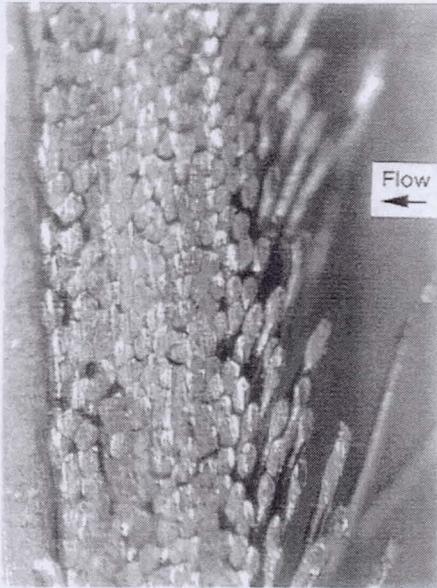
Figure 9.—Details of brush seal wear pattern from T-700 fourth-stage turbine test.

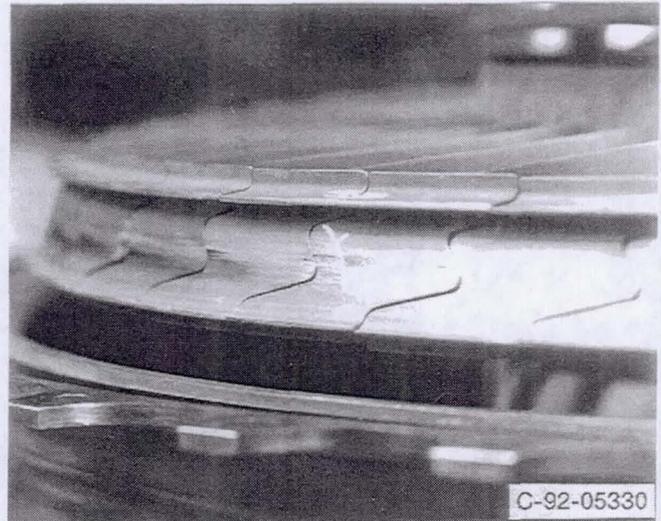
Figure 10.—Fourth-stage turbine after testing, showing polishing of leading edges.

1. Properly designed brush seals have sufficient integrity to withstand highly irregular surface operations at speeds to 335 m/s (1100 ft/s) and shroud temperatures to 620 °C (1150 °F) with a noncentered turbine orbit during steady and cyclic loading.
2. Upon initial startup, bristle debris can be expected when installations are blind and surfaces are disjointed (e.g., shrouded blades).
3. Brush wear was estimated to be line to line with the maximum rotor orbit.
4. Installed torques can be high, but rub-in torques are low. In this case rotor reversals are not permitted.
5. The sacrificial elements were the Haynes 25 brush bristles; the René 80 turbine blades evidenced minor polishing.

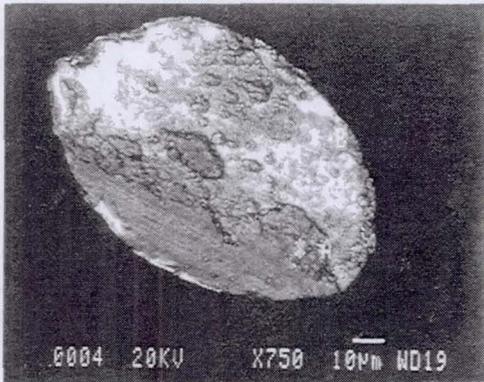
Figure 11.—Post-test metallographic results for bristle tip from wear track.

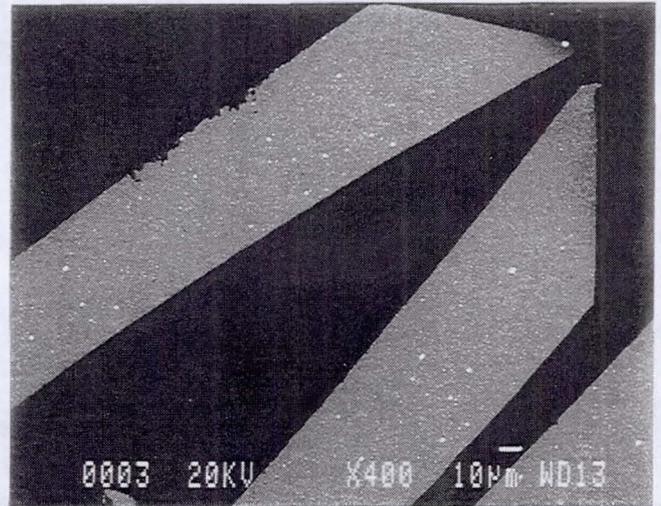
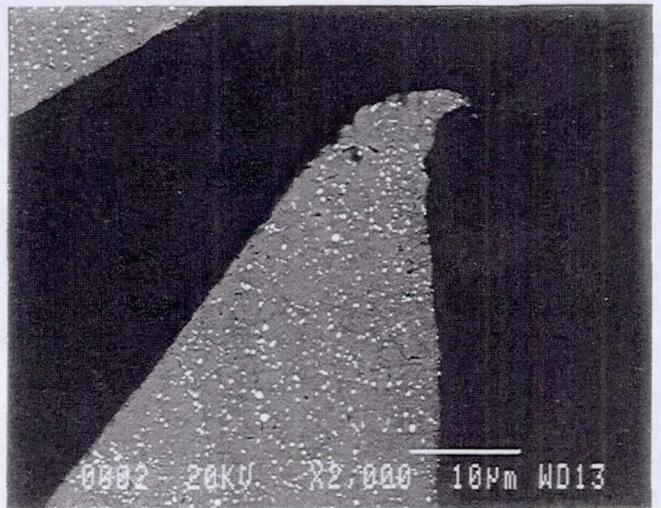
Figure 12.—Post-test analysis of bristles cut from brush seal, showing irregular tips.

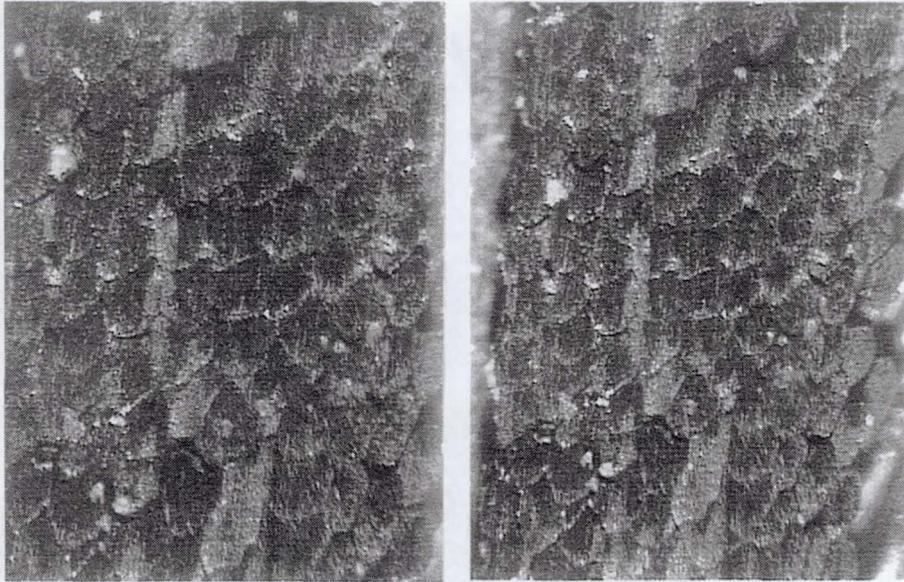
Figure 13.—"Smearing" of bristle tips (T-700 test).

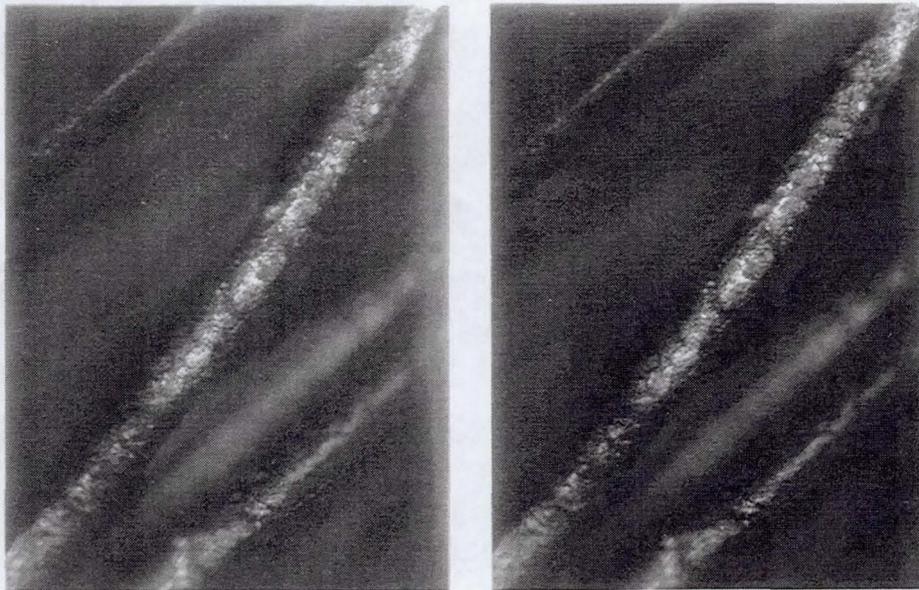
Figure 14.—Oxide scale on bristles (T-700 test).

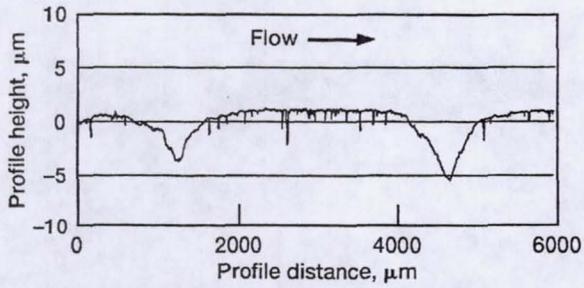
Figure 15.—Compressor discharge seal profile showing slight wear scars.

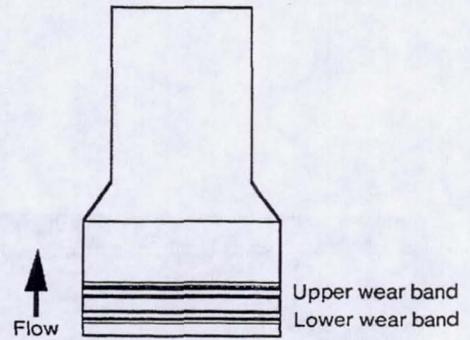
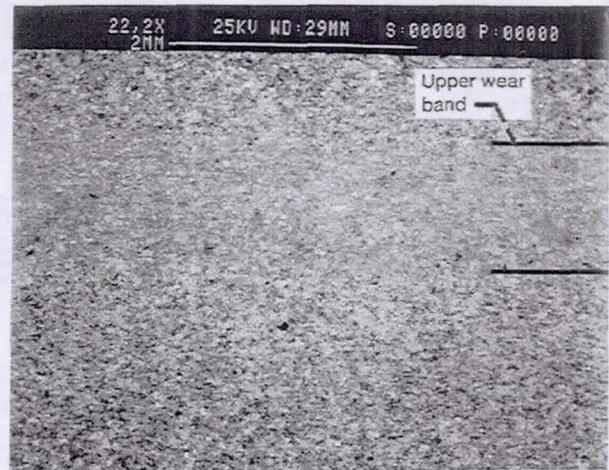
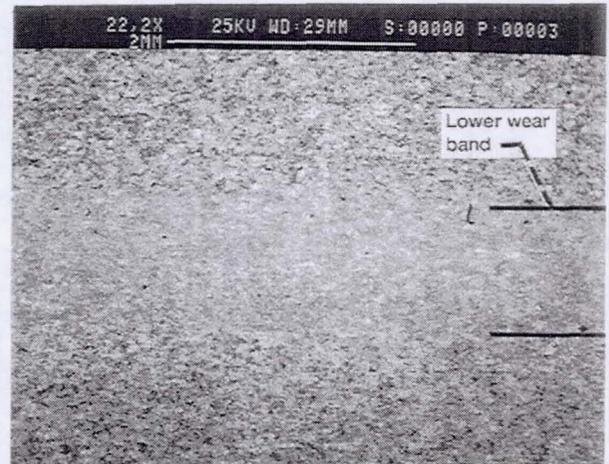
Figure 17.—Compressor discharge seal rub-runner wear bands.

(a) Upstream (lower) wear band.

(b) Downstream (upper) wear band.

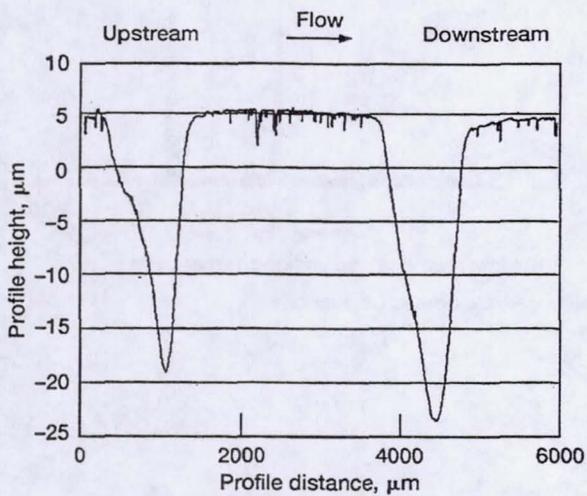
Figure 16.—Compressor discharge seal profile showing deeper wear scars.

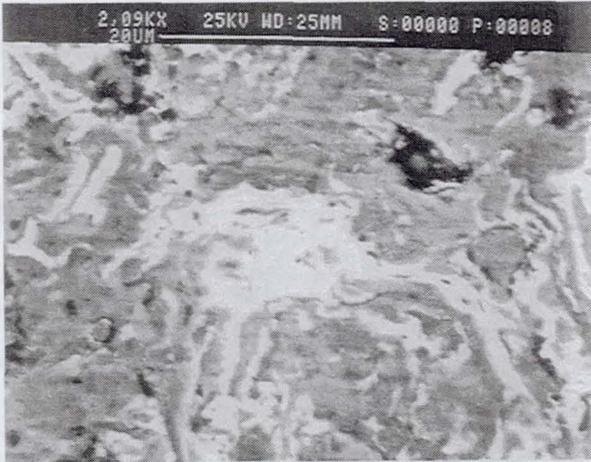
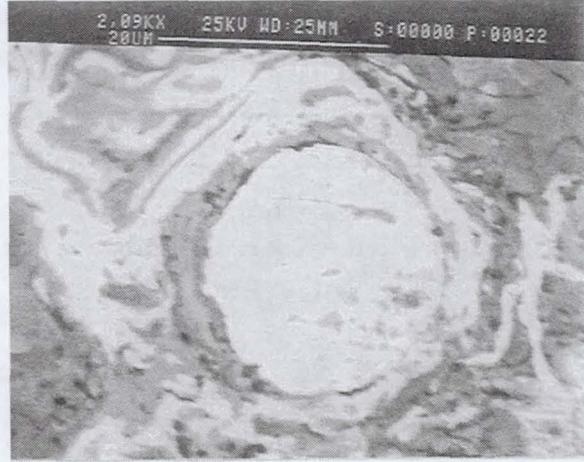
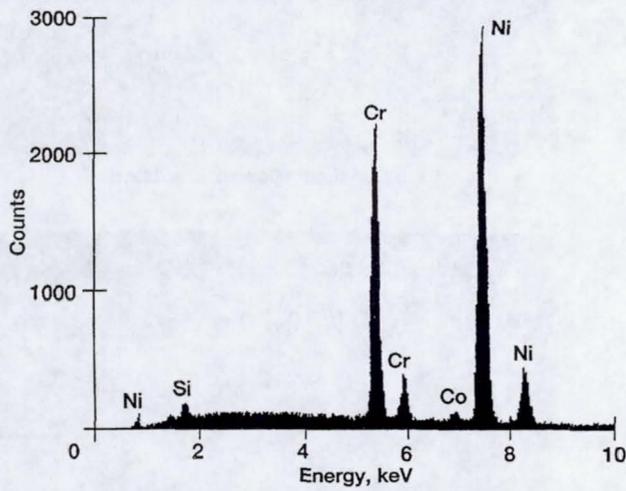
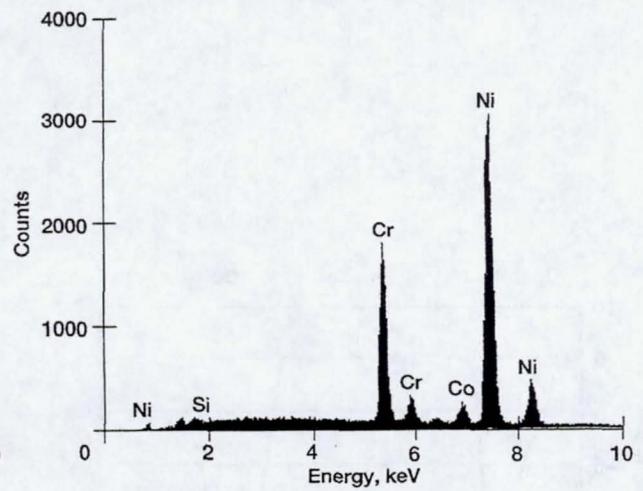
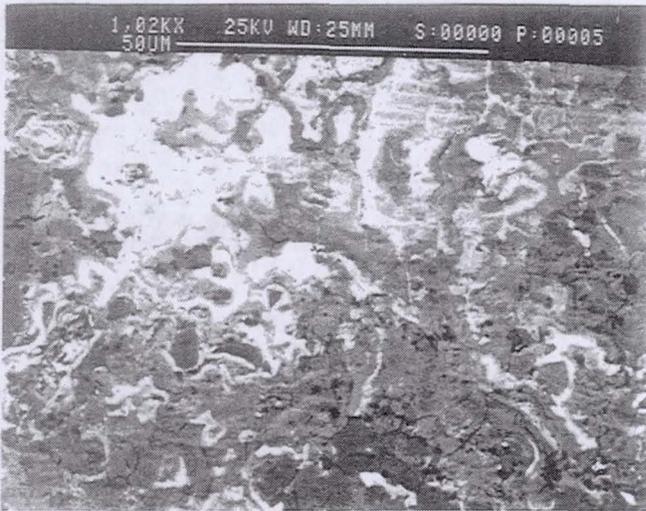
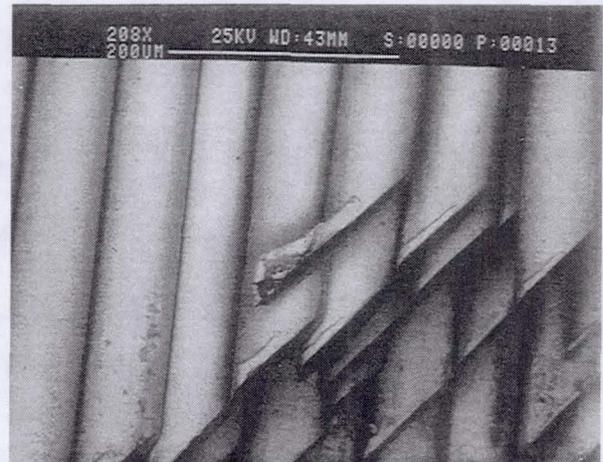
Figure 18.—SEM peaks associated with chromium-carbide-coated rub runner.

(a) Light area in coating matrix between bands.

(b) Light area in upstream (lower) wear band.

(c) Light area in downstream (upper) wear band.

The geometries of the seal, rub runner, and engine seal package were well defined. The nominally 0.13-mm (0.005-in.), 8-rms, rub-runner coating was chromium carbide, a D-gun-sprayed mixture of Cr_3C_2 and Cr_7C_3 with a nickel chromium binder [65(92Cr-8C) + 35(80Ni-20Cr)]. The bristles were Haynes 25 alloy. From testing experience, it was assumed that 40 percent of the pressure drop would occur across the first brush and 60 percent across the second brush, implying stiffer bristles and greater wear on the second brush. This anticipated result is shown in Figs. 15 and 16. Figure 15 illustrates the nominal rub surface wear; and Fig. 16, the wear associated with an assumed hard start or dynamic excursion. Further metallographic analysis of the brush bristle wear bands and the matrix material (Fig. 17) showed little or no evidence of material loss or transfer (Fig. 18). The bristle tips exhibited some shear smearing and evidence of some oxidation but were otherwise clean (Fig. 19).

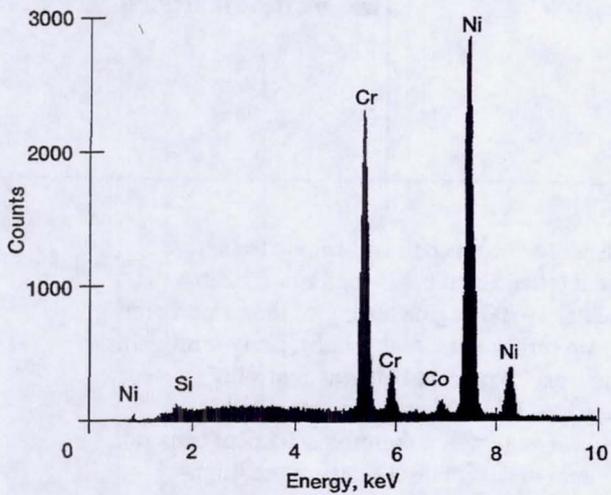
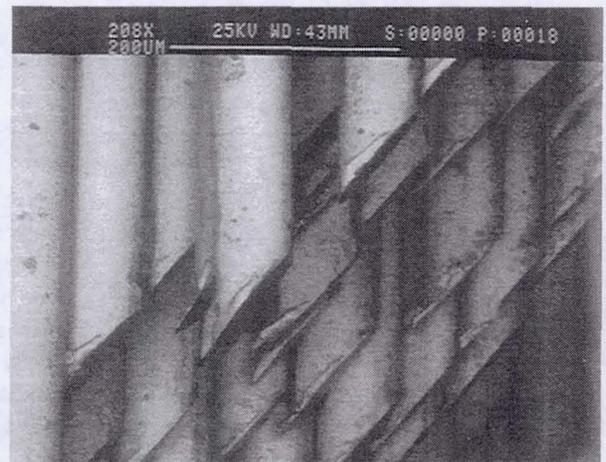
Figure 19.—Closeup views of bristles (compressor discharge seal).
