OUTGASSING PRODUCTS FROM ORBITER TPS MATERIALS

Gale A. Harvey, Tom J. Lash, and J. Richard Rawls

NASA Langley Research Center

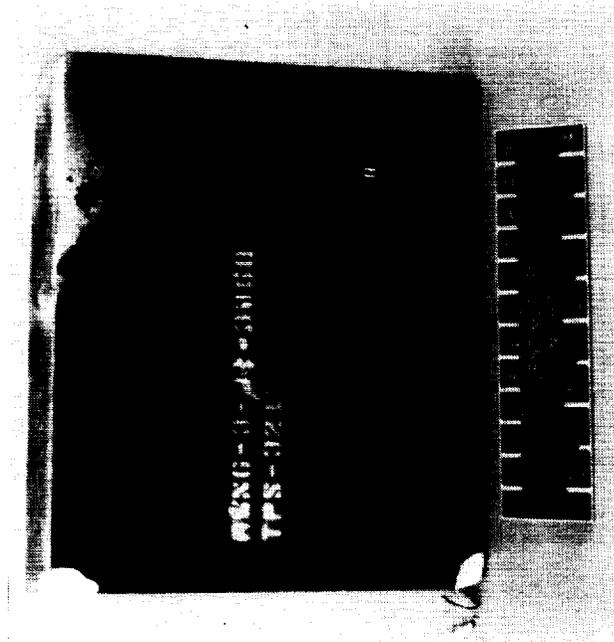
Figure 3. Photograph of a TPS tile.

A 1/2 inch cubed section from the back of a 0.025m² TPS tile (Fig. 3) was extracted by soaking in analytical grade isopropyl alcohol for 30 minutes. The infrared spectrum of the residue (Fig. 4) is that of phenyl methyl silicone and is identical to that from RTV 560. A similar size section from the interior or core of a tile was also extracted. The infrared spectrum of residue from the core of a tile (Fig. 5) shows the same phenyl methyl silicone and indicates that outgassing from the RTV 560 is absorbed within the tile. A similar amount of debris (0.5 in³) from an FIB (Fig. 6) removed from Columbia in September 1992 also had phenyl methyl silicone NVR (Fig. 7). However, the non-volatile residue (NVR) from a TPS gap filler was mostly esters.

The TPS tile (Fig. 3) was placed in a high-vacuum chamber (~10⁻⁷ Torr) and the outgassing at ambient temperature was measured with a mass spectrometer. The chamber background spectrum and the tile outgassing spectrum are shown in Figure 8. The heavy mass fragments are listed in Table 3 and show that the outgassing is phenyl methyl silicone. The absence of mass fragments 147 and 149 shows that the outgassing is not methyl silicone, or alkyl phthalates (the most common NVR on LaRC flight hardware). Similar outgassing measurements of TPS tile (Ref. 20) at Marshall Space Flight Center (MSFC) in 1975 also showed about one gram/0.1m² of phenyl methyl silicones.

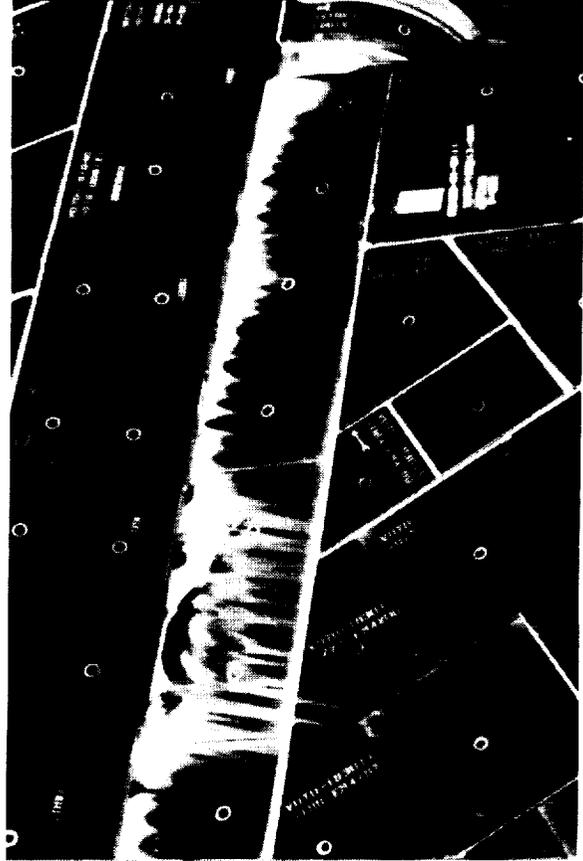
Figure 12. Heavy outgassing deposits on the elevon leading edge of Endeavor (May 1992).

Another type of evidence of outgassing of TPS materials is shown in Figures 11 and 12, photographs of black ceramic TPS tiles taken immediately after mission STS-49, the maiden flight of the Endeavor. Figure 11 is a closeup photograph of discolored tiles aft of the nose landing gear door, and Figure 12 is a photograph of heavy outgassing deposits on the elevon leading edge. In most cases the white color results from diffuse scattering of light from glassy deposits. The entire tile surface (black and white, Fig. 5) appears, under a 80X microscope, to be coated with a thin transparent film. Some of the white areas are pits which are partially filled in. The heavy white streams are multiple crazed and fused layers of relatively thick glass deposits. The black ceramic tile are good optical witness plates because of the high contrast and the flat surfaces which aid microscope examination.
