FOUR SPACE APPLICATION MATERIAL COATINGS ON THE
LONG-DURATION EXPOSURE FACILITY (LDEF)

John J. Scialdone and Carroll Clatterbuck
NASA Goddard Space Flight Center
Greenbelt, MD 20771
Phone: 301/286-6731; Fax: 301/286-2562

Organic Matrix Composite Protective Coatings for Space Applications*

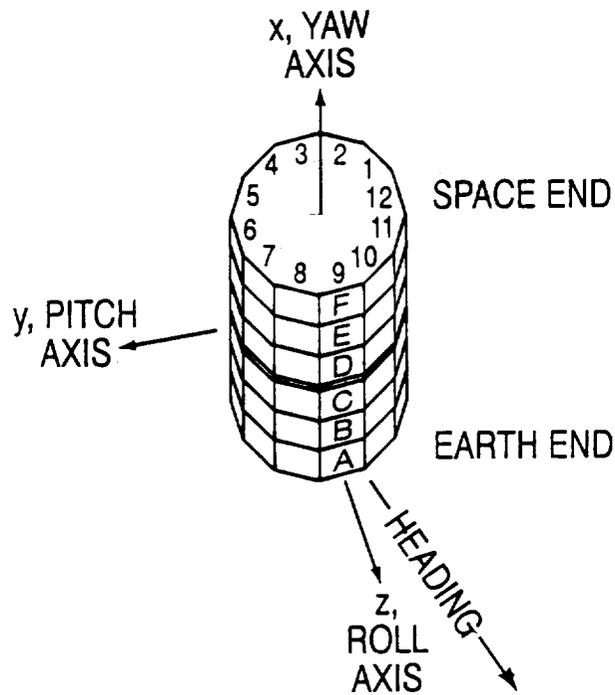
Figure 1. LDEF sketch and orbital configuration.

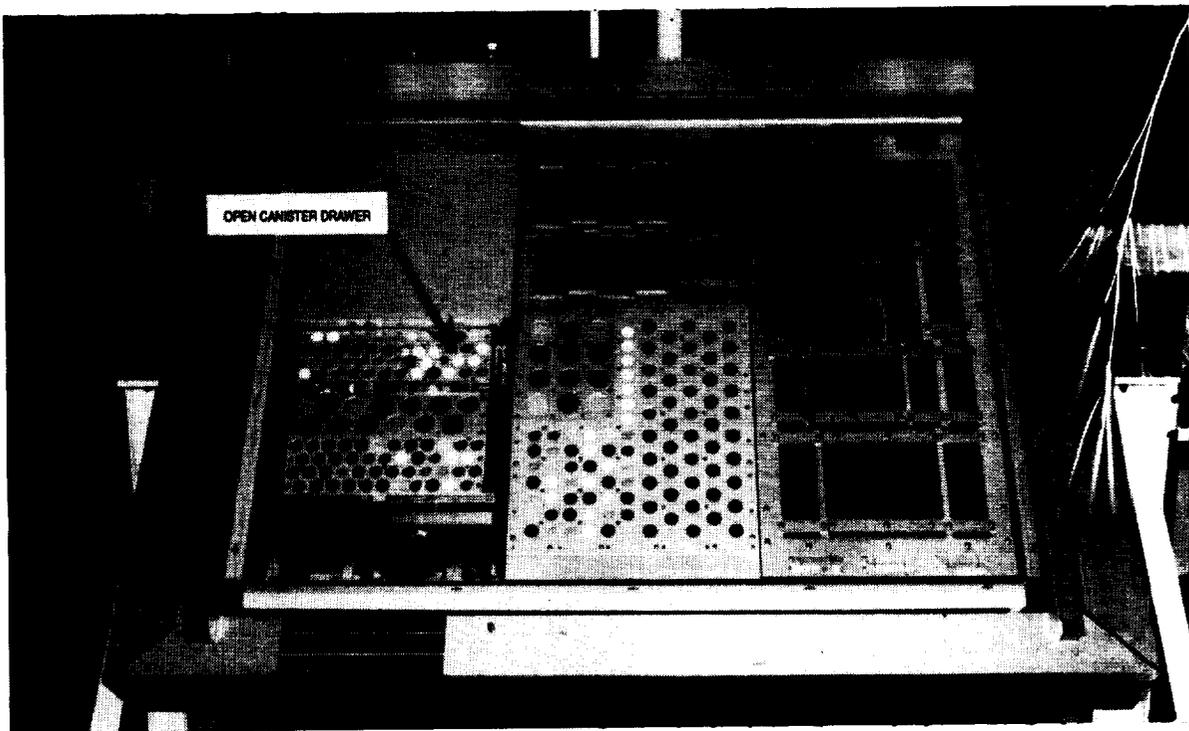
Figure 2. Photograph of Experiment Environmental Control Canister (EECC) with test specimen installed (Photo L-83-10,250).

The flight canister, shown in Figure 2, was provided with a drawer that opened and closed on command to expose the samples to the space environment while in flight. The container provided a clean, low-pressure inert gas environment while closed. A timer opened and exposed the samples 1 month after launch, and remained open for 10 months, at which time the drawer returned to the closed position to protect the samples during the remainder of the mission. The hermeticity of the drawer and canister was reconfirmed on the LDEF return, some 5 1/2 years after launch.

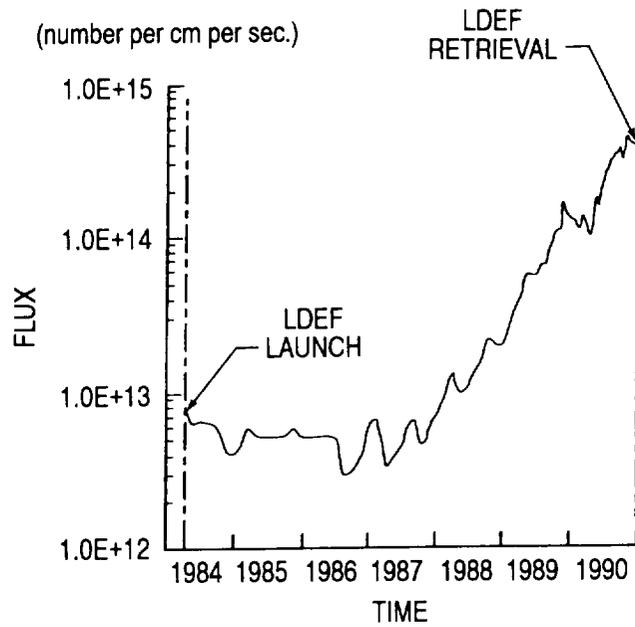
Figure 3. History of oxygen fluence on LDEF leading surfaces.

Table 1 shows the environmental exposure conditions as reported in Reference 1. The atomic oxygen fluence for the spacecraft (particularly for Row 9) and other data on the space environment are shown in Figures 3 and 4, taken from Reference 2 and 3.

For the 10-month exposure at an altitude of 260 nautical miles, the oxygen fluence is estimated to have been (from Figure 3 of the above reference) 2.6×10^{20} atoms/cm². The UV radiation exposure was 126,000 hours, as indicated in Table 1. The other environmental parameters are given in Table 1.

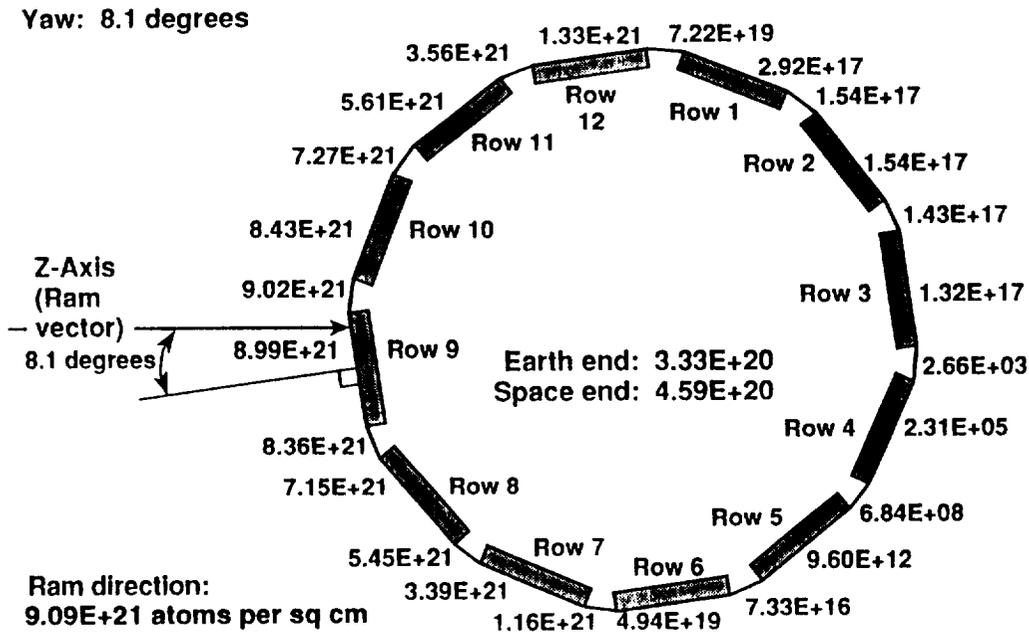
Figure 4. Calculated distribution of the total atomic oxygen fluence on each of the LDEF surfaces.

*Updated value of 9.09E+21 as in Figure 4.

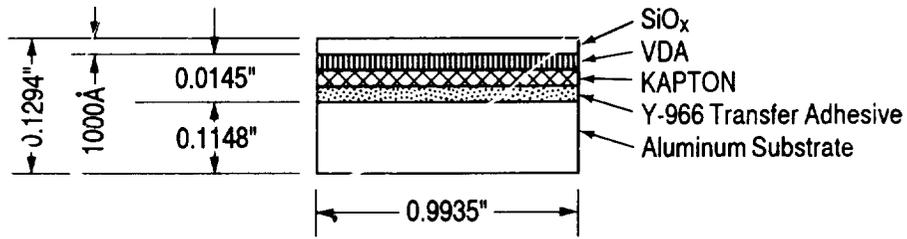
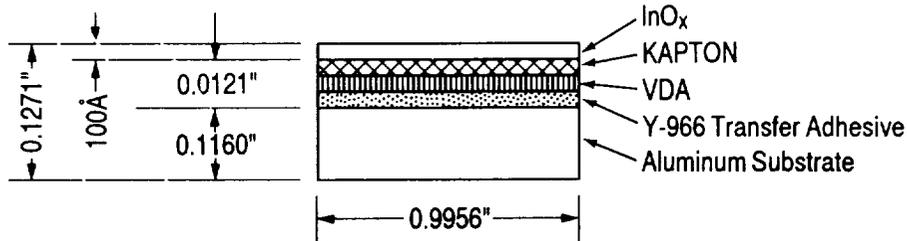
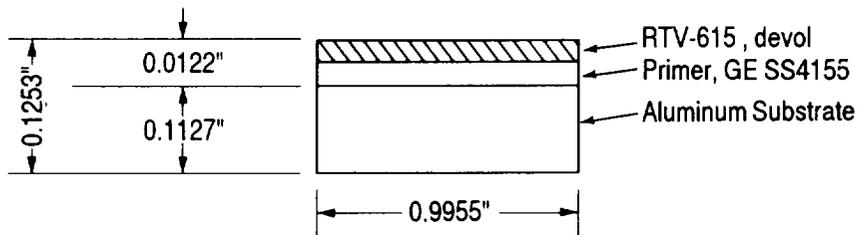
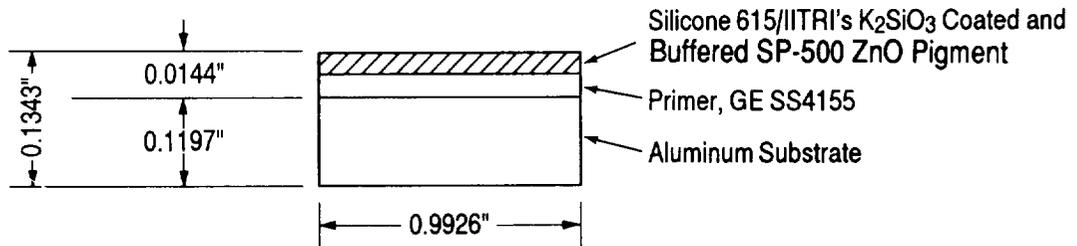
1. KAPTON®/VDA with 1000Å SiO_x coating

2. KAPTON®/VDA with 100Å In₂O₃ coating

3. RTV-615 Silicone on Aluminum

4. RTV-615 Silicone-Treated ZnO

Figure 5. Side views of LDEF specimens (not drawn to scale).

The four coating samples are shown schematically in Figure 5, indicating their compositions and the known dimensions. It is not known if, previous to the flight, those samples were baked out in vacuum to reduce their outgassing. We are assuming that they were not. The descriptions of the samples, the primary uses and advantages of the coatings, and available data on the samples follow.

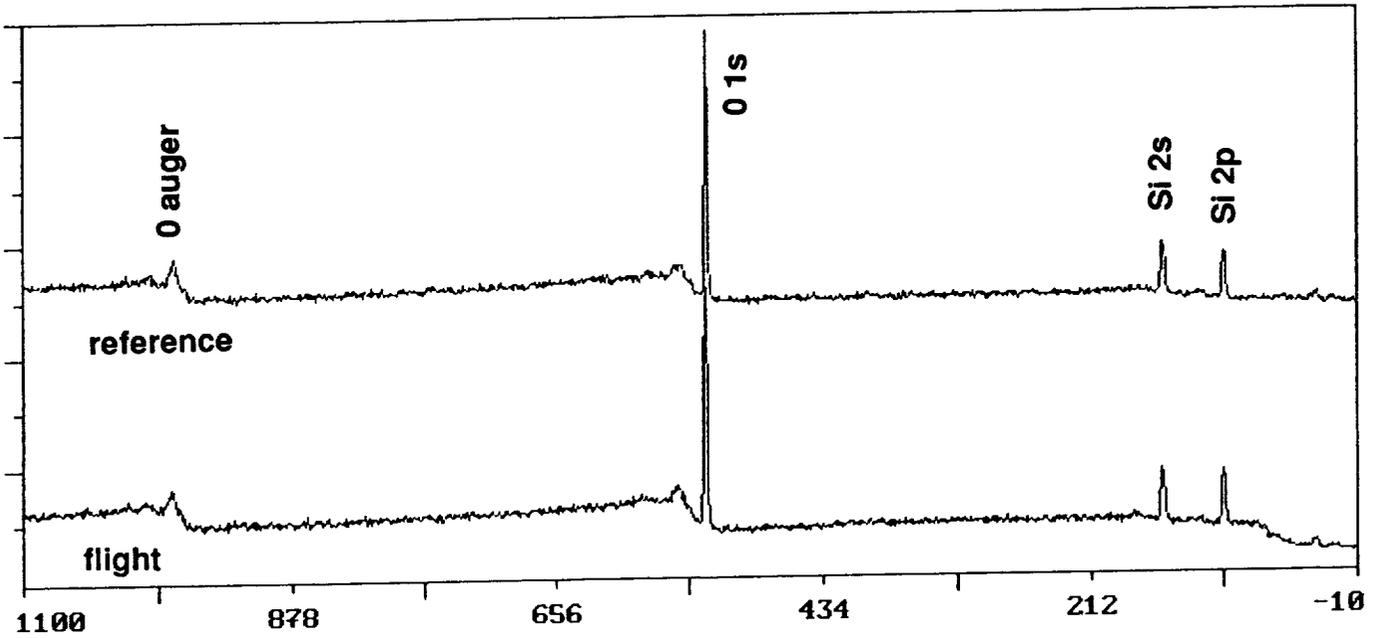
Figure 6. ESCA spectrum of 1000 Å of SiO_x on VDA/Kapton.

ESCA Analysis--The composition of both the flight and reference samples was similar, as shown by the spectrogram in Figure 6. The concentrations of Si and O remain constant through the thicknesses of both samples. Erosion may have been uniform over the surface. Peaks of silicone and oxygen are found within the various thicknesses.

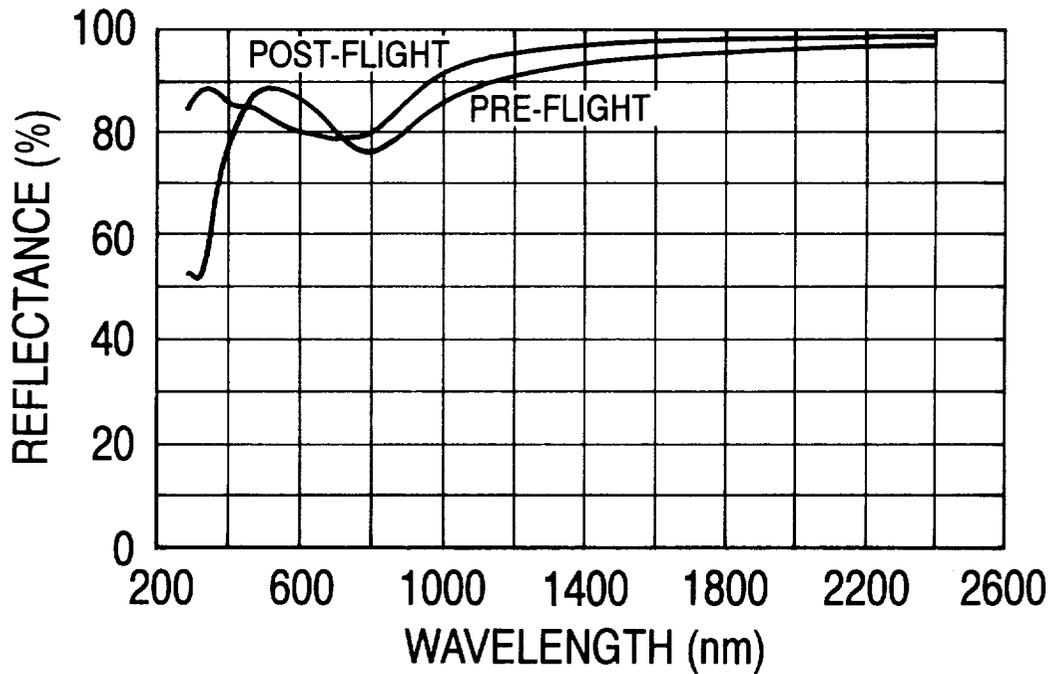
Figure 7. Reflectance of 1000 Å SiO_x coating on VDA/Kapton sample.

Radiative Analysis--The reflectances vs. wavelengths are shown in Figure 7. The exposed sample shows an improved reflectance below 450 nm and above 700 nm. The integrated properties are $\alpha = 0.127$ and $\epsilon = 0.023$ for the flight sample, and $\alpha = 0.155$ and $\epsilon = 0.025$ for the reference sample.

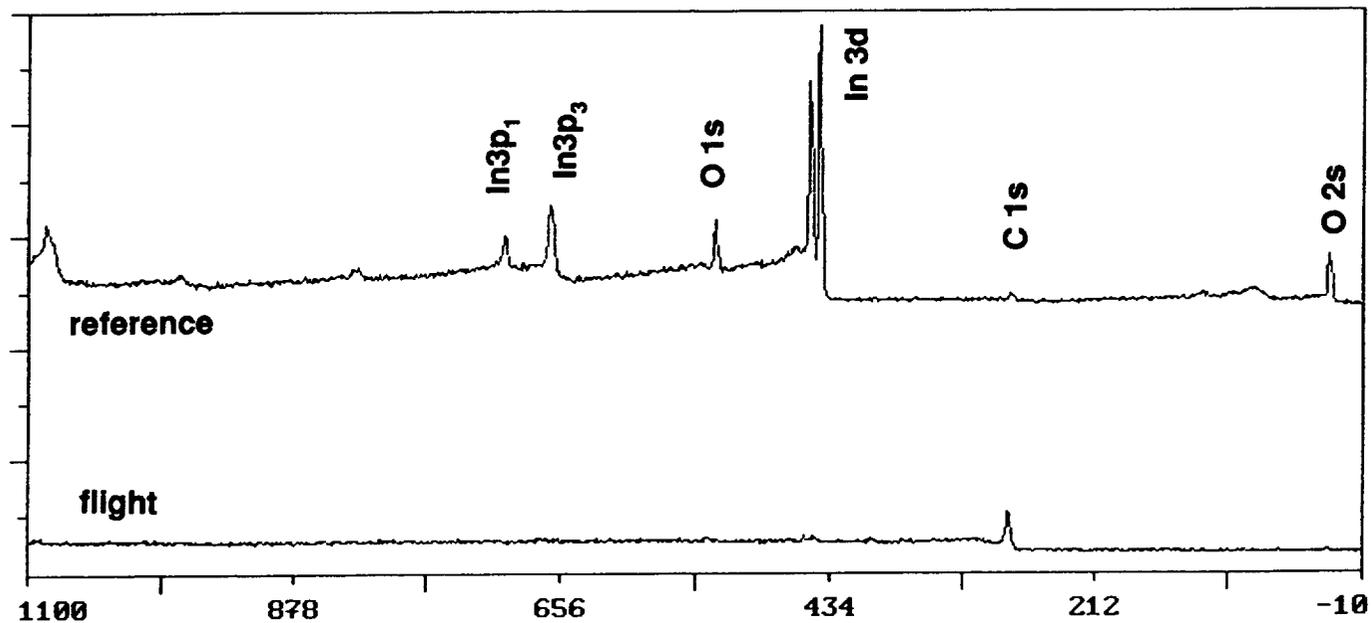
Figure 10. ESCA spectrum of sample with 100 Å of In₂O₃ on VDA/Kapton.

ESCA Analysis--The flown coating sample (Figure 10) has a rough surface with visible erosion and delamination. The non-exposed surface appears shiny at the outer edge, with no visible damage. The exposed surface is severely eroded and gray in color, with scratch marks around the eroded area. The scratched and eroded areas are made up mostly of Kapton, with some traces of indium. The indium at those locations measured up to 0.95 atomic % while at the unexposed surfaces, the indium was 7 atomic %.

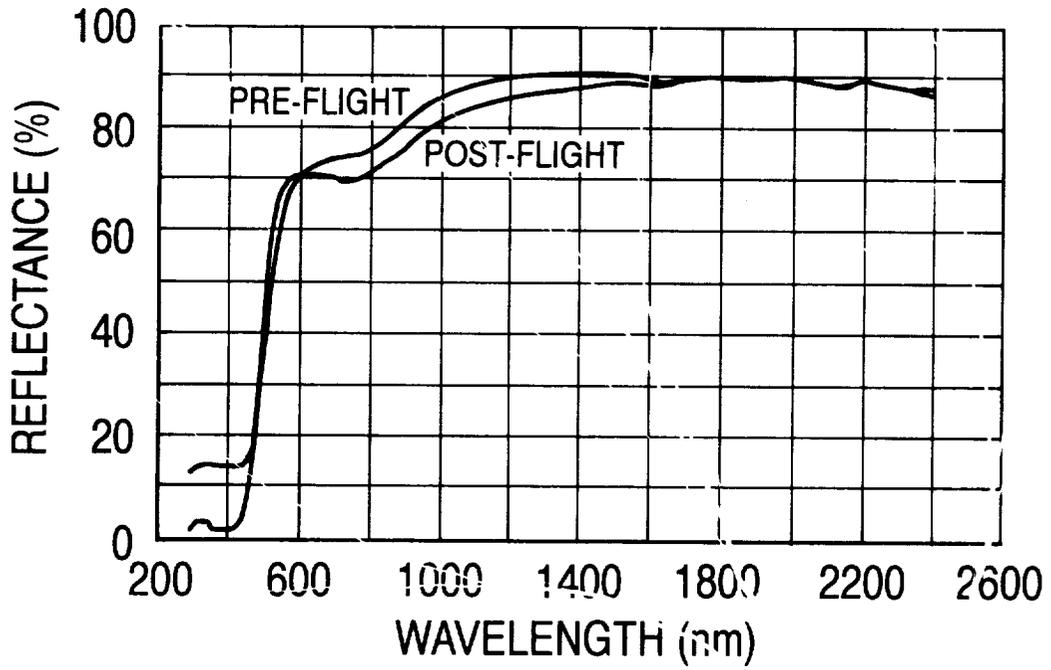
Figure 11. Reflectance of 100 Å InO₃ coating on VDA/Kapton sample.

Radiative Analysis--Figure 11 shows the reflectances of the exposed and reference samples. About 10% reflectance loss occurred at wavelengths below 450 nm and about 5% loss occurred between 600 and 1600 nm. The integrated values are 0.391 absorption and 0.547 emittance for the flown sample and are 0.363 and 0.564, respectively, for the reference sample.

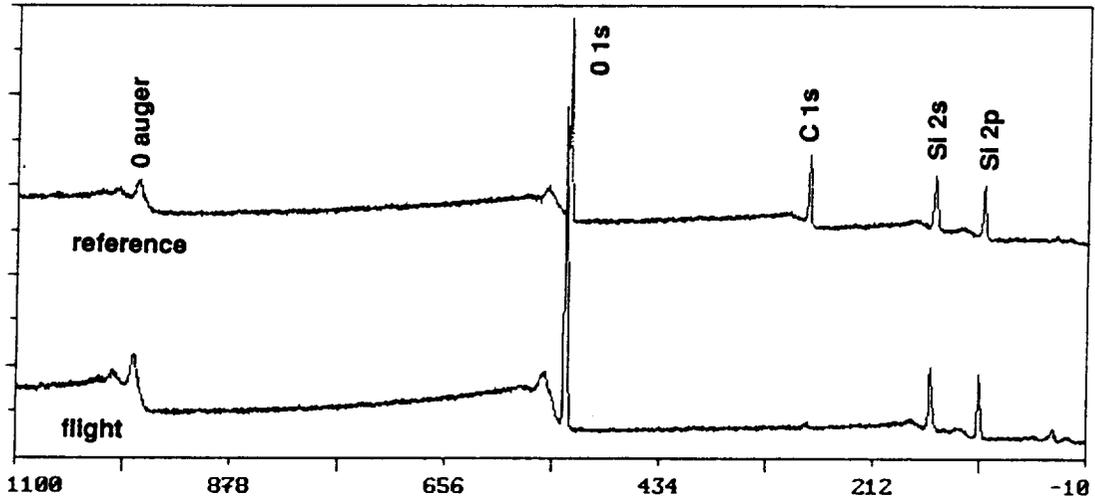
Figure 14. ESCA spectrum of sample with RTV-615 bonded on Al with SS 4155 primer.

ESCA Analysis--The erosion pattern is similar to that of the sample consisting of the same RTV with K₂SiO₃ and ZnO pigment. The flight sample shows carbon content of 1.5 atomic %, while the reference sample has 35 atomic %. The Si concentration did not change, while the O concentration doubled in the flight sample (Figure 14).

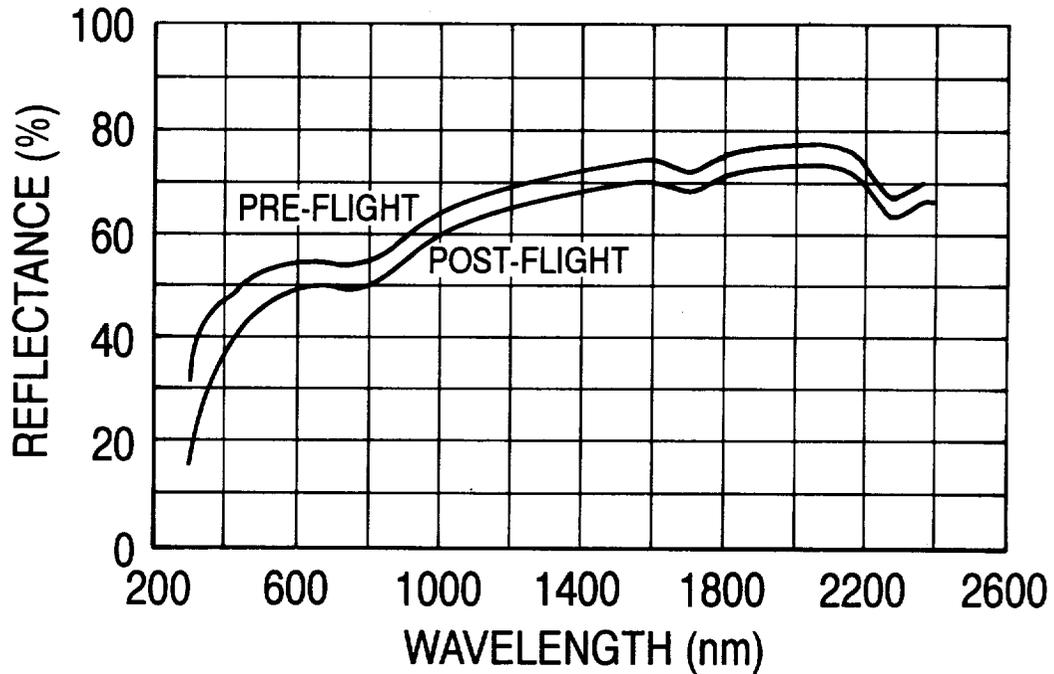
Figure 15. Reflectance of RTV-615 clear coating on aluminum.

Radiative Analysis--The flight sample experienced a loss of about 5% in reflectance throughout the measured range of wavelength with respect to that of the reflectance sample. The integrated properties are $\alpha = 0.489$ and $\epsilon = 0.819$ for the flight sample, and $\alpha = 0.432$ and $\epsilon = 0.824$ for the reference sample (Figure 15).

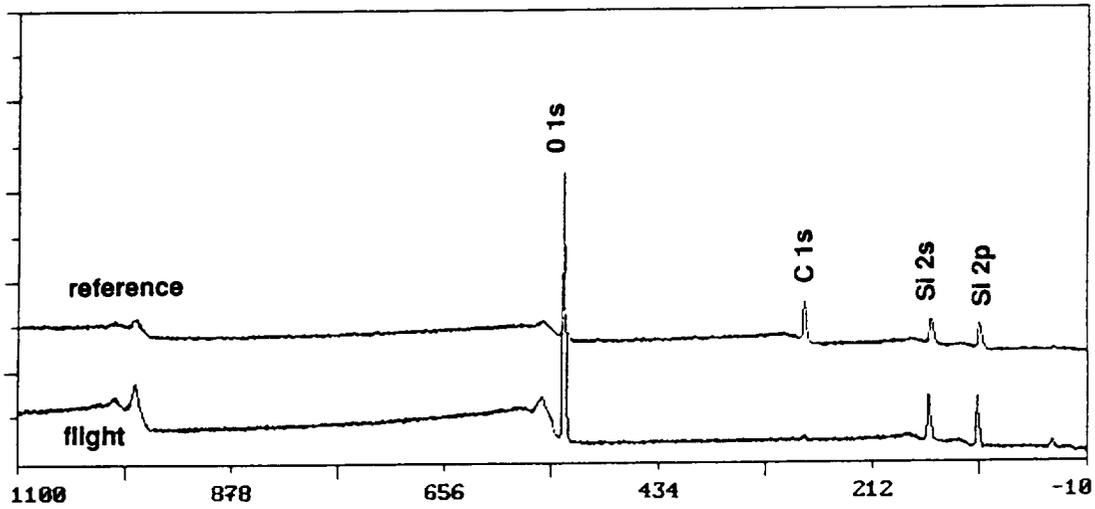
Figure 18. ESCA spectrum of sample with RTV-615 Silicone Treated with ZnO bonded on Al.

ESCA Analysis--This analysis (Figure 18) indicated considerable difference in the concentrations of carbon (C) between the flight and the reference specimens. The concentrations of Si between the two are about equal and constant through the thicknesses. The O and C concentrations differ. The C concentration decreases by 21 atomic % and O increases by 18 atomic % after 1 minute of etching. On the other hand, for the reference sample, the C decreases by 7 atomic % concentration and the O increases by 2 atomic % for the same etching time. No Zn or K peaks were found, even though the silicone was filled with potassium silicate and ZnO, indicating that they had eroded or that they had penetrated into deeper layers.

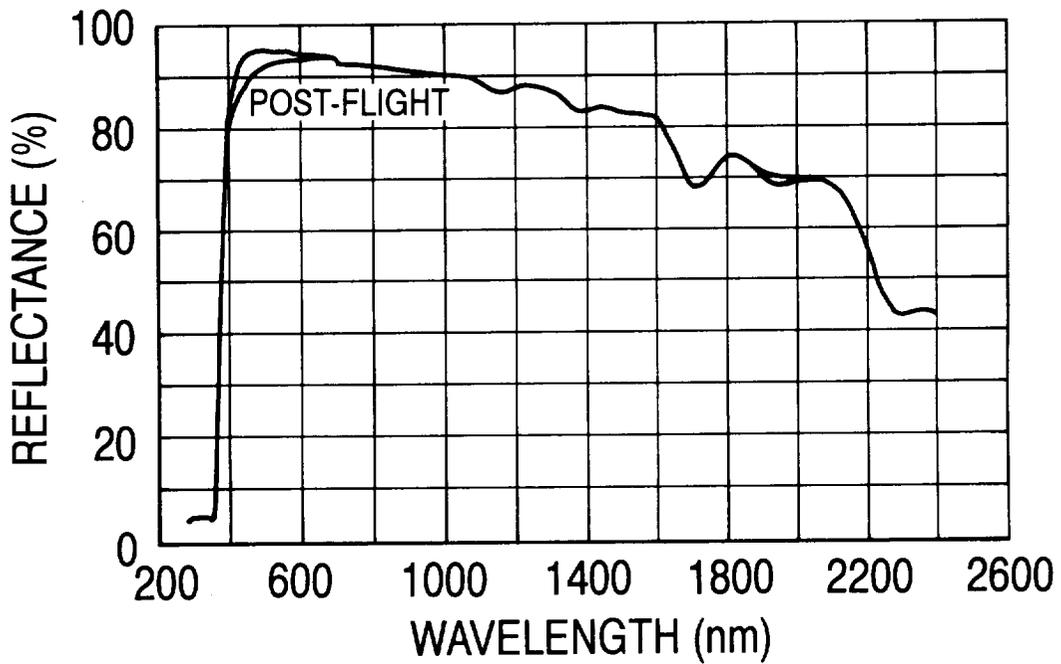
Figure 19. Reflectance of RTV-615/Silicone-Treated ZnO.

Radiative Analysis--The reflectance versus wavelength is shown in Figure 19. It shows some loss between 400 and 700 nm and between 1800 and 2100 nm. The integrated absorption is 0.201 and the emittance is 0.891 for the flown sample and 0.190 and 0.907, respectively, for the reference sample.

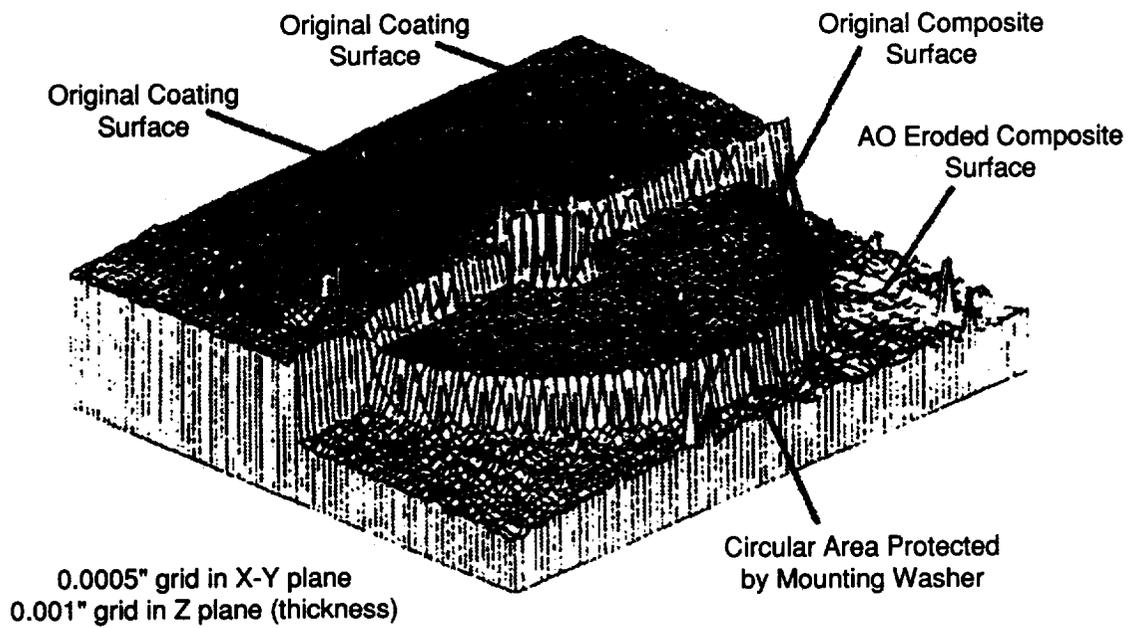
Figure 8. Three-dimensional Plot of Profilometry Measurements Taken From A Partially Coated Graphite/Epoxy Panel
