# Effects of Through-the-Thickness Stitching on Impact and Interlaminar Fracture Properties of Textile Graphite/Epoxy Laminates

Suresh K. Sharma and Bhavani V. Sankar  
*University of Florida, Gainesville, Florida*

February 1995

(NASA-CR-195042) EFFECTS OF  
THROUGH-THE-THICKNESS STITCHING ON  
IMPACT AND INTERLAMINAR FRACTURE  
PROPERTIES OF TEXTILE  
GRAPHITE/EPOXY LAMINATES Final  
Report (Florida Univ.) 132 p

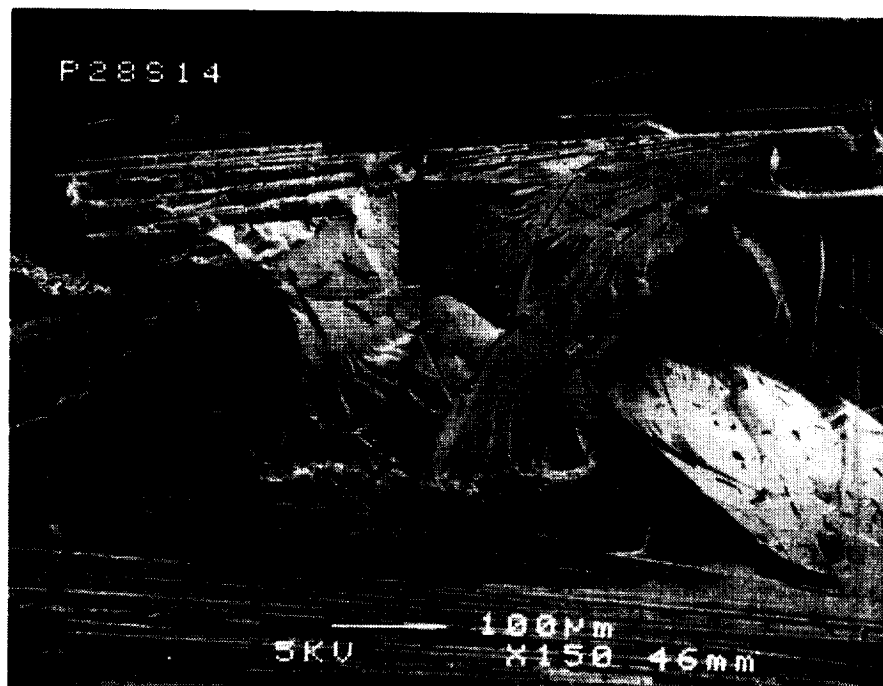
**Figure 3-15:** Matrix in the adjoining area of the Glass -750 stitch appears "ploughed"

In order to gain insight into debonding, stitch failure and the role of stitch-matrix interaction during the crack opening phase, Scanning Electron Microscopy was conducted on the top surface of a failed stitch and the adjoining matrix area. A stitch that was not compressed during the unloading phase of the test was selected for this study. Some of these photographs are shown in the Figs. 3-14 through 3-17. These studies indicate that the stitch yarn movement is resisted by the matrix surrounding it. Though the stitch yarn in a DCB test is assumed to fail in tension, it does deform the adjoining matrix as the yarn tends to bend when the crack openings grow. The resistance offered by the matrix adds to the toughness brought about by the yarn tensile strength. The texture of the plastically deformed matrix appears to be like that of "ploughing" of earth. The matrix appears "ploughed" by the stitch as seen in the Fig. 3-15.
