Developmental Problems and Their Solution for the Space Shuttle Main Engine Alternate Liquid Oxygen High-Pressure Turbopump: Anomaly or Failure Investigation the Key

R.S. Ryan and L.A. Gross

May 1995

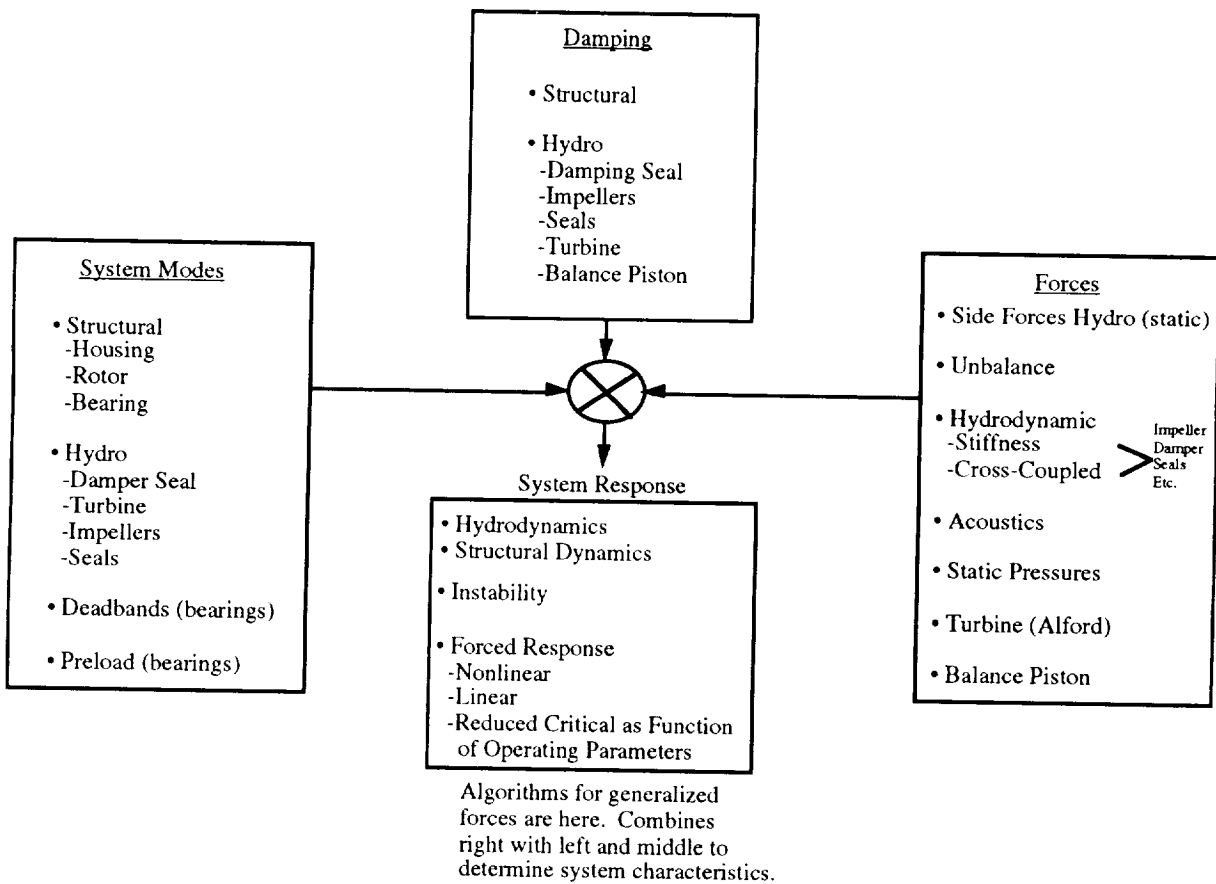
Figure 14 summarizes the rotordynamic characteristics to be considered in the turbopump. A detailed nonlinear rotordynamic simulation¹⁴ has been formulated and implemented to simulate the interactions of all these coupled parameters and/or subsystems. Because of the high-performance requirements, the system becomes a finely tuned and balanced system between these various parameters. The simulation can be linearized to produce frequencies, damping, and stability. The nonlinear formulation normally produces time responses as does the hot-fire instrumentation, which can be analyzed and evaluated using standard data processing techniques. These include analog amplitude plots versus time, root mean square (RMS) amplitude plots versus time, point time spectral analysis, and isoplots (frequency spectrums versus time). It is important for analysis/test correlation to utilize common data evaluation techniques for both.

Figure 14. System response.

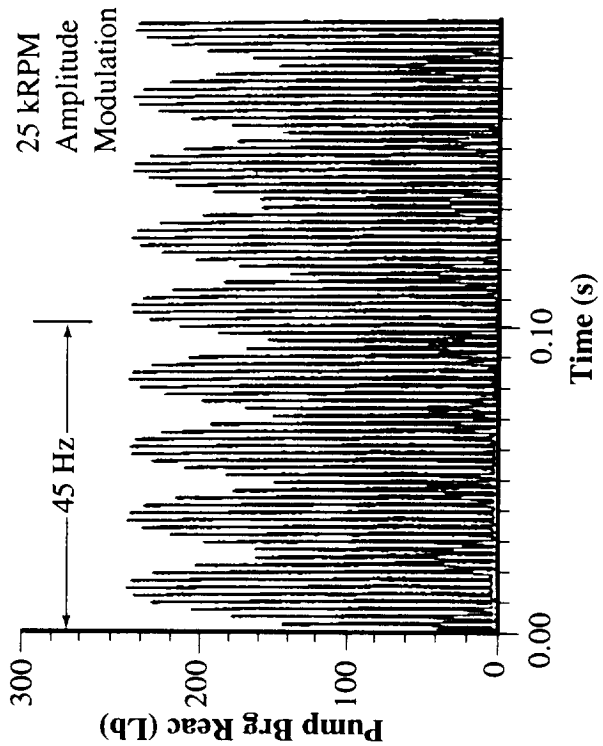
Figure 27. Analytical sideband simulation.

There are other modes in the operating range that are not sensitive to operating conditions and are generally low-gain modes. By plotting hot-fire data of acceleration versus pump speed (fig. 25), it is possible to interpret the results as a resonance; however, other interpretations of the data are possible. Typically during the runs of the early pump configurations, synchronous sidebands are present. These are probably caused by nonlinear amplitude resolution. Figure 26 shows this pictorially for these conditions: (1) the static load predominates, holding the rotor and bearing against the housing; (2) the dynamic and static load are equal, showing the rotor/bearing moving in and out of contact with the housing; and (3) the dynamic load is greater than the static load, showing full contact around the orbit. A simulation of this effect shows the amplitude modulations and the sidebands (fig. 27).
