# COMPRESSIVE RESIDUAL STRENGTH OF GRAPHITE/EPOXY LAMINATES AFTER IMPACT

Teresa A. Guy<sup>1</sup> and Paul A. Lagace  
Technology Laboratory for Advanced Composites  
Department of Aeronautics and Astronautics  
Massachusetts Institute of Technology

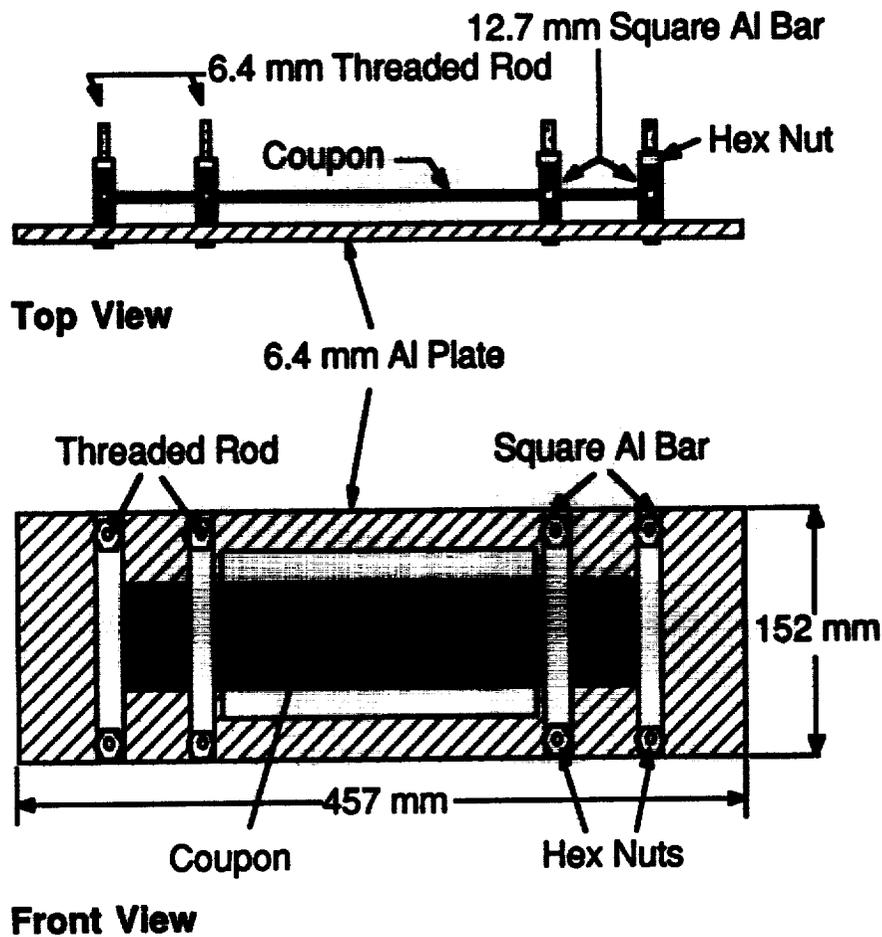
**Figure 1. Illustration of Coupon Holding Jig for Impact Tests.**

Two different impact test methods were used. For each, the test coupons were identical and a common holding jig, illustrated in Figure 1, was used. The holding jig includes a large aluminum plate with a rectangular opening; aluminum bars (in this case, square bars to simulate clamped boundary conditions); and threaded rods with hex nuts used to apply consistent torque (11.3 Nm) at each nut for each test.

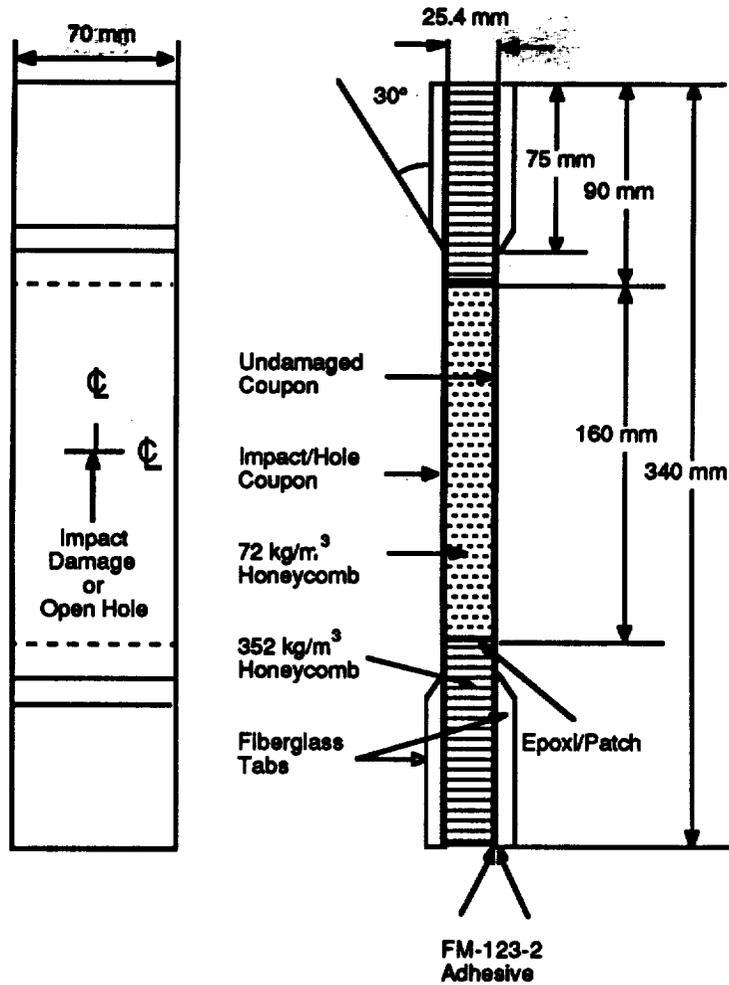
Figure 8. Compressive Residual Strength Test Specimen Geometry.

After nondestructive damage evaluation, specimens were prepared for compressive residual strength tests. A honeycomb sandwich specimen, shown in Figure 8 and

designed for characterization of the compressive strength of thin laminates [28], was used. Placement of the 25 mm thick honeycomb core between the two facesheets prevented global buckling of the laminate as a possible failure mode. The core was a combination of low density ( $72 \text{ kg/m}^3$ ) and high density ( $352 \text{ kg/m}^3$ ) aluminum honeycomb. The high density core was located in the grip area to prevent crushing of the specimen when it is held in the hydraulic grips of the test fixture. The core located in the test section was low density to virtually eliminate load-sharing with the facesheets.

The impacted coupon and an undamaged coupon were bonded to this aluminum honeycomb core after impact and nondestructive evaluation. The impacted surface was bonded to the honeycomb as it was smoother than the back surface with splinters and more likely to result in a good bond. American Cyanamid FM-123-2 film adhesive was used for bonding with a cure temperature of  $107^\circ\text{C}$  and pressure of 0.28 MPa for two hours. Using the same adhesive and cure cycle, fiberglass end tabs were then bonded to the graphite/epoxy to provide an efficient load transfer mechanism. Coupons with drilled holes, rather than impact damage, were also fabricated into identical compressive residual strength test specimens. Holes were drilled using diamond-coated drill bits and reamers. A strain gage was placed on the damaged facesheet, away from the damage, to provide data that was used as a specimen quality check through laminate stiffness measurement.

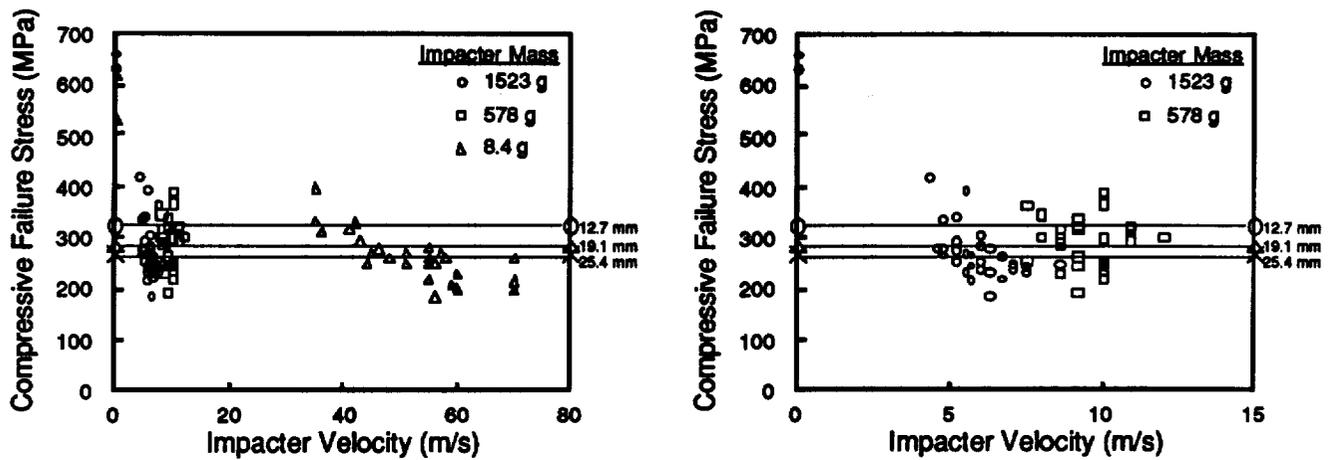
Figure 9. Compressive Residual Strength versus Impactor Velocity Data- (left) three impactor masses, (right) 1523 g, 578 g impactor masses.

The results of compressive residual strength versus impactor velocity for the cases of the three impactor masses are summarized in the left graph in Figure 9. All three data sets indicate a minimum compressive residual strength below the compressive strength for specimens with open holes. Furthermore, all three data sets exhibit asymptotic behavior approaching the strength value for the open hole of the same diameter as the impactor. (The results of the open hole and undamaged strength tests were presented in Table 2.) The right graph in Figure 9 is a plot of the same data on a scale of 0–15 m/s to better show the aforementioned trends for the 1523 g and 578 g

impactor mass cases. The minimum compressive residual strengths exhibited in the three data sets are: 184 MPa for the 1523 g mass at 6.3 m/s, 191 MPa for the 578 g mass at 9.2 m/s, and 187 MPa for the 8.4 g mass at 57 m/s. The three impactor masses, at their respective minimum compressive residual strength velocities, therefore caused virtually identical minimum compressive residual strengths. Thus, minimum compressive residual strength is apparently independent of impact mass.

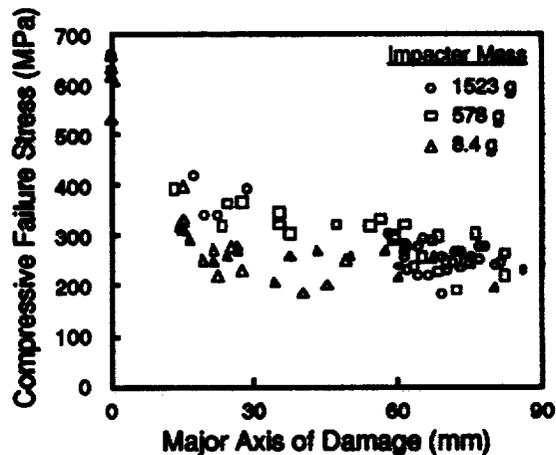
Figure 10. Compressive Residual Strength versus Major Axis of Damage Data.

Comparison of the compressive residual strength versus major axis of damage, presented in Figure 10, shows the curve for the 8.4 g impactor mass approaching the minimum compressive residual strength at a much smaller major axis of damage size (approximately 40 mm) than the curves for the 1523 and 578 g impactor masses (approximately 70 mm). There was a significant amount of scatter among the three impactor masses. Comparison of the compressive residual strength versus minor axis of damage, presented in Figure 11, resulted in less scatter than the major axis data comparison. Though the largest scatter band of data still represented a total difference of 33%, there was no obvious separation of data between the three impactor masses as there was in the case of the major axis. Comparison of the compressive residual strength versus core damage size, presented in Figure 12, also showed the curve for the 8.4 g impactor mass approaching the minimum compressive residual strength at a smaller core damage size (13 mm) than the curves for the 1523 and 578 g impactor masses (23 and 19 mm respectively). There was again, a significant amount of scatter among the three impactor masses. From these three comparisons, it would be inadvisable to predict compressive residual strength as a function of planar damage measurements such as the major axis, minor axis, or core damage size as there is insufficient detail in these damage measurements.

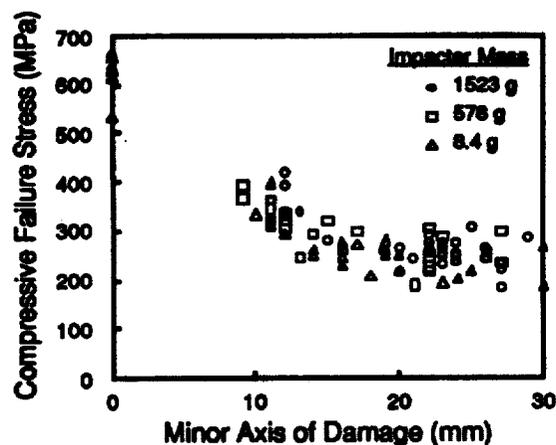
Figure 11. Compressive Residual Strength versus Minor Axis of Damage Data.

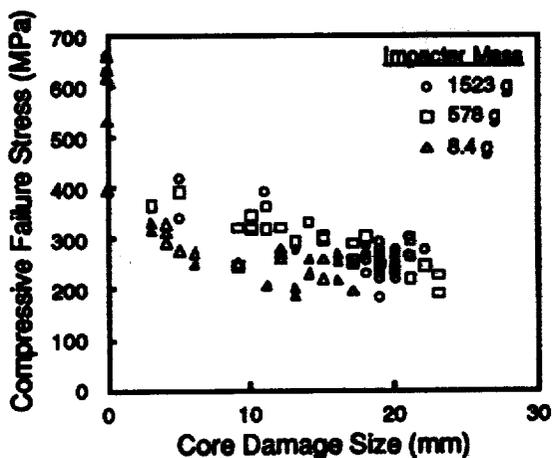
Figure 12. Compressive Residual Strength versus Core Damage Size Data.

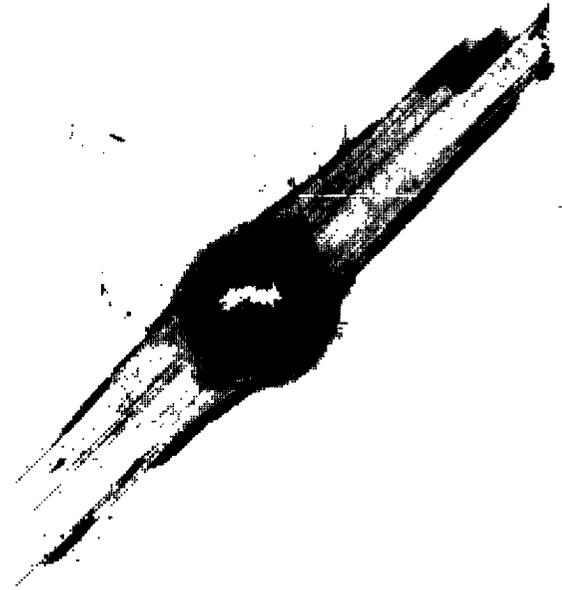
**(X-rays are to scale)**

**Figure 13. X-ray Photographs of Minimum Compressive Residual Strength Specimens for Three Impactor Masses (*top left*) 8.4 g, (*top right*) 578 g, and (*bottom*) 1523 g.**

This can be further seen in Figure 13 where the X-ray characterization of the damage state at the minimum compressive residual strength condition is shown for the three impactor masses. These three cases appear to have slightly different damage states as the core damage size ranges from 17 to 23 mm, the minor axis of damage ranges from

21 to 27 mm, and the major axis of damage ranges from 69 to 80 mm. The integrated damage thus does not provide sufficient detail either in the X-ray photographs shown here, or in a typical ultrasonic scan. Three-dimensional information about the damage is therefore necessary.

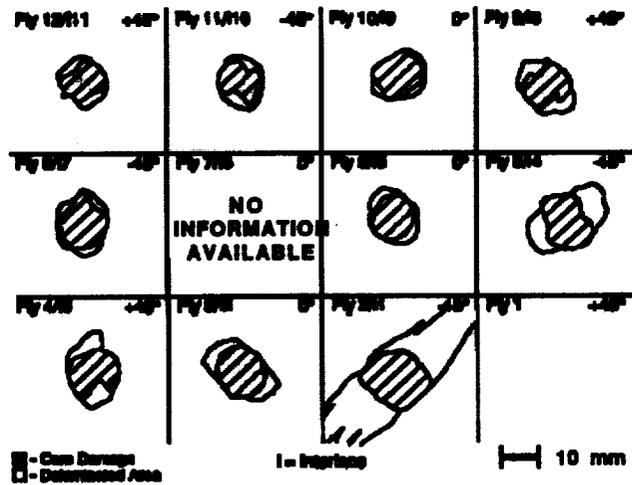
Figure 14. Summary of Damage Observed in Specimen M8-2 by Deply (Impactor Mass = 1523 g, Velocity = 6.3 m/s).

The three-dimensional damage state definitions at the minimum compressive residual strengths for the three impactor masses used in this work were best provided by the deply destructive damage evaluation method. The cross-section schematics also provided good definition of the three-dimensional damage state. However, this destructive evaluation method was much more time consuming and labor intensive [27]. The comparison of the three-dimensional damage state definitions by deply are similar for specimens impacted by all three masses as shown in Figures 14–16. All three summaries exhibit similar damage type, size, shape, orientation, and location. Core damage remains fairly constant through the thickness due to impact at velocities in the penetration range. Delaminations exist between every interface with the exception of interface 6 (between the two 0° plies). Delamination shape is roughly elliptical with orientation in the direction of the next ply further away from the impact surface. Delamination size increases as ply distance from the impact surface increases. And, there is consistent evidence of extensive delamination between plies 1 and 2 including indications of the back surface spalling.

The similar deply summaries of Figures 14–16 would appear to verify the hypothesis that similar minimum compressive residual strengths are due to the existence of similar three-dimensional damage states in these specimens. These summaries, however, still do not identify the controlling or key damage mechanisms.

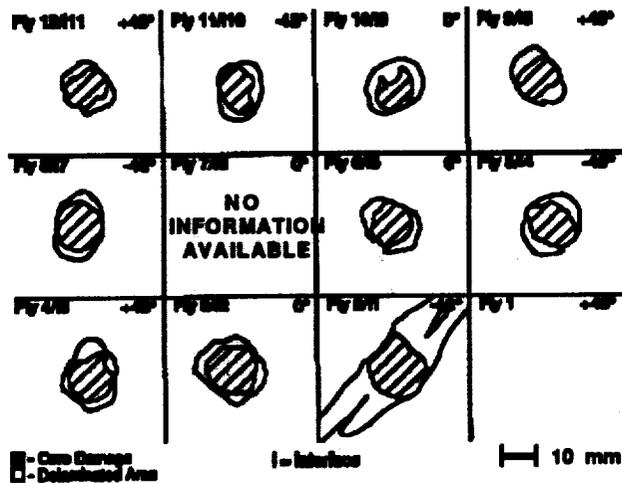
Figure 15. Summary of Damage Observed in Specimen M10-4 by Deply (Impactor Mass = 578 g, Velocity = 8.6 m/s).

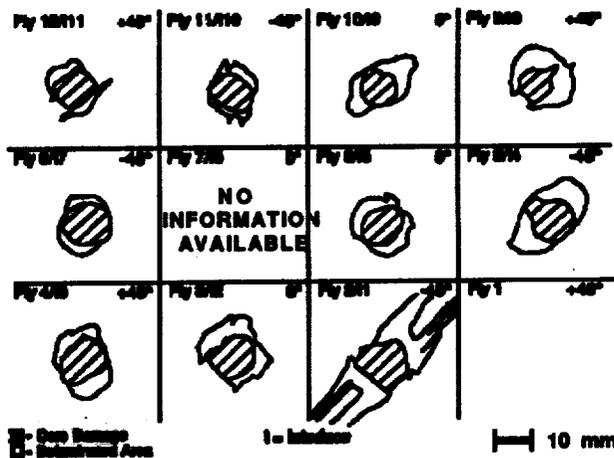
Figure 16. Summary of Damage Observed in Specimen M23-4 by Deply (Impactor Mass = 8.4 g, Velocity = 70 m/s).

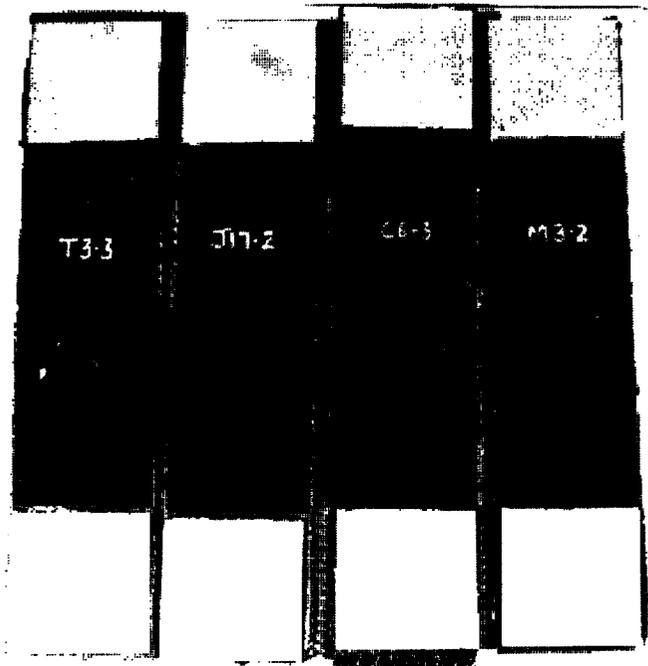
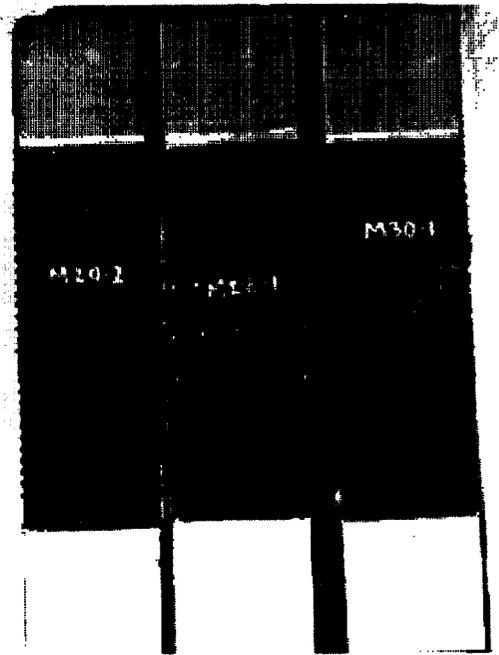
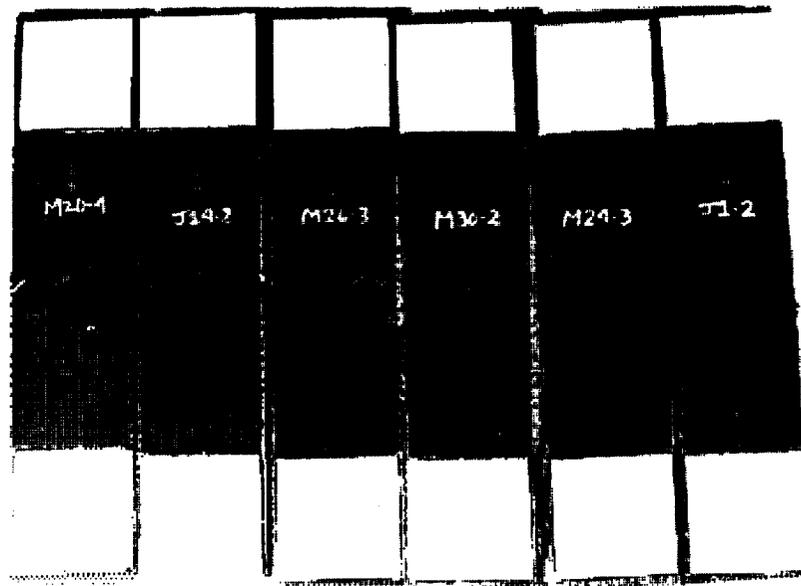
(Specimens - 70 x 340 mm)

**Figure 17. Photograph of Impact-Damaged Specimens After Fracture**  
 Masses of (top left) 1523 g, (bottom) 578 g, and (top right) 8.4 g.

A postmortem examination of the specimens that failed at the minimum compressive residual strengths for the three impactor mass cases was conducted to determine if the failure modes were the same. These specimens, after failure, are shown in Figure 17. The postmortem examination of these minimum compressive residual strength specimens showed sublaminar buckling of ply 1 and fiber failure in the remaining plies. (Also evident was the extensive core damage and back side spalling of ply 1 due to impactor penetration.) Although it was not possible from the postmortem examination to determine which damage mode or combination of damage modes were controlling the compressive residual strength, it was clear that the failure modes in these three cases were similar if not the same. The postmortem examination of the open hole specimens on the other hand, showed the fracture in these cases to be consistently due to in-plane mechanisms as catastrophic failure occurred completely through each facesheet with no indication of delamination as shown in Figure 18.

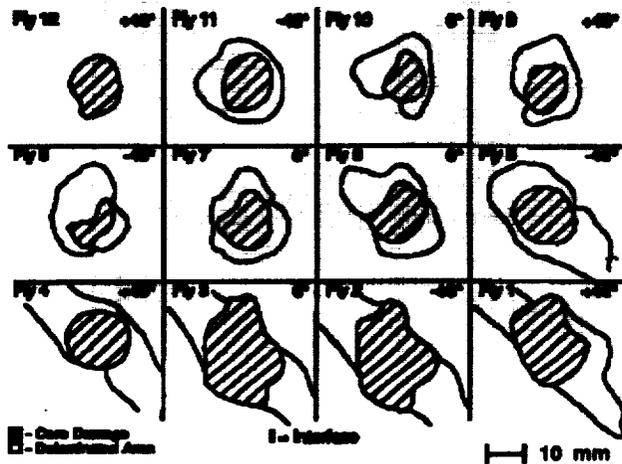
Figure 19. Summary of Damage Observed in Specimen M23-4 by Time-of-Flight Ultrasonic C-Scan (Impactor Mass = 8.4 g, Velocity = 70 m/s).

Time-of-flight ultrasonic pulse-echo scanning was performed on specimens to provide three-dimensional damage characterization via a nondestructive technique. A summary of the results of such an inspection is shown in Figure 19 for a specimen impacted at 70 m/s with an 8.4 g mass. This is the same specimen which was deplied and the damage summarized in Figure 16. The two damage summaries can therefore be directly compared. In this case, the core damage and delamination sizes seen via the time-of-flight technique are consistently larger than those seen via the deply technique. However, in general the damage sizes found via the time-of-flight technique were inconsistent with respect to the damage determined by the deply or cross-sectioning techniques.
