DEVELOPMENT OF COMPOSITE CARRYTHROUGH BULKHEAD*

R. J. Ehlen
 McDonnell Aircraft Company, St. Louis, MO
 and
 M. Libeskind
 Naval Air Development Center, Warminster, PA

SUMMARY

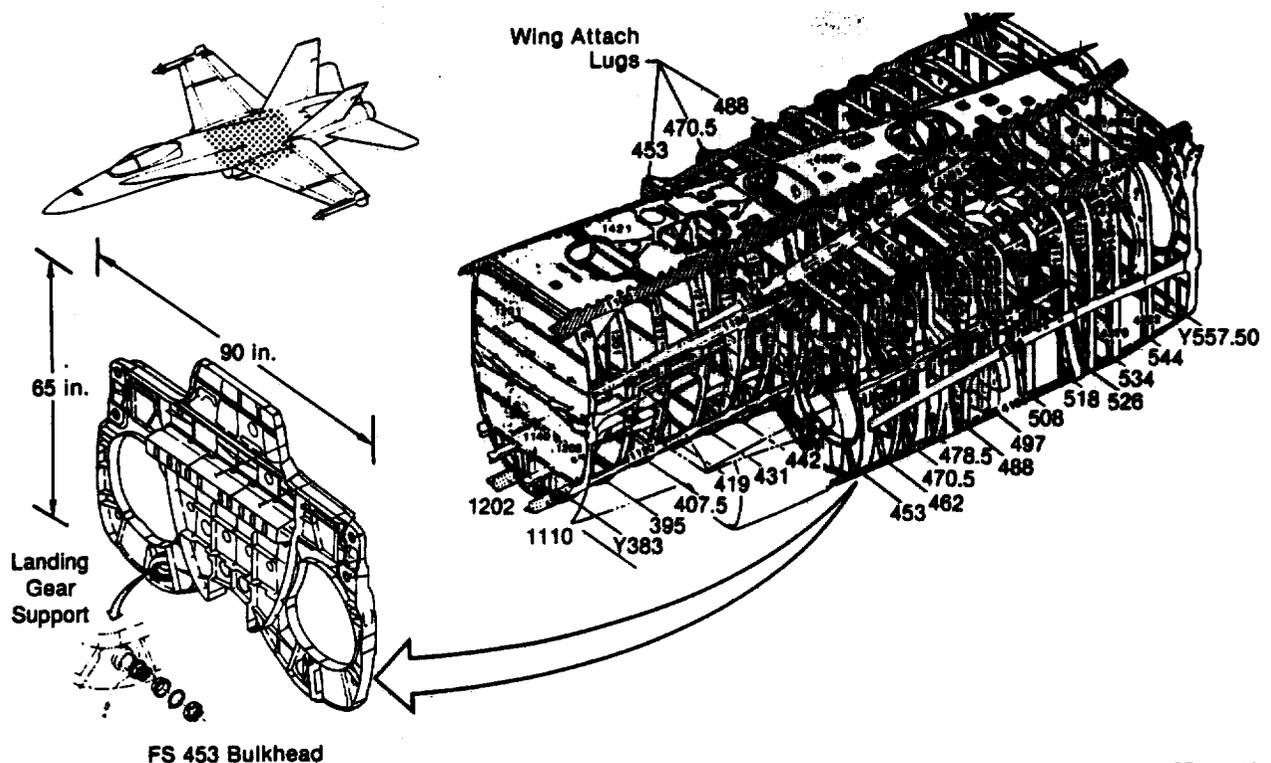
Figure 1. F-18 Aluminum Production Bulkhead

The selected baseline, Figure 1, is the F-18 F.S. 453 bulkhead to which the wing is attached and from which the main landing gear forward trunnion is supported. The baseline is machined from 6 in. 7050-T73651 aluminum plate and weighs 264 lbs. Stiffeners, flanges, and wing attachment lugs are integral with the bulkhead. The upper dorsal section is made separately and is mechanically fastened to the bulkhead lower section. Cutouts in the center web area permit fuel system plumbing to pass through. The plumbing is joined at the web by fittings.

The wing support lugs are integral parts of the bulkhead. Lug thicknesses and pin diameters are different for the upper and lower lugs, reflecting the magnitude and direction of the primary loads carried by each lug. The upper lug load acts primarily inboard; therefore the lug is sized for compression bearing stress. The lug is 1.56 in. thick and the pin diameter is 2.42 in. The lower lug load acts primarily outboard and is sized to prevent failure due to cleavage and tearout. This lug is 3.20 in. thick and pin diameter is 2.67 in.

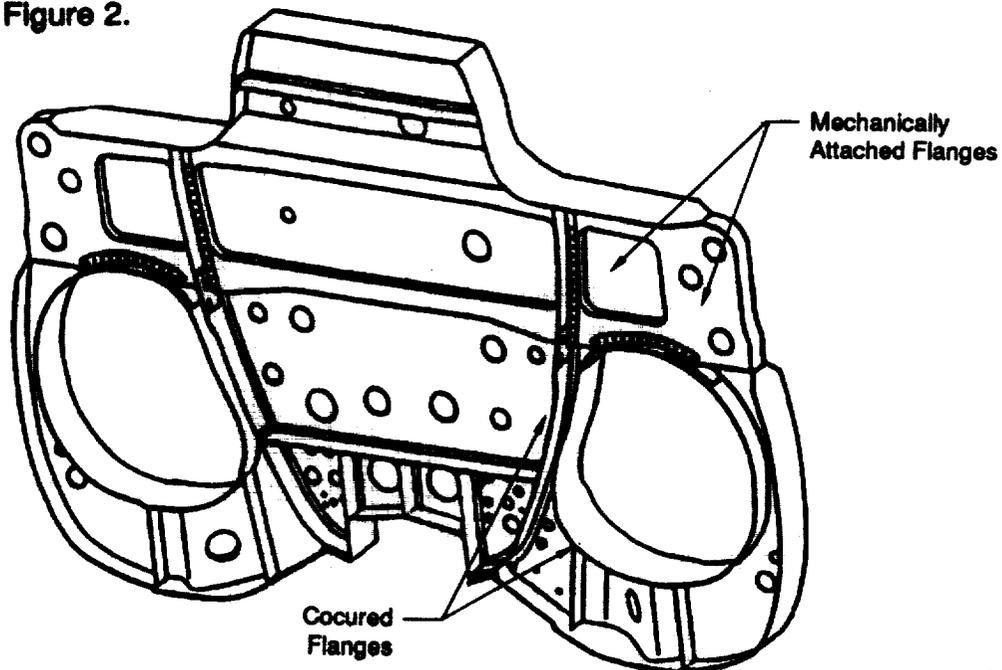
GP14-0175-3

Figure 2. Selected Composite Bulkhead Concept

Ten preliminary design concepts were defined and evaluated with respect to weight, cost, supportability, and fabricability. Selection of the best overall concept was made based on the results of this evaluation. Weight was the most important consideration in the selection of the preferred concept followed by cost, producibility, and supportability, in that order. The design concept selected is shown in Figure 2.

The second bulkhead fabrication procedure benefited from the lessons learned from the first bulkhead and the quarter-bulkhead subcomponent. Figure 8 shows this bulkhead after curing. The mechanical fittings shown in Figure 2 are not yet installed.

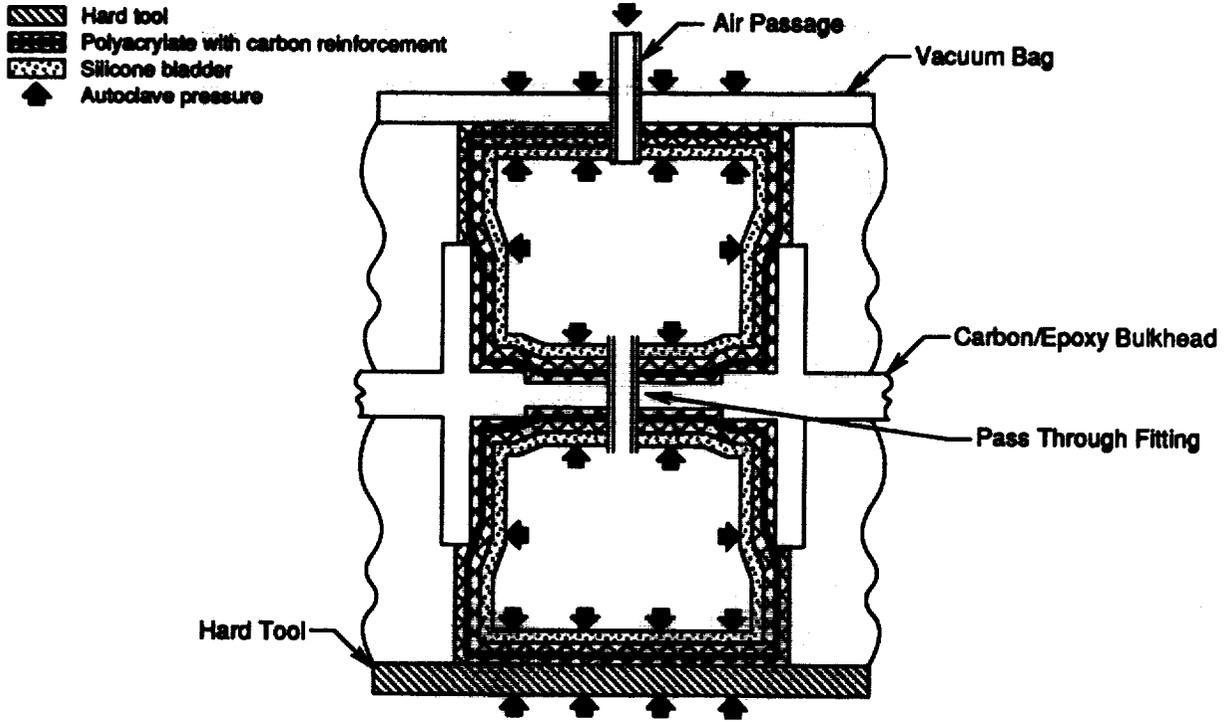
GP14-0175-5-D/dg

Figure 5. Conformal Tooling for First Bulkhead

Tooling used to fabricate the bulkhead consisted of aluminum, graphite, steel, carbon/epoxy and conformal pieces. The most important feature of the tooling is the conformal tool. The conformal tool is flexible and is pressurized during the autoclave cycle. This tool is capable of providing uniform pressure, simultaneously, against the web and adjacent flanges of the bulkhead. This tooling concept produces excellent corner details on the bulkhead and leaves no tool mark off. Figure 5 shows two conformal tools being used against the two sides of a bulkhead.

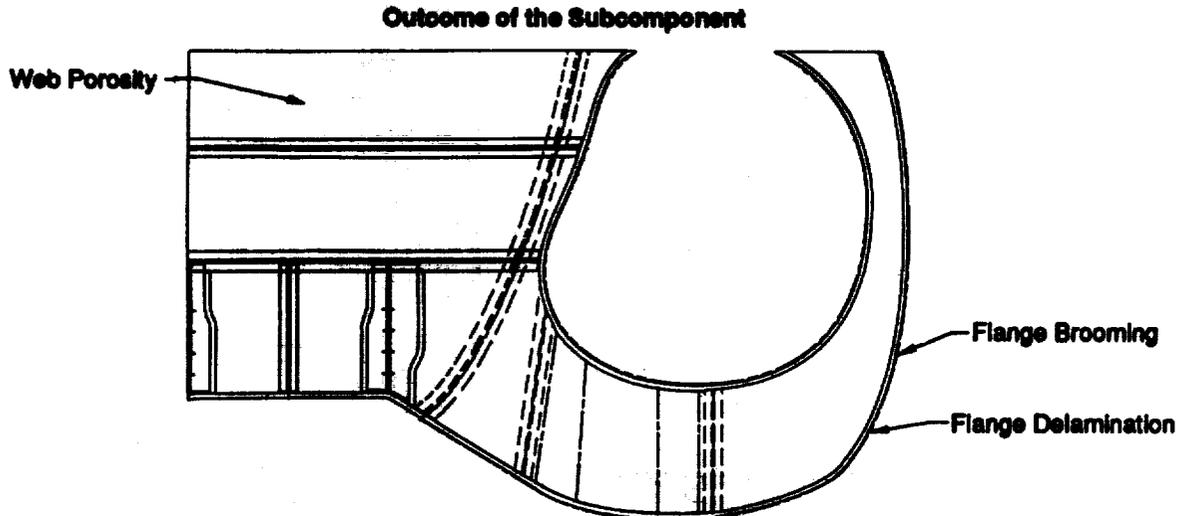
GP14-0175-7

Corrective Action to Be Applied to the 2nd Bulkhead

- Flange Brooming: Pre-Machined Flange Width Reduced to Avoid Tool Contact
- Flange Delamination: FM300 Inserted Between the Tape Ply Pack and Cloth Ply Pack
- Web Porosity: Porous Teflon Inserted Between the Bulkhead and the Conformal Tool

Figure 7. Lessons Learned From Subcomponent Fabrication

The risk reduction subcomponent had significantly improved quality from the first bulkhead but still contained some abnormalities. Figure 7 shows the few abnormalities of the subcomponent and the further corrective action to be applied to the second bulkhead.

To prevent the flanges from brooming, the flange width was reduced. Narrower flange width avoids flange contact with the bond tool. This approach has no detrimental impact to the bulkhead; the flanges are oversized during the cure cycle and then later trimmed to blueprint width.

The flange delamination occurred where the tape ply pack and cloth ply pack interface. FM300 adhesive was inserted at this interface on the second bulkhead.

The corrective action for the web porosity was to lay porous teflon cloth between the bulkhead web and the conformal tool. The porous teflon cloth helps to prevent the entrapment of air between the bulkhead web and the bond tools.

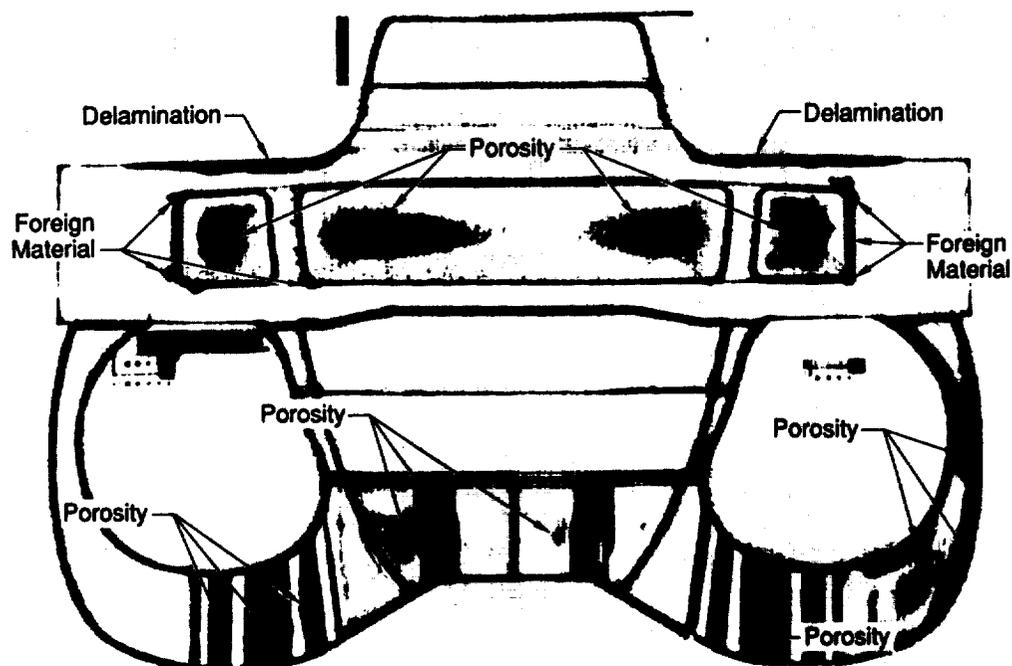
GP14-0175-9

Figure 9. Ultrasonic Inspection Summary of Second Bulkhead

The second bulkhead was of significantly better quality than the first bulkhead. Some porosity, delaminations, and foreign material were detected. Figure 9 shows the NDI results.

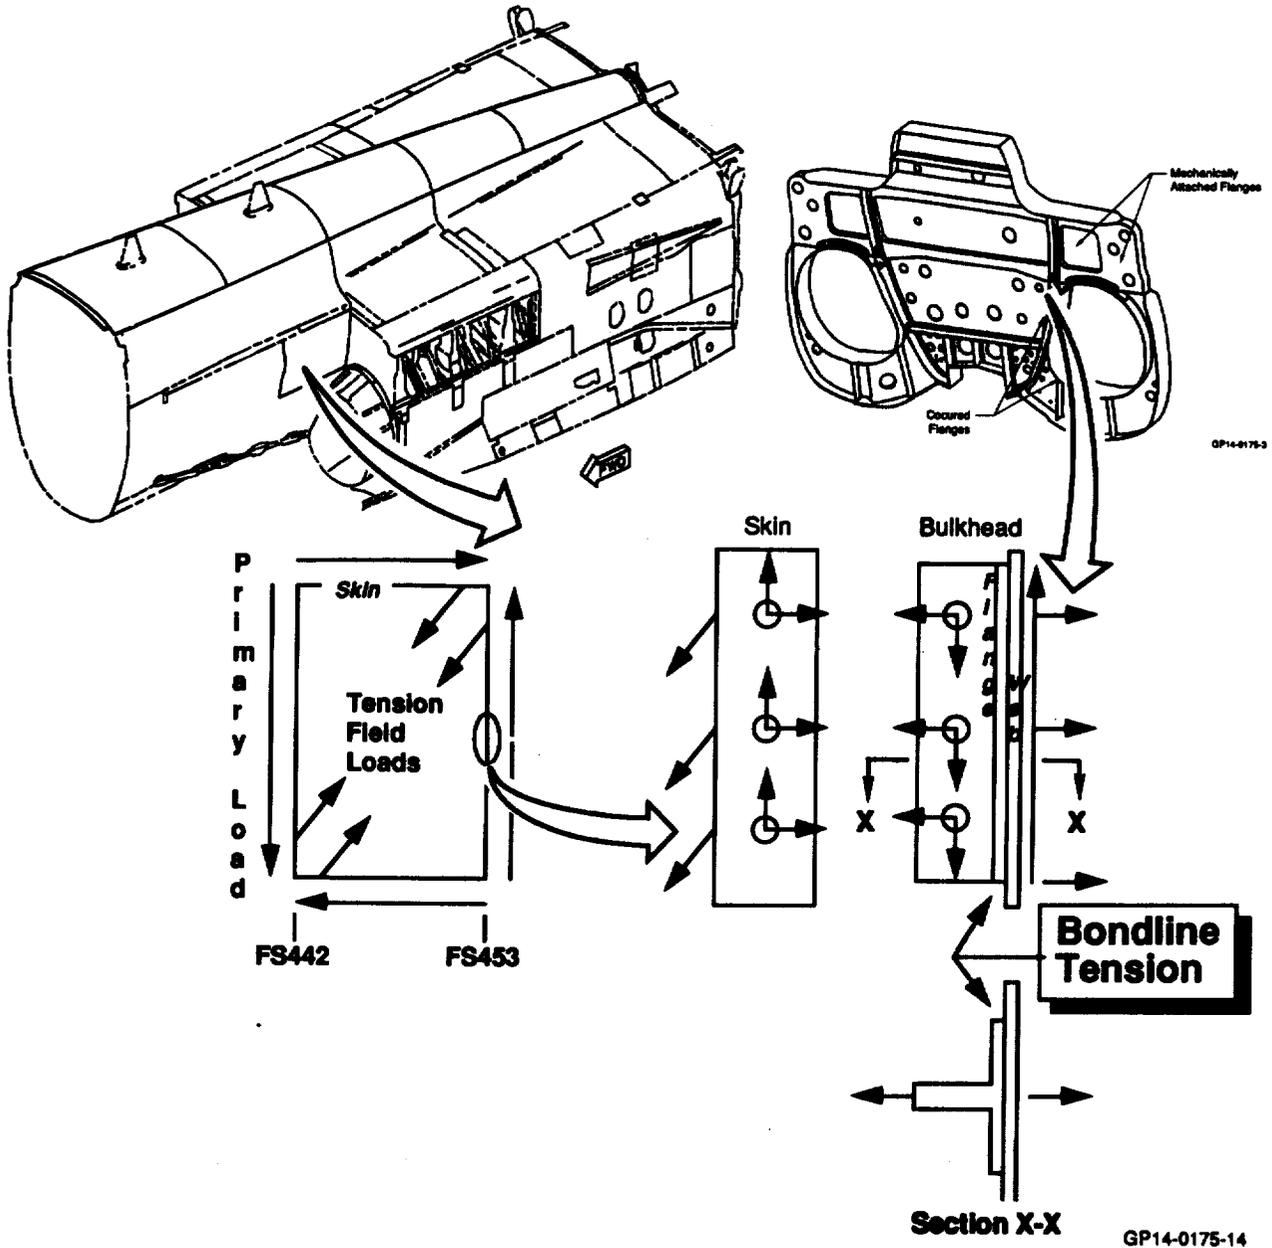
GP14-0175-14

Figure 14. Bondline Tension From Secondary Loads

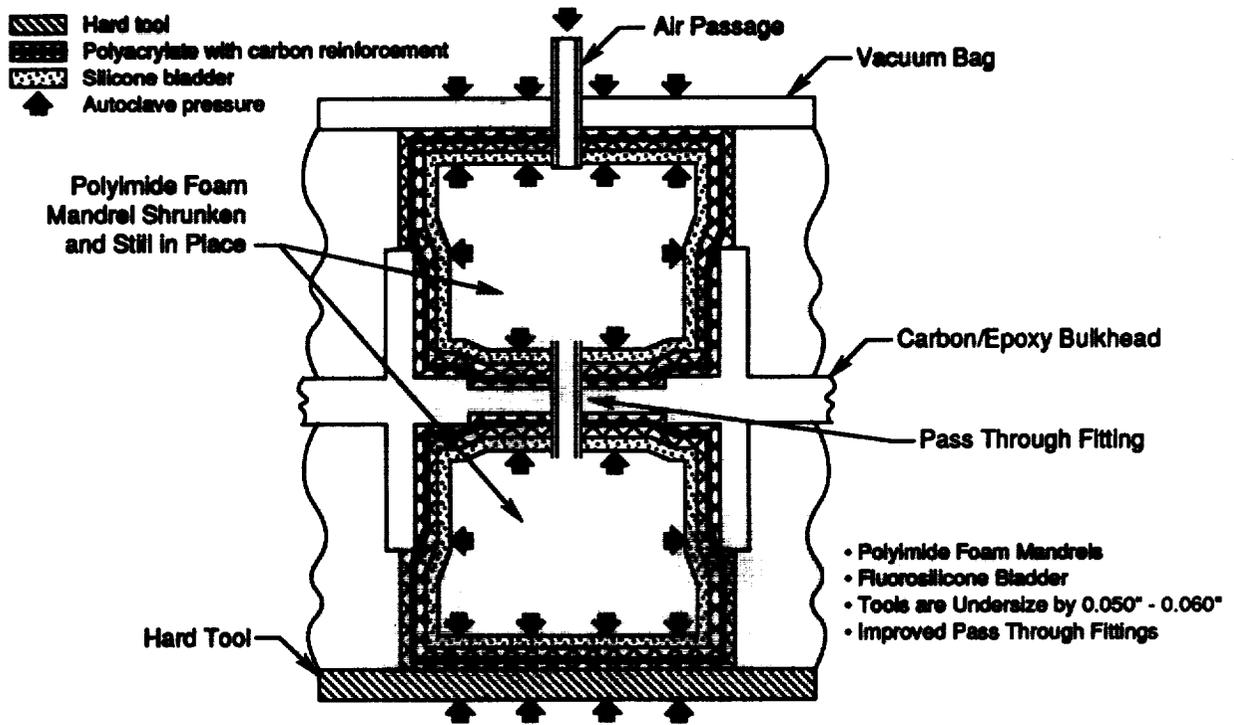
GP14-0175-15-D/dg

Figure 15. Conformal Tooling for Second Bulkhead

- Use conformal tools for fabrication of parts with multiple integral flanges. The conformal tools could be of the nature shown in Figure 15. If a remain-in-place mandrel is used for bladder lay-up and fabrication, it should be a material that will not puncture the bladder.
- It is advised to use film adhesive during the component lay-up to fill voids. A commonly occurring void is shown in Figure 16.
- To avoid porosity in thick laminates the use of multiple debulk cycles should be considered as shown in Figure 17.
- Use computer codes such as "Computer Aided Curing of Composites" (Reference 4) for the development of the autoclave cycle.
- Verify the manufacturing and design details by fabrication of a subcomponent.

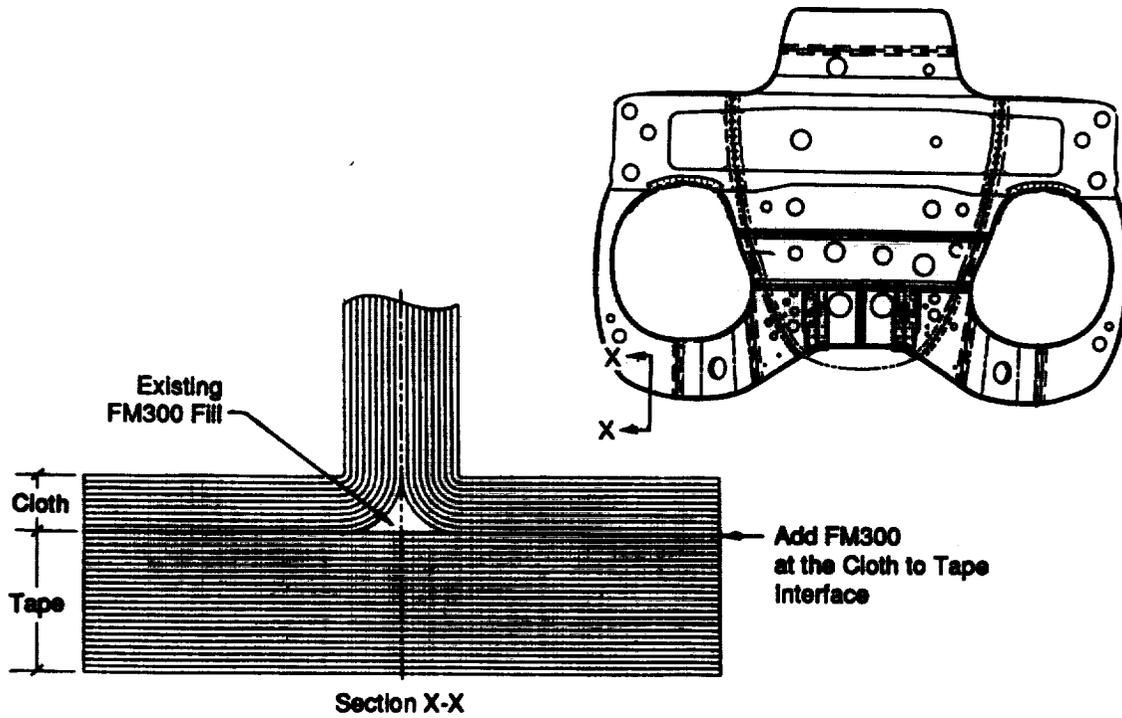
GP14-0175-16

Figure 16. Adhesive Usage During Layup

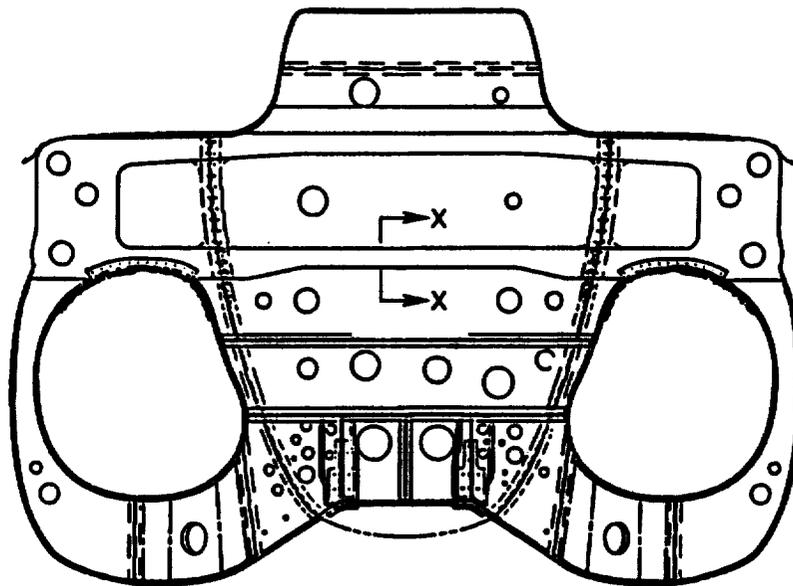
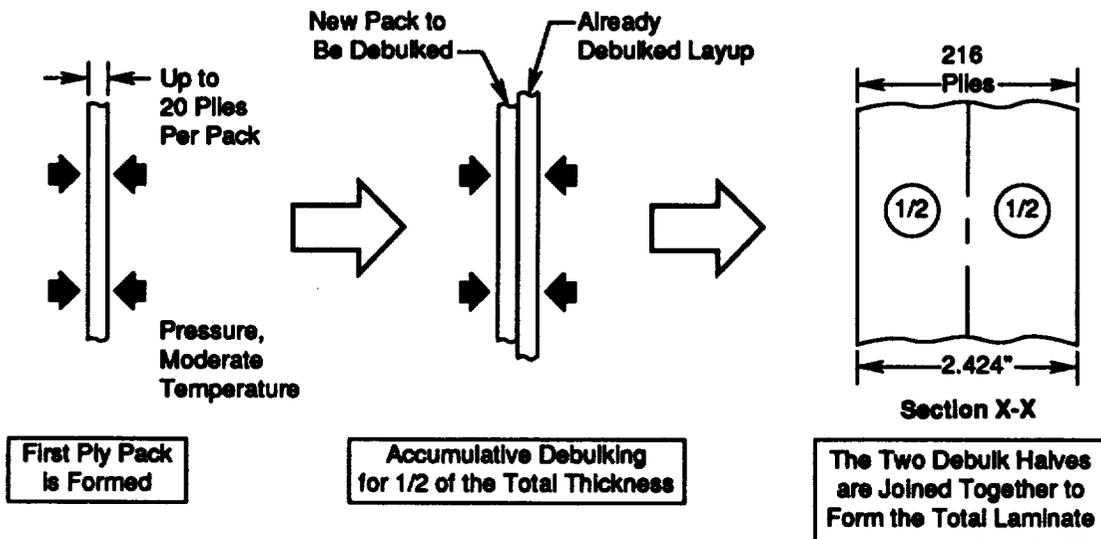
GP14-0175-17

Figure 17. Multiple Hot Debulking Cycles
