# Real Time Acousto-Ultrasonic NDE Technique for Monitoring Damage in Ceramic Composites Under Dynamic Loads

August 1995

# **REAL TIME ACOUSTO-ULTRASONIC NDE TECHNIQUE FOR MONITORING DAMAGE IN CERAMIC COMPOSITES UNDER DYNAMIC LOADS**

## **NASA Contractor Report**

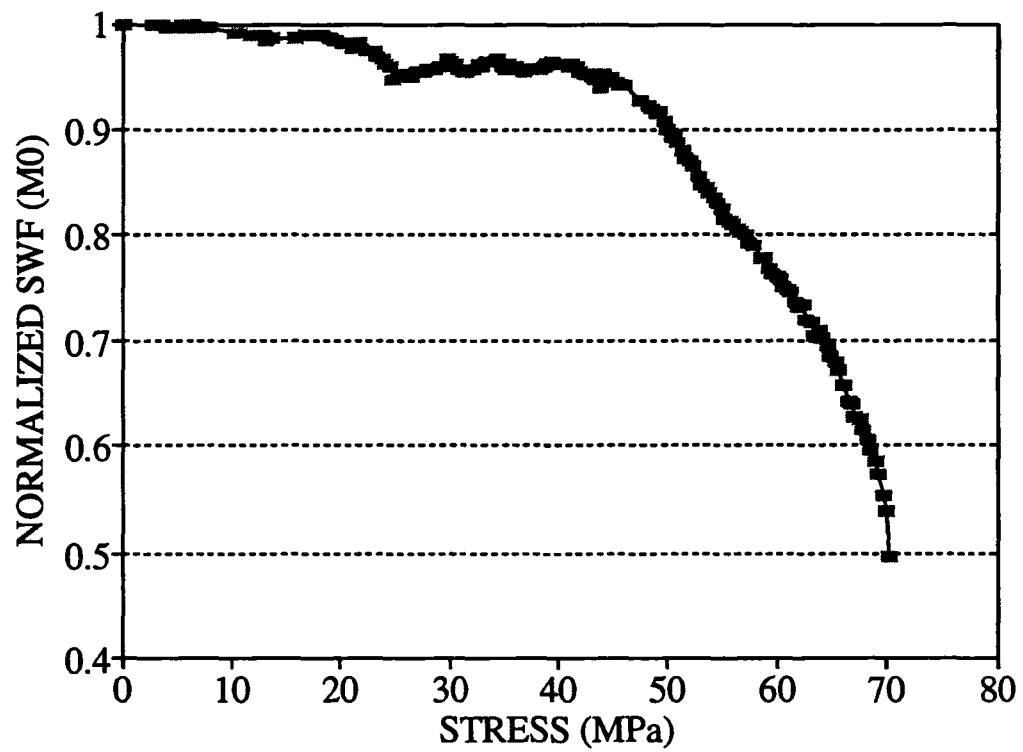
**Figure 29.** Normalized SWF (M0) vs stress for sample C9 ( SiC/CAS, [0/90]<sub>s</sub> ), (Heat treated at 1200°C for 48 hrs.)

Samples C8 and C9 were heat treated at 1200° C for 48 hours prior to static tests. Both samples were subjected to quasi-static ramp loading in tension to failure at 200 lbs/min. Figures 27 and 29 show the graphs of SWF (M0) versus stress for samples C8 and C9, respectively. Final failure is catastrophic in both samples with negligible fiber pull-out observed on the failure surfaces. Figure 28 shows the stress versus strain graph of sample C8. The failure strain and ultimate strength were 0.1 %, 55 MPa and 0.14 %, 70 MPa in samples C8 and C9, respectively. The stress levels for final failure of heat treated specimens are in the range of the stress levels for cracking in the 90° plies of non heat treated specimens. It is presumed that the interfacial bonding is stronger due to the heat treatment and the few cracks formed in the 90° plies connect and cause final failure by breaking the fibers in their path instead of debonding them. The SWF values drop by 45 % in the range of 50 MPa - 70 MPa in sample C9 whereas the drop is just 10 % prior to catastrophic failure in sample C8. Real-time AU gives no indication of impending final failure in sample C8. The close proximity of flaws in this specimen which serve as crack initiation sites could cause the cracks to become critical and thereby cause premature failure.

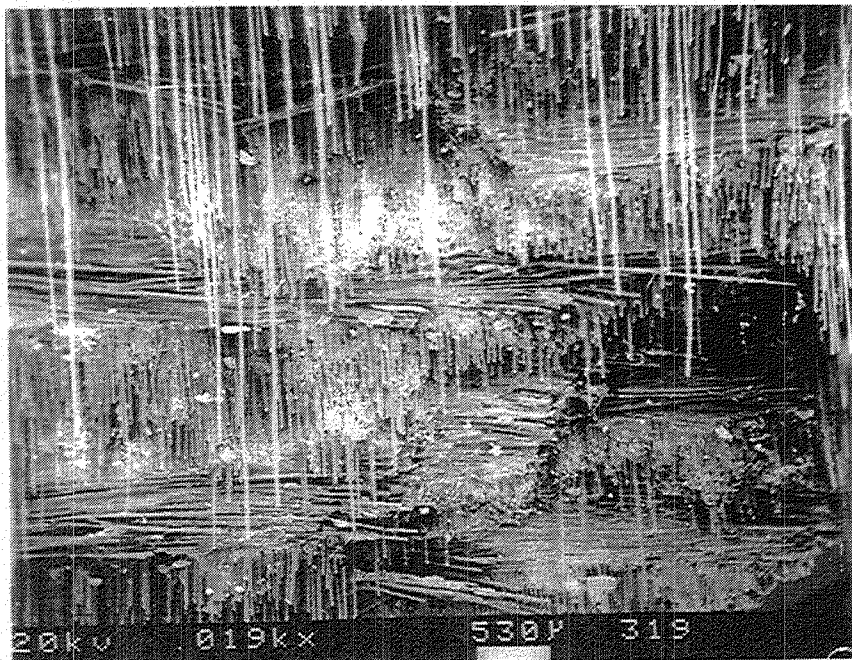
**Figure 66.** SEM photo-micrograph of the failure surface of sample C11, SiC/CAS [0/90]<sub>4s</sub>
