**Research Institute  
The University of Alabama in Huntsville**

Technical Report 5-33567  
Contract No. NAS8-38609  
Delivery Order No. 119

**Methods of Video and  
Shearography Inspection  
(5-33567)**

Final Technical Report for Period  
22 September 1994 through 21 September 1995

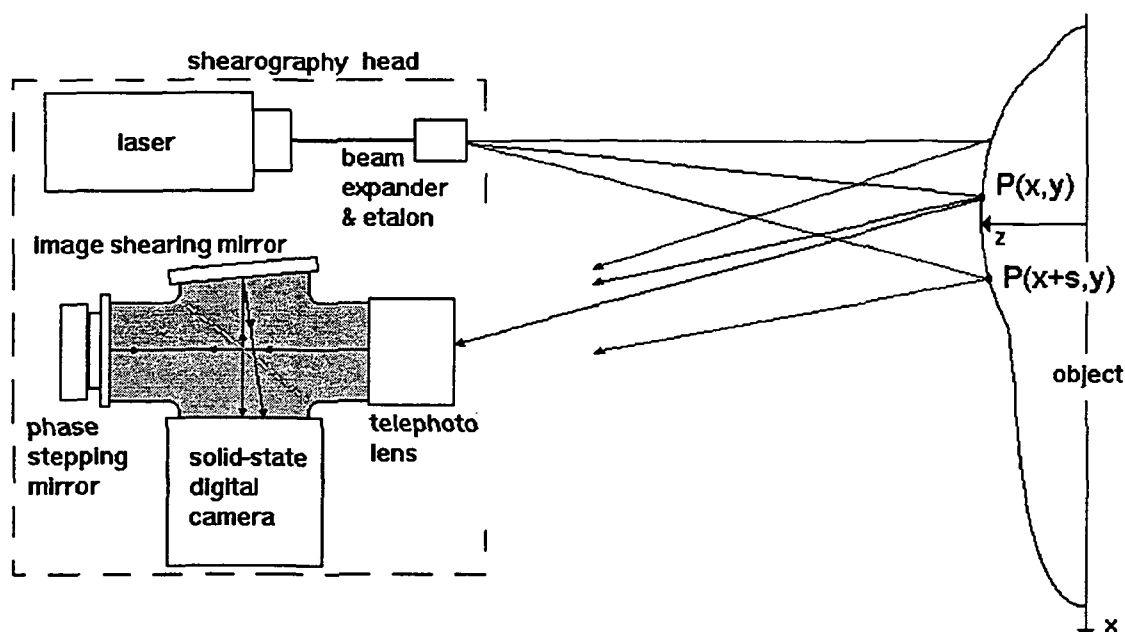
Figure 1. PW EH/SIS Optical Arrangement

sheared beam is incident on the sensor array at a point which is shifted, or sheared, from the reference beam. Each point on the surface of the object is thus imaged to two separate pixels on the camera sensor array. A more complicated reverse ray trace shows that, similarly, a single pixel on the camera sensor array images two sheared points on the surface of the object. Assuming a planar object, all points in the image are sheared by the same lateral distance, referred to as the image shearing distance,  $s$ . The sensitivity of the device is proportional to  $s$  and thus related to the angle at which the image shearing mirror is tilted. By varying the tilt angle and direction of the image shearing mirror, the operator may adjust the sensitivity of the device to suit the structure being evaluated and the type of excitation being applied.

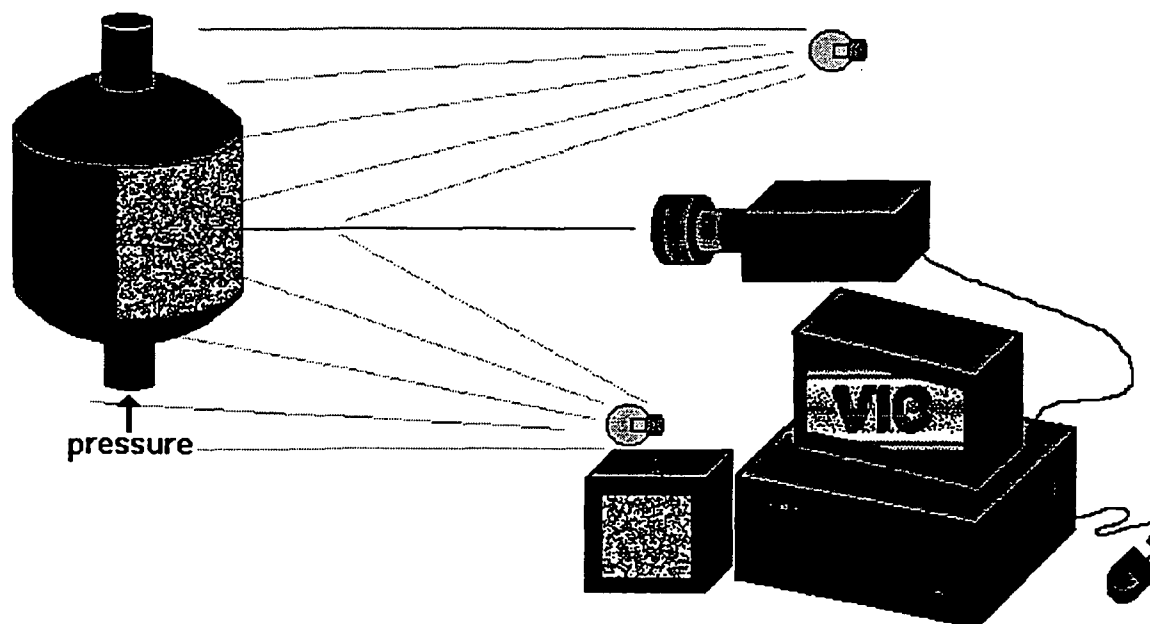
**Figure 2.** Apparatus used for SDVIC data acquisition.

The apparatus used to acquire and process images for SDVIC is shown in Figure 2. with a domed cylindrical pressure vessel as an example specimen. The over-spray from

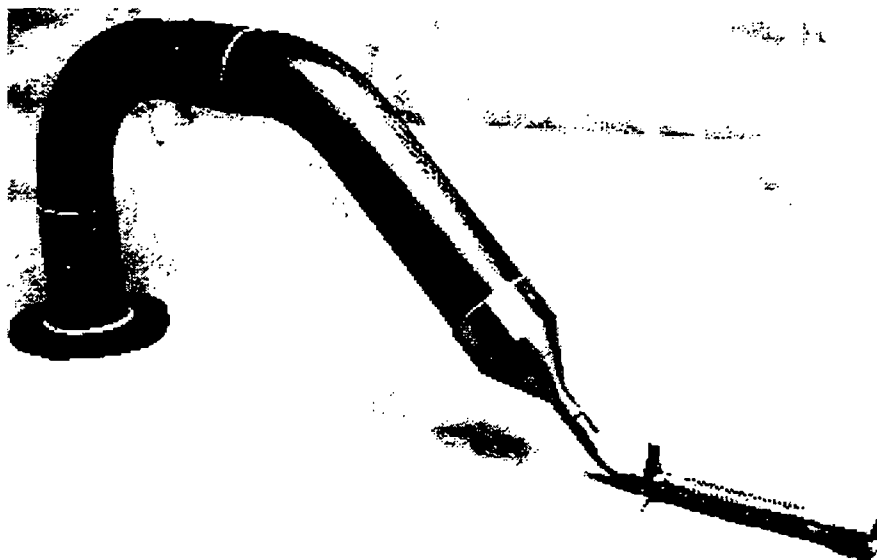
Figure 4. DCX-A composite liquid hydrogen feed line.

In addition to the composite fuel tanks, the DC-XA will utilize composite feed lines for liquid hydrogen between the fuel tank and liquid-gas converter (LGC). The geometry of the flight article feed line is shown in Figure 4. The presence of delaminations in the composite components or bonded joints could lead to catastrophic vehicle loss. Throughout this development effort, specimens were provided to the MSFC NDE Branch for ES inspection to detect such delaminations. Thermal excitation was used for all inspections.

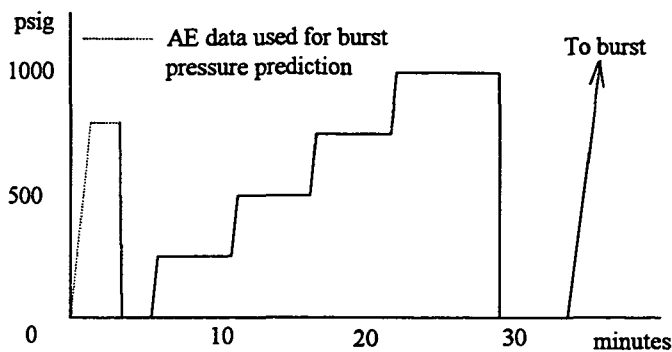
Figure 20. Typical Pressurization Schedule for Hydro-proof of FWPV (maximum pressure approximately 25% of expected burst for undamaged specimen.

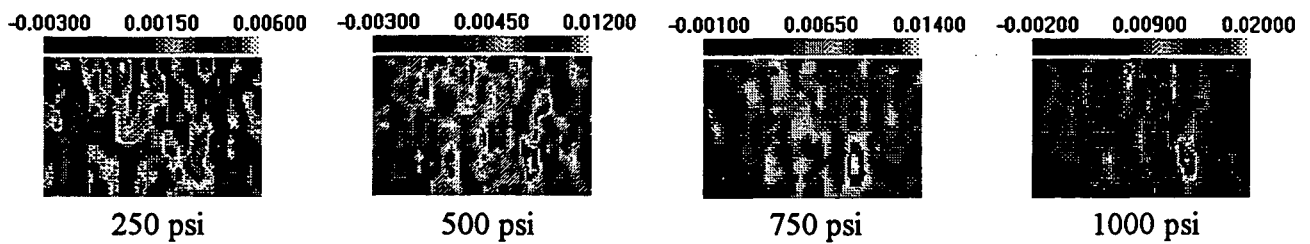
**Figure 23.a.** SDVIC Hoop Strain Measurements for a Blunt Tip High Energy Impact  
(Bottle No. A047-048, Resin X8553-45)

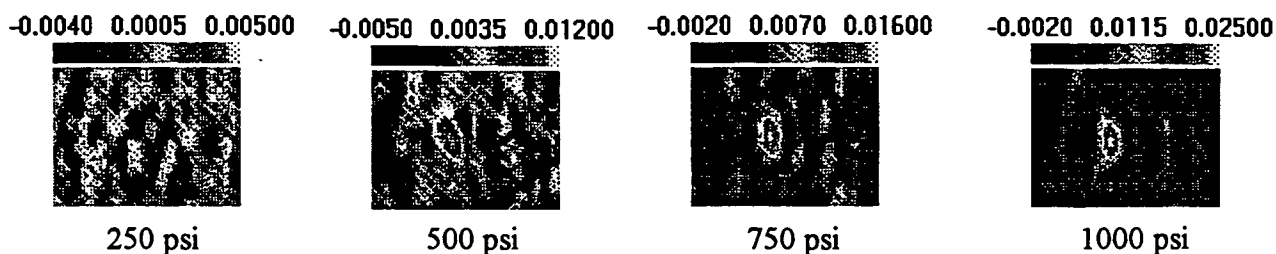
**Figure 24.a.** SDVIC Hoop Strain Measurements for a Sharp Tip Low Energy Impact  
(Bottle No. A013-014, Resin X8553-45)

Among FWPV of the same resin class, the observed strain magnitude and the size of the strain concentrated region was larger at each pressure interval for the high energy sharp tip impact bottle than for the low energy sharp tip impact bottle, as illustrated in Figures 24.a. and 25.a.

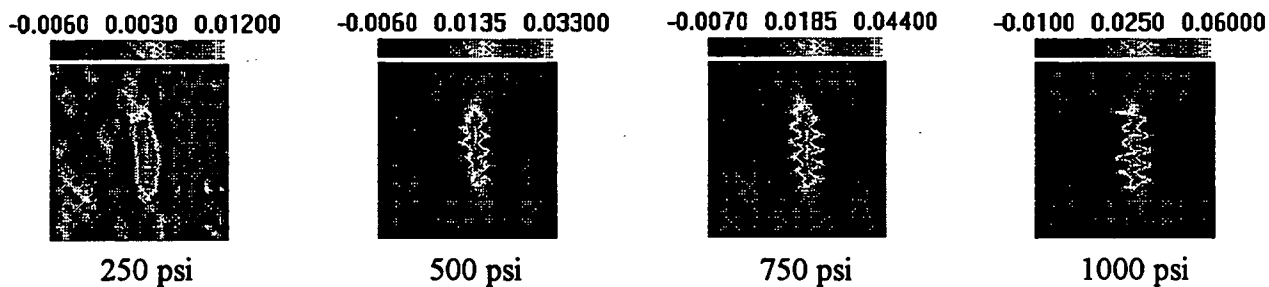
**Figure 25.a.** SDVIC Hoop Strain Measurements for a Sharp Tip High Energy Impact  
(Bottle No. C093-094, Resin X8553-45)

In the case of the high energy impact with a sharp tip, Figure 25.a., a linear vertical strain concentrated region is clearly indicated, with much higher strains than the previous examples, up to 6%. The only visible damage at this pressure was the original indentation. The first indication of eminent failure was the appearance of a visible vertical crack at elevated pressure in the final ramp to burst. The geometry of the localized region of high strain closely resembled the geometry of the first graphite tow failures. Before any damage propagation was visible to the unaided observer, SDVIC predicted the location and nature of the initial tow failures.

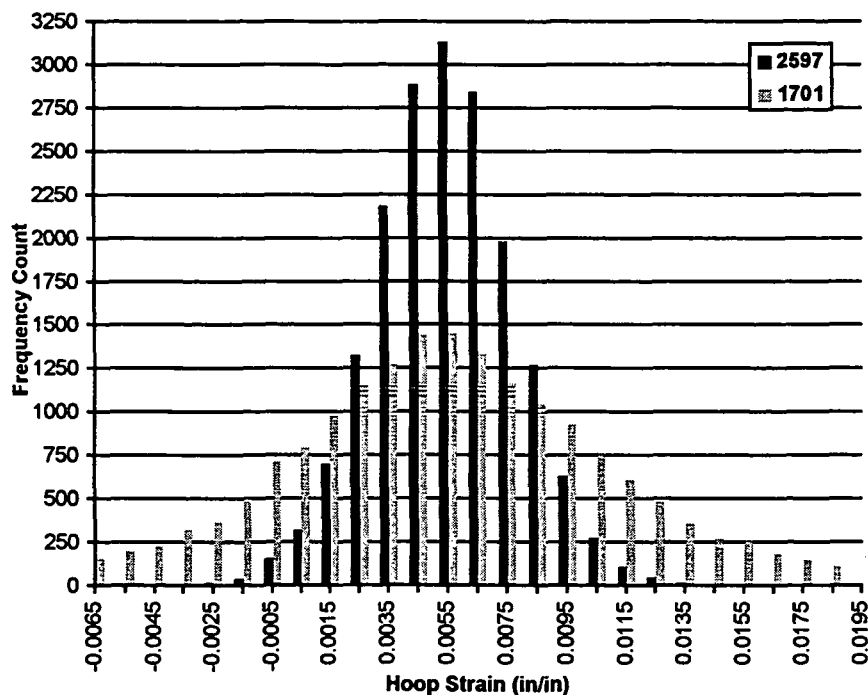
Figure 26. SDVIC Hoop Strain Histograms Generated by VICNet.

In general, those FWPV with lower burst pressures tend to have a lower and wider strain distribution than those with higher burst pressures. In this form the SDVIC data may be input to a BPNN to produce a quantitative means for predicting burst pressure based upon SDVIC hoop strain measurements. Each input neuron may be assigned a strain category and assigned the number of SDVIC data points having strain values in that category. As the strain is related to FWPV failure by material properties more strongly than minor geometry differences, this technique may be capable of predicting the failure

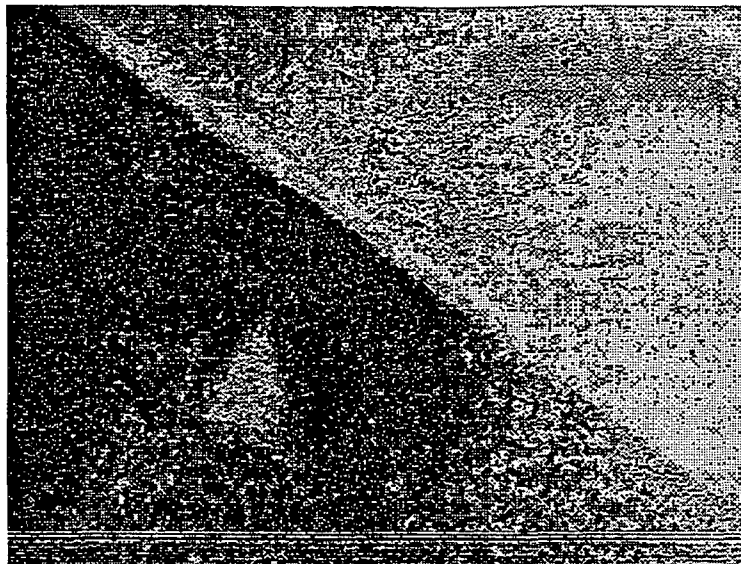
Figure 27. indicates the response of an insert close to the material surface with the convex surface of the nose cone facing the shearography apparatus. The symmetric dark and light triangles in the center of the shearogram correctly indicate the size, shape, and orientation of the near-surface delamination. The boundary between the dark and light regions is approximately normal to the direction of image shear. The mottled gray region enclosing the debond indication and filling the lower left portion of the figure is the surface of the nose cone section. The lighter region above and to the right of this is the background behind the specimen. Although the debond closest to the front surface was detectable whether the concave or convex surface was facing the shearography device, inspections failed to detect the inserts at the mid-plane and near the surface away from the shearography device.

Figure 27. (N) Indication of a Simulated Delamination

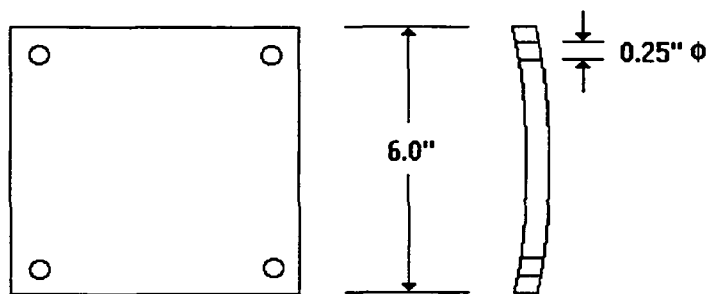
Figure 28. Gr-Ph ET-CNC Coupon with Machined Holes

Figures 28. and 30. Each image contains the appearance of each hole twice due to an image shearing distance 0.05 inches greater than the diameter of the holes.

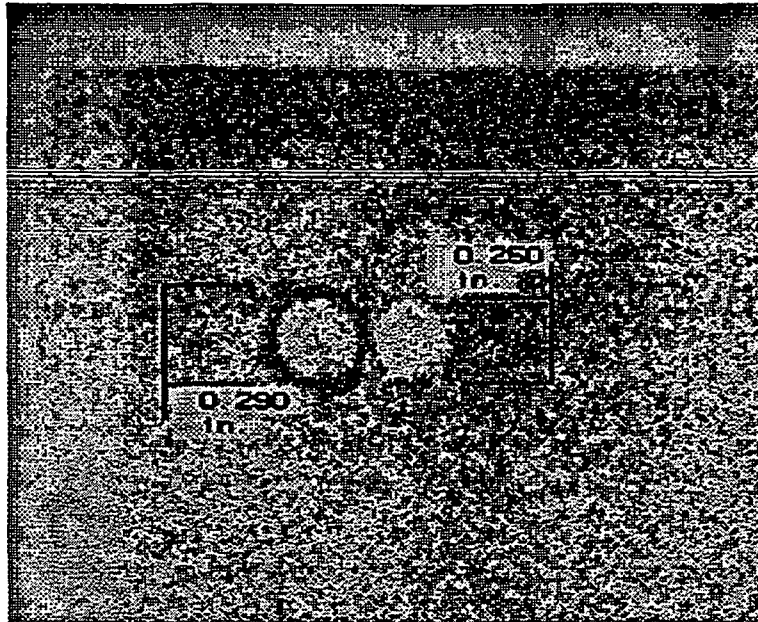
Figure 29. (N) Electronic Shearogram of Machined Hole with No Visible Damage

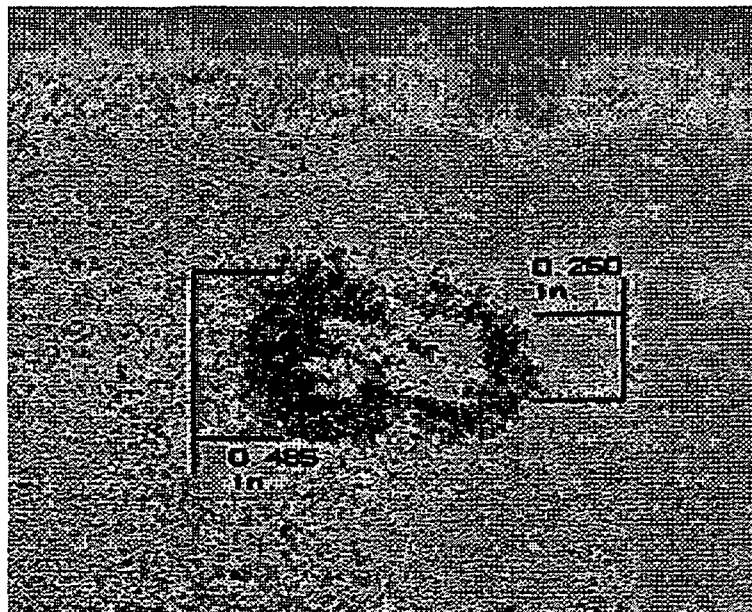
Figure 30. is a shearogram of a hole with visible machining damage in the form of frayed material inside the hole at the surface. The shearogram also indicates a damaged region with a diameter of 0.485 inches. That is, the damage extends radially 0.118 inches beyond the drilled hole. The latter damage is not visible to the unaided observer, but extends to almost twice the diameter of the intended hole.

Figure 30. (N) Electronic Shearogram of Machined Hole with Visible Damage

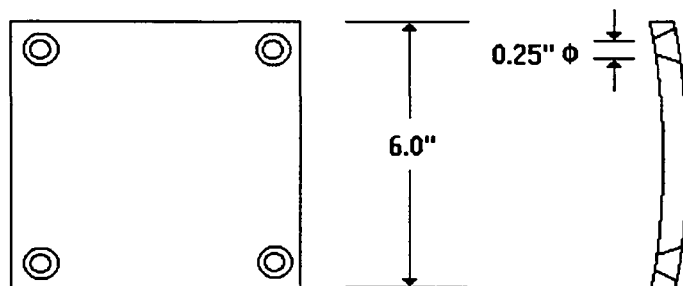
**Figure 31.** Gr-Ph ET-CNC Coupon with Conical Holes

The MSFC NDE Branch was provided a Gr-Ph coupon containing four drilled holes tapered to accommodate flat-headed fasteners. The geometry of this specimen is shown in Figure 31. The specimen is 6"  $\times$  6"  $\times$  1/4" thick and curved to the same radius as the ET-CNC. A 0.25 in. ID conical hole has been drilled in each corner. The image shearing distance was set to 0.063 inches at a lens-to-object distance of 4.5 feet.

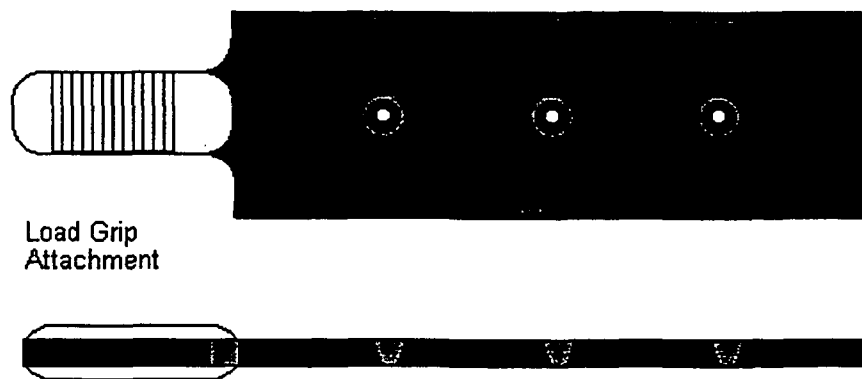
Figure 33. Specimen Geometry

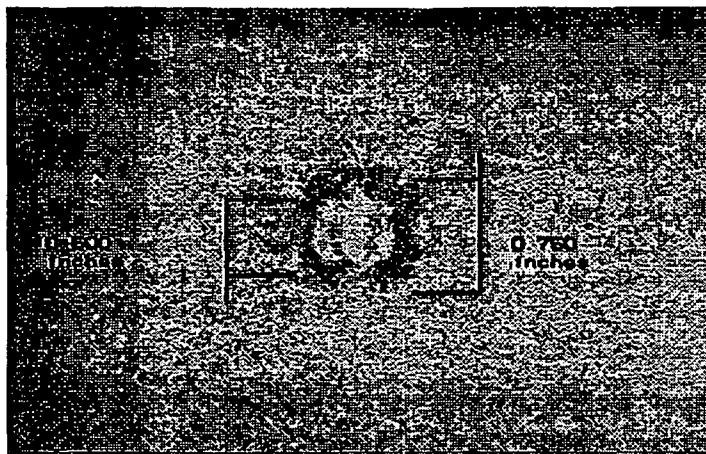
The shearograms of all three holes feature bright crescent shaped indications above the holes. This is the side against which the bearing load was applied by the bolts and upon which damage was observed visually.

**Figure 35. (N) Electronic Shearogram of Conical Hole Nearest to Load Grip.**

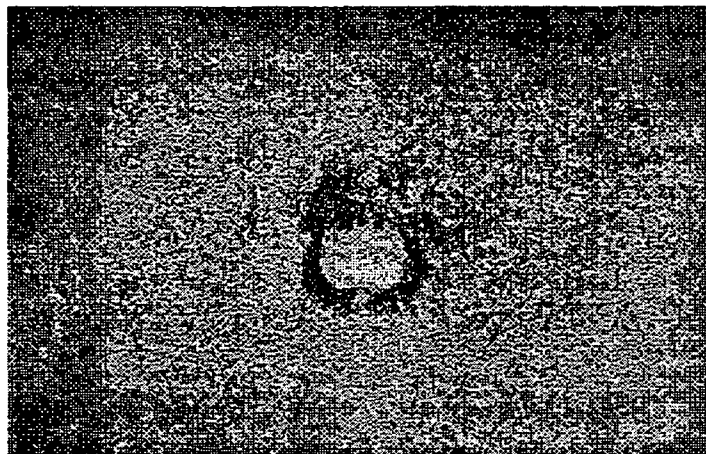
**Figure 36. (N) Electronic Shearogram of Middle Conical Hole.**

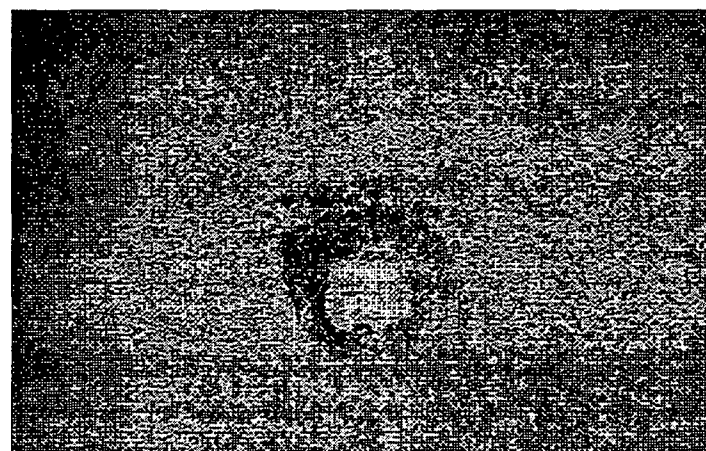
**Figure 37. (N) Electronic Shearogram of Conical Hole Farthest from Load Grip.**

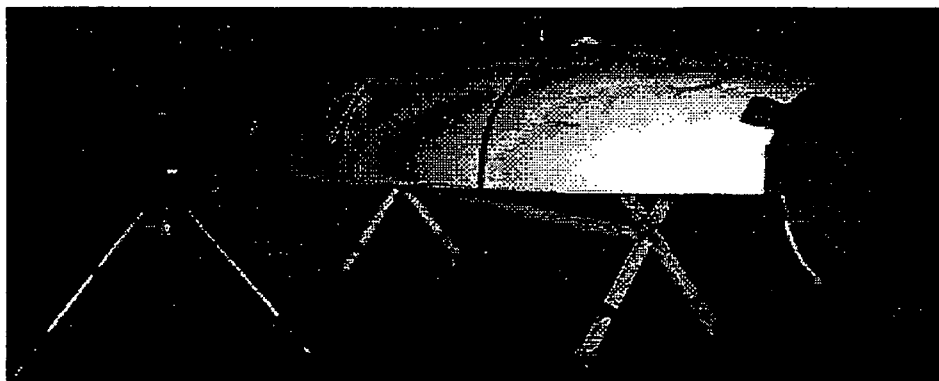
**Figure 40.** Electronic Shearography inspection of ORBCOMM Pegasus fairing at OSC manufacturing facility in Phoenix, Arizona.

The Pegasus fairing consists of a right and left half with the nose cone attached to the left side. The nose cone is quasi-hemispherical and attached to the cylindrical section by a short frustum as shown in Figure 40. During inspection the fairings were supported from the inside on a wheeled cart. In this position, the actual side of the fairing appears to be the top. The two halves of the fairing are bound with steel bands during launch and there are two black rings around the fairing which are bare of TPS to accommodate these straps. The optical head, containing the laser illumination source and the optics and CCD camera for image acquisition, was positioned on its tripod approximately 3 to 6 feet from the fairing. The apparatus is visible in the left portion of Figure 40., and the laser illumination is apparent as a bright circle on the side of the fairing at the aft retaining band ring. ES inspections were not possible for a region approximately two feet wide and extending from approximately two feet behind the nose cone to approximately two feet ahead of the aft edge because the tripod did not provide sufficient elevation.

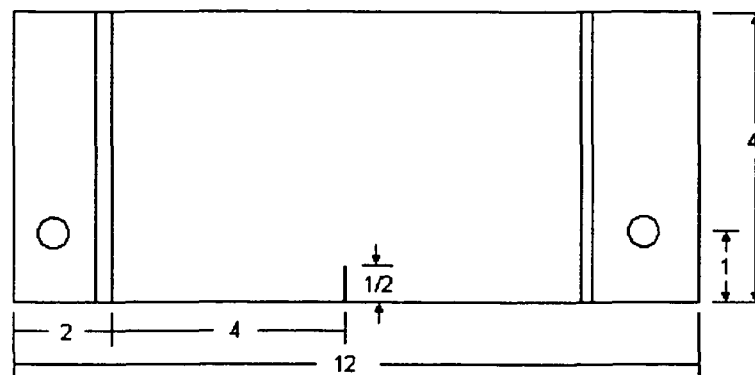
Figure 73. SEN specimen geometry, all dimensions in inches.

A short feasibility study was conducted to determine the potential for measurement of  $K$  with shearography. A single edge notch (SEN) specimen was constructed as shown in Figure 73. from polycarbonate for Mode I, or opening mode, loading. The specimen was loaded at a displacement controlled rate of 0.005 inch per minute. The image shearing distance was adjusted to approximately 0.004 inch at an object distance of 3.5 feet.
