# Atomic Oxygen Durability of Second Surface Silver Microsheet Glass Concentrators

Kim K. de Groh and Donald A. Jaworske  
*Lewis Research Center*  
*Cleveland, Ohio*

Prepared for the  
Third International Conference on Protection of Materials and Structures  
from the Low Earth Orbit Space Environment  
cosponsored by the Canadian Space Agency and the  
Institute for Space and Terrestrial Studies  
Toronto, Canada, April 25–26, 1996

1. AGENCY USE ONLY (Leave blank)	2. REPORT DATE April 1996	3. REPORT TYPE AND DATES COVERED Technical Memorandum		
4. TITLE AND SUBTITLE Atomic Oxygen Durability of Second Surface Silver Microsheet Glass Concentrators			5. FUNDING NUMBERS WU-233-1A-1E

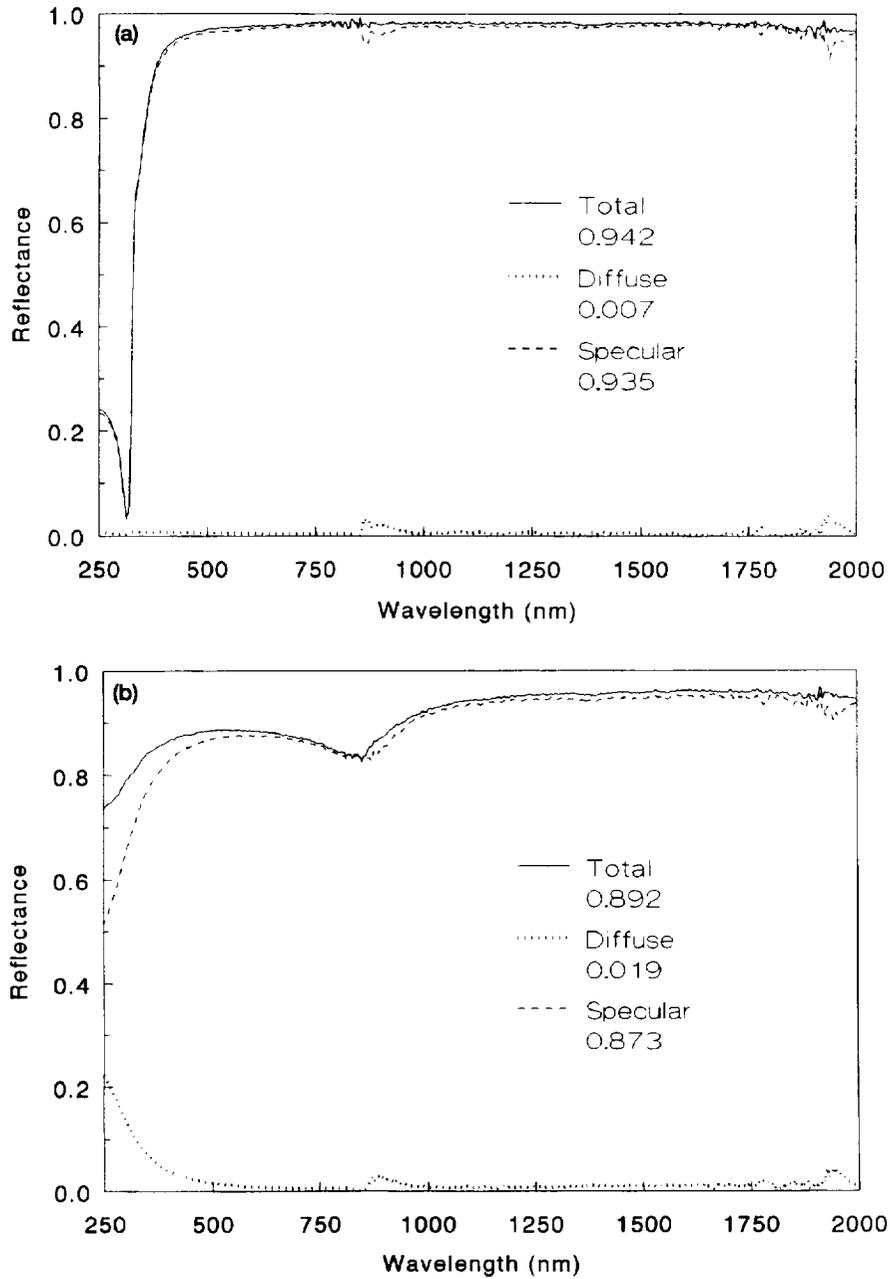
Figure 1. Spectral reflectance of first surface microsheet glass mirrors. (a) Silver mirror. (b) Aluminum mirror.

Silver has a greater integrated solar reflectance than aluminum, by several percentage points. Figure 1 shows the spectral difference and the corresponding integrated solar reflectance values for both silver and aluminum microsheet glass first surface mirrors (the reflective layer is on the front side of the microsheet glass). This distinct advantage of silver is offset in LEO applications by its high rate of oxidation by atomic oxygen. Aluminum, on the other hand, develops a very thin, passive oxide layer which makes it atomic oxygen durable. Therefore, aluminum, which is a poorer optical performer than silver, is generally a more durable reflective choice for conventional solar concentrators.

The integrated solar values for total, diffuse and specular reflectances of sample MD1 were 0.936, 0.049 and 0.887, respectively. The relatively large diffuse reflectance (4.9%) for this mirrored sample is due to the purposely centered impact site. Optical properties were obtained for a similarly coated second surface silver microsheet glass mirror not used for atomic oxygen durability evaluation. The integrated solar values for this non-defected mirror were 0.938, 0.016 and 0.922, for total, diffuse and specular reflectance, respectively. It is interesting to note, that for the second surface mirrors the microsheet glass absorbs most of the light which is reflected from the first surface mirror below  $\approx 325$  nm (see Figure 1a).

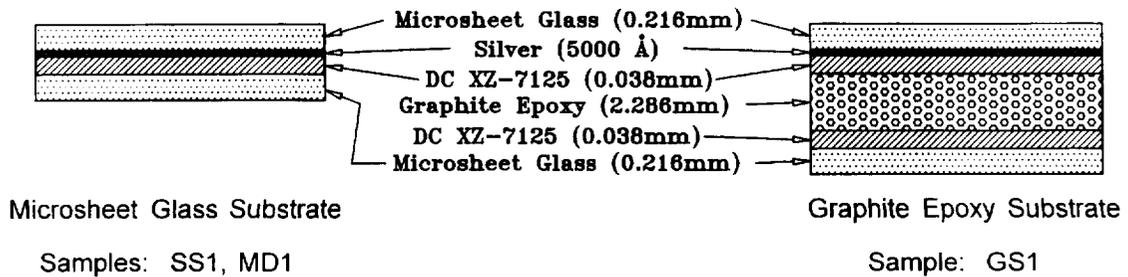
Figure 2. Cross-section composition of second surface microsheet glass concentrator samples used in this study.

A total of three microsheet glass concentrator samples were prepared for atomic oxygen exposure. Figure 2 summarizes the layered construction of the microsheet glass samples used for testing. A 0.216 mm thick borosilicate microsheet glass is on the top, followed by 5000 Å of silver, followed by a thin film (0.038 mm) of Dow Corning XZ-7125 silicone adhesive, all on top of a substrate material. Although several substrate materials have been considered so far (aluminum, magnesium and graphite epoxy for example), two substrates were chosen for these atomic oxygen exposure tests, 0.216 mm thick microsheet glass and 2.286 mm thick graphite epoxy. Microsheet glass was used as a substrate (as opposed to aluminum or magnesium) because it is atomic oxygen durable and allows the adhesive layer to be observed during testing. The Dow Corning thin film adhesive was used because it is a space qualified material. It should be noted that there is a potential for some contamination due to environmental interaction with the silicone adhesive contained in the DC XZ-7125, but the risk is greatly decreased because only the silicone at the edges could be exposed to some atomic oxygen, and should not be directly exposed to UV radiation in space.

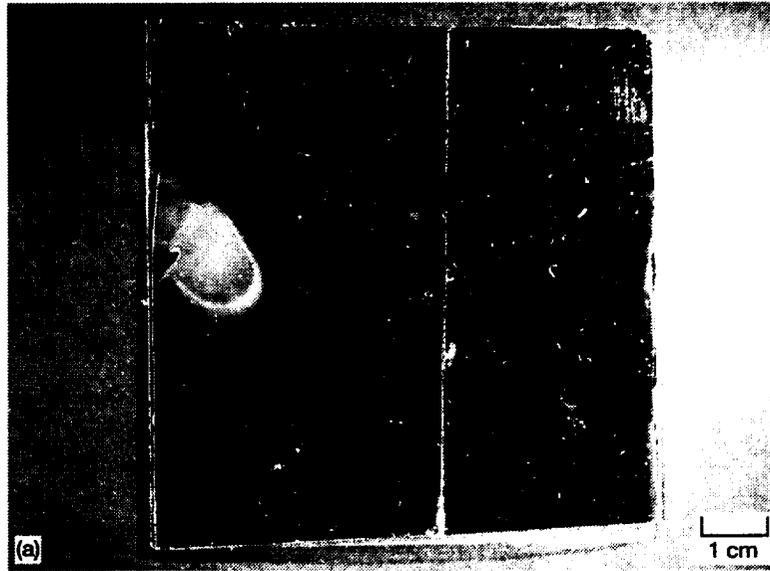
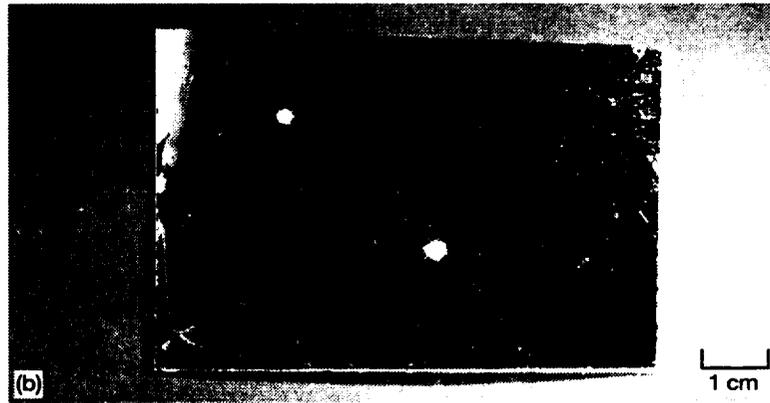
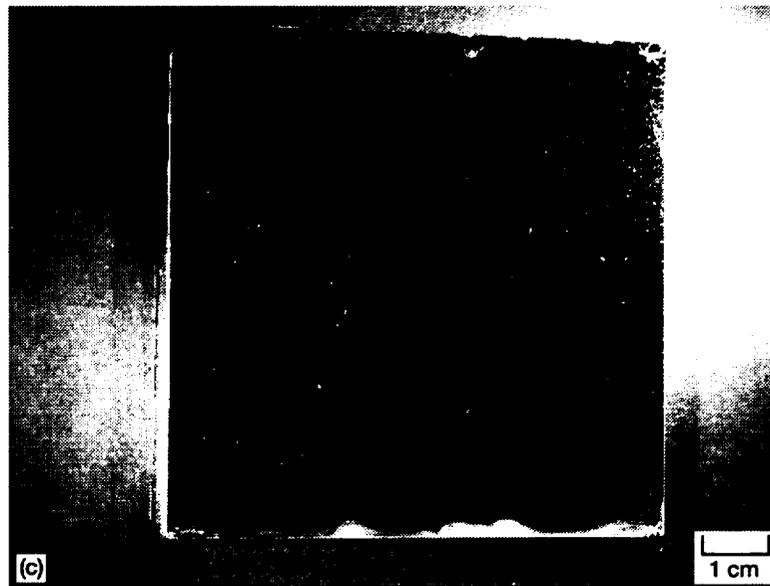
Figure 3. Pristine microsheet glass concentrator samples. (a) Sample SS1 with a seam. (b) Sample MD1 with two impact sites. (c) Sample GS1 with a graphite epoxy substrate.

As previously stated, three samples were fabricated and tested. The first sample, SS1, was prepared with a microsheet glass substrate and had a seam down the center of the microsheet glass cover. The primary purpose for testing this sample was to evaluate the degradation of concentrators in the vicinity of seams. The second sample, MD1, also had a microsheet glass substrate, but this sample was purposely prepared with two simulated micrometeoroid and debris impact sites. The MMD impacts were introduced manually by breaking the microsheet glass with a sharp implement. The third sample, GS1, was fabricated with a graphite epoxy substrate. This sample, which did not have seams or induced impact sites, was used to evaluate edge effects and to compare edge oxidation with the microsheet glass substrate samples. Graphite epoxy will be eroded by atomic oxygen so it has a greater potential for degradation at its edges than concentrators with atomic oxygen durable substrates. Because atomic oxygen arrival is isotropic in the atomic oxygen facility used, a microsheet glass layer was adhesively applied to the back of the graphite epoxy substrate to protect it from atomic oxygen attack. Graphite epoxy as a substrate has the advantage of being light weight, structurally strong and can be formed to any shape. Pre-exposure photographs of the three samples are shown in Figure 3.

Due to time constraints, these samples were made relatively quickly, which resulted in some imperfections in the as-fabricated samples. For example, there were some hazy areas present on the samples. One such area is visible on the left side of sample SS1 (see Figure 3a). There are also hazy areas along the left edge of sample MD1, and along the bottom edge of sample GS1, as can be seen in Figures 3b and 3c, respectively. These hazy areas appear to be due to chemical residues from the cleaning process, which have reacted with the silver. Also, there is a circular crack site on sample SS1 extending from the left side of the upper edge. This crack, which was induced accidentally, is in addition to the seam, which appears as a straight line down the center of the sample. Aside from the hazy patches, these as-fabricated samples had a very high specular appearance. In viewing the backsides of the samples, there were some air pockets present in the adhesive. These air bubbles were present around some of the defect areas such as the impact sites and the curved crack in SS1. Air entrapment can be avoided with special care in applying the film adhesive.

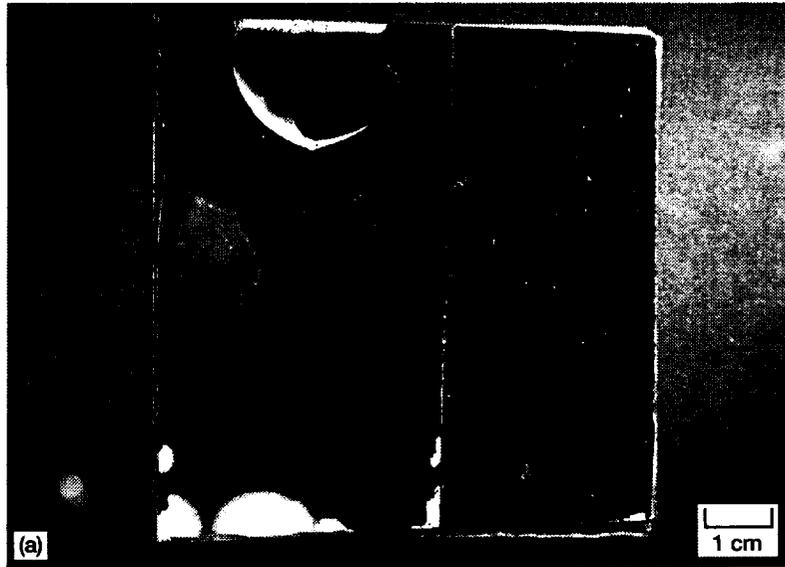
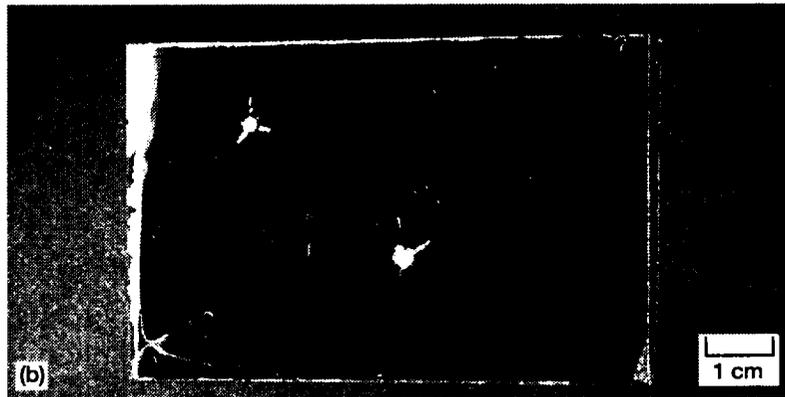
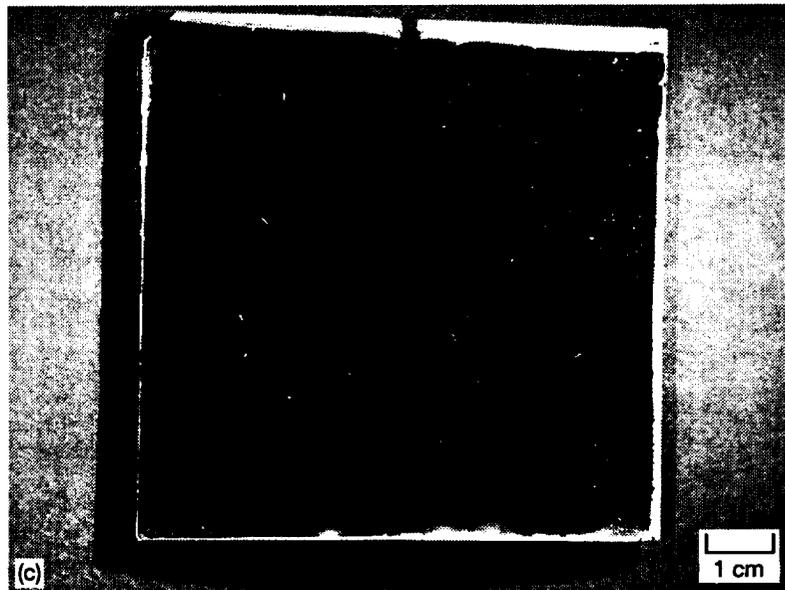
Figure 4. Microsheet glass concentrator samples after an initial atomic oxygen effective fluence of  $0.7-0.9 \times 10^{21}$  atoms/cm<sup>2</sup>. (a) Sample SS1. (b) Sample MD1. (c) Sample GS1.

After an initial atomic oxygen exposure to an effective fluence of  $\approx 1.2 \times 10^{21}$  atoms/cm<sup>2</sup>, oxidation was clearly visible on all samples (see Figure 4). Figure 4a shows sample SS1 after initial atomic oxygen exposure (compare this photo with the pristine sample in Figure 3a). Oxidation is apparent as the bright white regions on some edge areas and at the curved crack site of the sample. Oxidation occurred along only a small section of the seam. The oxidation which occurred on sample SS1 appears to have developed at observable fabrication imperfections, such as the curved crack. There are visible imperfections in the pristine sample along the top and bottom edges where oxidation took place (see Figure 3a). There also seems to be a correlation between oxidation and the presence of air pockets in the adhesive. For example, there are air pockets in the adhesive around the curved crack, along the area of the seam which oxidized and at the lower right corner of the sample which oxidized. There are some areas where air pockets are present which did not oxidize because there are no corresponding crack sites in the microsheet glass (seams or edges) to provide a pathway for atomic oxygen exposure. Finally, there appears to be adhesion failure, between the silver and adhesive, associated with the relatively large curved oxidized regions extending into the sample from the lower left edge of sample SS1. It is not known if the adhesion failure occurred prior to, or during exposure. It should be noted that photographic exposure variations for the photographs in Figures 3-5 caused slight under-exposure of the atomic oxygen tested samples compared to the pristine samples. This is why less features are visible on the atomic oxygen exposed samples.

Oxidation was present along some, but not all radial cracks around the two impact sites in sample MD1 (see Figure 4b). Some of these cracks extend across the entire sample, but the oxidation is present only near the impact site. Oxidation was present along most edges of the graphite epoxy based sample GS1. Compare the top and right edges in Figure 4c with those in Figure 3c. It should be noted, that the silverized microsheet glass cover overhangs this sample on most edges, by about 1 mm on the top side, exposing the silver directly to the atomic oxygen plasma. However, the extent of oxide growth is  $\approx 1.2$  mm into the graphite epoxy in this area (a total of 2.2 mm oxide growth). There was no observable oxidation at an edge where the graphite epoxy lines up with the cover glass. Oxidation of the overhung edge may be affected by scattering contributions, or it is possible that the adhesive was not completely bonded to the cover sheet at these edges. There appears to be a very small gap between the microsheet glass and the graphite epoxy at the extreme edges of the sample as seen from the backside of the sample. If this gap was also present between the silverized microsheet glass and graphite epoxy it may explain why the silver has oxidized along these edges. It is not clear if these gaps were present prior to exposure, or occurred due to atomic oxygen exposure. The silver at the edges of the graphite epoxy sample did appear to be somewhat more susceptible to oxidation than the silver at the edges of the microsheet glass samples, but the edges of the microsheet glass substrate samples may have been bonded better.

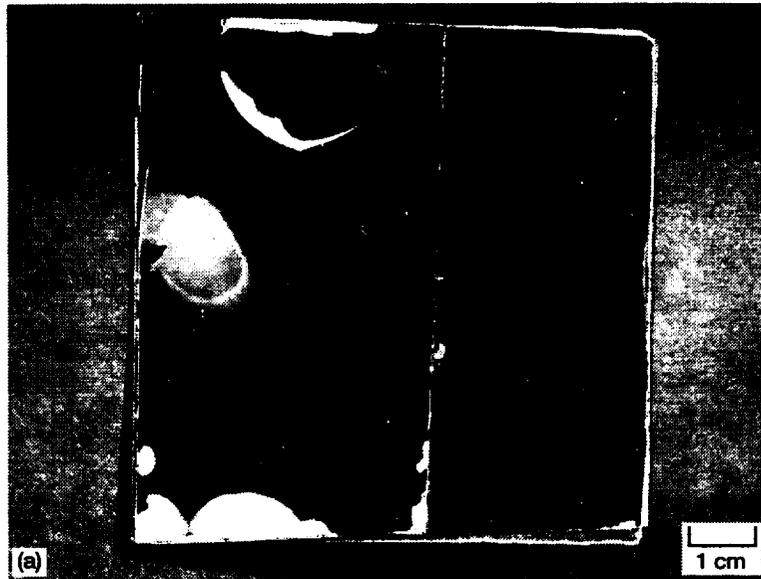
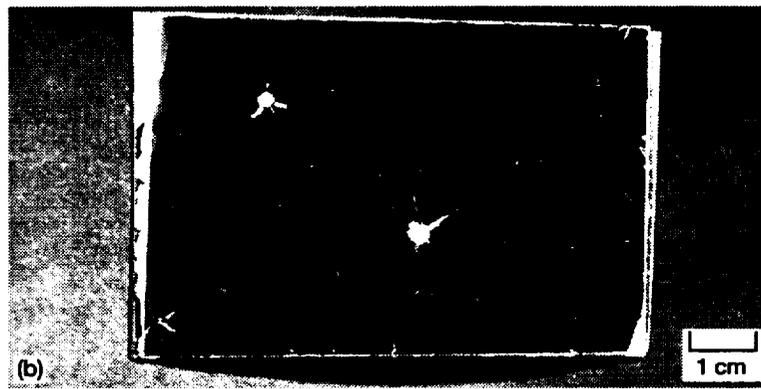
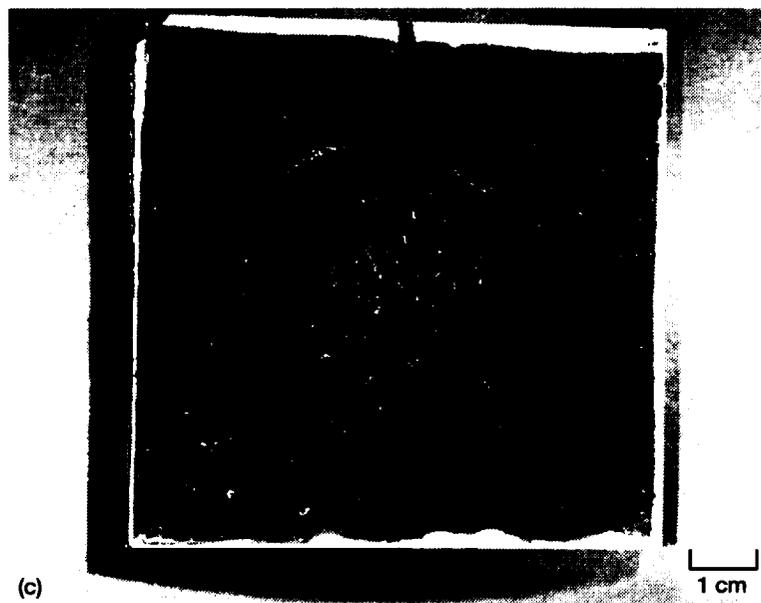
Figure 5. Microsheet glass concentrator samples after final atomic oxygen exposure to a total effective fluence of  $2.0 \times 10^{21}$  atoms/cm<sup>2</sup>. (a) Sample SS1. (b) Sample MD1. (c) Sample GS1.

Exposure to an additional effective fluence of  $0.7-0.9 \times 10^{21}$  atoms/cm<sup>2</sup> did not cause further extension of the optically observable oxidation. Figure 5 shows the samples after atomic oxygen exposure to a total effective fluence of  $2.0 \times 10^{21}$  atoms/cm<sup>2</sup>. An edge effect sequence of sample GS1 shown in Figure 6 demonstrates that oxidation appears to have stopped

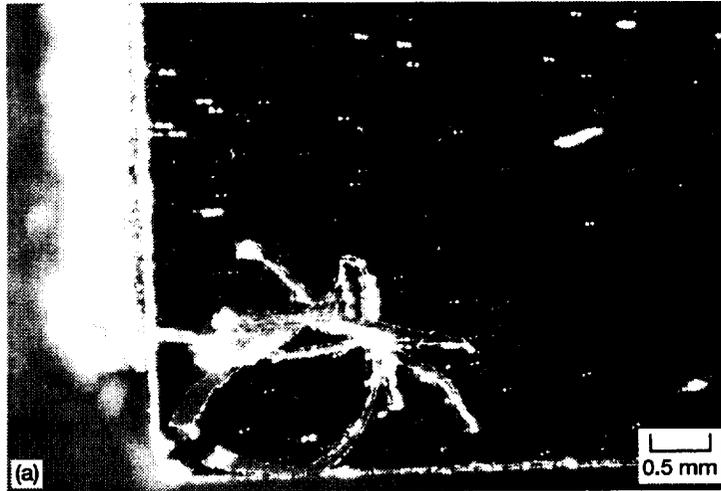
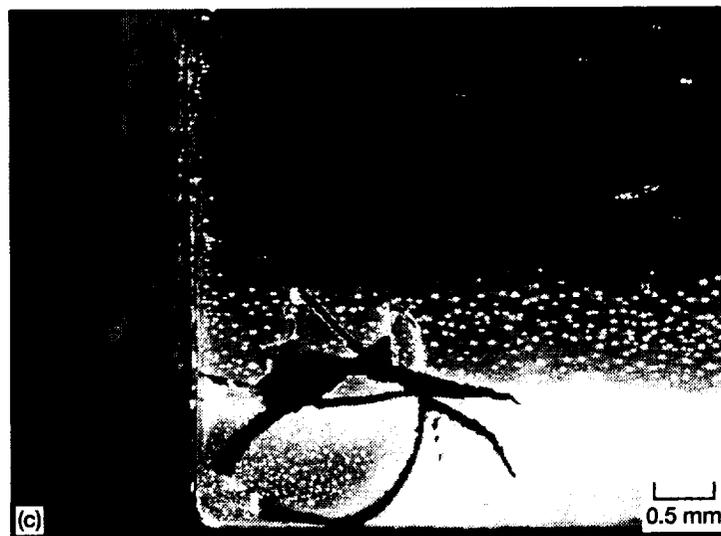
Figure 6. Corner edge of sample GS1. This sequence shows that oxidation did not progress after the initial fluence exposure. (a) Pristine. (b) Effective fluence of  $1.26 \times 10^{21}$  atoms/cm<sup>2</sup>. (c) Effective fluence of  $2.0 \times 10^{21}$  atoms/cm<sup>2</sup>.

progressing at some point during initial exposure (the defect is a scratch in the silver). Another possible explanation is that these oxidized areas were locations of poor adhesion and were directly exposed to the atomic oxygen plasma from the beginning. This would imply that only directly exposed silver areas will oxidize, and therefore this oxidation could be preventable. Figure 7 shows the effect of atomic oxygen exposure on one of the simulated MMD impact sites in sample MD1. Oxidation occurred along some of the radial cracks that extend from the impact site. Figure 8 is a closeup of the oxidation that developed along one of these cracks and shows bright oxide "spots". These spots appear to be areas of thicker oxide growth. It was noted that the oxide around these impact sites coincides with air pockets as seen from the back of the sample. Figure 9 is a close up of the lower right radial crack in Figure 7. Figure 9a shows the oxidation from the front of the sample. Figure 9b is a view of the back of the sample and shows that the oxide follows along horizontal air pockets. Figure 10, a back side view of edge oxidation on sample MD1, shows the same effect. In this area, oxidation is confined to a large air pocket (seen as a quarter circle in this micrograph). These data imply a link between oxidation and poor adhesion. Atomic oxygen exposure and the resulting oxidation caused a negligible decrease in reflectance of sample MD1. The total, diffuse and specular integrated solar values decreased from the pristine values of 0.936, 0.049 and 0.887 to 0.925, 0.044 and 0.881, respectively, with atomic oxygen exposure as shown in Figure 11. These reflectance measurements were taken at the partially oxidized impact site shown in Figure 7.

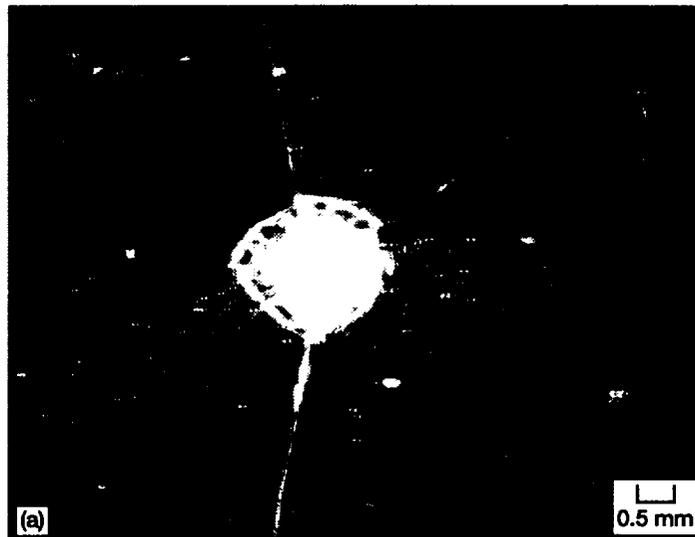
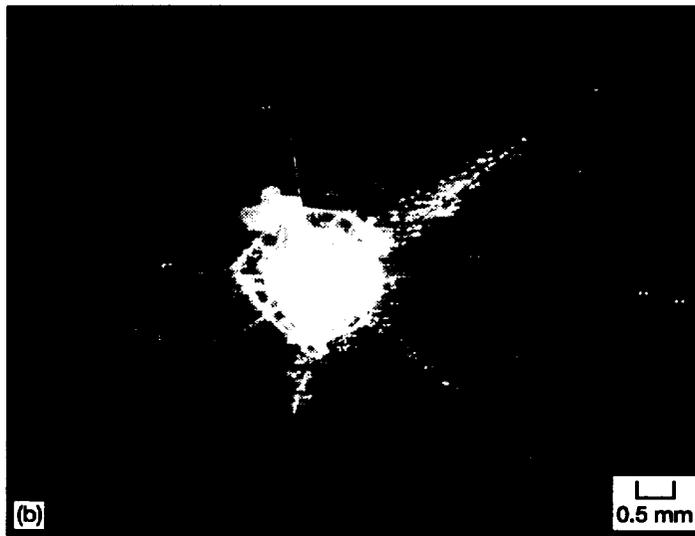
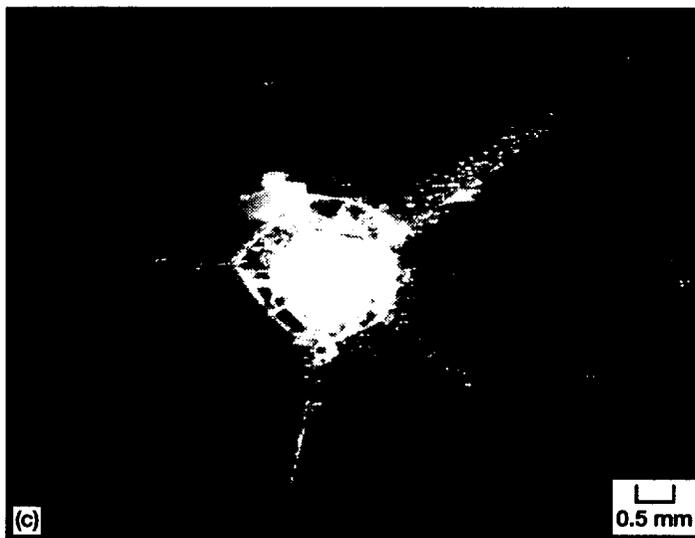
Figure 7. Impact site on sample MD1. Oxidation occurred along three of the six radial cracks. (a) Pristine. (b) Effective fluence of  $1.26 \times 10^{21}$  atoms/cm<sup>2</sup>. (c) Effective fluence of  $2.0 \times 10^{21}$  atoms/cm<sup>2</sup>.

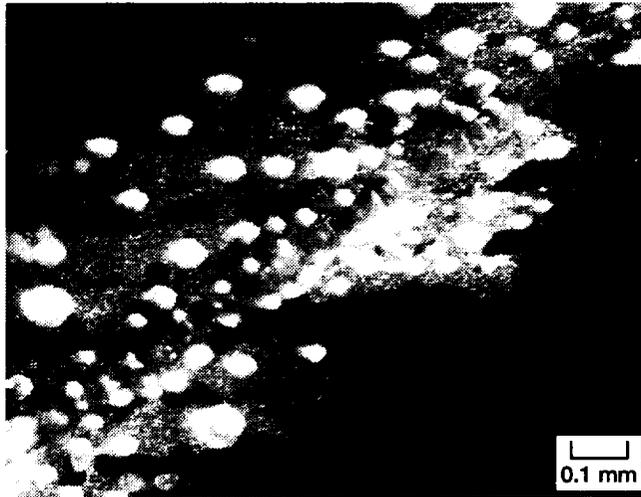
Figure 8. Sample MD1 after an effective fluence of  $2.0 \times 10^{21}$  atoms/cm<sup>2</sup>. Close-up of oxidation "spots" at a radial crack shown in Figure 7(c).

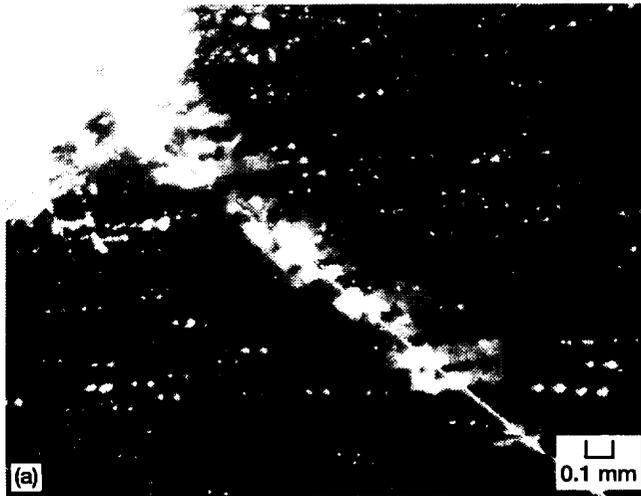
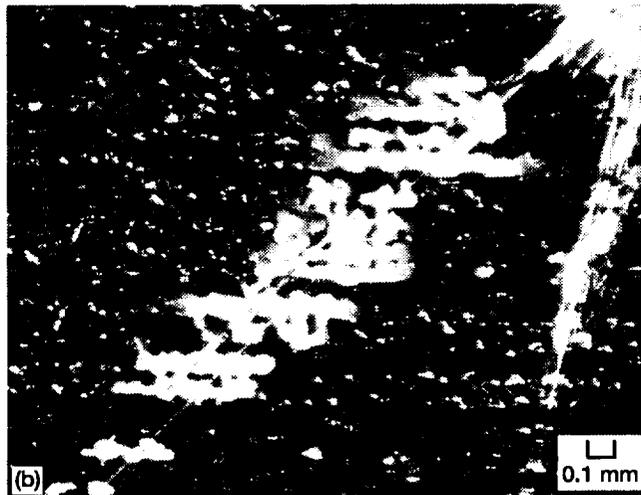
Figure 9. Lower right radial crack extending from the impact site in Figure 7. (a) Front side. (b) Back side, which shows that the oxide follows along horizontal air pockets.

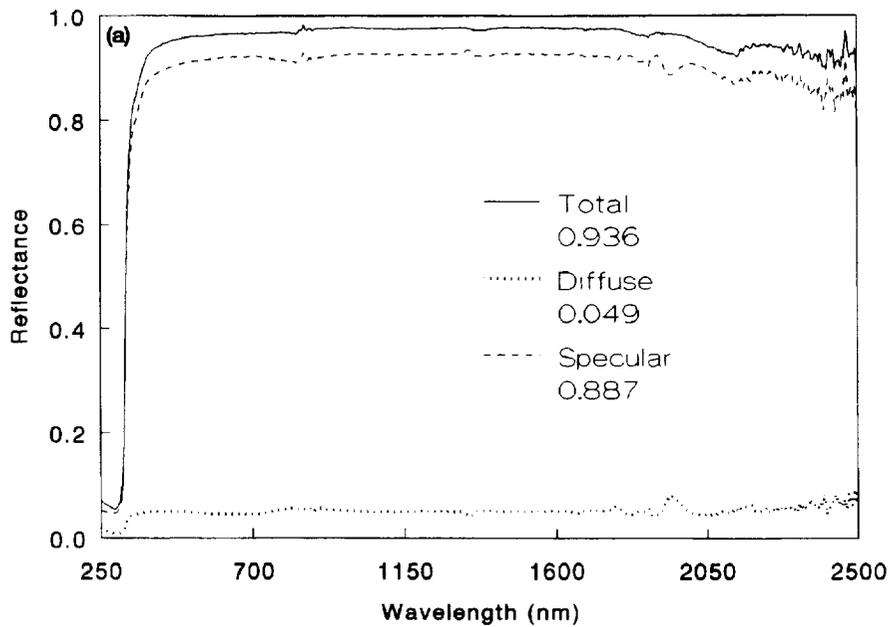
Figure 11. Spectral reflectance of sample MD1 at impact site shown in Figure 7. (a) Pristine. (b) Effective fluence of  $1.26 \times 10^{21}$  atoms/cm<sup>2</sup>. (c) Effective fluence of  $2.0 \times 10^{21}$  atoms/cm<sup>2</sup>.

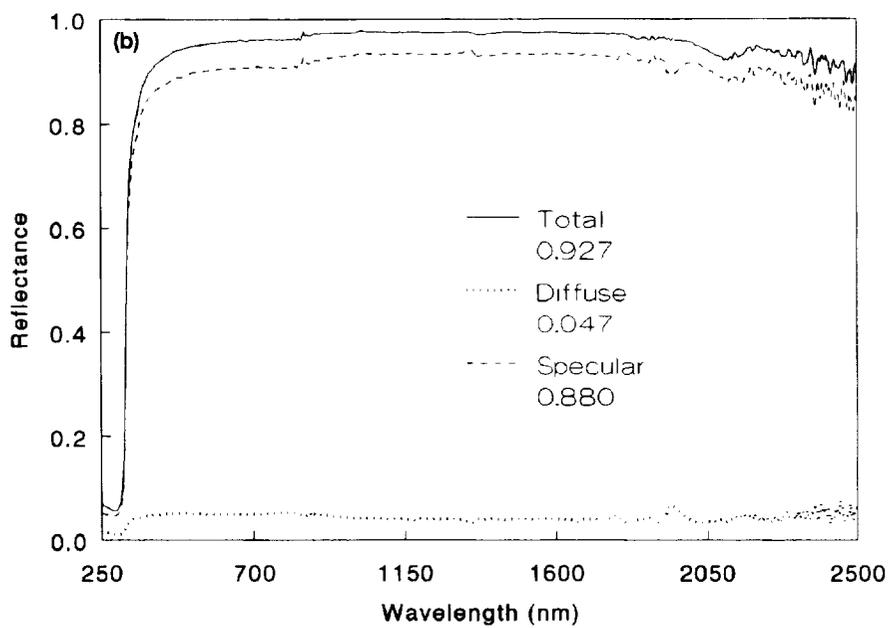
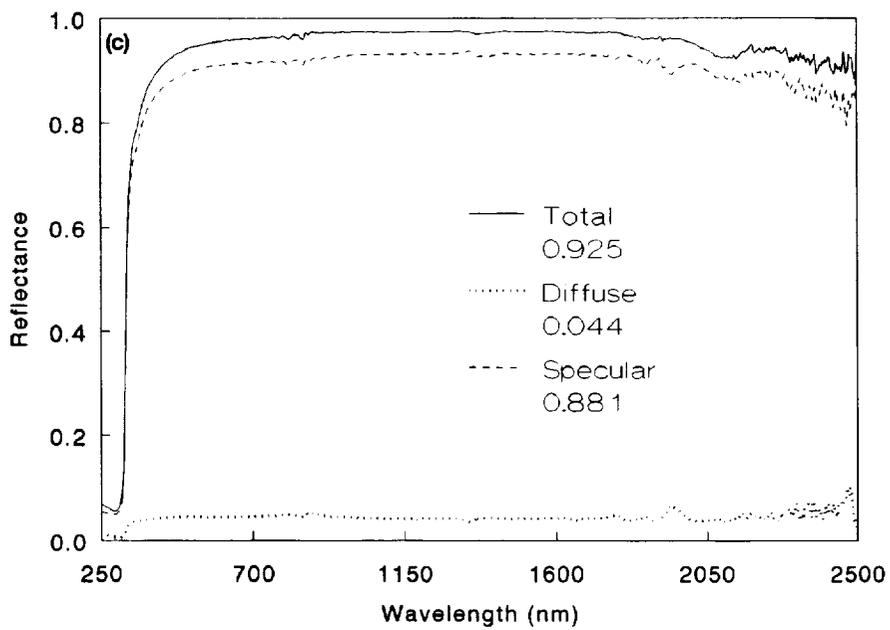
Figure 11. Concluded. (b) Effective fluence of  $1.26 \times 10^{21}$  atoms/cm<sup>2</sup>. (c) Effective fluence of  $2.0 \times 10^{21}$  atoms/cm<sup>2</sup>.
