A History of Aerospace Problems, Their Solutions, Their Lessons

R.S. Ryan
Marshall Space Flight Center • MSFC, Alabama

National Aeronautics and Space Administration
Marshall Space Flight Center • MSFC, Alabama 35812

September 1996

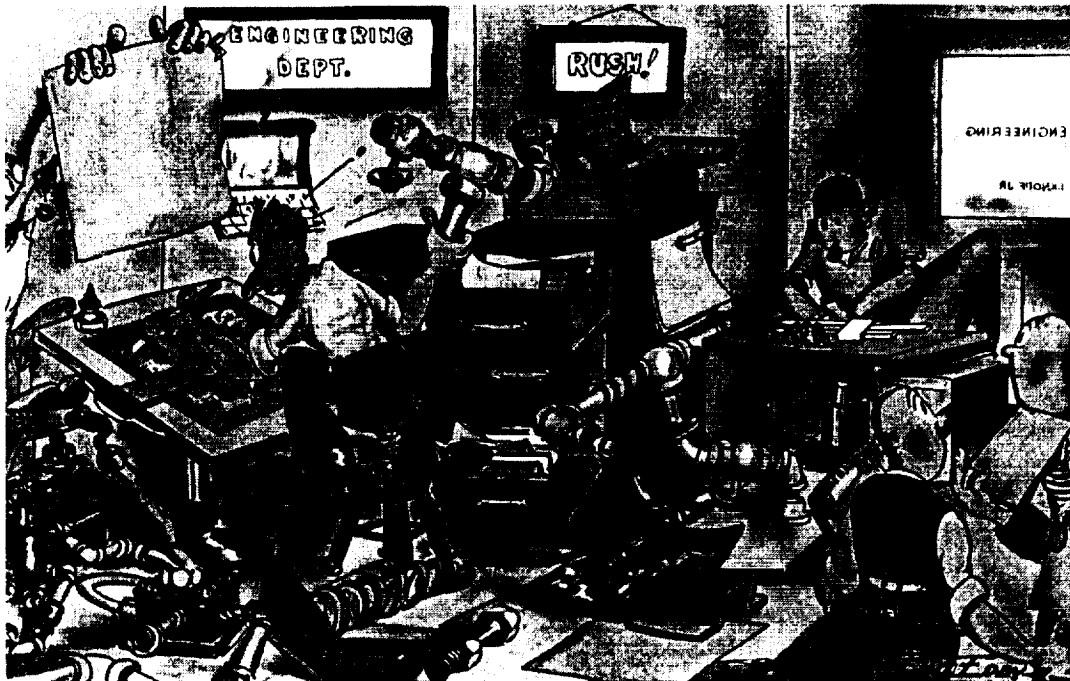
Figure 8. Change in what specs?

"I haven't the heart to tell him that the specs have changed"

In the Saturn Apollo days, Honeywell published yearly calendars with Bill Eddy's cartoons highlighting each month. There are two bound books of these cartoons, which are not only humorous but give great messages in unforgettable ways. Two of my favorites deal with specifications (fig. 7) and accuracy (fig. 8). "So that decimal point was a fly speck!" brings home a poignant point, as did all the other calendars that not only made us better engineers technically, but also made us laugh a little, which relieved work pressures. Remember, each of these lessons was displayed on our office walls for a whole month, speaking to us. Then came the next month. Today we see planes, ships, electronics, etc., trying to sell us on a product.

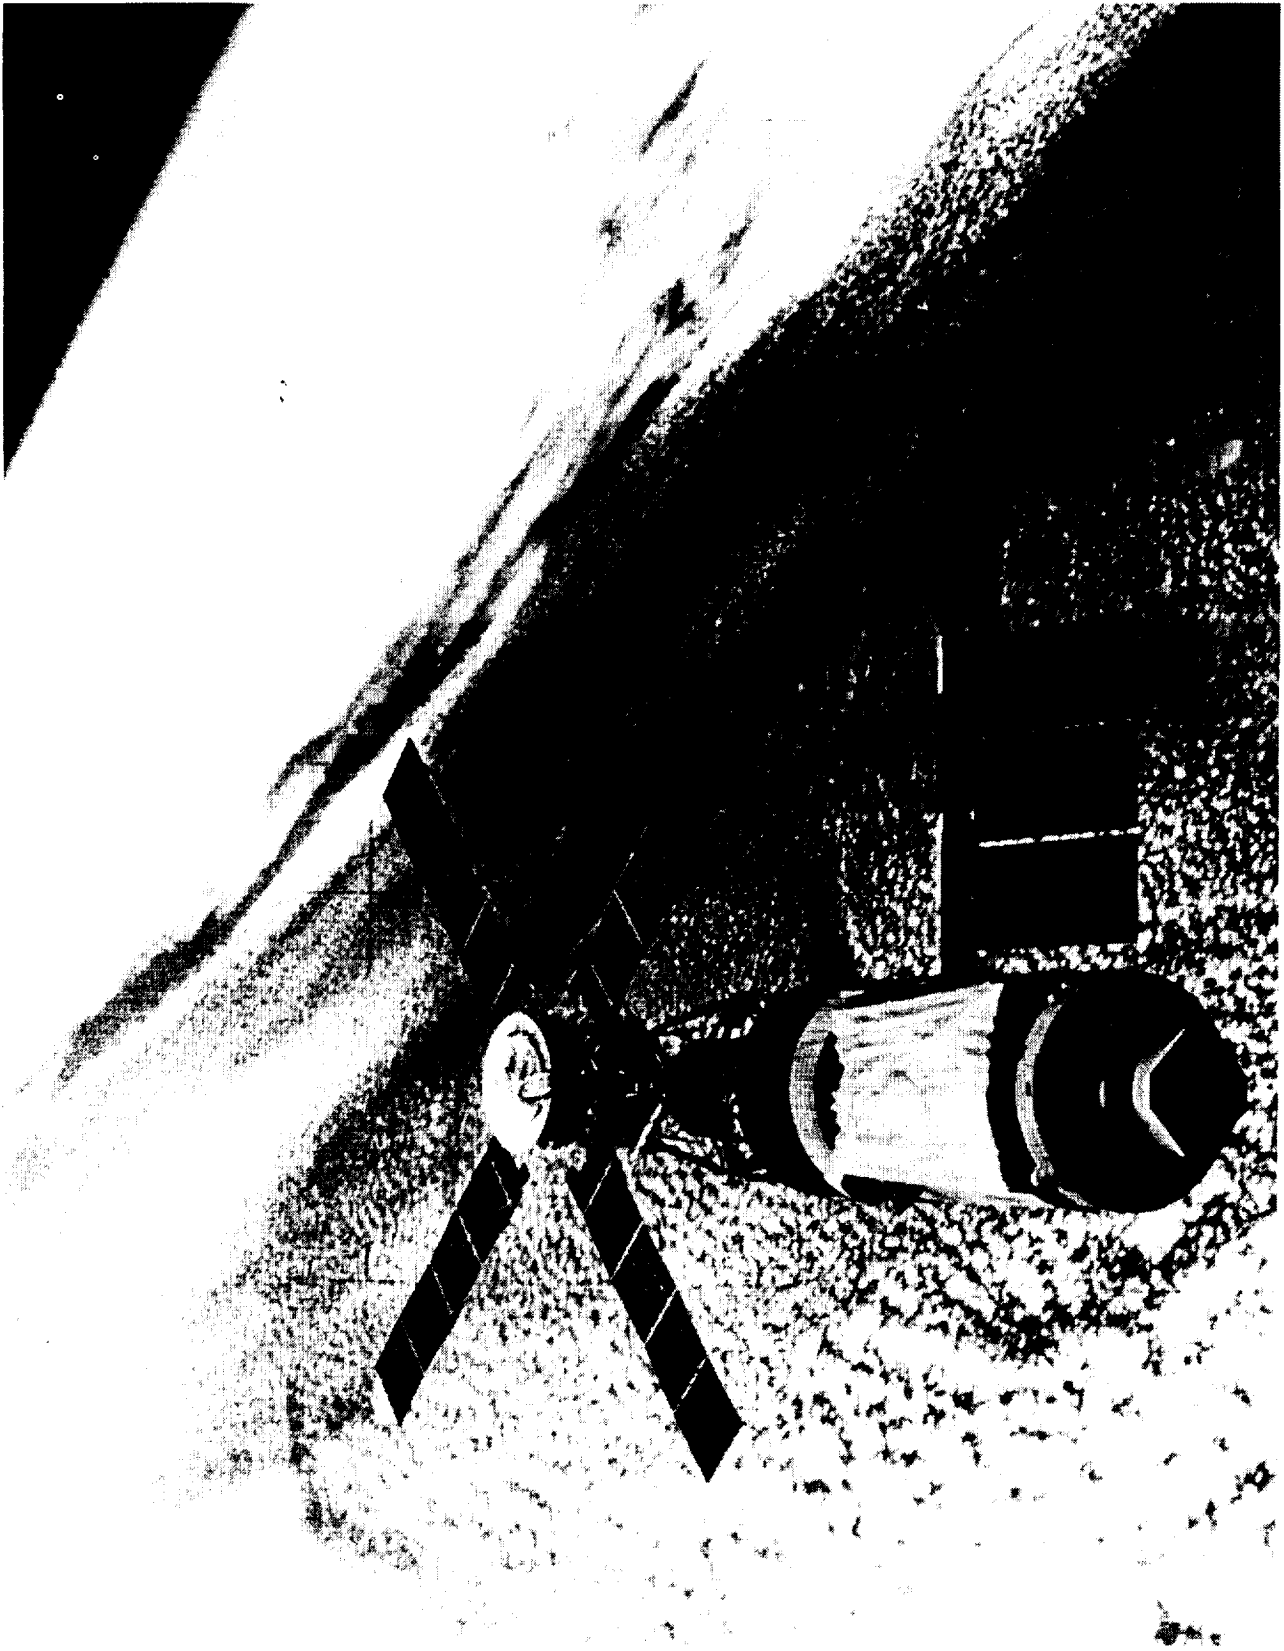
Figure 34. *Skylab* configuration.

The *Skylab* space station evolved into a configuration composed of (a) docking adapter; (b) solar observatory; (c) airlock module; (d) workshop solar wings (solar energy for electric power) (was launched with two solar wings, but operated with one since the other was lost during launch); and (e) workshop and living quarters (fig. 34). Cutaways of the living and working quarters are shown on figure 35 and include all the life support system shown on figure 36. Table 1 lists the basic subsystems, the manufacturers, module name, function, length, diameter, and habitable working volume. The heart of the science mission was the solar observatory (fig. 37), which had its own fine pointing control system with ATM instruments, solar power system (four solar arrays), and EVA access. A typical mission profile is shown on figure 37.

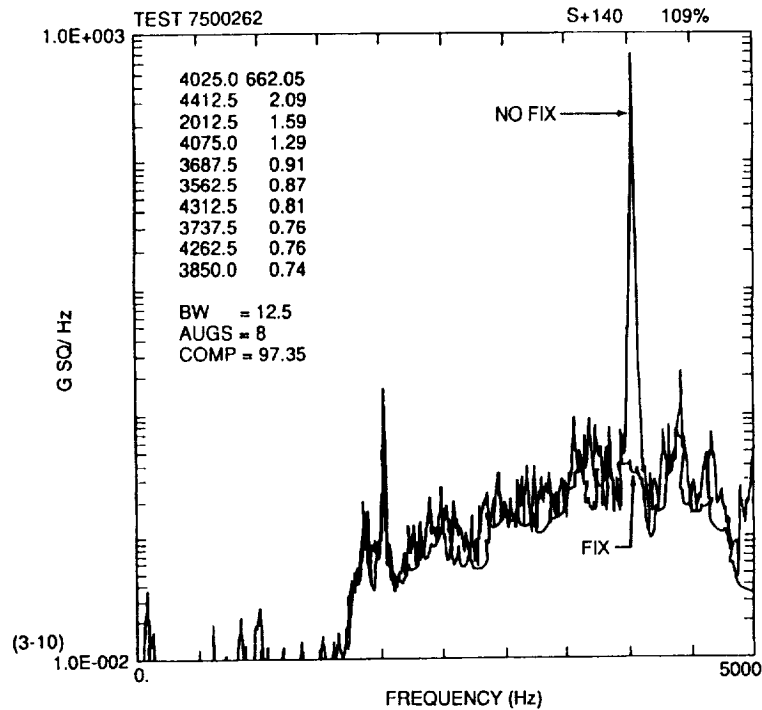
Figure 57. SSME response of 4,000 Hz.

fluid flow analysis, (4) fatigue and fracture mechanics analysis, and (5) structural dynamic and static testing. These efforts led to the conclusion that the basic instability was essentially vortex shedding. Figure 57 shows a typical response of buzzing and nonbuzzing engines. The first is a spectrum showing the very sharp narrow band resonance peak indicating an instability. Conducting a correlation analysis shows that the response is single-frequency sinusoidal. The fix consisted of scalloping the leading edges to allow more flow between the blades and tapering the trailing edge to eliminate vortex sheets. In addition, the frequency of the vane was raised slightly, helping to detune the system. Figure 58 shows the fix. Figure 57 is a plot of the response before and after the fix.

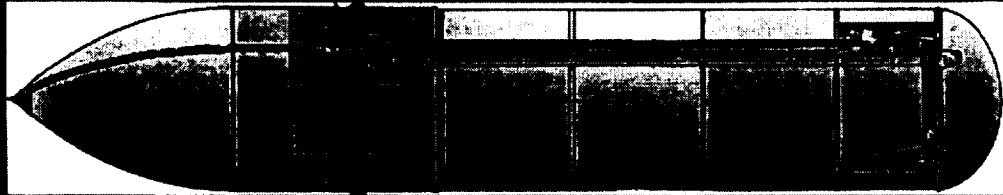
SLWT Changes to Intertank

- Main and Intermediate Ring Frames**
- Reduce thickness of Al 7075 beaded webs
 - Substitute Al 2090 for selected Al 7075 flat webs, chords and stiffeners
 - Resize thickness where possible

- Skin/Stringer Panel**
- Substitute Al 2090 for Al 2024 and Al 7075 on skin panels, doublers, butt straps and sheet metal stringers
 - Resize thickness where possible

(b) Super Lightweight Tank. The decision to join with the Russians for the design of the *International Space Station (ISS)* created the need for a 51¹/₂° orbit inclination. The shuttle, in its present configuration, cannot deliver the complete *ISS* elements into that orbit without performance enhancements. A major step in performance enhancements can be made by substituting aluminum-lithium (Al-Li) for the current 2219 Al in most of the tank structure. Also, further gains can be made through the use of an orthogrid structure milled into the tank panels. Approximately 8,000 lb of payload enhancement can be achieved with the SLWT. The tank's basic geometry does not change; however, the material does, as well as going to the orthogrid as mentioned above. Figure 100 shows the changes in the fuel tank. Figure 101 depicts the intertank. Figure 102 shows the lox tank changes. The critical design challenges for SLWT have been: (1) welding and weld repairs, (2) achieving a proper fracture toughness, and (3) ratios of ultimate to yield materials properties. All these will be discussed.
