DOE/NASA/0027-1
NASA CR-198497
AlliedSignal Engines 31-13043

DURABILITY TESTING OF COMMERCIAL CERAMIC MATERIALS FINAL REPORT

J. L. Schienle
AlliedSignal Engines, Phoenix, Arizona
A Unit of AlliedSignal Aerospace Company

January 1996

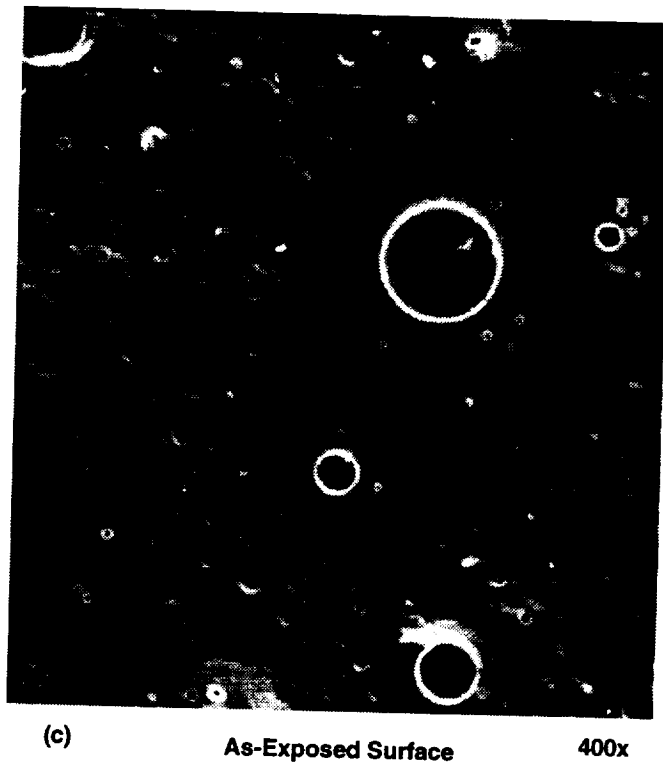
G6253-27

Figure 27. Typical RBN104 Specimen Failure Origins And Surface Topography Following 1050 Hours Exposure At 1371C (2500F).

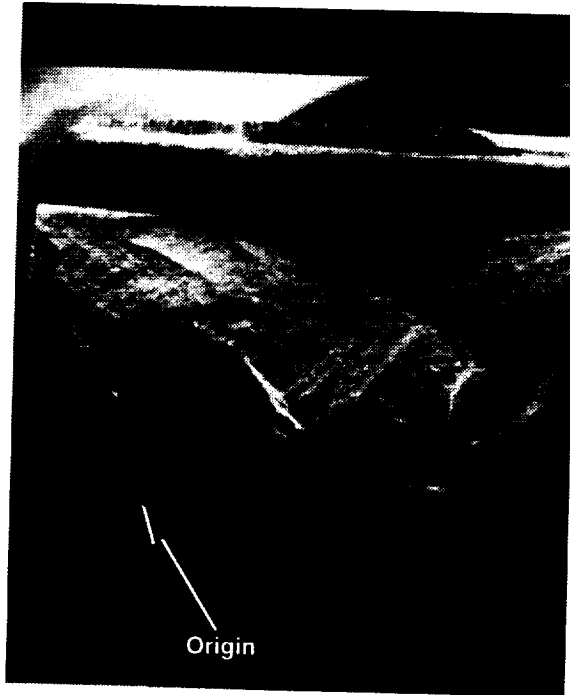
G6253-38

Figure 38. Typical Hexoloy SA Room-Temperature Baseline Test Specimen Failure Originating From Machined Surface; No Prominent Material Defects Were Noted.

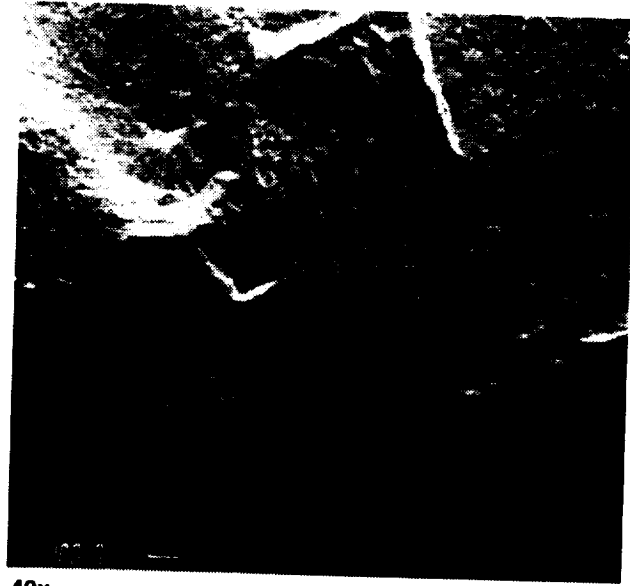
G6253-50

Figure 50. Hexoloy SA Specimen Flexure Tested At 1204C (2200F) Exhibiting Flat, Transgranular Fracture Following 2100 Hours Exposure At 1371C (2500F).

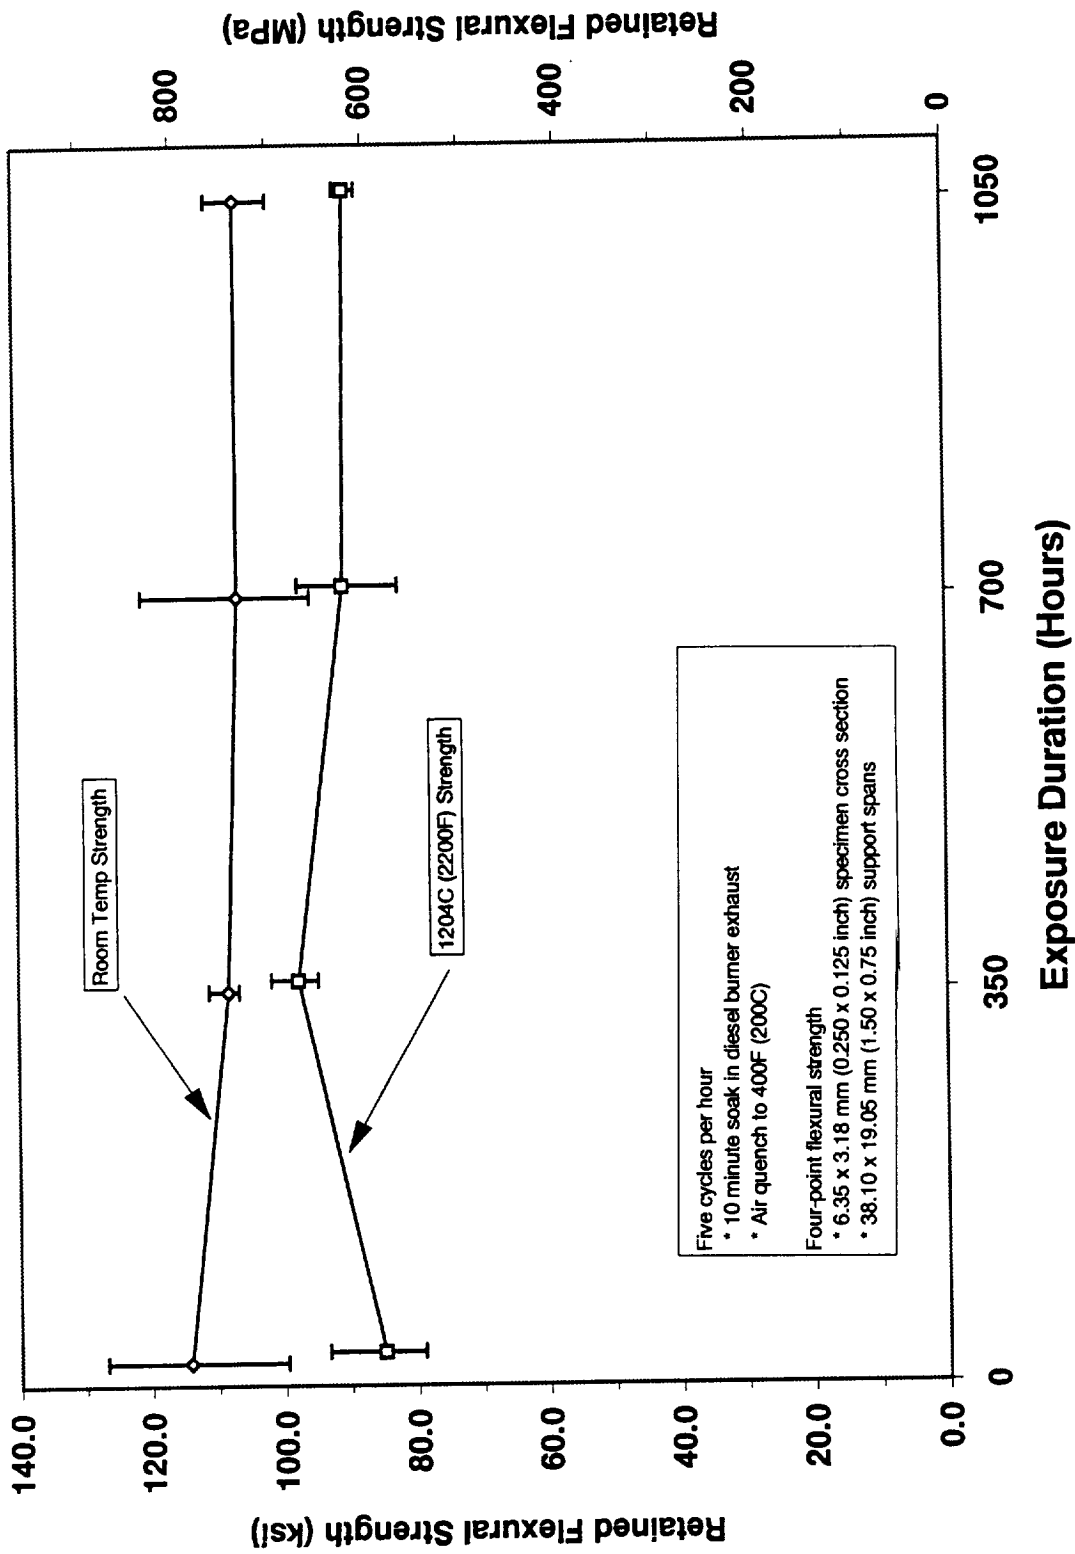
Figure 106. SN-251 Post-Exposure Room-Temperature And 1204C (2200F) Strength Test Results Following 1204C (2200F) Cyclic Oxidation Durability Testing.

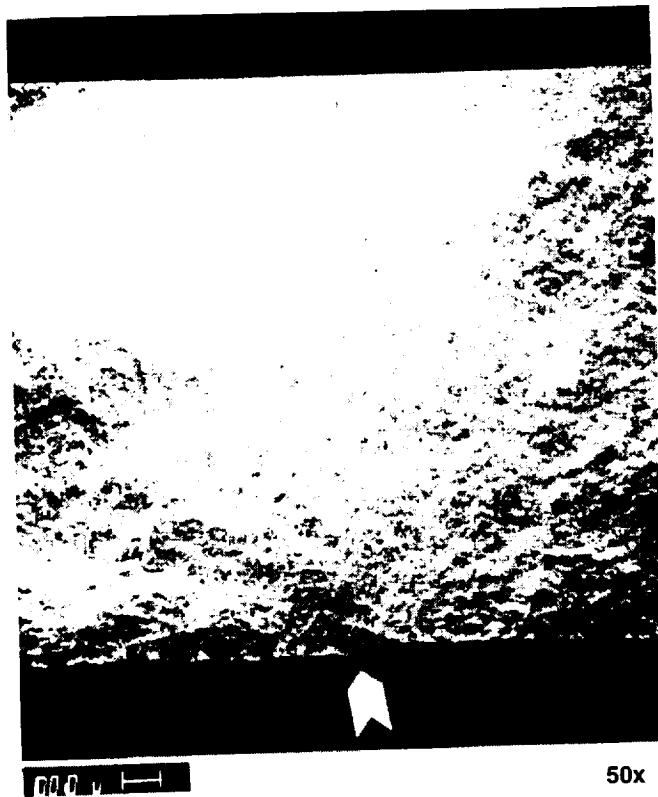
G6253-122

Figure 122. Typical SN-260 Baseline Specimen Failure Originating From Pit In As-Processed Surface.

The average baseline SN-260 room-temperature flexure strength was 94.1 ksi, with a standard deviation of 10.5 ksi, and the 1260C (2300F) flexure strength was 80.7 ksi, with a standard deviation of 11.0 ksi. The majority of the baseline specimen fractures originated from the as-processed surface. Figure 122 shows a typical SN-260 fracture origin at a pit in the as-processed surface. Some failures from internal porosity were also documented (Figure 123).

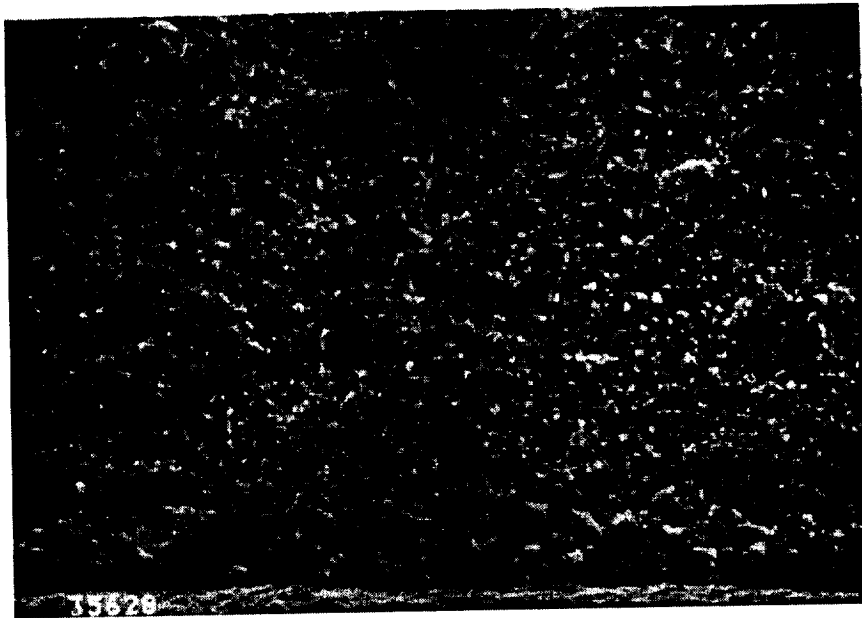
G6253-128

Figure 128. SN-281 Baseline Test Specimen Failure Originating From As-Processed Surface.

The average baseline room-temperature flexure strength was 104.5 ksi, with a standard deviation of 6.8 ksi, and the 1316C (2400F) flexure strength was 85.4 ksi, with a standard deviation of 2.8 ksi. All baseline SN-281 specimen fractures originated from the as-processed surface. No pits or other surface anomalies were noted in optical examinations or SEM of the fracture surfaces. Figure 128 illustrates a typical SN-281 specimen fracture originating from the as-processed surface. A single specimen exhibited a stringer-like inclusion in the vicinity of a surface failure origin. Wavelength-dispersive X-ray (WDX) analysis revealed the stringer was a concentration of sintering additive (Figure 129).

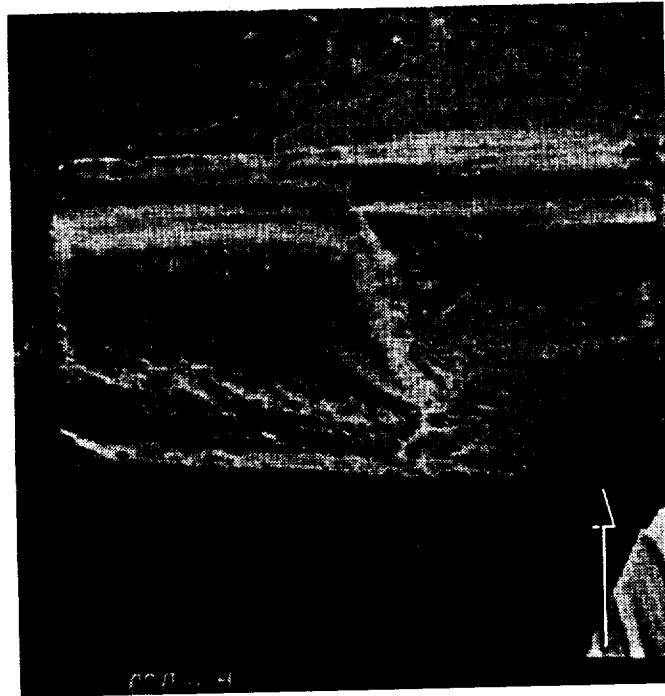
G6253-149

Figure 149. SN-84 Specimen Failure Originating From Oxidation Pit Following 700 Hours Exposure At 1204C (2200F).

The NGK SN-84 specimens initially exhibited large losses in strength during the first 350 hours of exposure. After 350 hours of exposure, the SN-84 specimens had lost 56 percent and 47 percent of the pre-exposure baseline room-temperature and 1204C (2200F) strength, respectively. With continued exposure, SN-84 exhibited less changes in post-exposure strength at both room and elevated temperature. After 1050 hours of exposure, the SN-84 room-temperature strength dropped a total of 64 percent, from 139.7 ksi to 50.8 ksi, and the 1204C (2200F) strength dropped 41 percent, from 134.5 ksi to 79.1 ksi. All of the post-exposure specimen failures originated from oxidation pits beneath the rough oxide layer formed during exposure. Typical post-exposure fracture-originating flaws for SN-84 are shown in Figures 149 and 150.

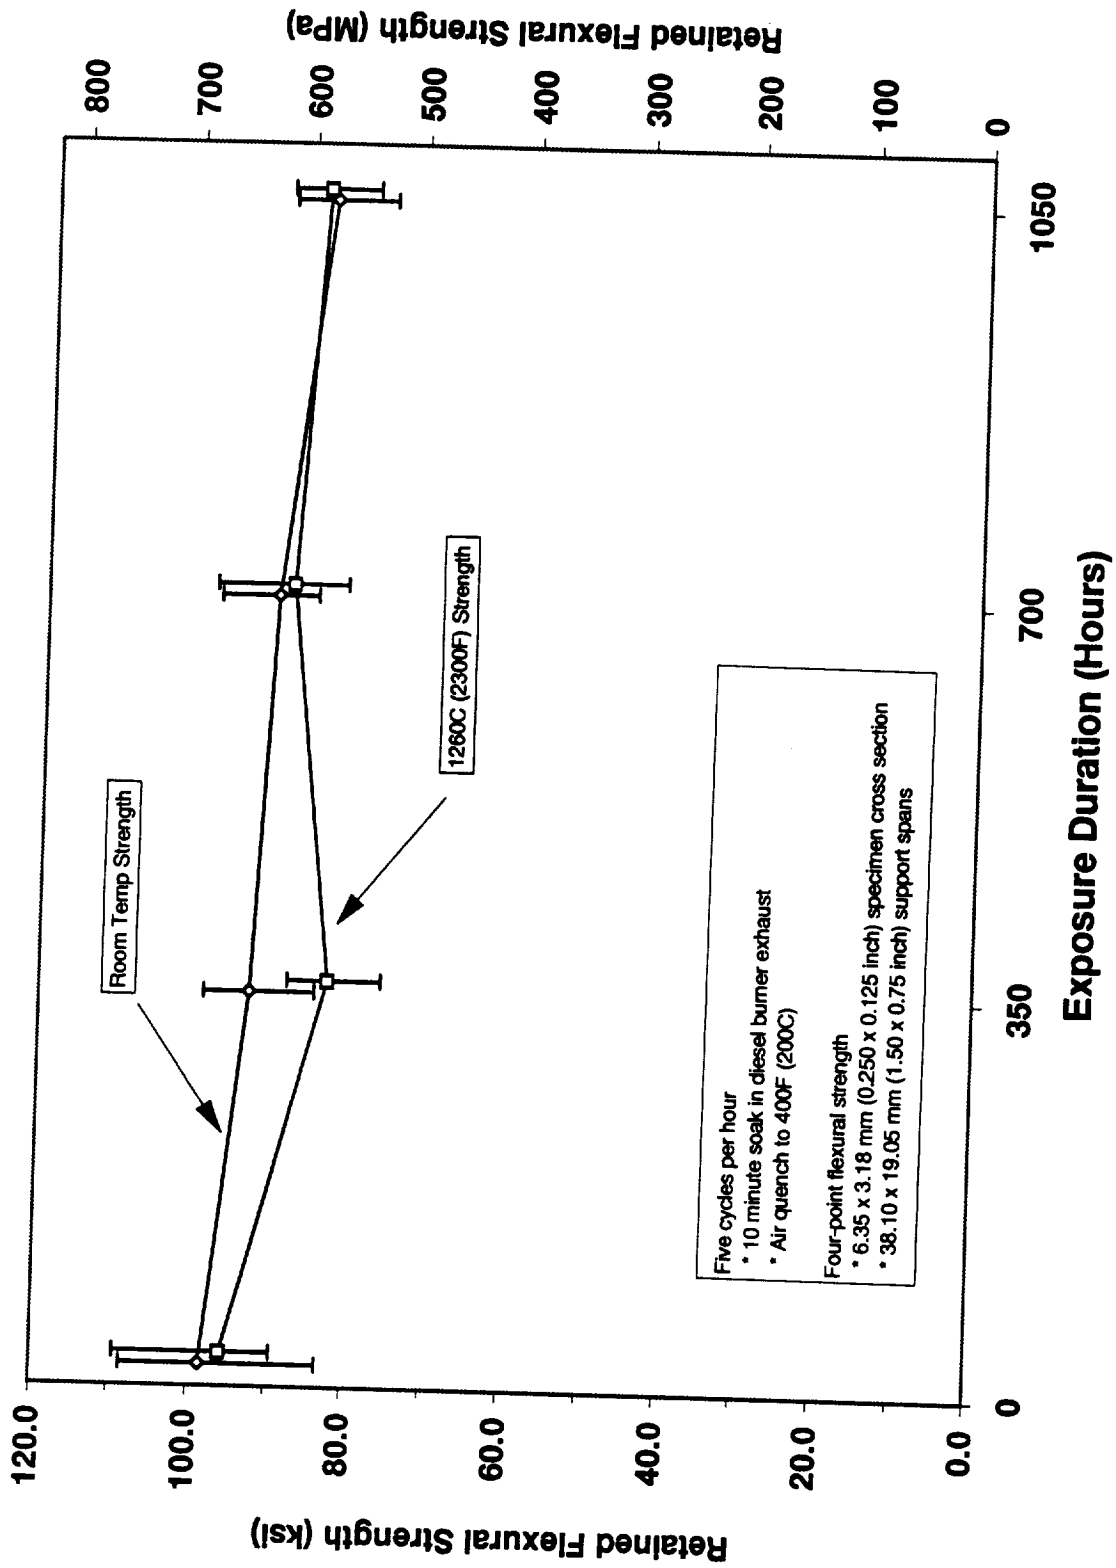
Figure 155. SN-88 Post-Exposure Room-Temperature And 1260C (2300F) Strength Test Results Following 1260C (2300F) Cyclic Oxidation Durability Testing.

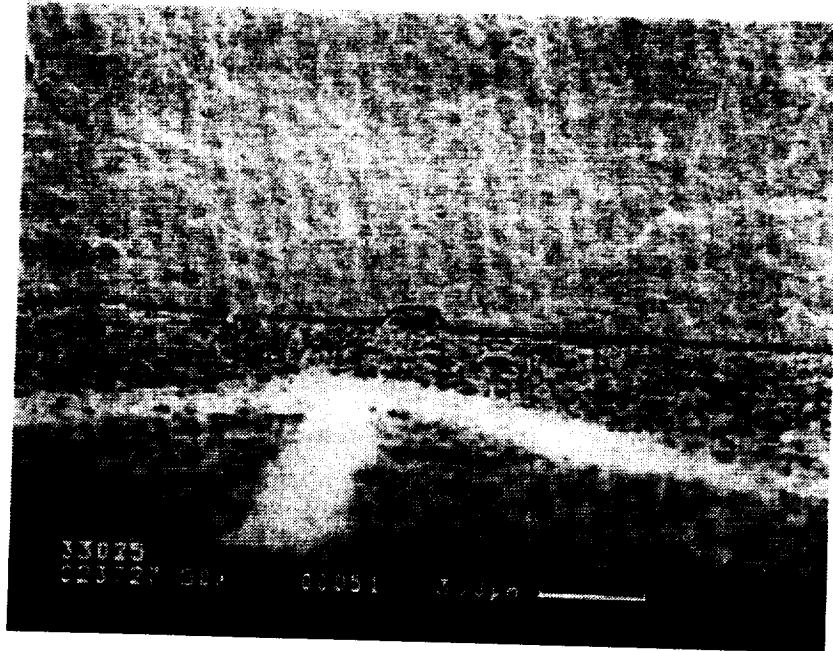
G6253-156

Figure 156. SN-88 Fracture Origin At Acicular Si_3N_4 Grain Intersecting The Surface Following 350 Hours Exposure At 1260C (2300F).

The post-exposure SN-88 specimen fracture origins were located predominately at the flame-exposed surface. For short exposure times, the fractures originated from the oxidized surface or from acicular silicon nitride grains (Figure 156). After longer exposure times, the predominate fracture-originating flaw types were pits in the flame-exposed surface (Figure 157). A few internal failure origins at silicon nitride grains were noted in 1260C (2300F) flexural test specimens with longer exposure times (Figure 158).

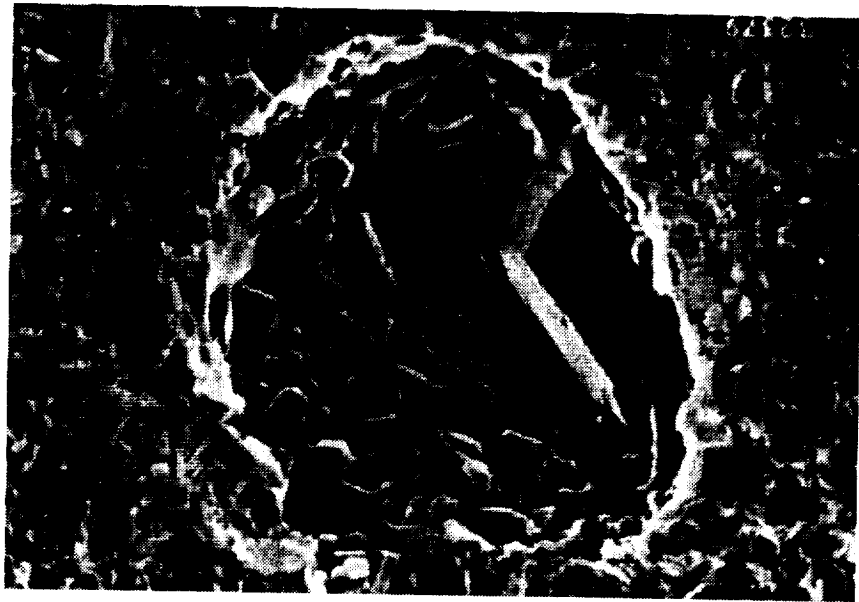
G6253-190

Figure 190. NT-230 Baseline Test Specimen Failure Originating From Surface-Connected Pore.

The baseline flexural strength of the NT-230 specimens was measured at room temperature and 1260C (2300F). The average baseline room-temperature flexure strength was 57.2 ksi, with a standard deviation of 9.6 ksi, and the average strength at 1260C (2300F) was 73.9 ksi, with a standard deviation of 9.8 ksi. The NT-230 specimens exhibited a relatively equal number of surface and internal failure origins in the pre-exposure flexure tests. Both the surface and internal failures originated from pores (Figures 190 and 191).

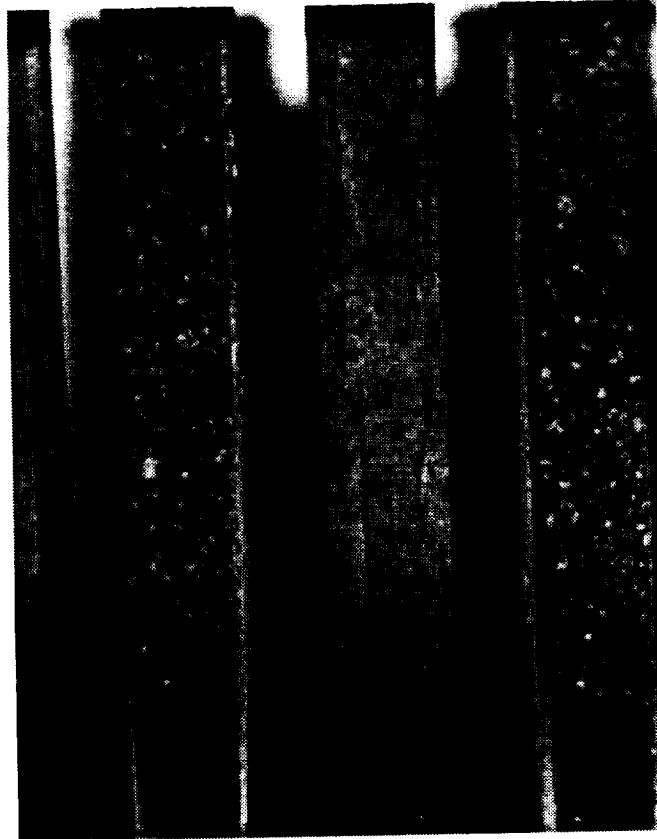
G6253-203

Figure 203. Refel Si-SiC Specimen Surface Topography Following Cyclic Oxidation Durability Exposures At 1204C (2200F): (a) 350 Hours; (b) 1050 Hours.

The typical surface topography of the Refel Si-SiC specimens after 350 hours and 1050 hours of exposure is shown in Figure 203. A dense, coarse surface oxide layer approximately 6 microns thick was present after 350 hours of exposure. The oxide layer roughened and increased in thickness to approximately 10 microns after 1050 hours of exposure.

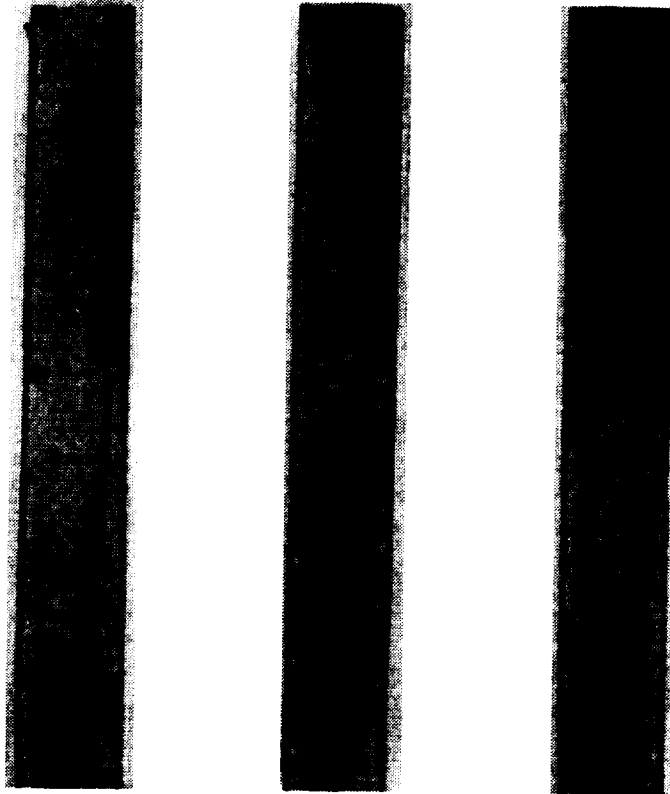
G6253-204

Figure 204. Refel Si-SiC Specimens Exhibited Cracking And Silicon Material Exuding From Exposed Areas Following 168 Hours Exposure At 1371C (2500F).

Cyclic exposure testing of machined-surface Refel Si-SiC specimens was initiated at 1371C (2500F). However, the testing was terminated after 168 hours of exposure, when test bar cracking and silicon material exuding from exposed specimen areas became evident (Figure 204). Static furnace exposure tests were performed to study the degradation of Refel Si-SiC specimens. However, unlike the NCX-34 static furnace tests (see Section 6.24), the cracking problems observed in the cyclic durability tests could not be reproduced in the static furnace environment. These results indicated that the "active" environment conditions in the cyclic durability testing are different and more severe than the conditions in the static furnace test environment. Subsequently, the unused Refel Si-SiC specimens from the 1371C (2500F) testing were used in lower-temperature cyclic oxidation durability tests to determine the maximum use temperature for this material.
