NASA
Technical Memorandum 107439

Thermal Fatigue Testing of ZrO_2 - Y_2O_3 Thermal Barrier Coating Systems Using a High Power CO_2 Laser

Dongming Zhu and Robert A. Miller
*Lewis Research Center
Cleveland, Ohio*

THERMAL FATIGUE TESTING OF ZrO₂-Y₂O₃ THERMAL BARRIER COATING SYSTEMS USING A HIGH POWER CO₂ LASER

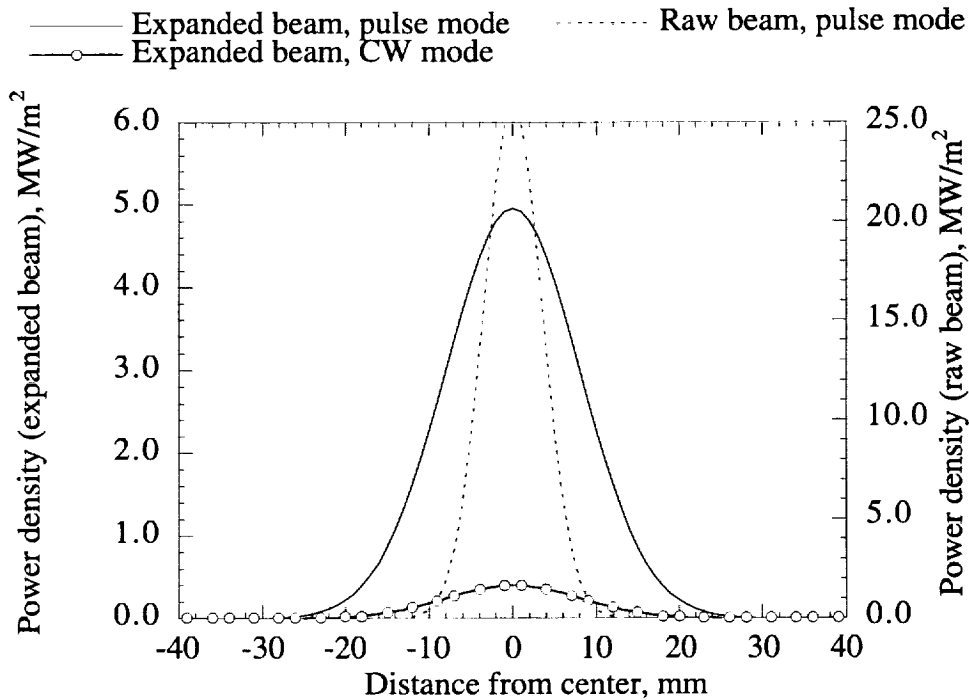
Fig. 1 Laser power density distributions estimated from the measured laser waveform and total power output [11]. The peak power density from the pulsed laser beam at the beam center is 4.95 MW/m², corresponding to the average or equivalent CW laser power density 0.323 MW/m². Minor beam non-uniformity observed is neglected.

Low cycle and high cycle fatigue tests under simulated engine temperature and thermal stress conditions were conducted using a high power 1.5 KW CO₂ laser (EVERLASE, Coherent General Inc., Massachusetts). This test rig was controlled by a PC programmed to simulate different LCF and HCF temperature cycles. The pulsed laser mode for combined LCF and HCF tests, and the continuous wave (CW) mode for pure LCF tests, were used to generate the heating and cooling cycles. The specimen and experimental conditions for LCF and HCF tests are summarized in Table 1. In order to produce a spread beam with lower power density suitable for simulating diesel engine conditions, a Plano Concave ZeSe lens with focal length -330 mm was used. The specimen was placed at a distance 460 mm from the magnifying lens, the beam radius was increased from 7 mm to about 16 mm ^[11]. Because of the expanded Gaussian laser beam used, laser power density is expected to vary across the beam diameter. This beam profile can provide additional information on coating failure mechanisms associated with heat flux distributions. Laser power density distributions under test conditions are shown in Figure 1.

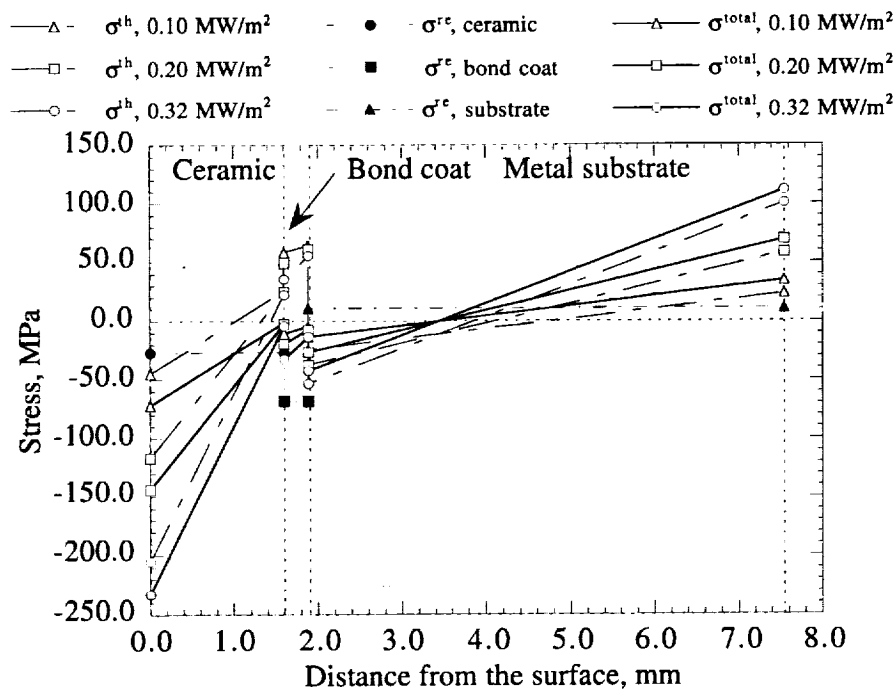
Fig. 3 Stress distributions in a thermal barrier coating system on an angle iron at steady state heating for various heat fluxes (LCF or HCF conditions). σ^{th} , σ^{re} and σ^{total} are thermal stresses, residual stresses and total stresses in the coating system, respectively.

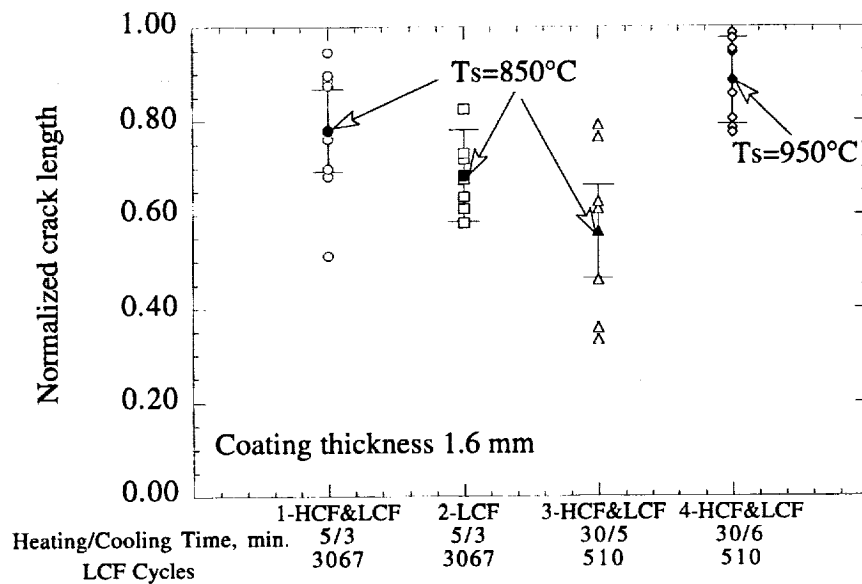
Fig. 9 Thermal fatigue crack lengths measured in thermal barrier coatings after laser LCF and HCF testing. Experimental data with Bonferroni multiple range analysis (95% confidence), significant difference detected between tests 1 and 3, 2 and 4, and 3 and 4. Total heating time 256 hours, total HCF cycles 10 million for combined LCF and HCF tests.

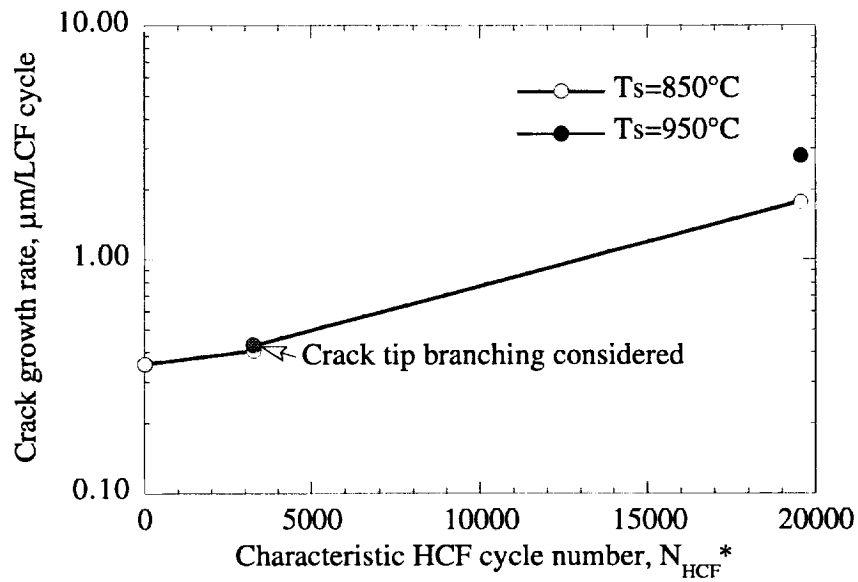
Fig. 10 Fatigue crack propagation kinetics. Ceramic coating thickness 1.6 mm, total heating time 256 hours, and total HCF cycles 10 million for combined LCF and HCF tests. (a) The crack length (normalized to coating thickness) as a function of LCF cycle number; and (b) Crack growth rate as a function of characteristic HCF cycle number, N_{HCF}^* .

Surface crack growth rates for the angle iron specimen, under various test conditions, have been determined by measuring various crack lengths observed in single specimens after each test. Statistical analysis has been used to compare these results, as shown in Figure 9. Under the present testing conditions, the total crack length in the ceramic coating system increases with LCF cycle number. Higher surface temperature results in a longer crack length. Even though the differences between the major crack lengths (measured from the primary cracks perpendicular to the coating surface) under HCF and LCF test conditions (No.1 and No.2 tests in Table 1) are not so significant, the HCF component tends to increase the overall coating crack length especially when crack branching is considered. However, from the crack propagation rates plotted in Figure 10, it can be seen that significant LCF and HCF interactions exist during the thermal fatigue tests. The crack tip branching effect in test No.2 has been illustrated in the hatched area in Figure 10 (a). It seems that the fatigue crack growth rate in the ceramic coating strongly depends on the characteristic HCF cycle number, N_{HCF}^* , which is defined as HCF cycle numbers per LCF cycle. From Figure 10 (b), it can be seen that, the crack growth rate is increased from $0.36 \mu\text{m}/\text{LCF}$ cycle for a pure LCF test ($N_{HCF}^*=0$) to $1.8 \mu\text{m}/\text{LCF}$ cycle for a combined LCF and HCF test ($N_{HCF}^*=20,000$), when the maximum surface temperature T_s is 850°C . The crack growth rate is approximately $2.8 \mu\text{m}/\text{LCF}$ cycle when the maximum surface temperature T_s is 950°C .

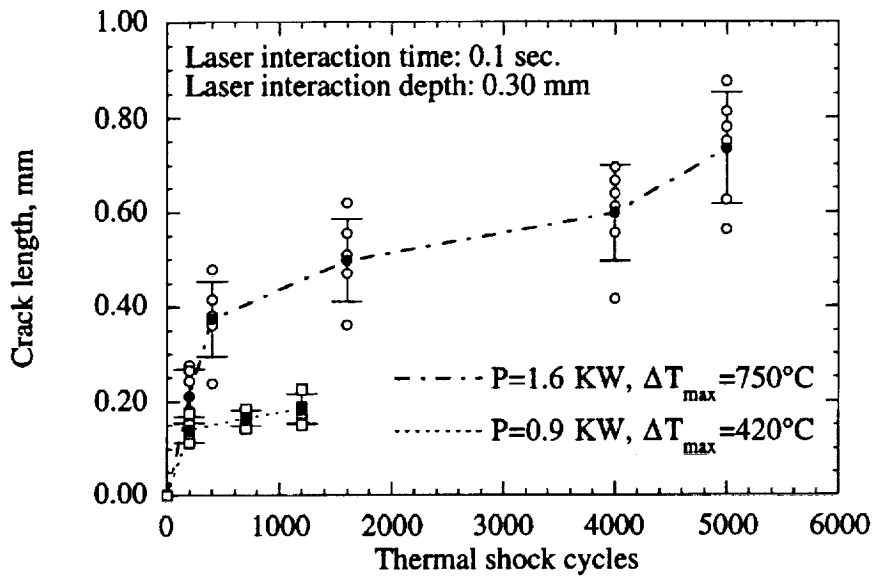
Fig. 11 The crack propagation rates as a function of thermal shock cycles. Ceramic coating thickness 1.0 mm.

Figure 11 illustrates the crack growth kinetics under laser thermal shock conditions. It can be seen that higher temperature swing results in faster crack growth rate. The cracks initiated and extended rapidly during the initial stage, then grew in a much slower rate. Although the thermal loading was acting only on the surface layer, the cracks propagated continuously, deep into the coating. These experiments demonstrate the even shallow surface thermal cyclic loading can cause not only surface crack initiation but also propagation. In fact, some of the cracks have reached near the ceramic/bond coat interface after 5000 cycles, when surface temperature swing was about 700°C. A typical micrograph of a specimen cross-section showing crack morphology induced by thermal shock tests is shown in Figure 12.

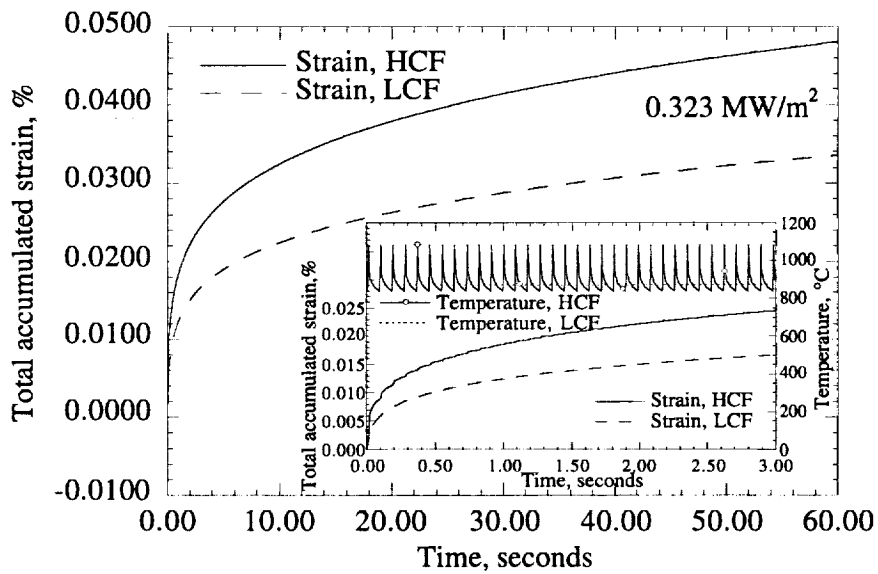
Fig. 14 Predicted instantaneous, incremental creep strains and total accumulated strains under LCF and HCF conditions from the literature reported ceramic creep data showing that HCF component significantly increases the coating creep strains. Heat flux is 0.323 MW/m^2 . The stress exponent $n = 0.48$, time exponent $s = 0.82$ and activation energy $Q = 114 \text{ KJ/mol}$. (a) Instantaneous creep strains; (b) Total accumulated strains.

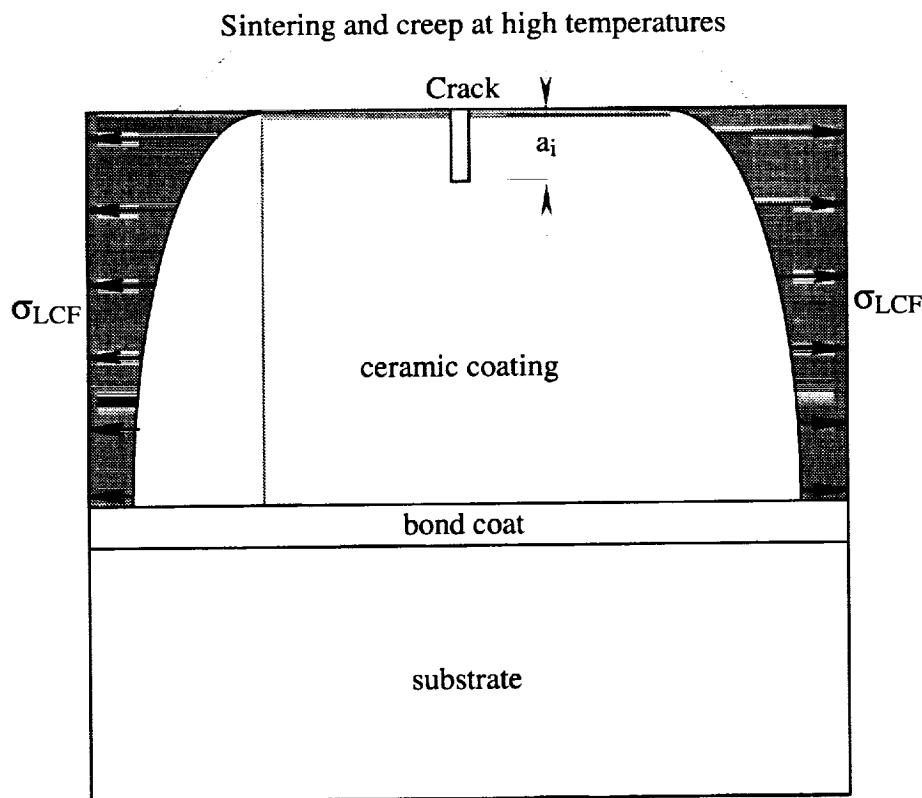
Fig. 16 Ceramic sintering and creep result in non-elastic strains (shown in shadowed area) at temperature, thus generating tensile stresses upon cooling.

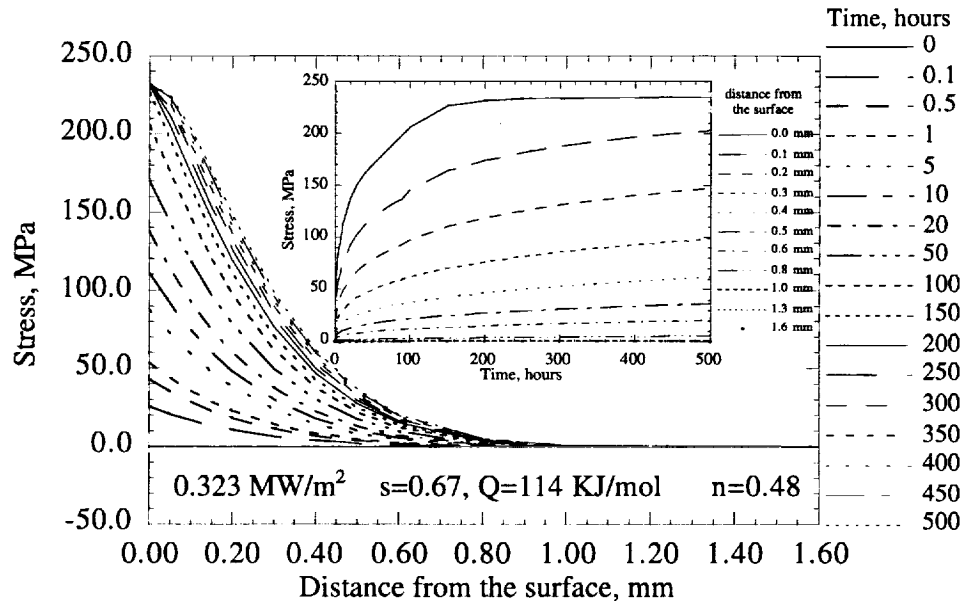
Fig. 17 Tensile stresses are generated in the ceramic coating during cooling as a function of time and coating layer depth. These stresses are considered as a primary mechanism for LCF crack growth.

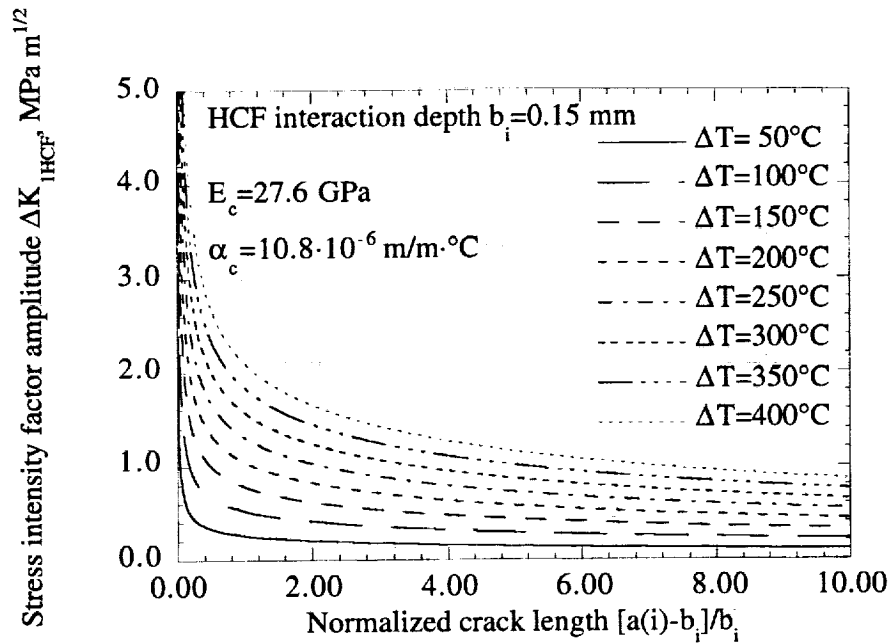
Fig. 20 The relationship between the stress intensity factor amplitude and the temperature swing ΔT as a function of the normalized crack length.

Figures 19-22 illustrate the relationship between the stress intensity factor amplitude and the normalized crack length, with various values of b_i , ΔT , α_c and E_c of the coating. In general, the stress intensity factor induced from the HCF loads has the highest values when the crack is relatively small (the normalized crack length below 1), then decreases as the crack grows and approaches the interface. The HCF damage effect will increase with heat flux (thus with the temperature swing), the thermal expansion coefficient and elastic modulus of the ceramic coating, as well as with the HCF interaction depth. The proposed HCF mechanism is consistent with experimental observations from thermal fatigue tests and thermal shock tests.
