EFFECT OF CURVATURE ON THE IMPACT DAMAGE CHARACTERISTICS AND
RESIDUAL STRENGTH OF COMPOSITE PLATES

Damodar R. Ambur and James H. Starnes, Jr.
NASA Langley Research Center
Hampton, VA

Presented at the 39th AIAA/ASME/ASCE/AHS/ASC Structures,
Structural Dynamics, and Materials Conference

AIAA Paper No. 98-1881

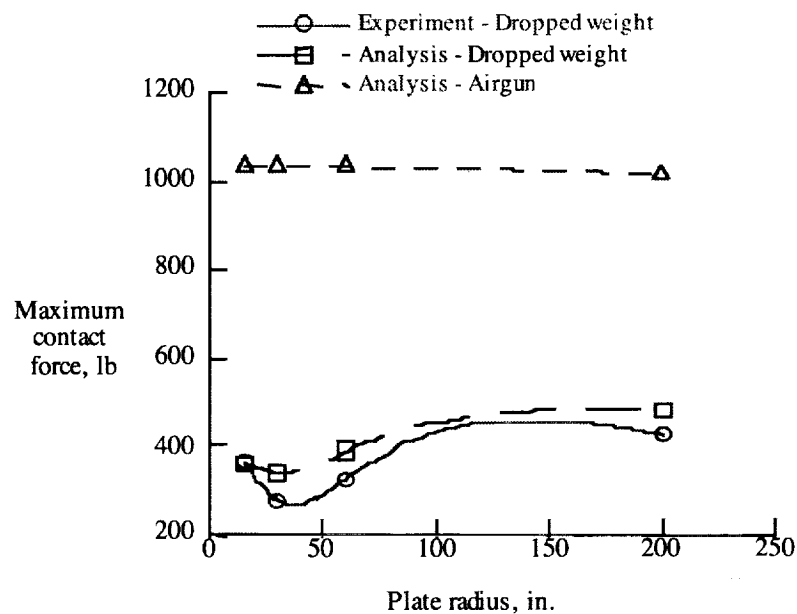
Figure 1. Contact force results for 16-ply-thick, quasi-isotropic plates impacted by dropped weights and airgun propelled impactors with 1.5 ft-lbs of impact energy.

The maximum values of the contact forces measured by the instrumented dropped-weight test apparatus are shown in Fig. 1 for 16-ply-thick plates with different radii and impacted with 1.5 ft-lb of impact energy. The experimental results are shown in the figure by the open circles and the corresponding analysis results from the analysis of reference 8 are shown by the open squares. The flat plate results are presented in this figure against a plate radius of 200 inches. These results indicate that the value of the contact force decreases significantly for radii between 15 and 60 inches, and then increases to a value that closely corresponds to the flat-plate contact-force result for radii greater than 60 inches. These results suggest that the curved plates have a nonlinear response for radii less than 60 inches. These experimental and analytical contact-force results for dropped weights compare well. Analytical results from the analysis of reference 8 are shown in the figure by the open triangles for the airgun-propelled impactors with 1.5 ft-lb of impact energy level. The magnitudes of these contact forces are significantly greater than the contact forces for the dropped weights, and the radius of the plate has an

insignificant influence on the value of the contact forces. Apparently, the high-speed transient nature of the airgun impact event results in a very local response of the plate which does not affect the value of the contact forces for the plates considered in this study.

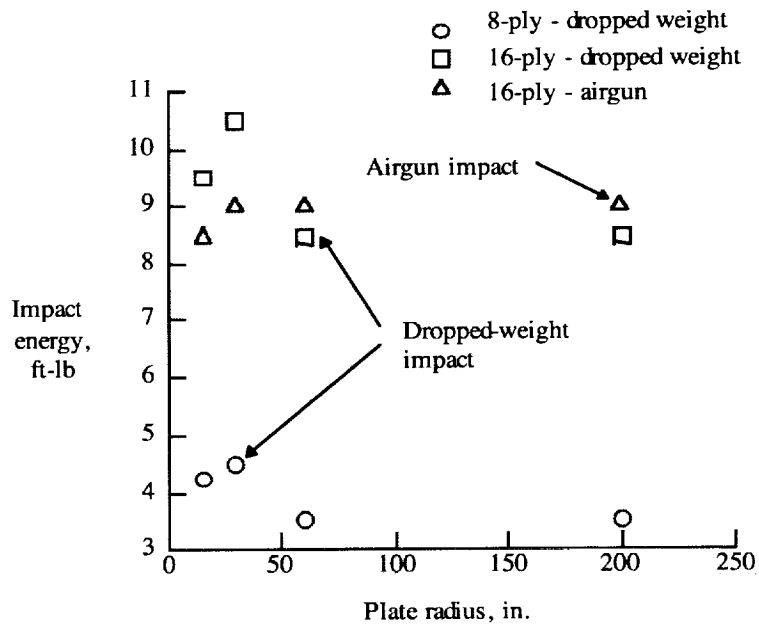
Figure 5. Dropped-weight and airgun impact-energy levels for barely visible impact damage in 8- and 16-ply-thick quasi-isotropic plates with different radii.

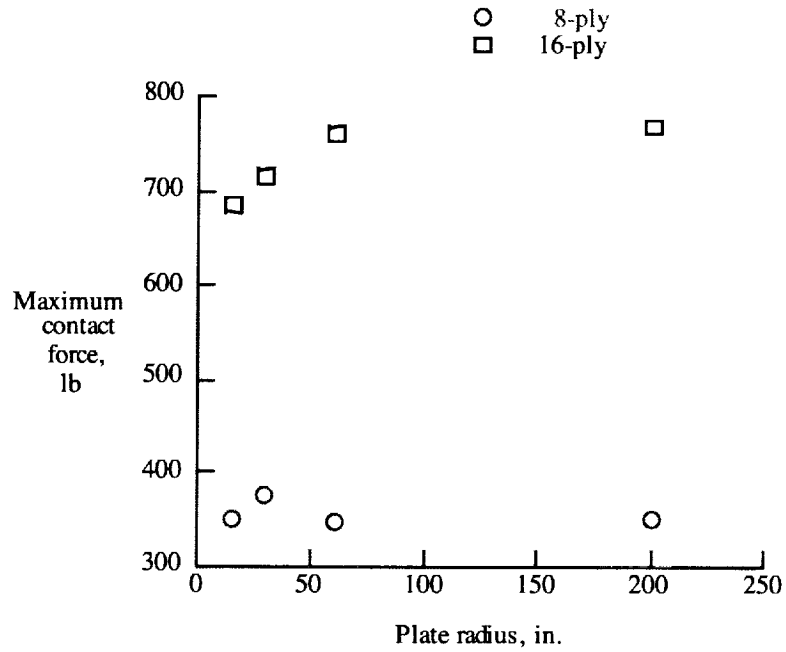
Figure 6. Maximum contact force magnitudes for dropped-weight impact-energy levels for barely visible impact damage in 8- and 16-ply-thick quasi-isotropic curved plates with different radii.

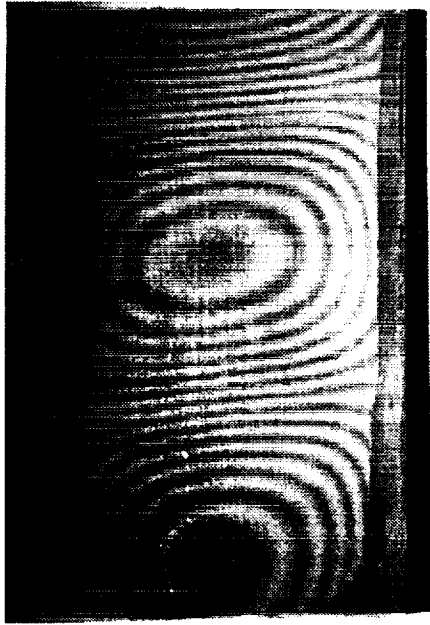
a. Buckling pattern with three half-waves

b. Off-center panel failure

Failure location

Figure 10. Out-of-plane displacement contours for a compression-loaded 16-ply-thick undamaged 15-in. radius curved plate.

Typical out-of-plane displacement results for an undamaged 15-in.-radius plate loaded in compression are shown in Fig. 10. The curved plate has a buckling mode with three-half waves along the length as shown in Fig. 10(a). Failure of the specimen occurred at a location that is approximately 40 percent along the length of the plate as shown in Fig. 10(b). The recorded failure load is 10.51 kips. The response of a damaged 15-in.-radius plate for an applied compression load is shown in Fig. 11. Local out-of-plane deformations in the vicinity of the impact-damage site are indicated by the moiré fringe pattern as shown in Fig. 11(a), and these deformations are representative of a locally buckled delaminated region. This plate failed at a compression load of 8.98 kips prior to buckling. The failure propagated across the plate at the mid-section as illustrated in Fig. 11(b). The failure load of the damaged 15-in.-radius curved plate is approximately 15 percent less than the failure load of the corresponding damaged flat plate. Residual-strength results for damaged and undamaged 8- and 16-ply-thick cylindrically curved plates are summarized in Fig. 12. These results indicate that the residual strength of these plates is a function of the plate radius. The 15-in.-radius plates have the most severe reduction in residual strength relative to the flat plates. The results for the 16-ply-thick curved plates indicate that the plates with radii between 30.0 and 60.0 inches have higher failure loads than the flat plates, and the plates with radii approaching 15.0 inches have lower failure loads than the flat plates.

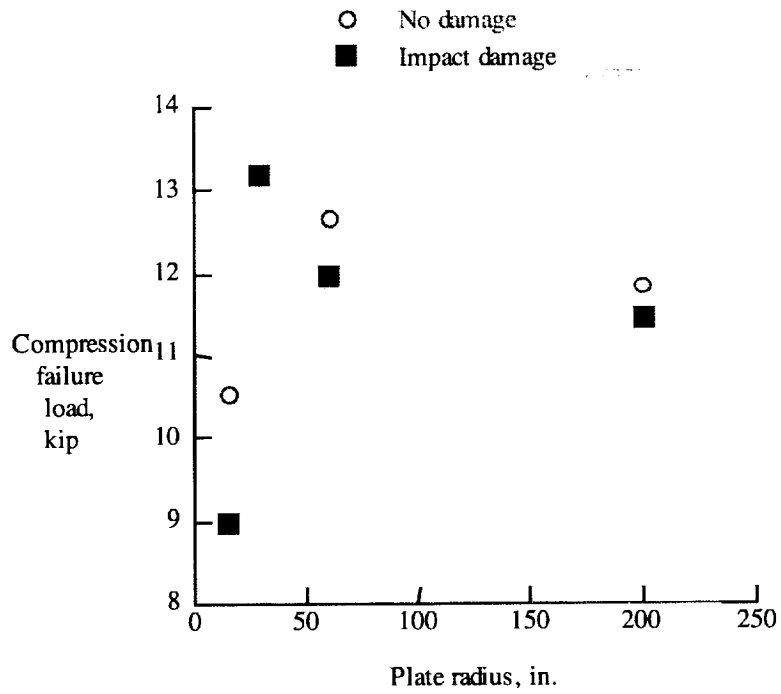
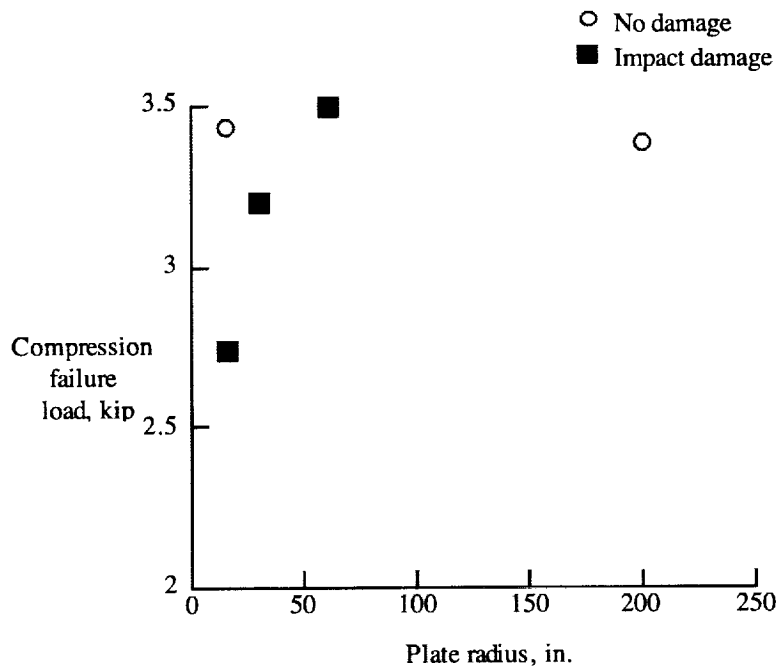
a. 16-ply-thick curved plates

b. 8-ply-thick curved plates

Figure 12. Summary of residual strength results for curved plates with different radii.

The compression-after-impact residual-strength results for flat and curved 8- and 16-ply-thick plates suggest that these results are also a function of the plate radius. The residual strength of flat and 15-in.-radius curved plates with barely visible impact damage is approximately 3 and 15 percent less than the failure load for the corresponding undamaged plates, respectively. These results suggest that radius of curvature is an important structural parameter that must be considered when determining the damage-tolerance characteristics of thin, cylindrically curved, composite plates.
