## FINAL REPORT FOR ETP-0403, RESIDUAL STRESS MEASUREMENTS AFTER PROOF AND FLIGHT

NASA/CR- -97- 208242

November 24, 1997  
E611-FY98-242

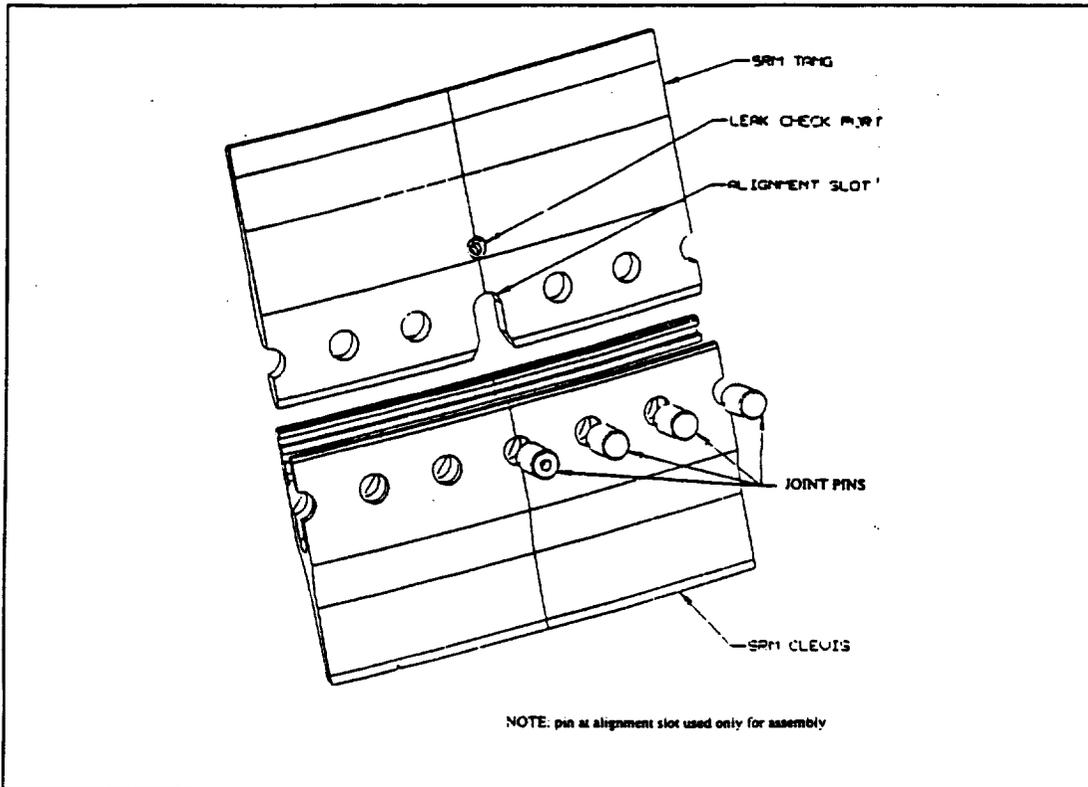
Figure 1 Configuration of Factory Joint Alignment Slot Region

Figures 1 and 2 show the general configurations the alignment slot and stiffener stub features of a stiffener segment.

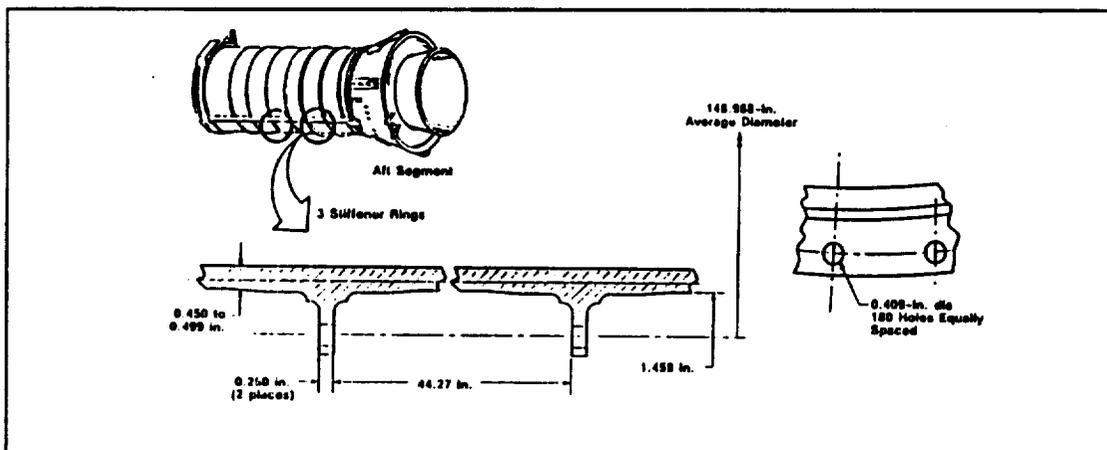
Figure 2 Configuration of Case Stiffener Stubs

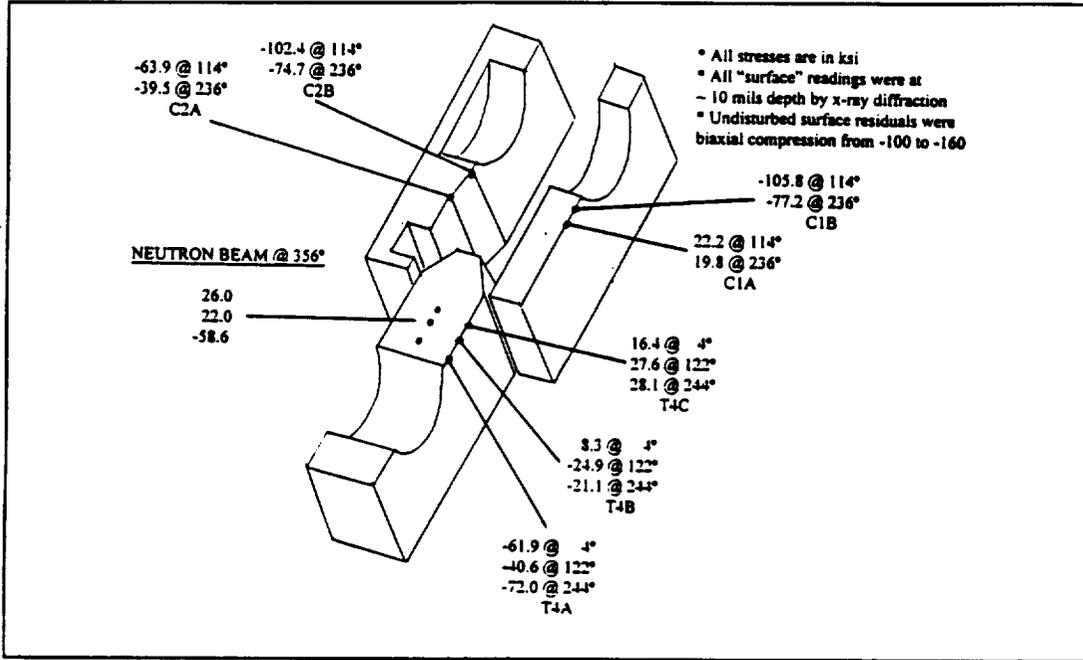
Figure 3 Summary of Hoop Residual Stresses on Factory Joint Features

All test objectives were met. There were no abnormal occurrences or adverse findings. Figures 3 and 4 summarize the residual stress results obtained from the x-ray diffraction evaluations. Although the lightweight stiffener S/N L023 test article had seen two flight uses, the effects of water impact and recovery were found to be minimal. The primary effects represented in the residual stresses retained in the test pieces were from 3 proof tests and 2 refurbishments prior to the DM-8 static firing.

The magnitudes of the surface compressive stresses found were generally in the range of 100 to 150 ksi at all points evaluated. They decreased rapidly with depth from the surface, extending inward less than 10 mils. The combination of x-ray diffraction and material removal was not precise enough to estimate the actual depth of this effect. These surface compressive stresses are most likely to be the result of the shot-peening effect from cleaning using glass bead blasting.

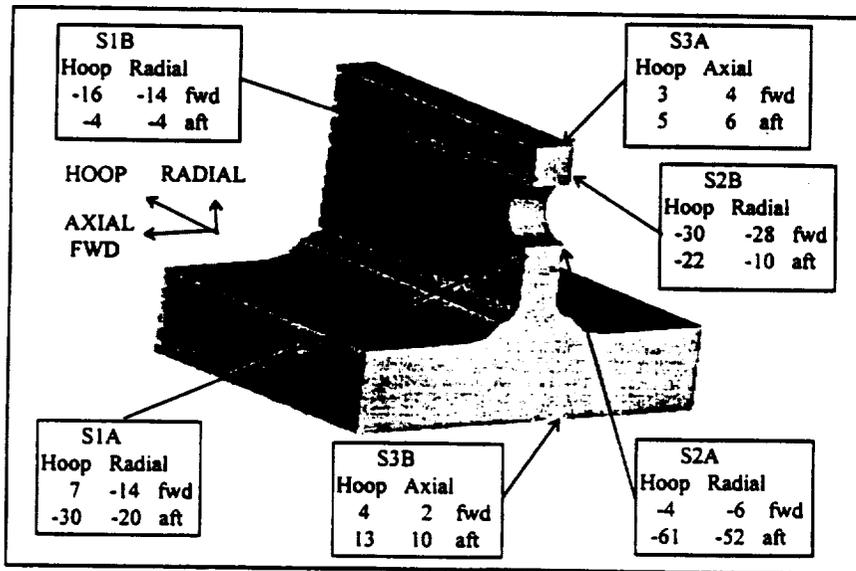
Figure 4 Summary of Residual Stresses on Stiffener Stubs

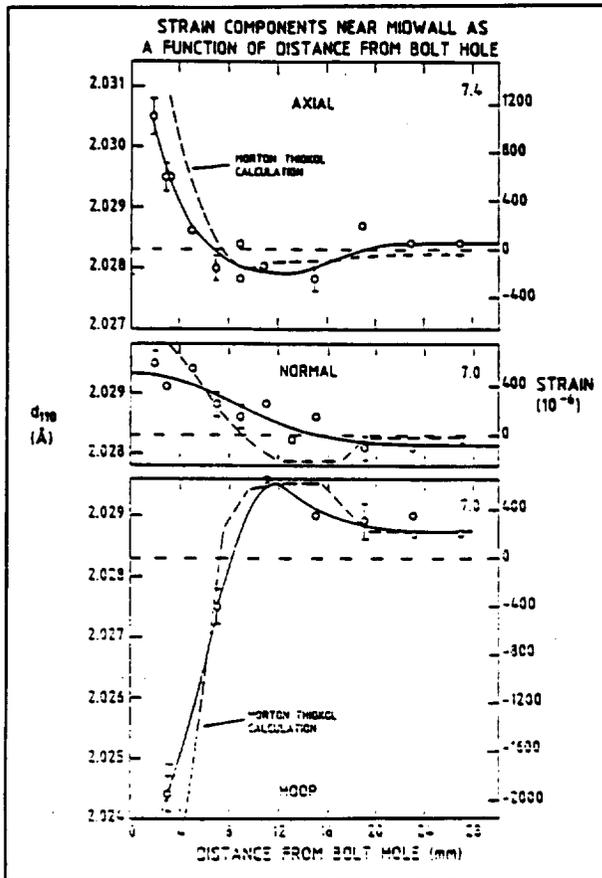
The neutron beam diffraction investigation of a 4" hole on the Tang-000 specimen succeeded in evaluating the in-depth residual stresses between the edge of the pin hole and the tip of the tang. These are considered to be representative of the in-depth residual stresses produced by three proof tests. Measurements were made of the tang radial, hoop, and axial residual strains at 57 interior points. No material removal was needed in this process. Each of these points were used to compare the patterns of residual strain variation between the experimental and analytical distributions. There was reasonably good agreement. In most cases the values computed from the finite element model were found to lie within the error band of the experimental data. This level of agreement is about as good as can be expected with the differences that exist between actual hardware (properties, geometry, and loading) and the worst case conditions assumed in the finite element analysis [4]. Figure 5 shows the level of agreement between measured and analytical estimates of residual strains with a graph of the values along the mid-thickness line between the pin hole and the tip of the tang.

Figure 5 Comparison of Neutron Beam Measured and Analytical Residual Strains

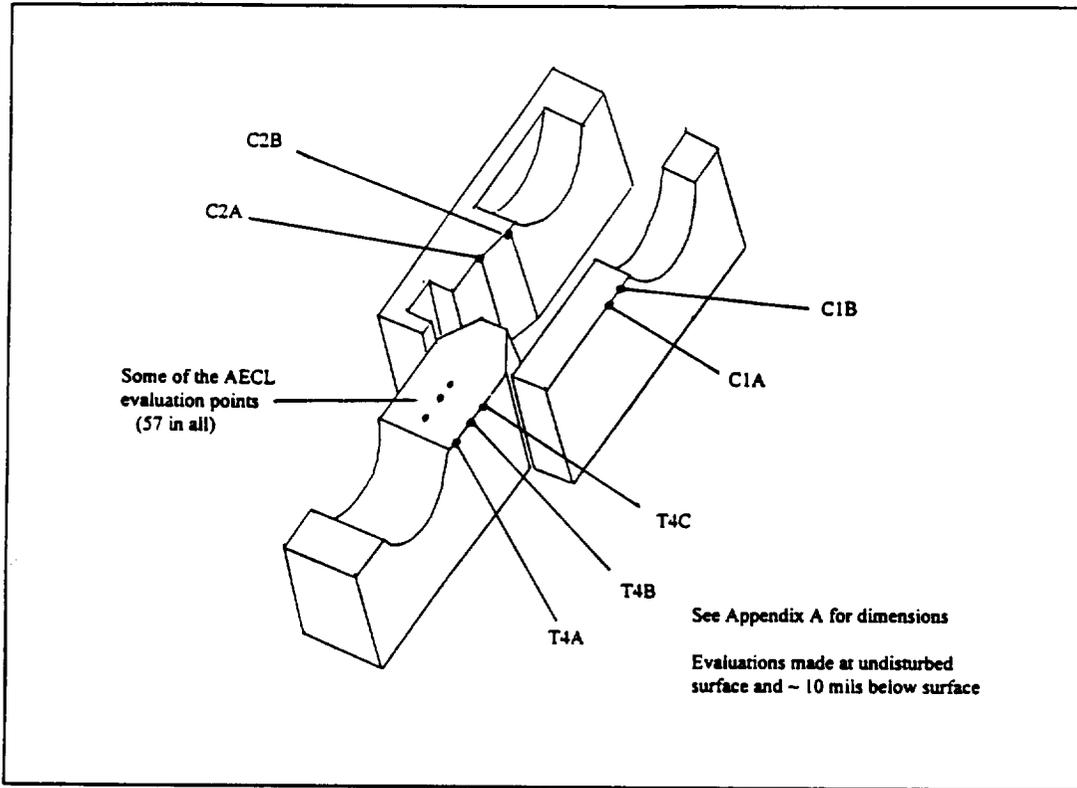
Figure 6 Tang and Clevis Measurement Locations

X-ray diffraction measurements were taken before and after local material removal by electropolishing (etching). The depth of the material removed at each evaluation point was intended to be about 5 mils. This depth was selected to investigate the residual stresses that could exist at the depth of a surface crack that may not be detected. Table 1 lists the sequence of steps used in the test measurements at the points shown in Figures 6-8.

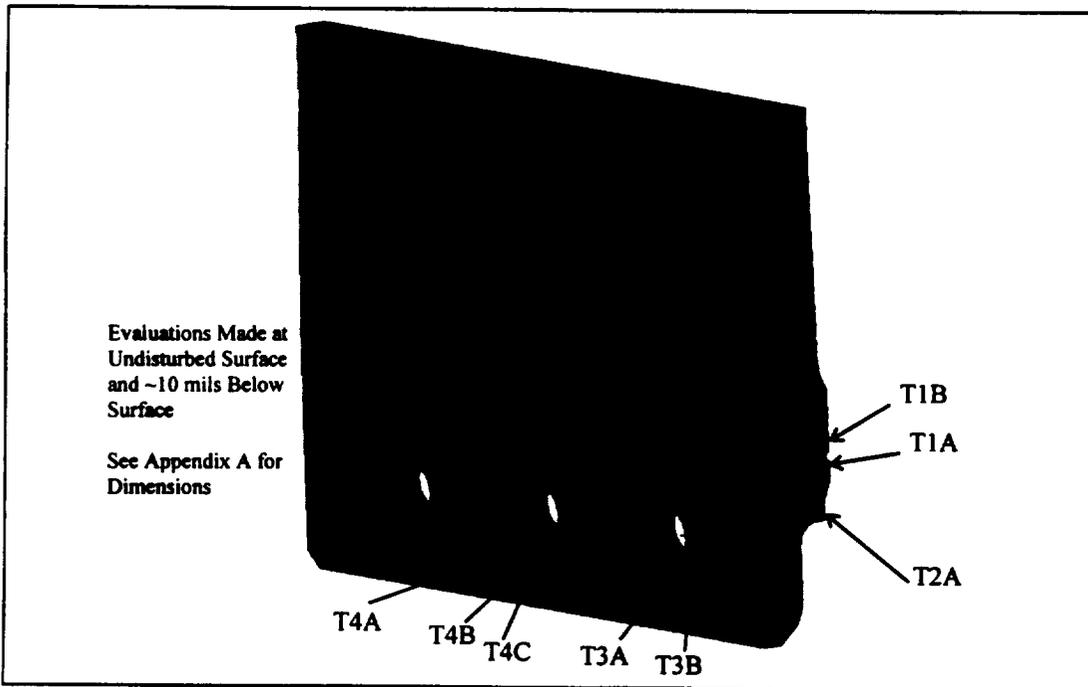
Figure 7 X-ray Diffraction Evaluation Points for Tang Specimens

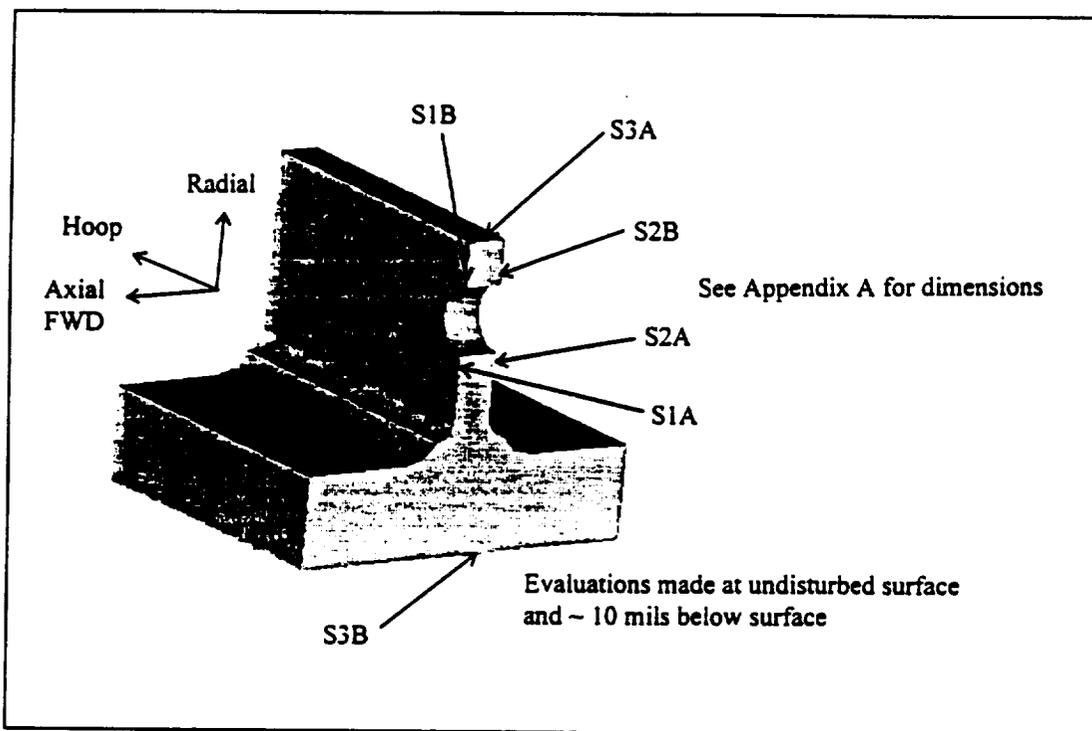
Figure 8 X-ray Diffraction Evaluation Points For Stiffener Stubs

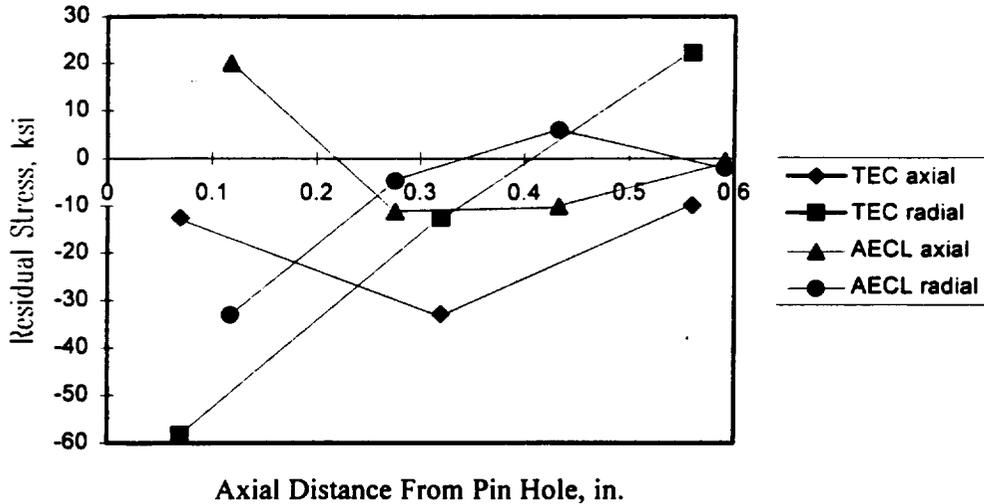
Figure 9 Comparative Measurement Trends

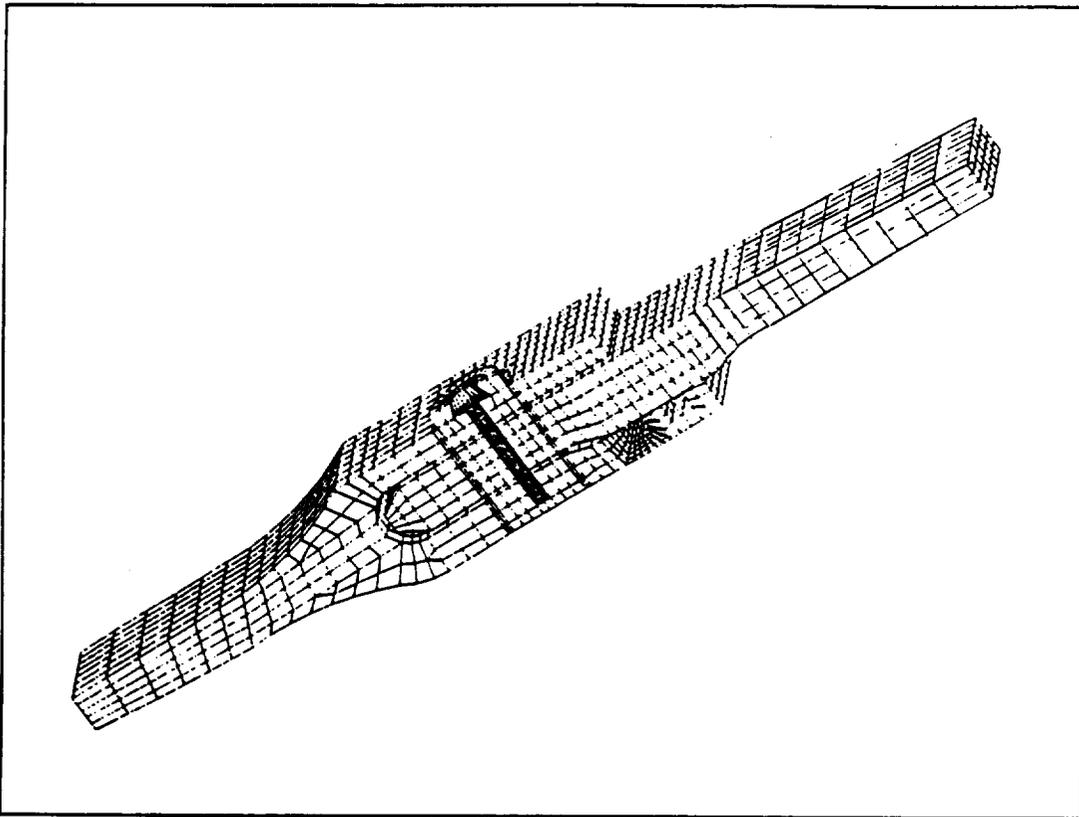
Figure 10 Finite Element Model of Typical Factory Joint Pin Locations

An overview of the nonlinear stress analysis results for the case factory joint is given in Figures 10-13. They are based on computer runs reported in Reference 4. These are the analyses used in the results comparisons reported in Appendix B. The analysis of the factory joint was done for a generic pin location subjected to a pressure of 1070 psig. This is significantly higher than the maximum expected operating pressure (MEOP). The pressures imposed in flight and static firing involving this stiffener segment were considerably lower than MEOP at the forward case field joint. This is because the gas dynamics of motor operation results in a pressure drop in the aft regions of the motor and MEOP is a statistically conservative number. The proof pressure, on the other hand, is selected to be higher than case MEOP. The peak proof pressure at the time Lightweight Stiffener SN L23 was proof tested and used was 1070 psig. The proof pressure currently imposed on the lightweight stiffener proof tests is 1055+30,-0 psig. Figure 14 gives a qualitative view of the yield zones developed around the pin holes, leak check port, and alignment slot from successive pressurizations. The yielding effects around the pin holes adjacent to the alignment slots (2' holes) are not shown, but they have slightly larger yield zones that are not aligned with the axial direction, but are skewed toward the alignment slot. Figure 15 shows the finite element model use to study the behavior of alignment slot region [5].

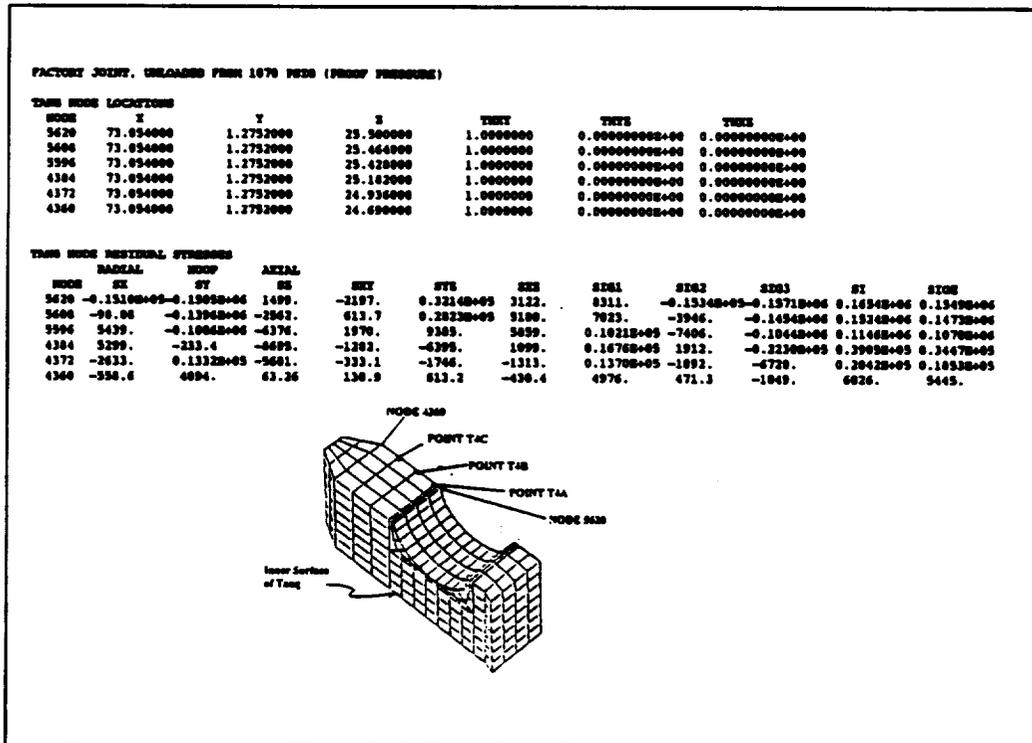
Figure 11 FE Analysis Results for Tang Nodes

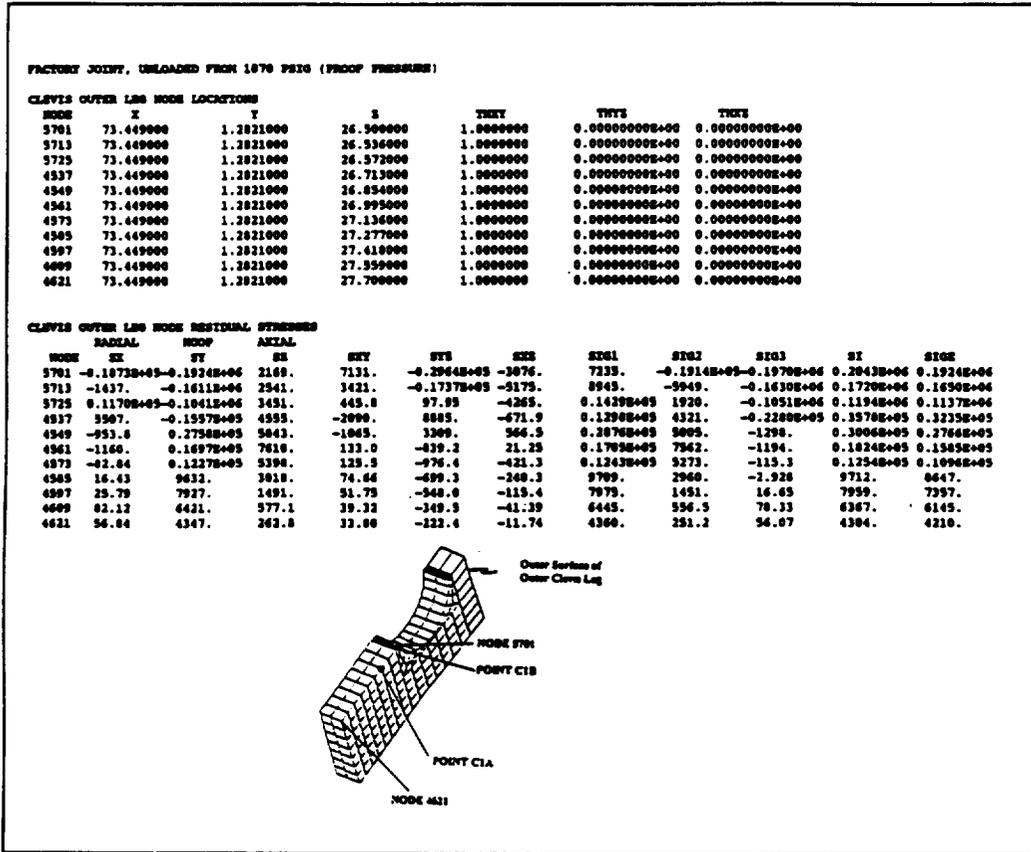
Figure 12 FE Analysis Results for Outer Clevis Leg Nodes

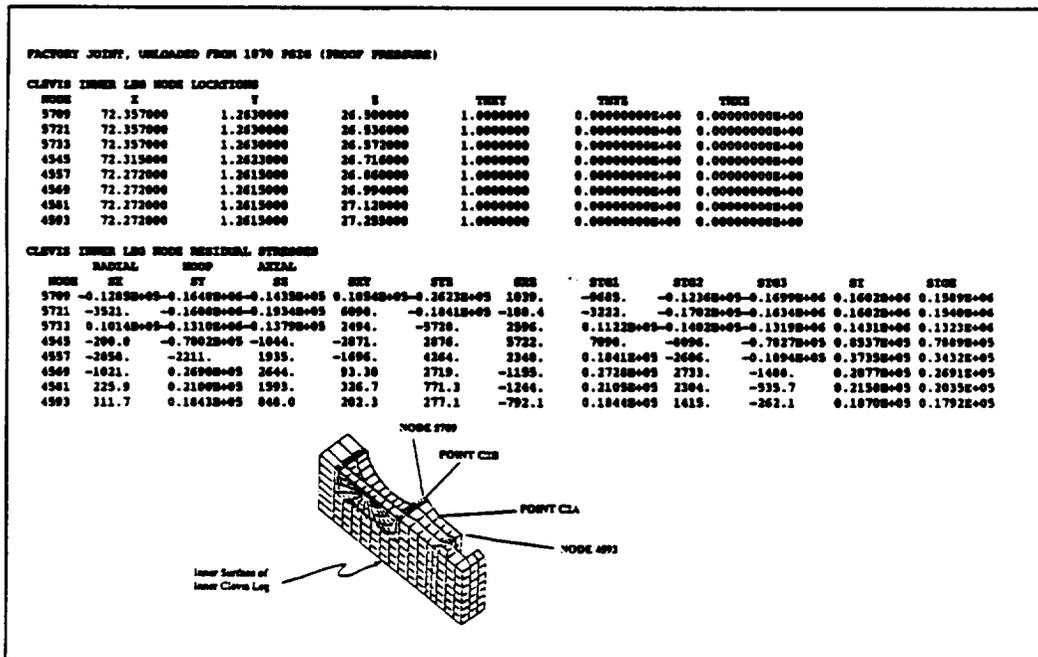
Figure 13 FE Analysis Results for Inner Clevis Leg Nodes

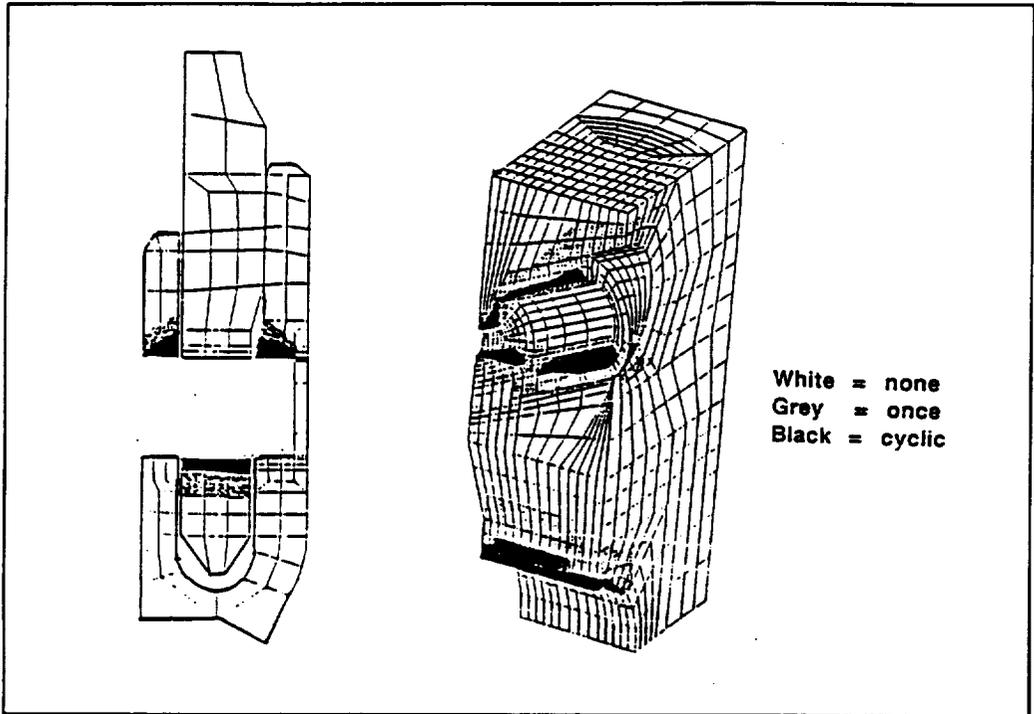
Figure 14 Yield Zones for a Typical Pin Hole and an Alignment Slot

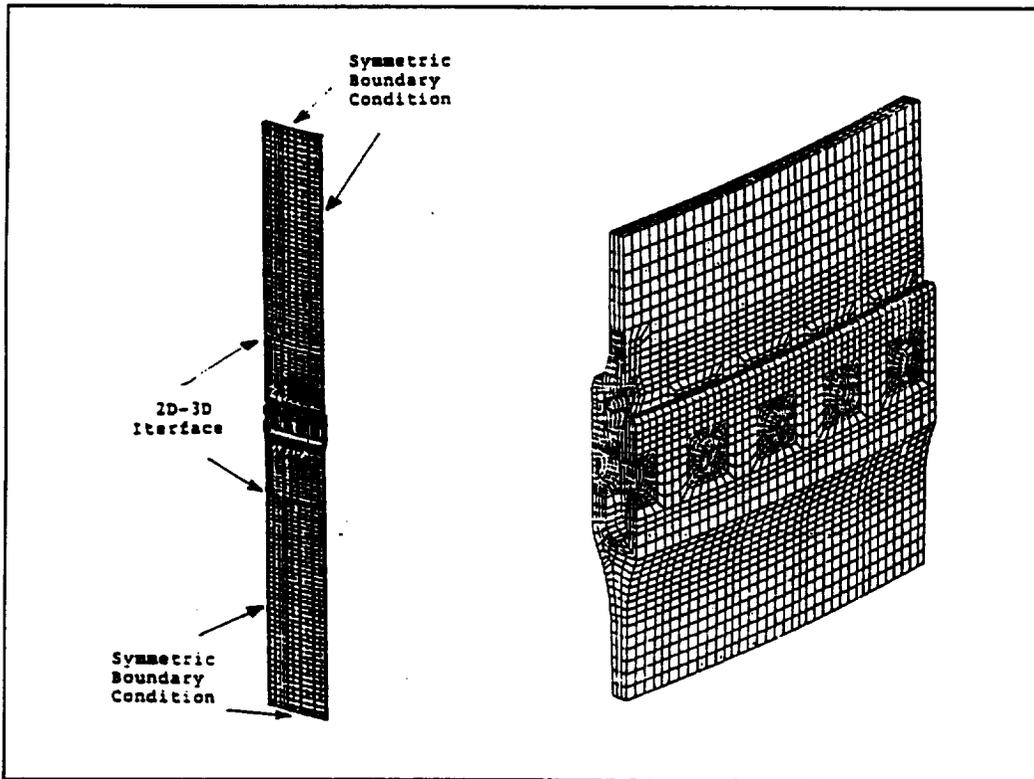
Figure 15 Finite Element Model of the Alignment Slot Zone

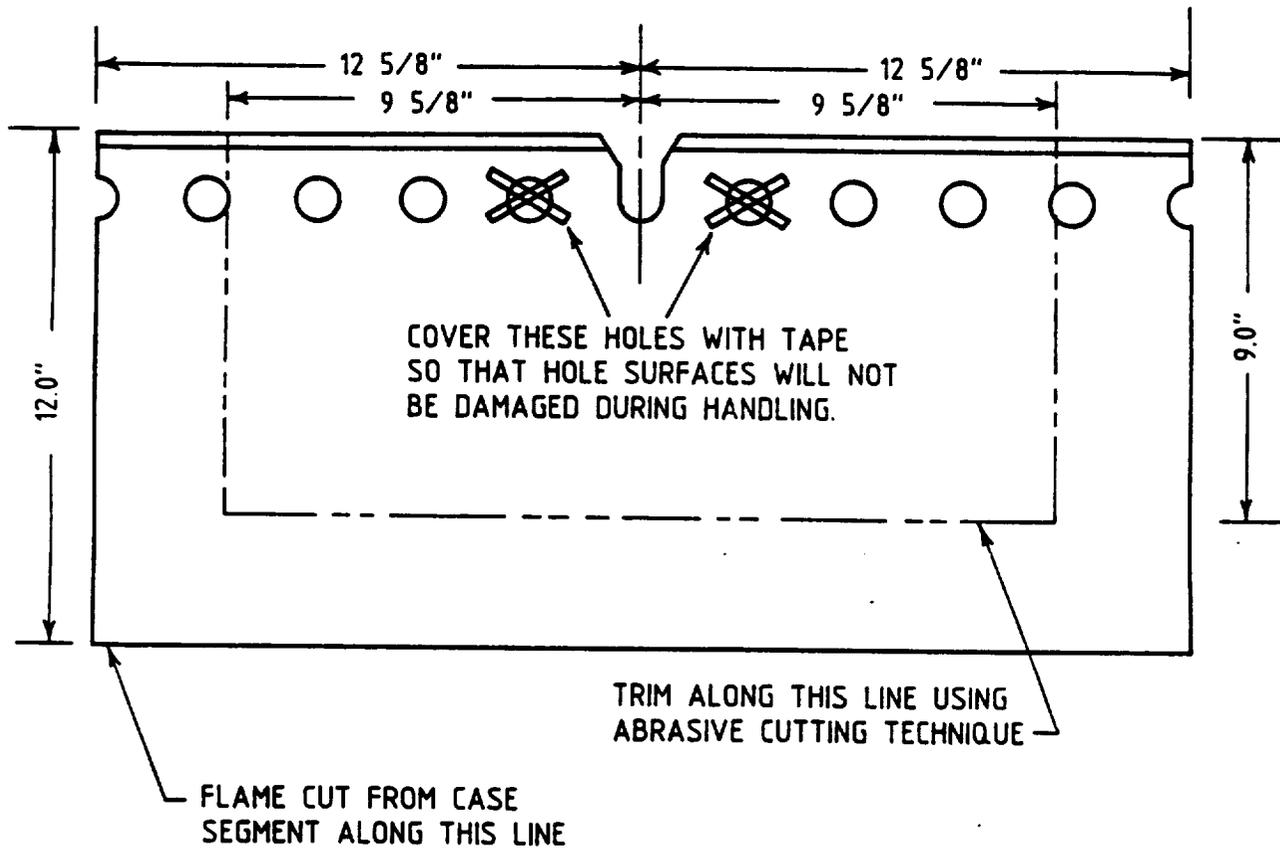
Fig. 1 - Cutting sketch for tang specimens taken from a segment of a solid fuel booster rocket.

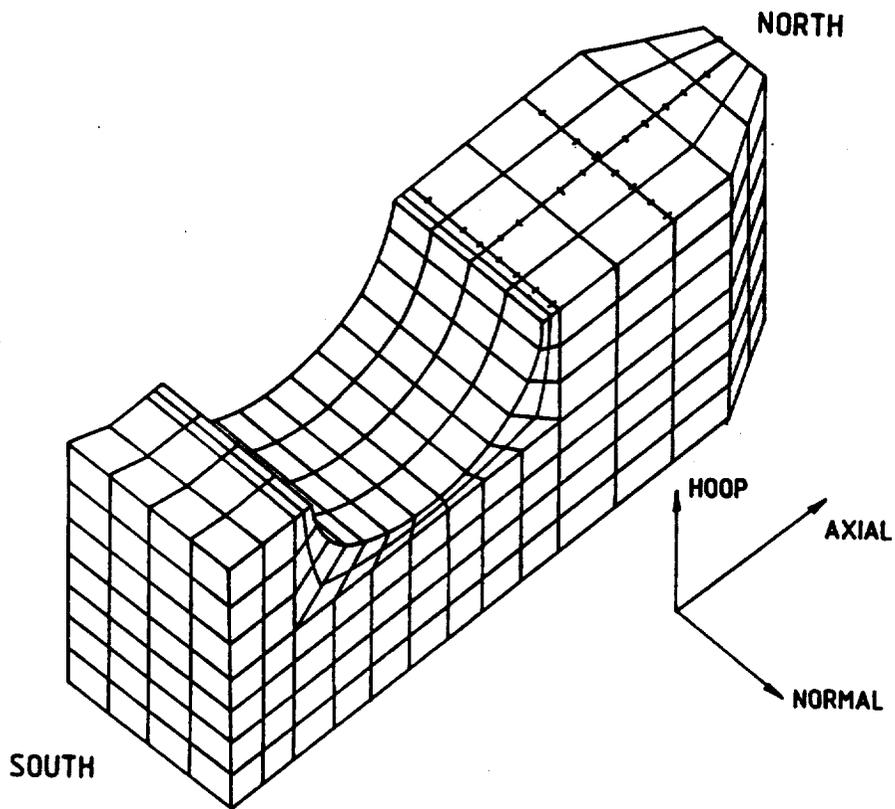
Fig. 3 - Schematic diagram of the tang end of a solid fuel booster rocket casing indicating axial, hoop and normal directions. The plane in which the measurements were taken is the top plane of the diagram defined by the axis of the bolt hole and a North-South axis indicated on the diagram.

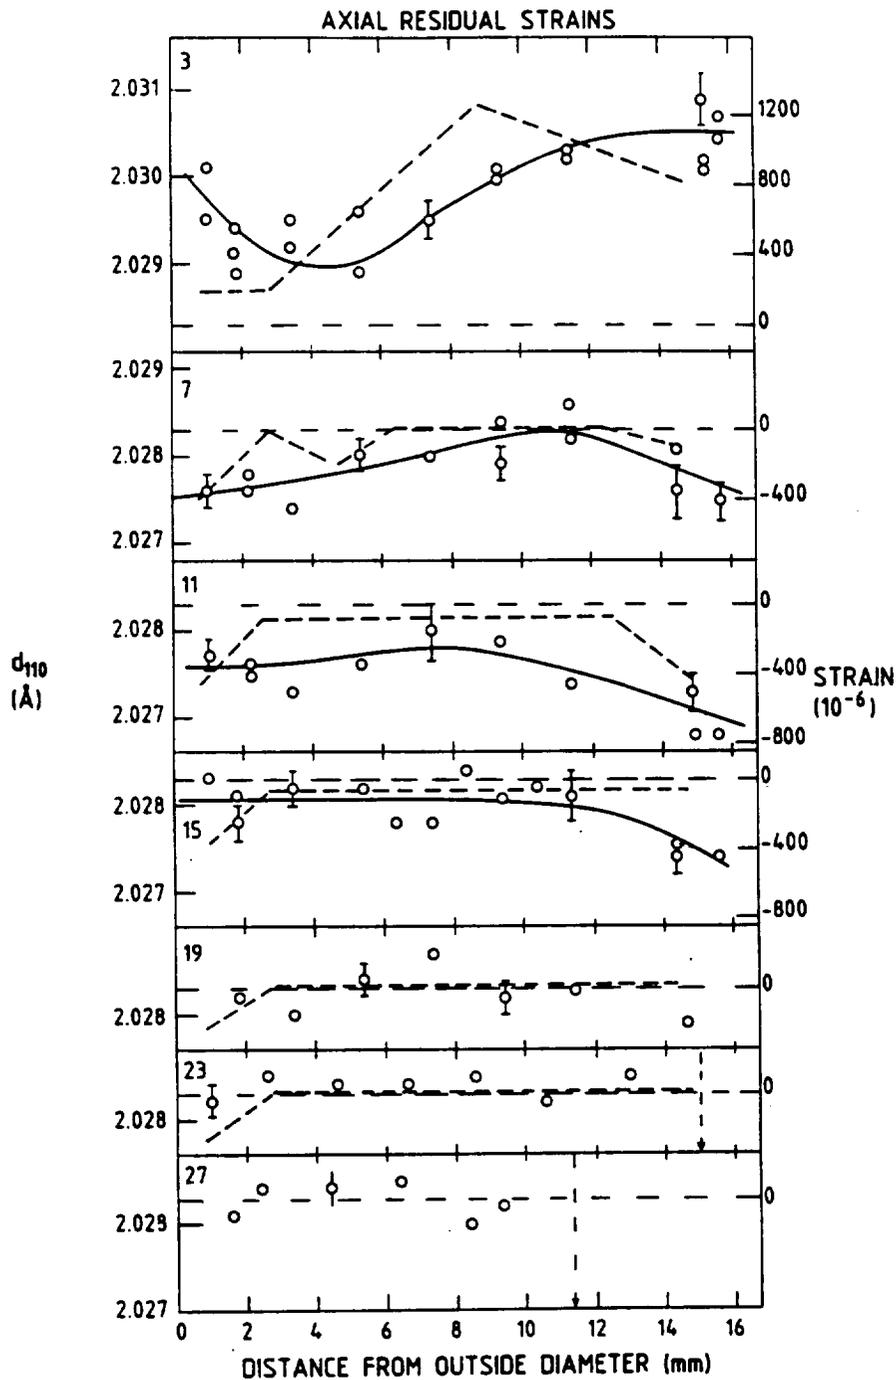
Fig. 4 - Variation of the axial strain through the wall of the casing from the outside wall for distances of 3, 7, 11, 15, 19, 23 and 27 mm from the outside diameter of the bolt hole. Short dashed lines indicate the results of finite element calculations.

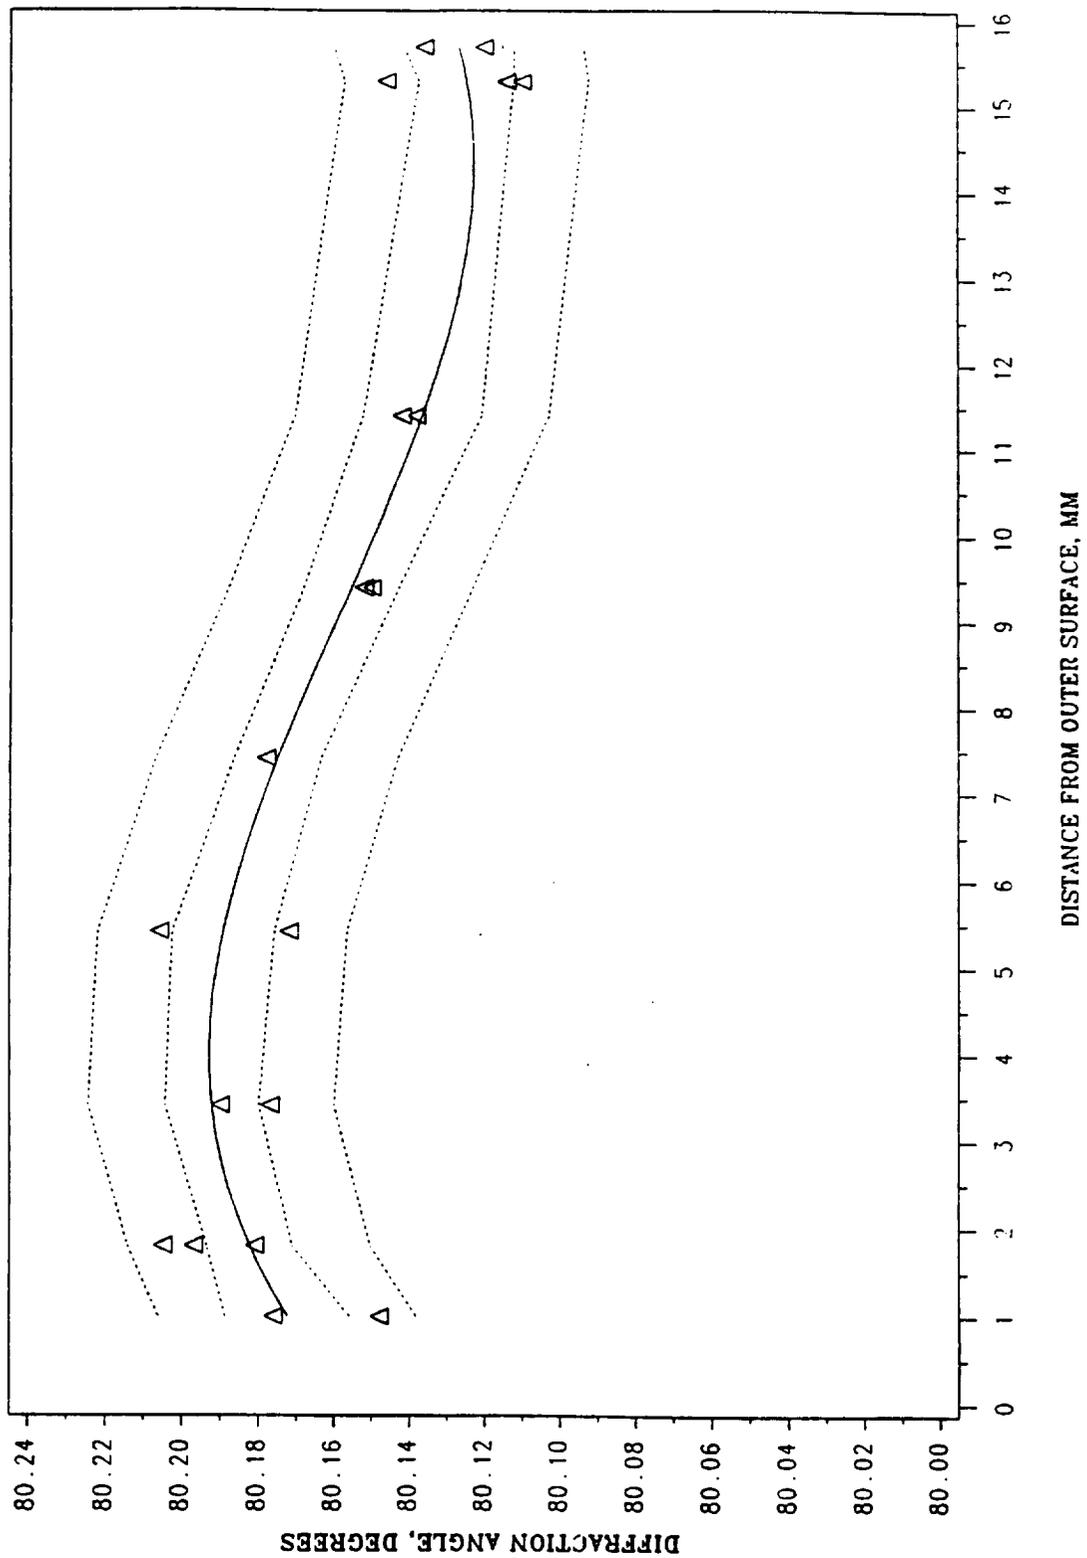
Fig. 5 - Third order polynomial fit to the twenty measurements of diffraction angle for the axial strain component measured at a distance of 3 mm from the edge of the pin hole. Error bands for  $\pm\sigma$  and  $\pm 2\sigma$  are shown by dotted curves.

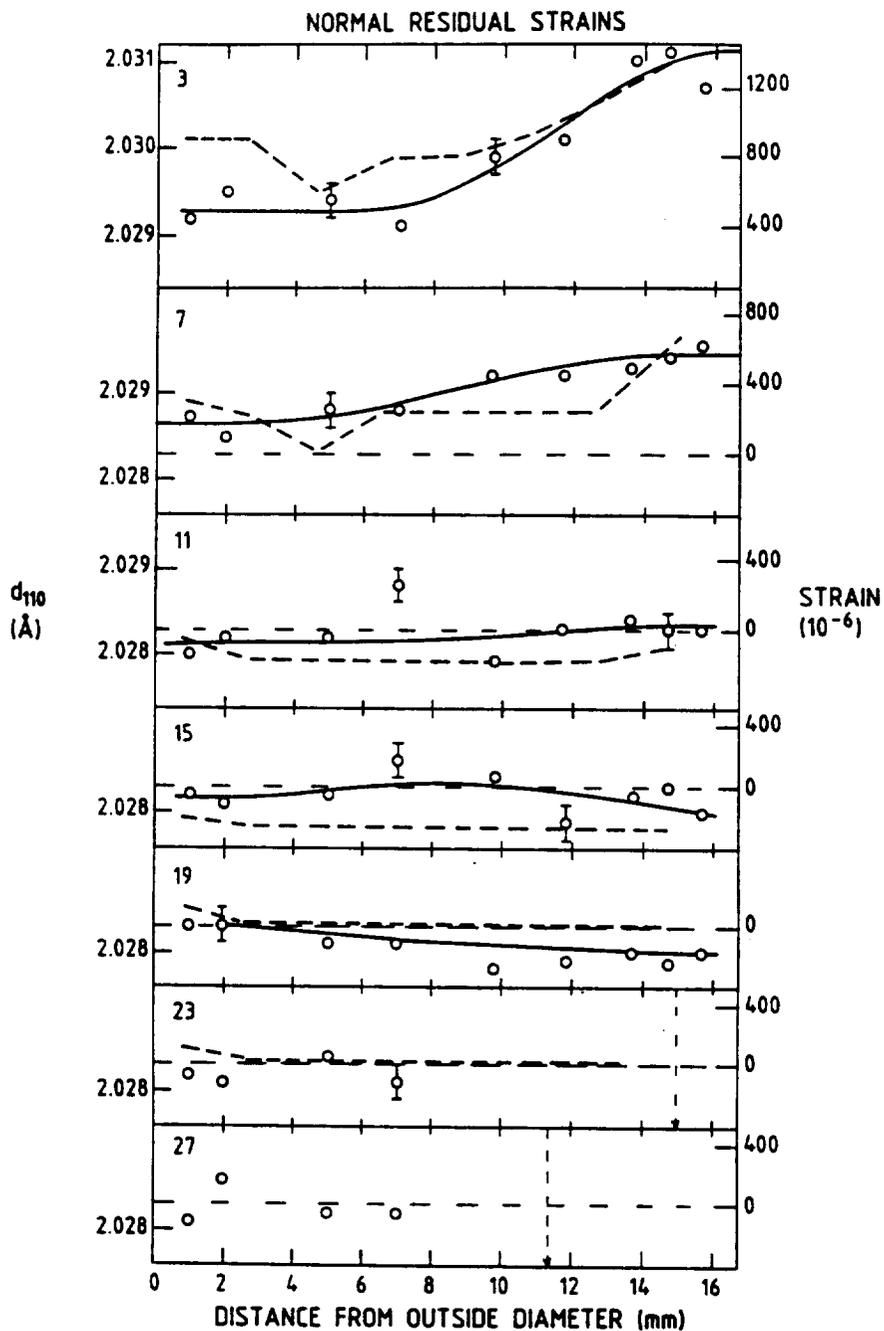
Fig. 6 - Variation of the normal strain through the wall of the casing for distances of 3, 7, 11, 15, 19, 23 and 27 mm from the outside diameter of the bolt hole. Short dashed lines indicate the results of finite element calculations.

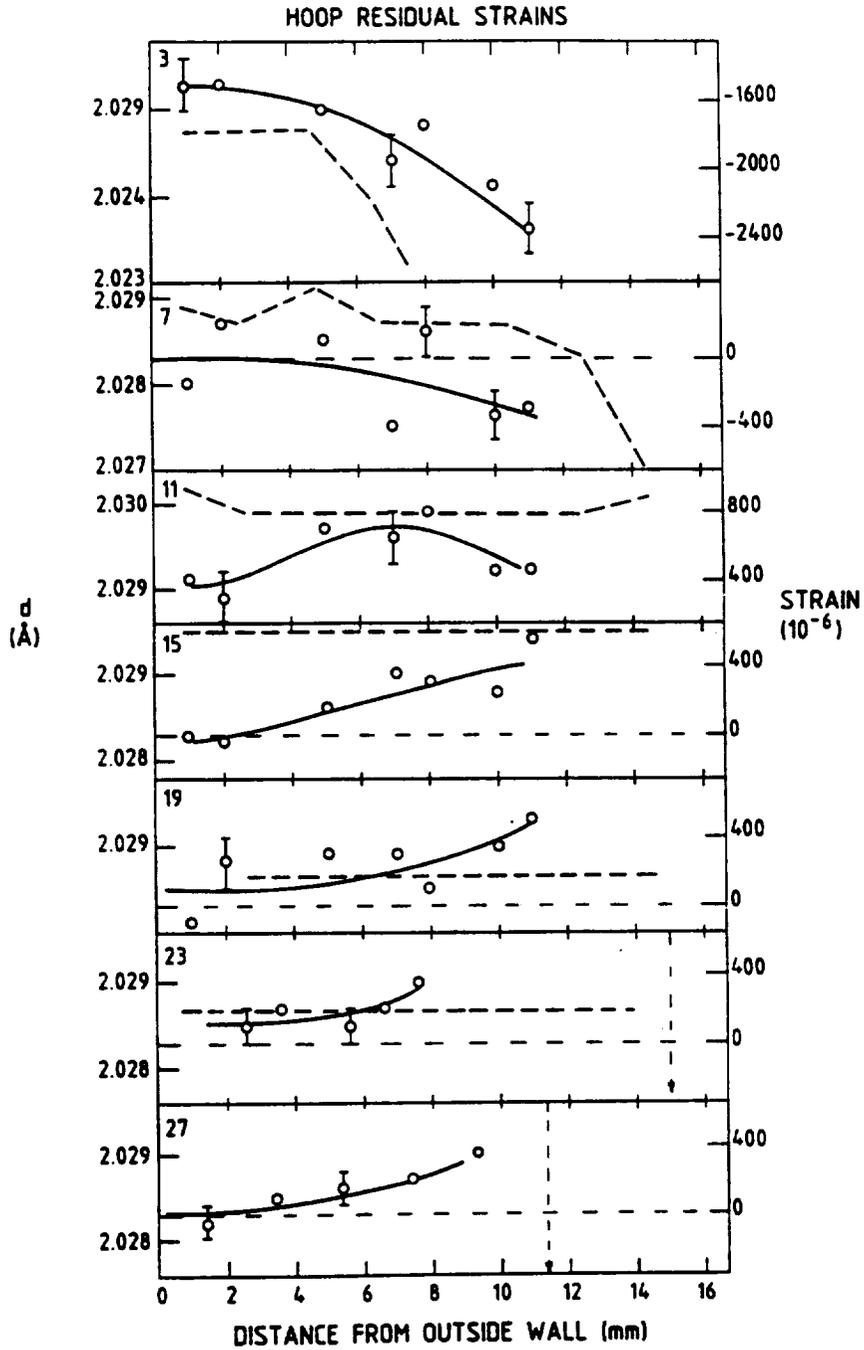
Fig. 7 - Variation of the hoop strain through the wall of the casing for distances of 3, 7, 11, 15, 19, 23 and 27 mm from the outside diameter of the bolt hole. Short dashed lines indicate the results of finite element calculations.

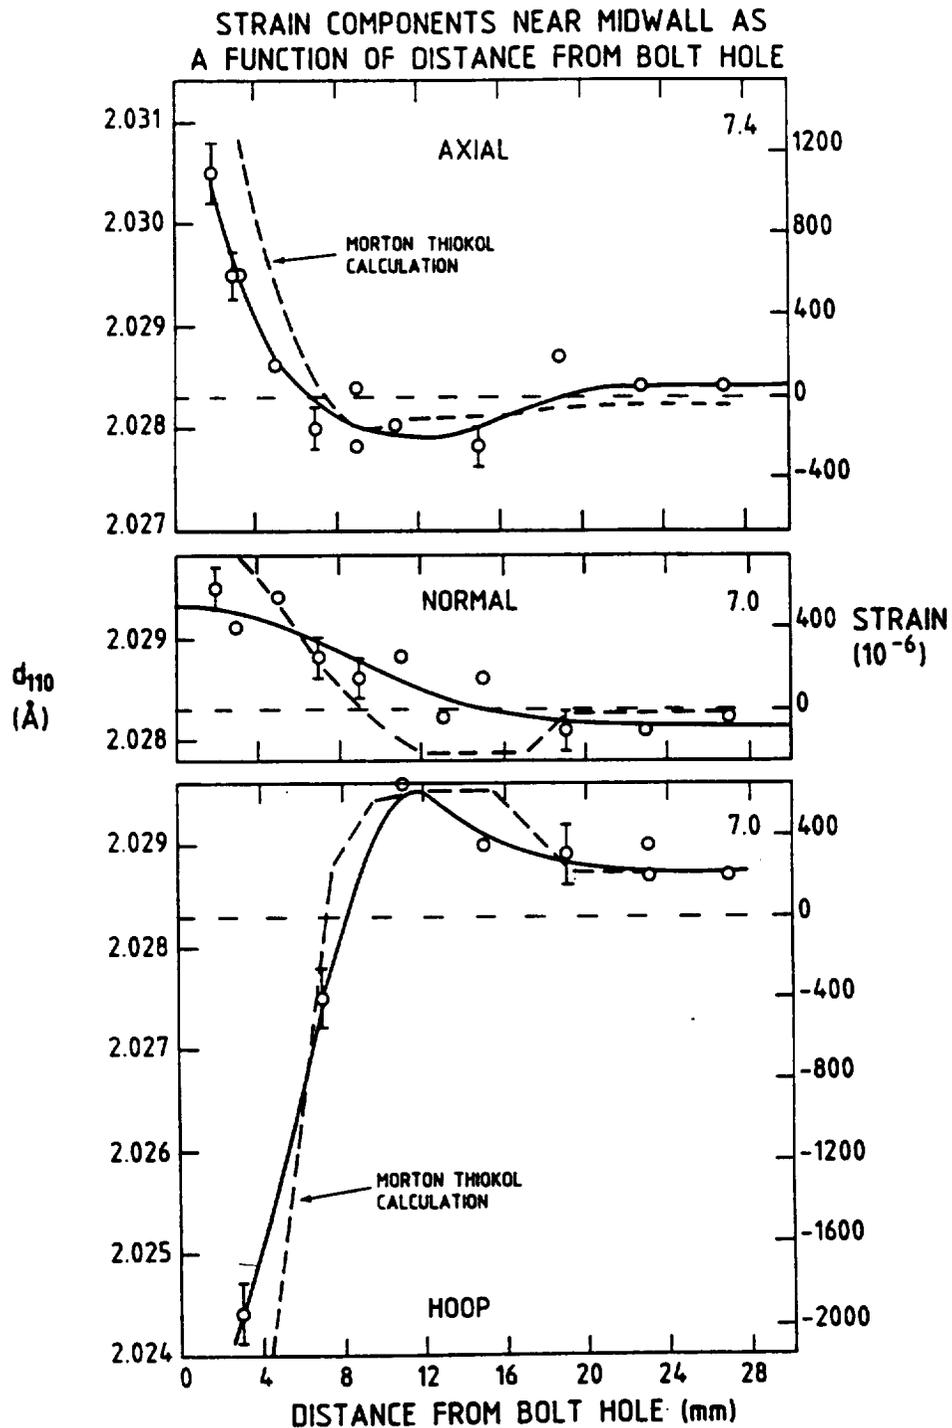
Fig. 8 - The axial, normal and hoop components of residual elastic strain as a function of distance from the outside diameter of the bolt hole at a position close to the mid-wall of the casing. Short dashed lines indicate the results of finite element calculations. The numbers 7.4, 7.0, 7.0 refer to the precise distance from the outside wall.

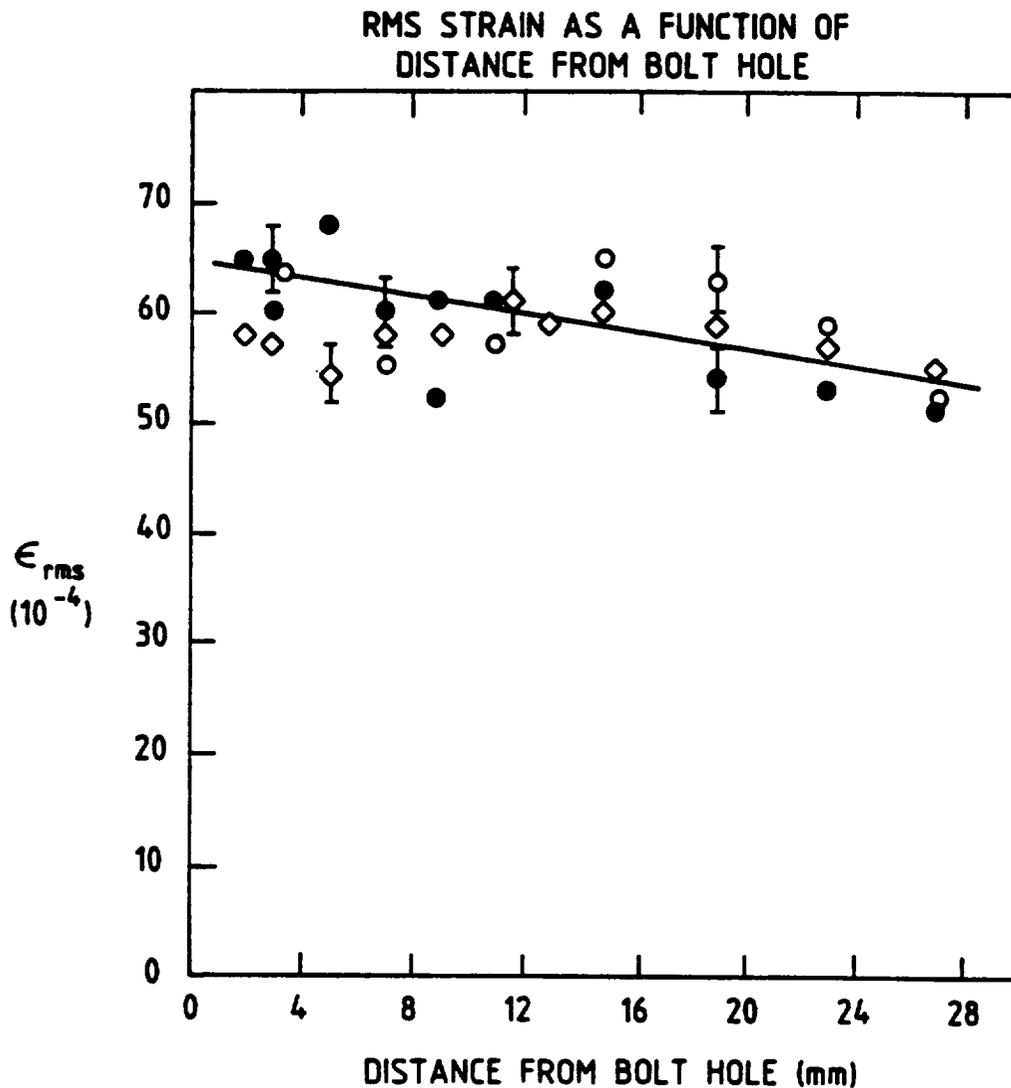
Fig. 9 - Root mean square strain derived from the intrinsic linewidth of the diffraction peaks as a function of distance from the bolt hole near the midwall. Solid circles, open circles, and diamonds correspond to axial, hoop and normal results respectively.
