## **ANALYSIS OF RETRIEVED HUBBLE SPACE TELESCOPE THERMAL CONTROL MATERIALS**

Jacqueline A. Townsend, Patricia A. Hansen,  
NASA Goddard Space Flight Center, Greenbelt, Maryland, 20771 USA

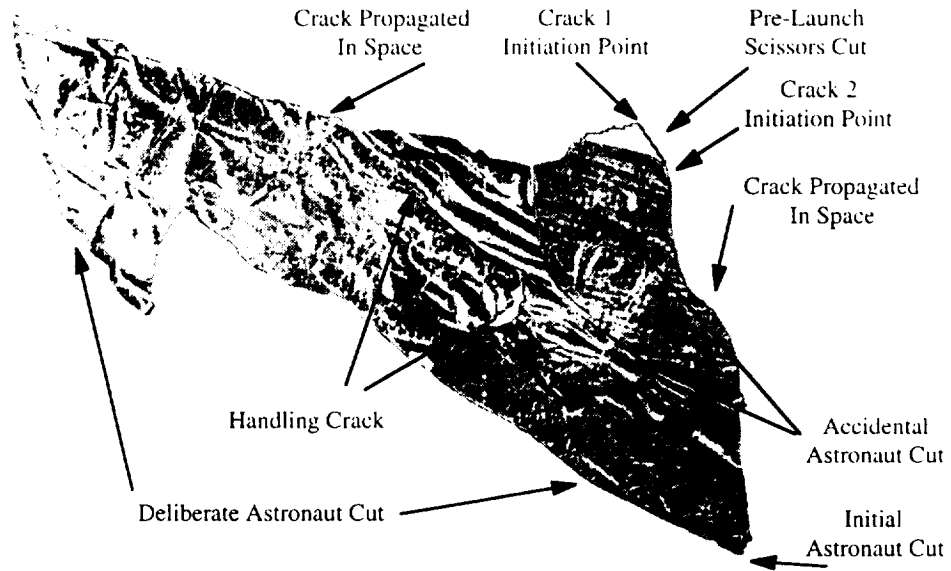
**3.1 Scanning Electron Microscopy (SEM) and Optical Microscopy** The first task was to document the MLI SM2 specimen and assemble the four pieces received into the single specimen that was cut in orbit. Both SEM and optical microscopy were utilized in this effort. Once the original configuration had been determined, the edges were identified as either a deliberate cut, a handling artifact, or an on-orbit fracture (see Figure 1). From this information, the fracture initiation site became apparent.

FIGURE 1: MLI SM2 SPECIMEN WITH CRACKS IDENTIFIED

The fractures that resulted in the MLI SM2 specimen initiated at an edge of the MLI that had been cut to fit around a handrail. From small defects in this cut edge, two fractures developed and propagated in orbit almost normal to one another, resulting in a roughly triangular specimen. The VDA was completely missing from the MLI SM2 specimen in regions where the Teflon® FEP was bonded to the rest of the blanket, which included the region where the cracks initiated.
