An Experimental and Numerical Study of Icing Effects on the Performance and Controllability of a Twin Engine Aircraft

Prepared for the
37th Aerospace Sciences Meeting & Exhibit
sponsored by the American Institute of Aeronautics and Astronautics
Reno, Nevada, January 11–14, 1999

National Aeronautics and
Space Administration

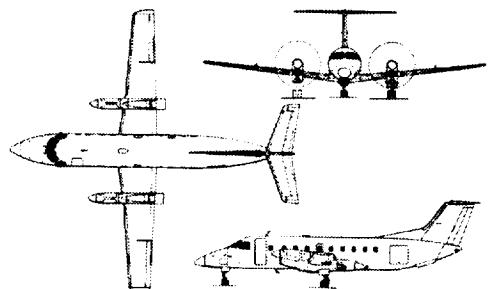
Figure 1., Twin-Engine Commuter Aircraft

In early 1997, a twin-engine commuter aircraft (Figure 1) crashed during a rapid descent after an uncommanded roll excursion. There were no survivors. The ground impact forces and post accident fire destroyed the aircraft. Instrument meteorological conditions prevailed at the time of the accident¹. During the investigation, the National Transportation Safety Board (NTSB) contacted the Icing Branch at NASA Lewis Research Center. The NTSB requested NASA's participation since ice contamination was suspected as being a factor. NASA offered to pursue a study that included experimental and computational elements to identify the broad nature of possible ice contamination and the likely associated performance degradation.

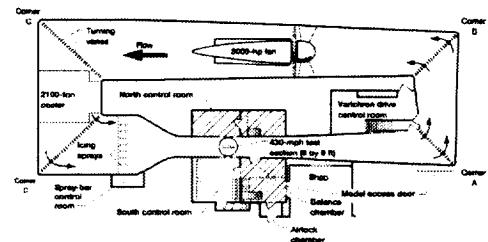
Figure 2., Planview of IRT

The Icing Research Tunnel (Figure 2) is a closed-loop atmospheric tunnel with a test section that is 6 ft high, 9 ft wide, and 20 ft long. It is equipped to support testing at airspeeds from 50 to 430 mph in a temperature and water-droplet environment that simulates natural icing conditions². Temperature is controllable between -20 and +33°F. Clouds can be produced in a controlled manner with droplet mean volumetric diameter (MVD) between 9.5 and 270 µm.

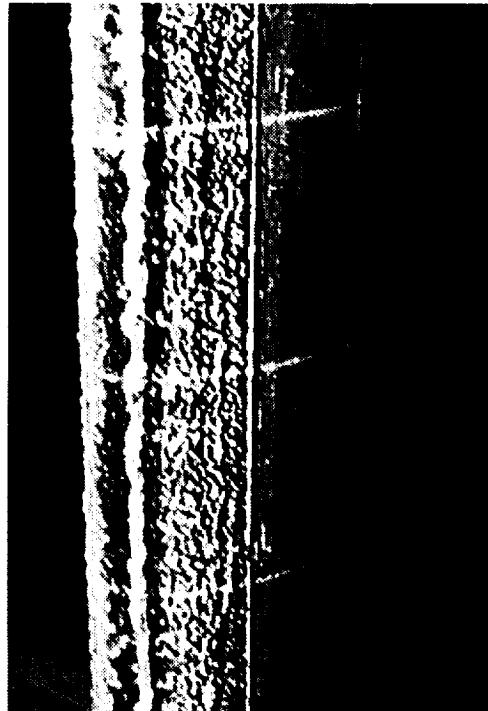
Figure 4., Digital Photograph of Model with Ice Accretion

The IRT test was conducted over two weeks in January 1998. The conditions described in Table 1 were used for this test and the most significant conditions were repeated at least once, as seen in Table 2. The normal process used during this test was to cool the IRT to the desired temperature and set the airspeed. When the temperature and airspeed were stable at the desired test conditions, the spray was activated for the length of time at air and water pressures defined by the test matrix to simulate a natural icing cloud. When the spray was shut off, several wake survey probe traverses were made behind the model. These wake probe traverses were used to calculate an uncorrected tunnel centerline section drag. Due to project time constraints, further correction, analysis, and comparisons of this data have not been completed. Following the wake probe traverses, the tunnel fan was stopped so that test personnel could enter the test section. Upon entering the test section, the test engineers would first photograph the model. Both digital and film cameras were utilized for this test, with the film photos typically being used for close-up detailed shots and the digital photos for overview shots (Figures 4 and 5). When the photographs were completed, the leading edge ice accretion was sliced with a hot knife, then traced onto a cardboard template (Figure 6). These tracings were made at 30, 36, and 42 inches from the wind tunnel floor (the 36 inch location is the vertical center of the test section). The ice shapes originally traced onto cardboard are then later digitized and stored electronically. All tracings presented here are digitized data

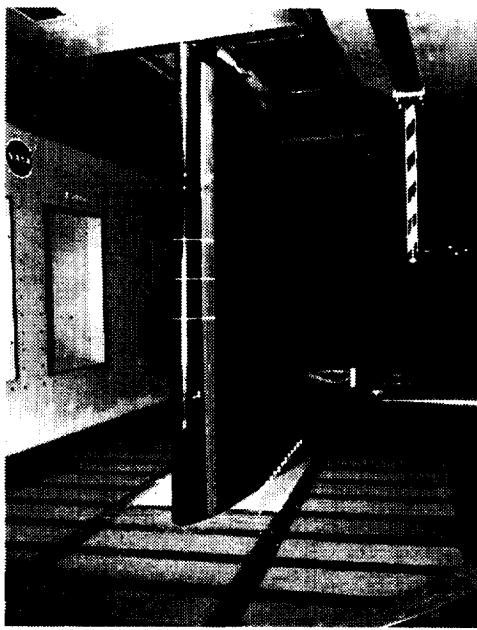
Figure 3., Model installed in IRT

For this test an existing model was utilized. The model was a modified piece of wing from the subject aircraft centered on the inboard region of the aileron. The model had a 6-foot span and was mounted vertically in the IRT (Figure 3). The wing had a modified trailing edge and pneumatic boot. The trailing edge was faired behind the aft spar to avoid the mechanical complexity of the aileron. The pneumatic boot was modified for its original test to allow the incorporation of thermal measurements. This feature was not utilized for this subject testing, however, the modification resulted in the boot extending further aft on the lower surface than a production boot for this wing. This extended boot surface acted as an enhanced ice accretion location that is evident when reviewing the test ice shape tracings. Except for the cases when the pneumatic boot was activated, the manufacturers recommended level of vacuum was applied to

the boot throughout the testing to prevent auto-inflation. To ensure that the air temperature in the test section was accurate at the desired near-freezing condition, an auxiliary temperature probe was mounted near the model and is visible in Figure 3.

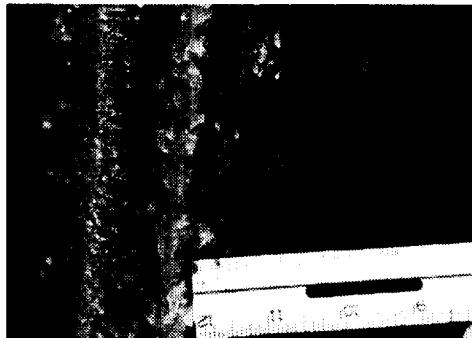
Figure 5., Close-up Film Photograph of Ice Accretion

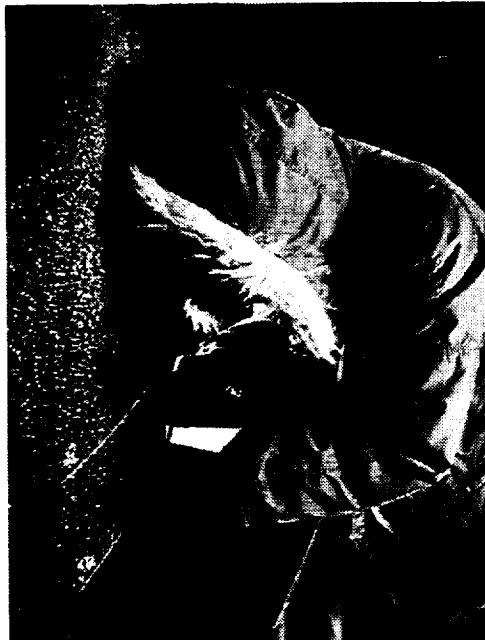
Figure 6., Ice Tracing Technique

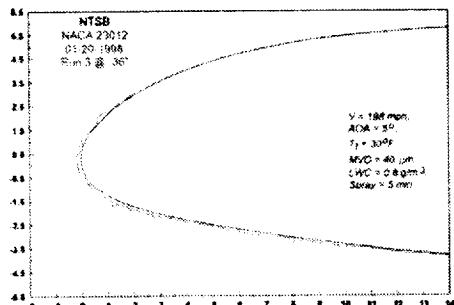
Figure 7., Example Digitized Ice Shape

(Figure 7). Three channels of video were also recorded for each ice accretion. The video cameras captured upper and lower leading edge views along with a broad model view. The video signals were recorded to SVHS format tapes.

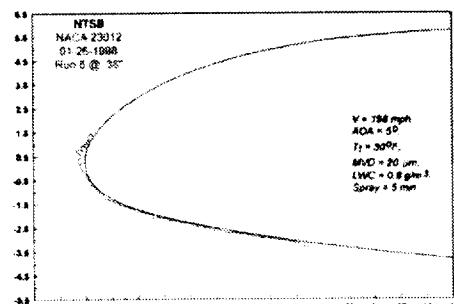
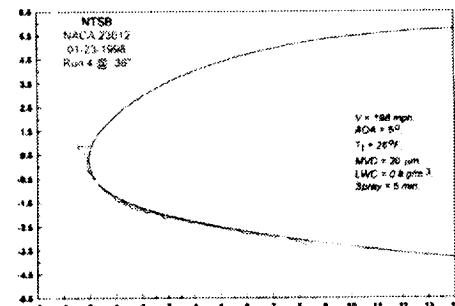
Figure 8., Tracing of Non-Ridge Shape

Figure 9., Tracing of Ridged Ice Shape

Repeatability was good for all cases, with the volume of ice, impingement limits, and horn or ridge location closely matched for repeat cases. The majority of the ice shapes accreted during this test fell into two categories. The first was a thin ice shape with a rough surface made up of small bumps of varying size and sharpness (Figure 8). The second category of ice shape had the same general volume of ice with similar roughness elements as the first category, but also a prominent ridge (Figure 9). This ridge was approximately 0.5 inches high.

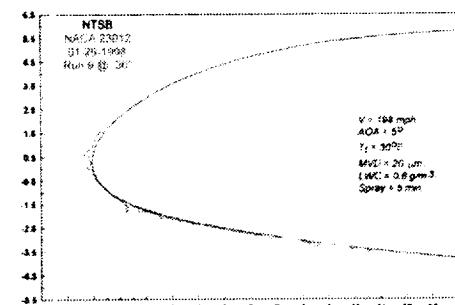
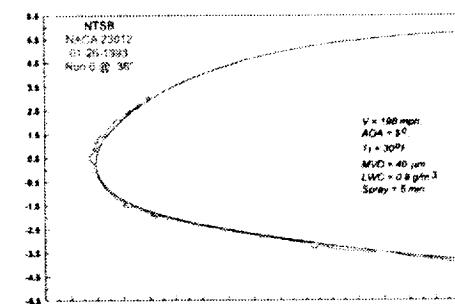
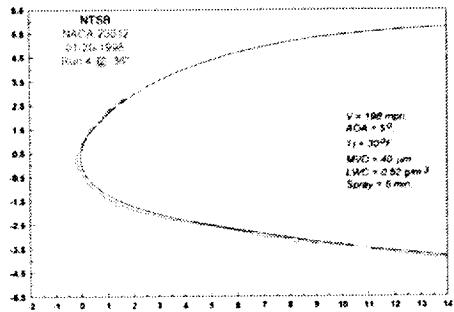
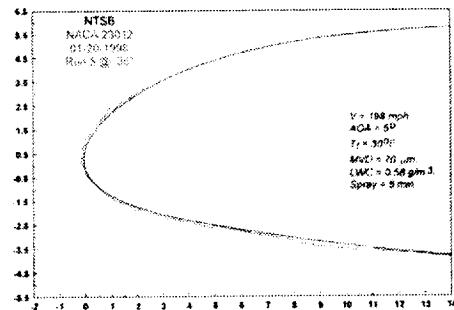
Figure 10., Baseline condition,
Matrix number 2 tracing

Figure 11., Baseline condition,
Matrix number 3 tracing

Figure 12., Baseline condition,
Matrix number 4 tracing

Figure 13., Baseline condition,
Matrix number 5 tracing

- The baseline series (see Table 1) resulted in thin ice accretions with distributed roughness and no ridge formation for all four of the series conditions (Figures 10 to 13).

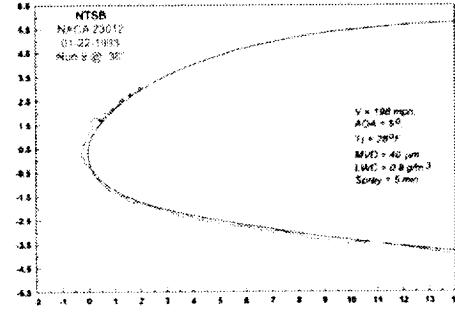
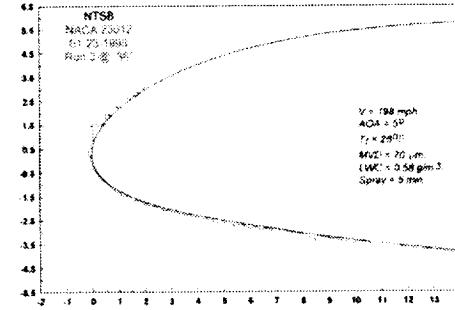
Figure 15., Lower temperature condition,
Matrix number 23 tracing

Figure 16., Lower temperature condition,
Matrix number 25 tracing

- The lower temperature series (at 28 degrees Fahrenheit total temperature instead of 30 degrees) produced slightly more total ice volume than the baselines series and more importantly started to exhibit some ridge formation for the 40 and 70 μm MVD cases (Figure 15 and 16).

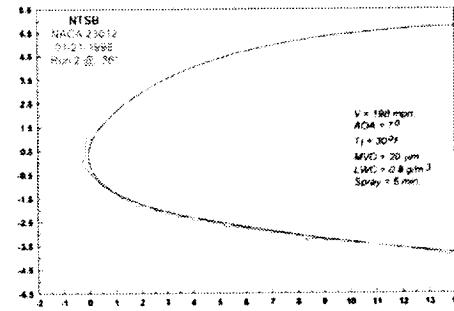
Figure 14., Higher AOA condition,
Matrix number 6 tracing

- Compared to the baseline series, the higher angle-of-attack series (at 7 degrees instead of 5 degrees) produced ice shapes that were shifted towards the lower surface, as would be expected with this change of angle-of-attack (Figure 14). Since the upper impingement limit moved forward, the overall ice thickness of these shapes was somewhat greater than that seen in the baseline series.

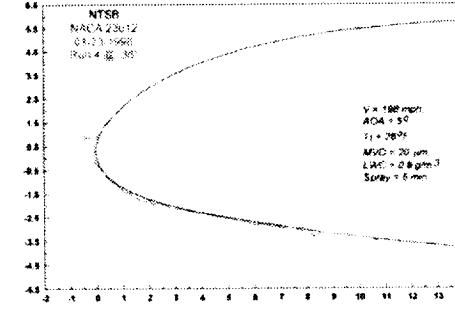
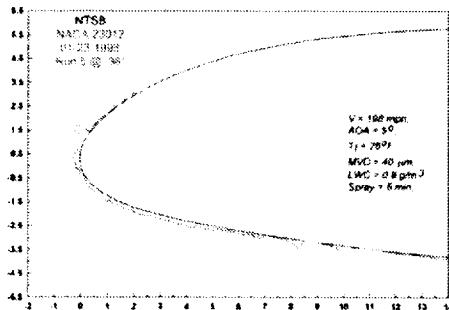
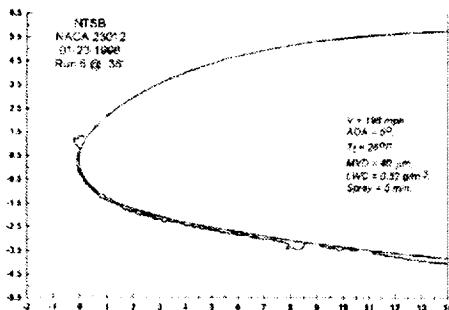
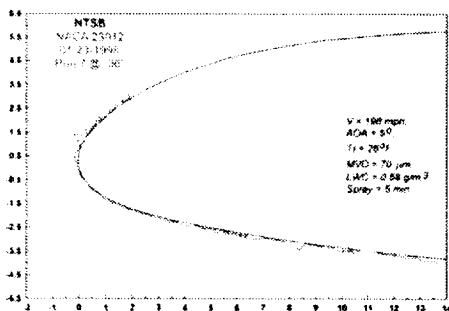
Figure 17., Second lower temperature condition,
Matrix number 26 tracing

Figure 18., Second lower temperature condition,
Matrix number 27 tracing

Figure 19., Second lower temperature condition,
Matrix number 28 tracing

Figure 20., Second lower temperature condition,
Matrix number 29 tracing

- The second lower temperature series (at 26 degrees Fahrenheit total temperature instead of 30 degrees) exhibited an ice ridge for all four conditions (Figures 17 to 20). The ridges apparent in these accretions are different from a standard horn formation in that they are surrounded by only a thin layer of ice, where a standard horn is part of a more substantial ice accretion. The ridge was most prominent for the two cases with $\text{LWC}=0.8 \text{ g/m}^3$ (matrix numbers 26 and 27, Figure 17 and 18). For the two cases with constant LWC, the ridge moved aft with increasing MVD. For the two cases with constant MVD, the ridge moved aft with increasing LWC.

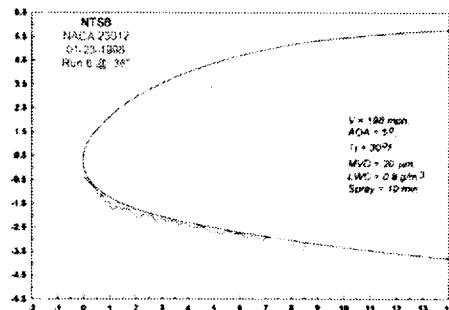
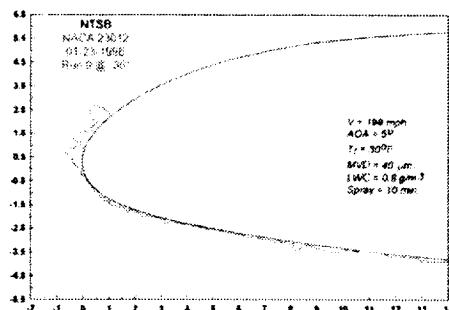
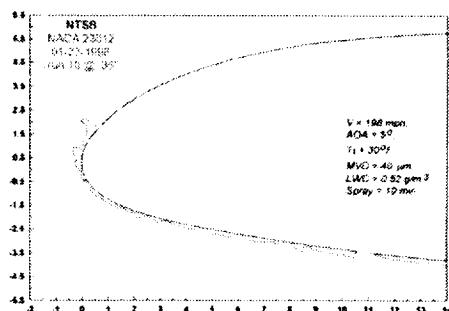
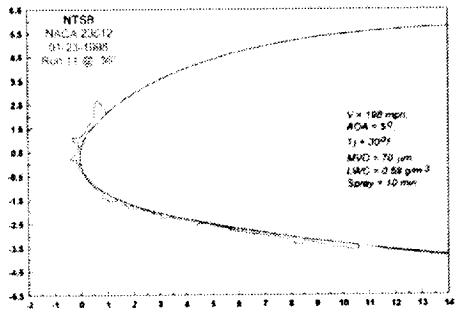
Figure 21., Ten minute accretion condition,
Matrix number 32 tracing

Figure 22., Ten minute accretion condition,
Matrix number 33 tracing

Figure 23., Ten minute accretion condition,
Matrix number 34 tracing

Figure 24., Ten minute accretion condition,
Matrix number 35 tracing

- In the longer time series (with an accretion time of 10 minutes instead of 5), self-shedding occurred in matrix number 32 (Figure 21). For the remaining cases in this series the ice mass was greater than in the baseline series, as would be expected. These shapes also exhibited a ridge formation (Figures 22 to 24). However these ridge formations appeared to be much more like a standard horn formation. These ice shapes were in general larger and rougher than those seen in the baseline series.

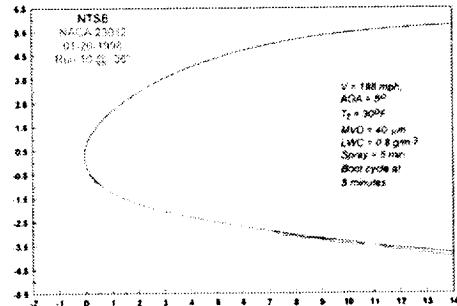
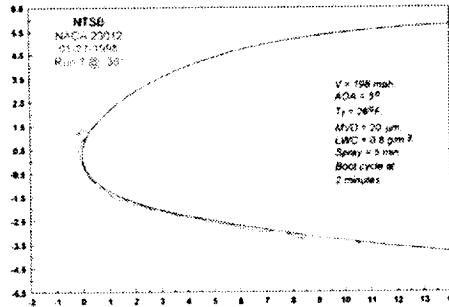
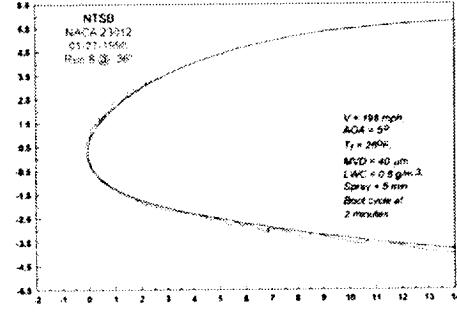
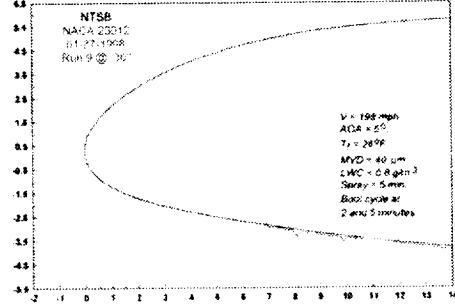
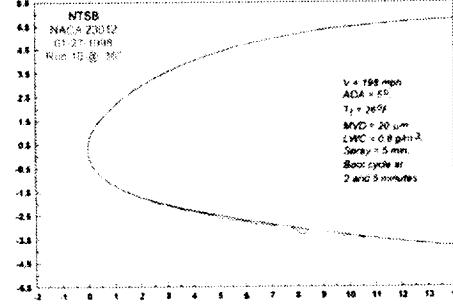
Figure 27., De-ice at 2 minutes of spray,
Matrix number 27Deice tracing

Figure 25., End of spray De-ice,
Matrix number 3Deice tracing

Figure 28., De-ice at 2 minutes and at end of
spray, Matrix number 27Deice tracing

Figure 26., De-ice at 2 minutes of spray,
Matrix number 26Deice tracing

Figure 29., De-ice at 2 minutes and at end of
spray, Matrix number 26Deice tracing

- The pneumatic boot was operated for several cases in the de-ice series. It was operated for the matrix number 3, 26, and 27 conditions. Depending on the case, the pneumatic boot was either activated at spray-off only (Figure 25), at two minutes into a five-minute spray (Figures 26 and 27), or at

two minutes and at spray-off (Figures 28 and 29). In all cases when the pneumatic boot was operated at the end of the icing spray, the leading edge ice shed very well. For the two cases when the boot was activated at two minutes into a five-minute spray, in one case it prevented the development of a ridge formation, and in the other case it did not. Whether the ridge was suppressed or not was probably dependant on how well the boot cleared the ice at the two-minute activation. It should be noted that the pneumatic boot used during this test was not a production boot and it had never experienced the operational environment. However, no special steps were taken to enhance the boot performance, such as the application of Ice-X, and it was operated at the same pressures as a flight system. The boot performance in the deicing tests is therefore considered to be broadly representative of that of a flight system.

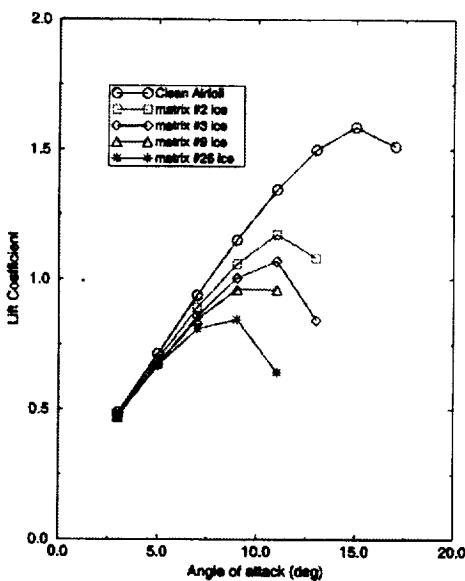
Figure 30., Lift curves for clean airfoil and airfoil contaminated with various ice shapes

For the 2-D calculations, a significant effort was undertaken to determine the best level of ice tracing point smoothing and optimal grid point resolution^{7,8}. The calculated lift curves of the four ice shapes examined compared to that of the clean airfoil are presented in Figure 30. As expected, when ice was added to the airfoil, the calculated lift was degraded. The matrix 2 shape had the least degradation since it had the lowest level of roughness of the shapes examined, followed by the matrix 3 shape, which had larger, rougher roughness elements. When the ice thickness increased, as in matrix number 9, the lift degradation was further increased. The surprising result was the level of degradation when a ridged ice shape was examined. The major difference between the ice shape from matrix number 2 and that from matrix number 26 was the ice ridge. The roughness levels observed in the two cases were very close. When the ice ridge was present, a 45 percent reduction of maximum lift coefficient ($C_{L,max}$) was predicted in comparison to the clean airfoil. Since the ridged ice shape caused the greatest lift degradation, it was selected for all further computational analysis.

Of the four ice shapes analyzed with the Navier-Stokes code, the degraded $C_{l,\max}$ from the ice shape with the lowest level of roughness, matrix number 2, was about 75 percent of the clean airfoil. The $C_{l,\max}$ from the ice shape with larger, sharper roughness elements, matrix 3, was about 68 percent of the clean airfoil. The $C_{l,\max}$ from the rough shape with more ice accretion on the upper surface of matrix number 9 was about 60 percent of the clean airfoil. And the $C_{l,\max}$ from the ice ridge case, matrix 26, was about 53 percent of the clean airfoil.

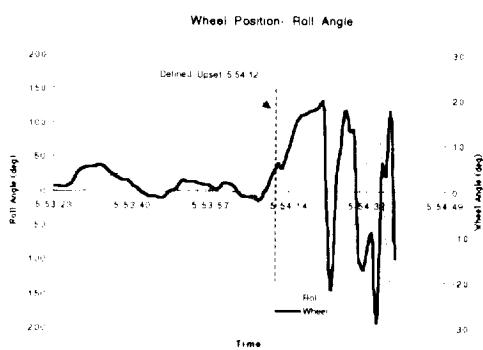
Figure 31., Flight Data Recorder Tracing including upset

Of equal significance compared to the lift degradation caused by the ice contamination is the effect of aileron deflection for contaminated airfoils. Navier-Stokes calculations were performed for the wing in the configuration at the moment of the control upset. The moment of control upset was defined for this activity as the point when the aircraft's roll no longer tracked the aileron input. The roll angle and aileron (control wheel) position were recorded on the FDR (Figure 31.). The configuration of the aircraft with regards to bank and aileron position is shown in Figure 32. It should be noted that the aircraft flight variables of interest here (airspeed, angle-of-attack, altitude, and temperature) are different from those used to

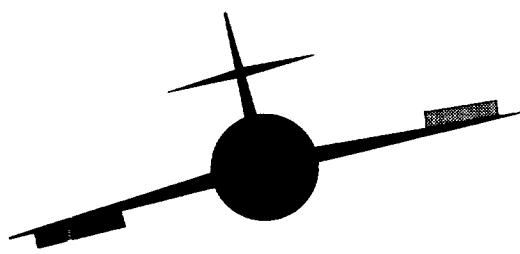
Figure 32., Aircraft and aileron position (not to scale) at upset (view from behind looking forward)

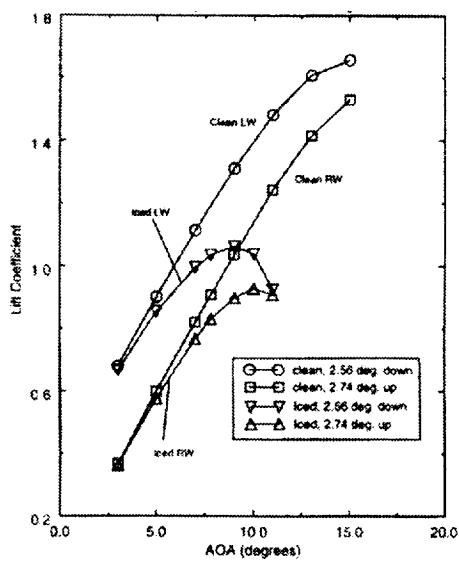
Figure 33., Lift curves for clean airfoil and ridge ice shape contaminated airfoil with aileron deflections

When the aileron deflection effect was added to the degradation caused by the ridged ice shape the lift curves in Figure 33 resulted. The clean left wing (Clean LW) line represents the lift curve for the airfoil with the aileron deflected down at 2.56 degrees. The clean right wing (Clean RW) line represents the lift curve for the airfoil with the aileron deflected up at 2.74 degrees. The left wing generates more lift than the right; therefore the aircraft will roll right. This was the intention of the pilot when these control inputs were made. However, with the ridged ice shape contamination on the wings, both the Iced LW and Iced RW lines show how the left and right airfoil lift curves were degraded. As angle-of-attack increases the differential lift decreases and at an angle-of-attack around 11 degrees the difference in lift between the two wings goes to zero. This degraded roll control authority is a possible answer as to why the aircraft continued to roll to the left when the aileron inputs were commanding a right roll.

With the aileron effects added to the lift degradation caused by the ridged ice shape, the resultant lift curves for the left and right wing airfoils display that little or no lift difference may have been present and therefore roll control authority may have been significantly degraded.
