Aerospace Mechanisms and Tribology Technology: Case Study

AEROSPACE MECHANISMS AND TRIBOLOGY TECHNOLOGY: CASE STUDY

CASE STUDY: GALILEO SPACECRAFT AND HIGH-GAIN ANTENNA DEPLOYMENT ANOMALY

1. AGENCY USE ONLY (Leave blank)		2. REPORT DATE May 1999		3. REPORT TYPE AND DATES COVERED Technical Memorandum
4. TITLE AND SUBTITLE Aerospace Mechanisms and Tribology Technology: Case Study			5. FUNDING NUMBERS WU-523-22-13-00

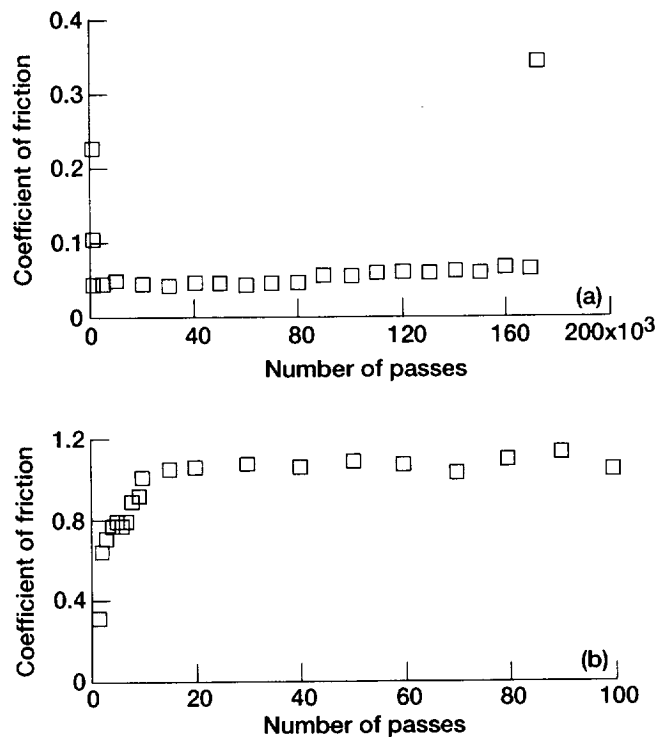
Figure 6.—Coefficients of friction for dry-film-lubricated and unlubricated Ti-6Al-4V pins sliding against high-nickel-content superalloy disks as function of number of passes in vacuum. (a) Dry-film-lubricated pin at 8.5-N load. (b) Unlubricated pin at 4-N load.

Effect of dry-film lubricant: The coefficient of friction for the dry-film-lubricated Ti-6Al-4V in contact with the bare high-nickel-content superalloy started at 0.23 but rapidly decreased and reached an equilibrium value of about 0.04 (fig. 6(a)). It remained constant at 0.04 for a long period of time. The friction trace fluctuated slightly with no evidence of stick-slip behavior. The sliding action finally caused the coefficient of friction to rapidly increase at 172 370 passes. Wear damage (i.e., local removal of the dry-film lubricant and consequent exposure of the substrate surface), which will be discussed later, caused the high friction at this stage.

The coefficient of friction for the unlubricated, bare Ti-6Al-4V in contact with the bare high-nickel-content superalloy started at 0.31. The friction force traces for the first few sliding passes were characterized by random fluctuation, with only occasional evidence of stick-slip behavior. The presence of oxides and contaminants on the surfaces of the bare Ti-6Al-4V pin and the bare high-nickel-content superalloy disk contributed to the low initial coefficient of friction. Stick-slip behavior became dominant after a few sliding passes. The coefficient of friction rapidly increased with an increase in the number of passes. Also, the higher the number of passes, the greater the stick-slip behavior. At ~10 passes and above, the coefficient of friction reached an equilibrium value of about 1.1 and remained constant for a long period of time (fig. 6(b)). The traces for 10 passes and above were primarily characterized by a continuous, marked stick-slip behavior. This type of friction is anticipated where strong metallic

Comparing figures 6(a) with (b) shows that the adhesion and friction in equilibrium conditions for dry-film-lubricated Ti-6Al-4V were less than those for unlubricated, bare Ti-6Al-4V by a factor of 28. Thus, the dry-film lubricant on the Ti-6Al-4V pin surface was effective and greatly reduced adhesion and friction.

Self-healing of dry-film lubricant.—At 172 370 passes of sliding contact in vacuum (fig. 6(a)) the sliding motion was stopped because of high friction (0.36 or greater) caused by the wear damage. After holding conditions for about 18 hr the sliding was restarted. The result is presented in figure 7(a). The coefficient of friction after restart became much lower than 0.36, generally decreasing to about 0.05 with increasing number of passes. This result suggests that the wear damage occurring in vacuum, which caused high friction at 172 370 passes, can self-heal when rerun in vacuum after a period of hold time.

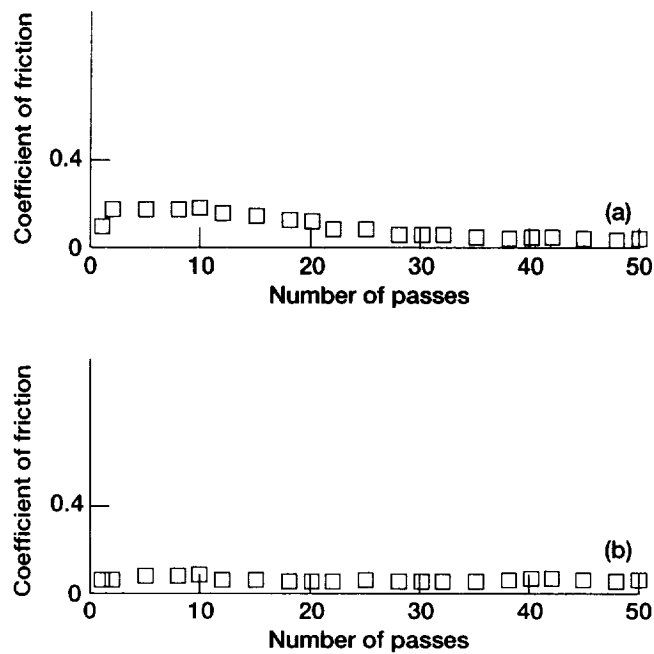
Figure 7.—Coefficients of friction for surfaces previously worn in vacuum of dry-film-lubricated Ti-6Al-4V pin sliding against high-nickel-content superalloy disk as function of number of passes when rerun in vacuum. (a) Load, 8.5 N; rotating speed, 40 rpm. (b) Load, 2.5 N; rotating speed, 1 rpm.

After 50 passes of sliding contact in the rerun process, the sliding motion was stopped, and the load was decreased from 8.5 to 2.5 N. Contact was maintained for 30 sec and then sliding was begun at the new load. Decreasing the load from 8.5 to 2.5 N did not affect the coefficient of friction, as shown in figure 7(b).

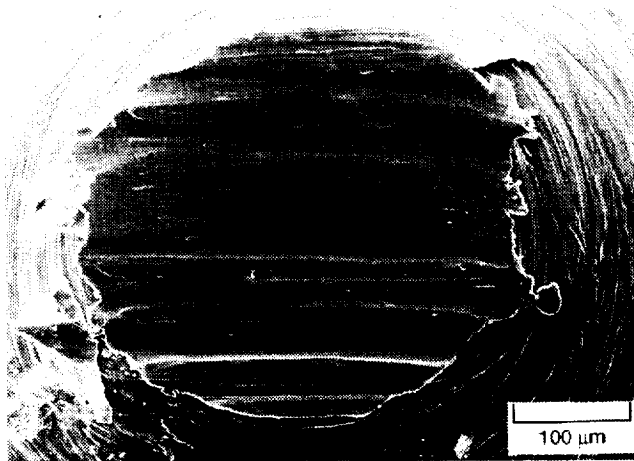
Figure 10.—Wear scar on unlubricated Ti-6Al-4V pin after sliding against high-nickel-content superalloy disk at 2.5 N in vacuum.

Contact between unlubricated Ti-6Al-4V pin and high-nickel-content superalloy disk: Scanning electron microscopy (SEM) photomicrographs and energy dispersion x-ray analysis (EDX) spectra of the wear damage produced on an unlubricated Ti-6Al-4V pin and on a high-nickel-content superalloy disk after 100 passes at a load of 2.5 N are presented in figures 10 to 13. Figure 10 shows that substantial plastic deformation occurred on the pin. Large wear debris particles formed by plastic deformation and ductile fracture of the Ti-6Al-4V pin are present around the wear scar. Also, plastically deformed grooves and clogged wear debris are present on the wear scar of the pin. Closer SEM examination and EDX analysis of the wear debris showed it to be composed primarily of elements from the Ti-6Al-4V pin (fig. 11) and of small amounts of chromium, iron, and nickel from the disk. Note that abnormally high friction (1.45) was observed when relatively large wear debris clogged the sliding interface.

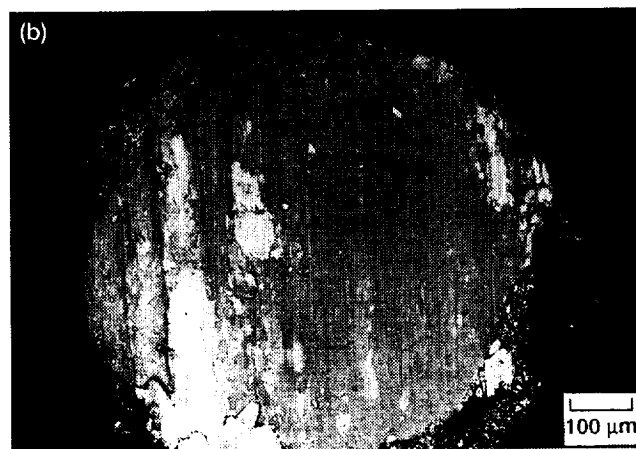
Figure 18.—Wear scar on dry-film-lubricated Ti-6Al-4V pin after sliding against high-nickel-content disk in humid air and then rerun in vacuum.

Contact between dry-film-lubricated Ti-6Al-4V pin and high-nickel-content superalloy disk worn in humid air and rerun in vacuum: SEM photomicrographs and EDX spectra of the worn surfaces of a dry-film-lubricated Ti-6Al-4V pin and a high-nickel-content superalloy disk run in humid air for 700 passes and then rerun in vacuum for 100 passes are shown in figures 18 to 24. Figure 18 shows that both plastic deformation and ductile fracture occurred in the dry-film-lubricated Ti-6Al-4V pin. The backscatter photomicrograph (fig. 18(b)) reveals three different materials: (1) the light areas show where the transferred patches from the disk stayed on the Ti-6Al-4V pin, (2) the gray areas show the Ti-6Al-4V substrate with no dry-film lubricant present, and (3) the salt-and-pepper areas around the edge of the wear scar show the dry-film lubricant. In addition to the major elements of the disk material the transferred patches also contained elements such as molybdenum and sulfur from the lubricant (fig. 19(a)). On the other hand, the gray areas contained only the elements of Ti-6Al-4V pin (fig. 19(b)).

Thus, the worn surfaces of the pin and disk first run in humid air and then rerun in vacuum were completely different from the pin and disk surfaces run only in vacuum. The surfaces worn in humid air (figs. 18 and 20) exhibited galling accompanied by severe surface damage and extensive transfer of the Ti-6Al-4V to the high-nickel-content superalloy disk, or vice versa.
