Evaluation of Carburized and Ground Face Gears

David G. Lewicki and Robert F. Handschuh
U.S. Army Research Laboratory, Glenn Research Center, Cleveland, Ohio

Prepared for the
55th Annual Forum
sponsored by the American Helicopter Society
Montreal, Quebec, Canada, May 25-27, 1999

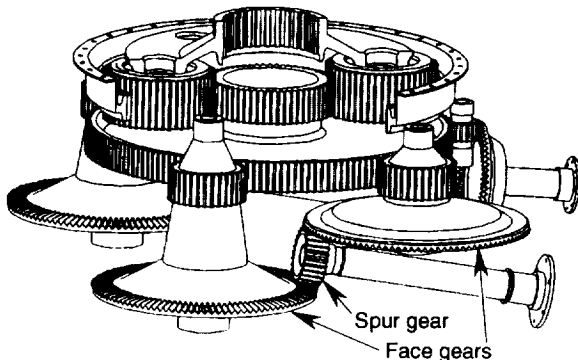
Figure 1 shows the split-torque, face-gear transmission developed during the U.S. Army Advanced Rotorcraft Transmission (ART) program [1]. For this configuration, an involute spur

Figure 1. Split-torque, face-gear transmission from ART program [1].

gear drives both an upper face gear and lower face gear. These face gears are connected to spur gears which drive a large bull gear. By splitting the power flow in these two paths, smaller components can be utilized which leads to reduced weight. Compared to spiral-bevel gears, face gears allow the use of a simpler, less expensive, involute spur pinion. In addition, the pinions do not produce axial forces and have less axial misalignment restrictions than spiral-bevel gears. It was estimated that a 40-percent weight reduction resulted from the split-torque, face-gear design compared to a conventional design. The conventional design weight used for comparison above was based on a parametric upscale of transmission design technology existing at that time.

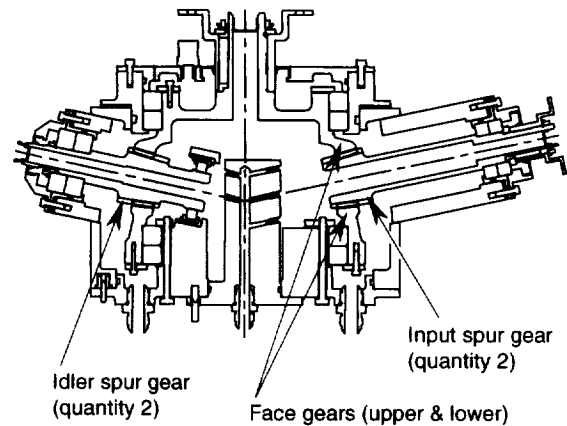
A design configuration which can be installed in existing aircraft much more readily than the preceding ART design is shown in Figure 2. This is

Figure 2. Split-torque, face-gear transmission from TRP program [12].

a concentric, split-torque, face-gear design developed during the DARPA Technology Reinvestment Program [12]. This reduced-scale test gearbox will be used in proof-of-concept test evaluations. For this concept, an involute spur gear also drives a pair of face gears and the power flow is split in two. For the upper face gear, the power flow is direct from the input spur gear to the face gear. For the lower face gear, however, the power flow is from the input spur gear through the lower face gear, to an idler spur gear, and then the upper face gear. This configuration allows a large power capacity in a relatively small package. Assuming a full size production design, this concept has an estimated weight savings of 25-percent compared to a modern technology conventional design. These two examples show the potential benefits for the use of face gears in helicopter transmissions.

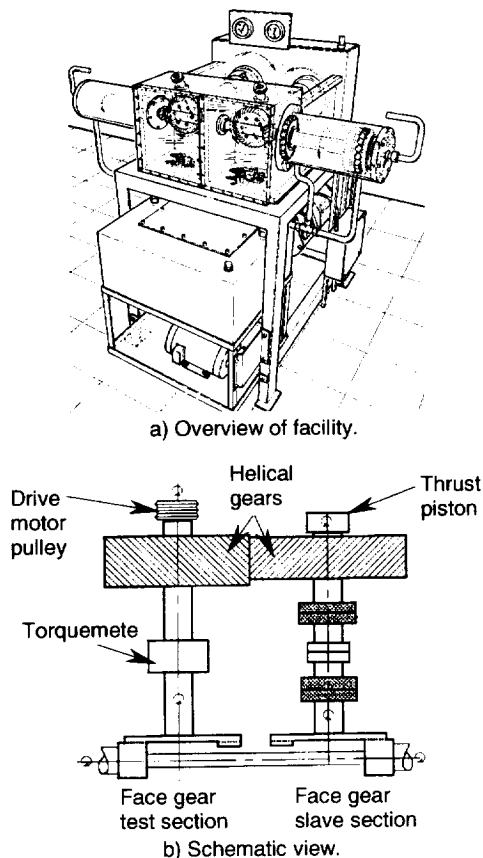
The experiments reported in this report were tested in the NASA Glenn spiral-bevel-gear/face-gear test facility. An overview sketch of the facility is shown in Figure 3a and a schematic of the power loop in shown in Figure 3b. The facility operates in a closed-loop arrangement. A spur pinion drives a face gear in the test (left) section. The face gear drives a set of helical gears, which in turn, drive a face gear and spur pinion in the slave (right) section. The pinions

Figure 3. NASA Glenn spiral-bevel-gear / face-gear test facility.

of the slave and test sections are connected by a cross shaft, thereby closing the loop. Torque is supplied in the loop by a thrust piston which exerts an axial force on one of the helical gears. A 75-kW (100-hp) DC drive motor, connected to the loop by V-belts and pulleys, controls the speed as well as provides power to overcome friction. The facility has the capability to operate at 560 kW (750 hp) and 20,000 rpm pinion speed. A torque meter in the loop measures torque and speed. The facility is also equipped with thermocouples, oil flow meters, pressure transducers, and accelerometers.

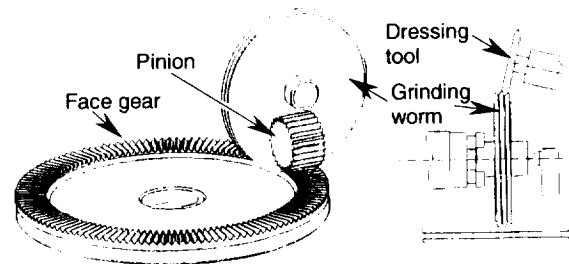
Figure 4. Face-gear grinding setup.

the face gear teeth in a setup similar to that shown in Figure 4. The worm wheel rotational axis was located perpendicular to the face gear axis at an offset distance. During grinding, the worm rotated about its axis as it translated across the face gear teeth along a nearly radial line. The translation was at a small angle to the true radial line and related to the lead angle of the worm. The face gear work piece also rotated slowly during grinding so that all teeth were generated synchronously after multiple turns of the face gear as the grinding worm slowly translated inward. An effective method of redressing the grinding wheel (without tooth undercutting) during the above process was also developed.

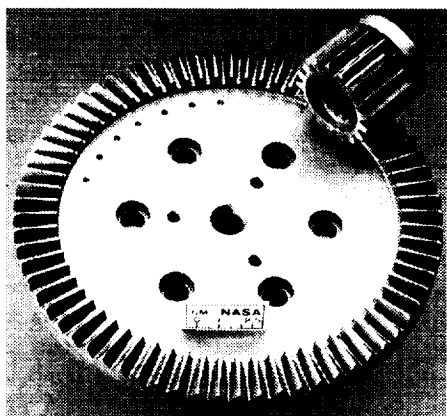
The design parameters for the pinions and face gears used in the tests are given in Table 1. A photograph of the test specimens is shown in Figure 5. This set was a hybrid between the ART program design and the TRP design. The set had a module of 2.54 mm (diametral pitch of 10 teeth/in) and a reduction ratio of 4.059:1. The face width of the face gears was 15.7 mm (0.620 in). The face width of the spur pinions was 32.6 mm (1.285 in). The shaft angle was 90 deg to accommodate the facility. The pinions were made from carburized and ground AISI 9310 steel using standard aerospace practices. The face gears were made from the same material and manufactured using the grinding procedure previously mentioned.

Figure 5. Test spur pinion and face gear.

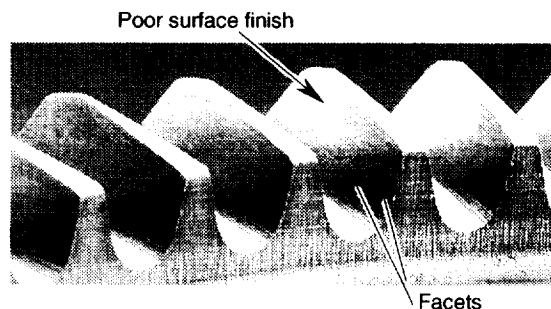
Due to the manufacturing problems previously mentioned, the face gears actually produced by the grinding procedure described above were not up to aerospace quality standards. The teeth had a

Figure 6. Development problems with initial ground face gear.

relatively poor surface finish as well as faceted areas (Figure 6). In order to improve the surface finish, the teeth were subjected to a super-finish process [13]. In this process, the gears were immersed in a container of small zinc chips, water, and aluminum oxide powder. The container was vibrated for a number of hours and the grade of oxide powder was increased in fineness in several stages. Figure 7 shows a face gear after such a process. Although

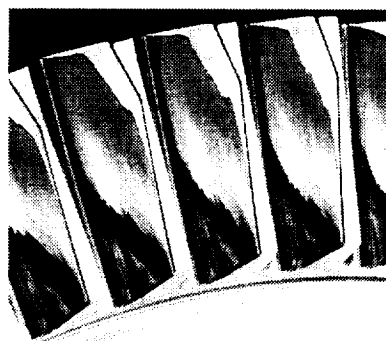
Figure 7. Super-finished face gear.

actual surface roughness measurements for the face gears tested were not available at the time, it was reported in [13] that a four to six-times improvement in surface finish was achieved on those specific gears studied.

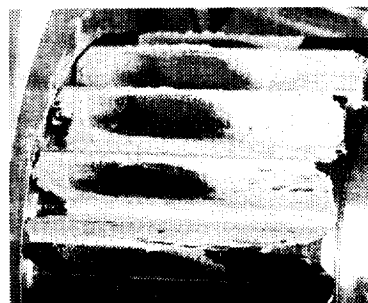
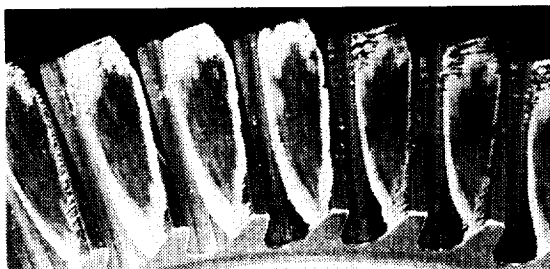
Although not as stringent as for spiral-bevel gears, proper pinion and face gear installation is crucial for successful operation. The installation procedure for the gears tested was as follows. First, the test-side pinion and face gear were installed in the facility (with no cross shaft connected to the pinion). The pinion was locked to ground and backlash measurements were taken for the mesh. A dial indicator was installed at the center of the face gear tooth, the face gear was manually rotated back and forth, and the backlash was recorded. After completion, marking compound was applied to the pinion and face gear teeth. No-load contact pattern checks were performed by manually rotating the pinion/face-gear assembly. If necessary, the shim located behind the face gear, which moves the face gear in the axial direction, was adjusted to achieve the proper backlash and contact pattern. This process was then repeated for the slave-side pinion/face-gear mesh. After proper shimming was achieved, the cross shaft was installed. Marking compound was then re-applied to all the pinions and gears and a loaded static roll test was performed. This was done by applying a moderate torque in the loop, manually rotating the complete assembly, and photographing the contact patterns. Figure 8 shows a typical example of a tooth contact pattern check for a loaded static roll test. Again, the objective of this procedure

a) Pinion.

b) Face gear.

Figure 8. Typical tooth contact pattern checks from loaded static roll tests during installation.

was to ensure the proper shimming to produce a tooth contact pattern that was centered on the pinion and face-gear teeth in order to avoid edge loading.

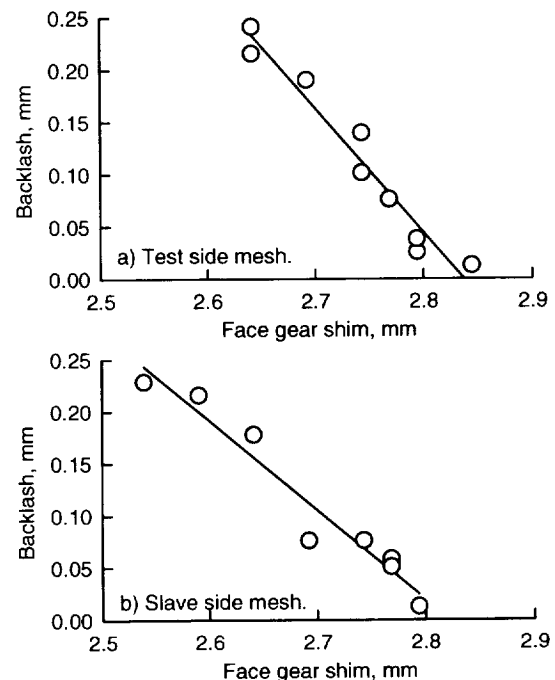
At the start of the project, it was unclear as to the proper value of shim that would produce the required backlash and contact pattern. To gain experience, a study was conducted to determine the effect of shimming on backlash and contact pattern. Here, various shims were installed while backlash and pattern checks were measured for the test and slave sections using the procedure described above. Figure 9 documents the effect of shimming on backlash. It should be noted that there was some

Figure 9. Effect of face-gear shimming on tooth backlash.

variability in the backlash measurement. Overall, there appeared to be a linear relationship between shimming and backlash for the selected range presented. Figure 10 shows the effect of backlash on tooth contact pattern. The results depicted are for the test side, but a similar trend resulted for the slave side also. Note that the figure contains hand-drawn sketches of the contact pattern. The purpose is not to quantitatively define the required magnitude of backlash, but to show an important trend in the installation process. If the backlash is too loose (higher number), the tooth contact approaches the inner-diameter edge of the face gear, possibly leading to edge contact. If the backlash is too tight (lower

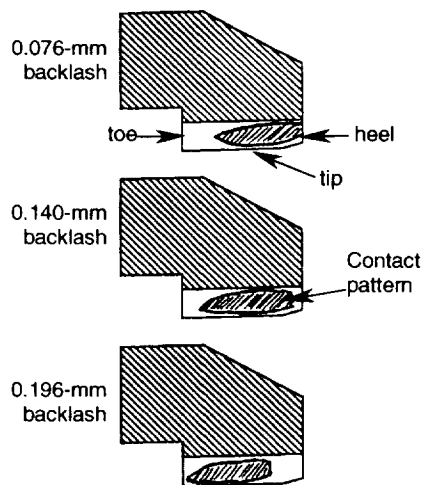
number), the tooth contact approaches the outer-diameter edge of the face gear, again possibly leading to edge contact. In addition, the clearance between the pinion and face gear could be critically reduced when the gears reach operating temperature if the backlash is too tight. This could result in jamming, coast-side contact, or scoring failure. From the experience of the tests performed, backlash in the range of 0.178 to 0.254 mm (0.007 to 0.010 in) produced acceptable tooth contact patterns.

Figure 10. Effect of face-gear shimming and backlash on tooth contact pattern (test side face gear).

- 2) Proper installation was critical for the successful operation of the spur pinions and face gears. Backlash too high produced tooth contact patterns that approached the inner-diameter edge of the face-gear tooth. Backlash that was too low produced tooth contact patterns that approached the outer-diameter edge of the face-gear tooth. Measured backlashes in the range of 0.178 to 0.254 mm (0.007 to 0.010 in) produced acceptable tooth contact patterns.

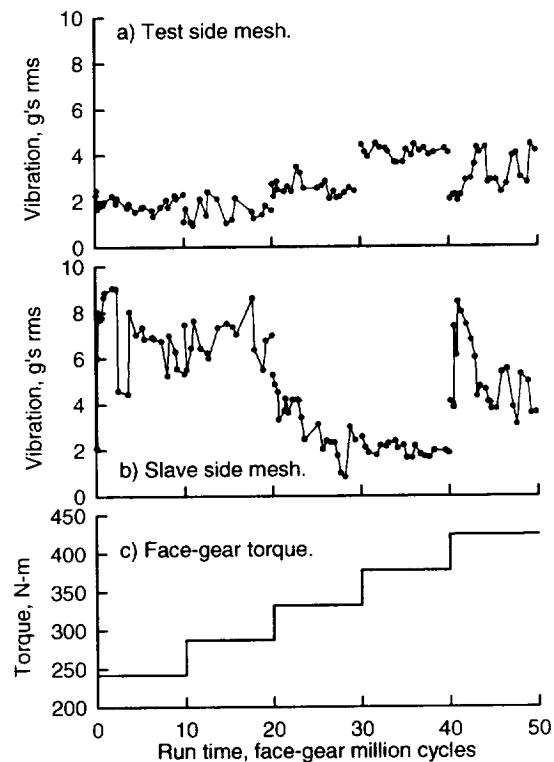
Figure 12 gives the maximum vibration as a function of run time for all the tests. The maximum vibration is defined as the maximum value of the spectrum, and usually occurred at the pinion/face-gear fundamental meshing frequency. Note that the vibration was rather sporadic during the tests. This is

not uncommon for vibration of high-speed machinery. Also, there appeared to be no definite trend of vibration with torque. This is consistent with previous studies performed on helicopter transmissions [14, 15]. From Figure 12b, a significant reduction in vibration for the slave side occurred at 20 million cycles. This was probably due to the replacement of a failed pinion shaft support bearing at the end of test 2. Also, significant changes in vibration occurred at 30 and 40 million cycles for both the test and slave sides (Figures 12a and 12b). This was probably due to installation of replacement pinions for tests 4 and 5.

Figure 12. Maximum vibration of spectrum as a function of run time.
