NASA/CP-1999-208982/PART1

The Second Joint NASA/FAA/DoD Conference on Aging Aircraft

*Charles E. Harris, Editor
Langley Research Center, Hampton, Virginia*

Proceedings of a conference sponsored by the
National Aeronautics and Space Administration,
Federal Aviation Administration, U.S. Air Force
Materiel Command, U.S. Naval Air Warfare
Center, and U.S. Army Research Laboratory, and
held in Williamsburg, Virginia
August 31 - September 3, 1998

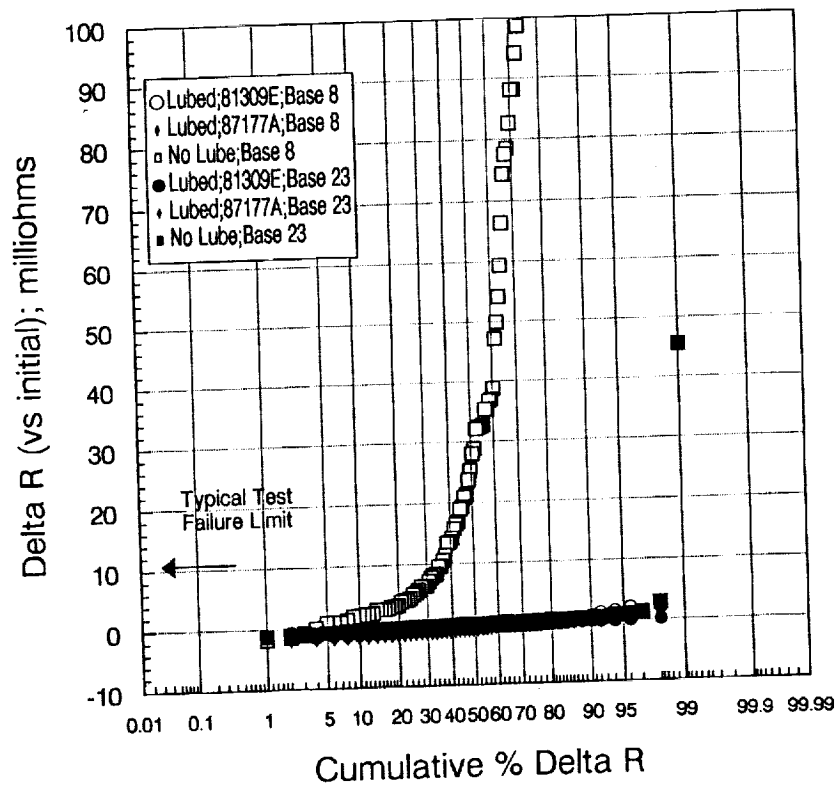
Figure 5. Contact resistance change of gold-plated connector test samples with and without lubricants; Base 8 and Base 23; exposed 1 year..

The significance of the data in Figures 5 and 6 is simply to emphasize what was stated earlier. This is that every effort should be made by whatever means to prevent ingress of ambient environments to connector interfaces. If this cannot be assured, and no supplemental protection such as lubrication is used, there is a reasonably high probability that corrosion will occur.

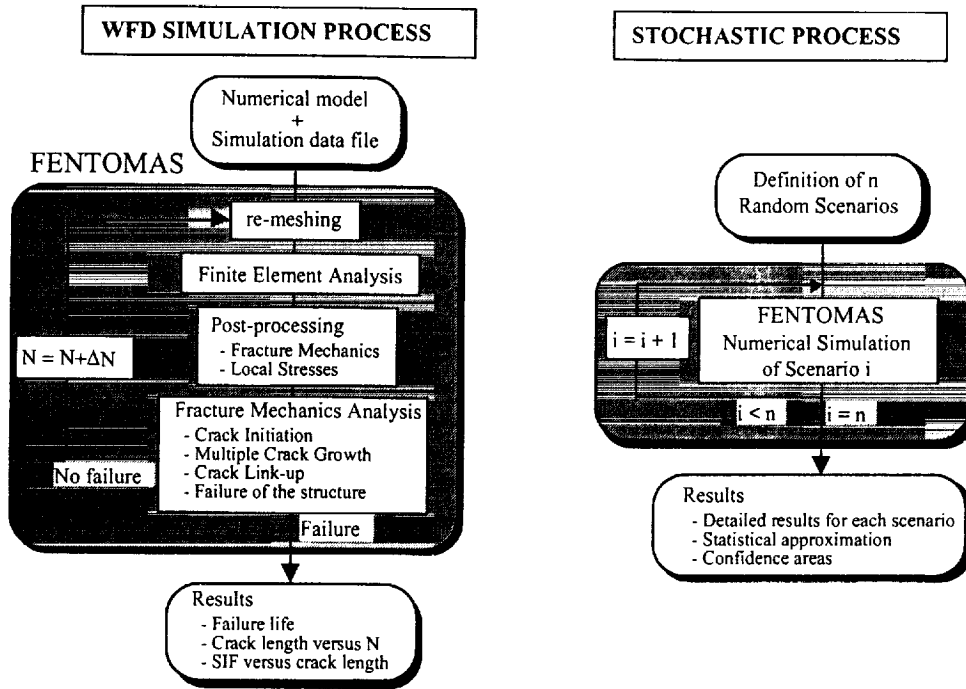
Figure 3 – Overall Assessment tool

Deterministic simulation can be achieved with the same tool by defining the initial scenario with set values. These values can come from the mean S-N curve, or any kind of failure probability S-N curve.

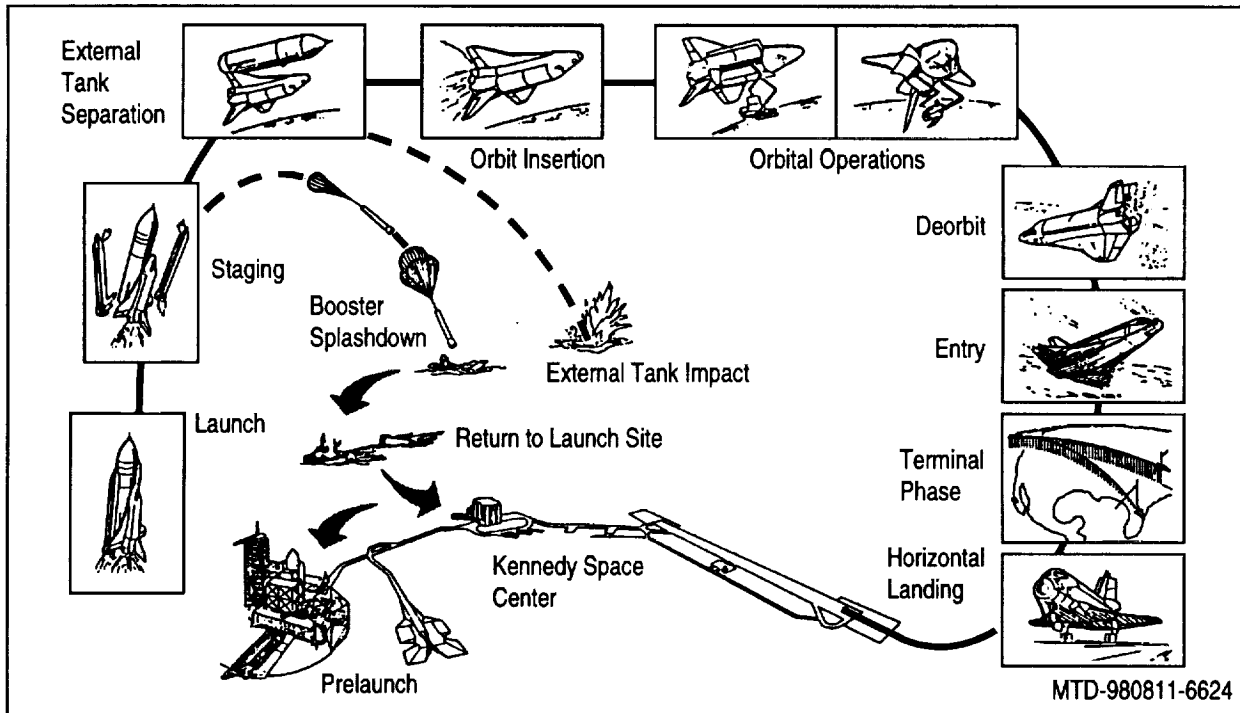
Figure 3. Typical mission profile

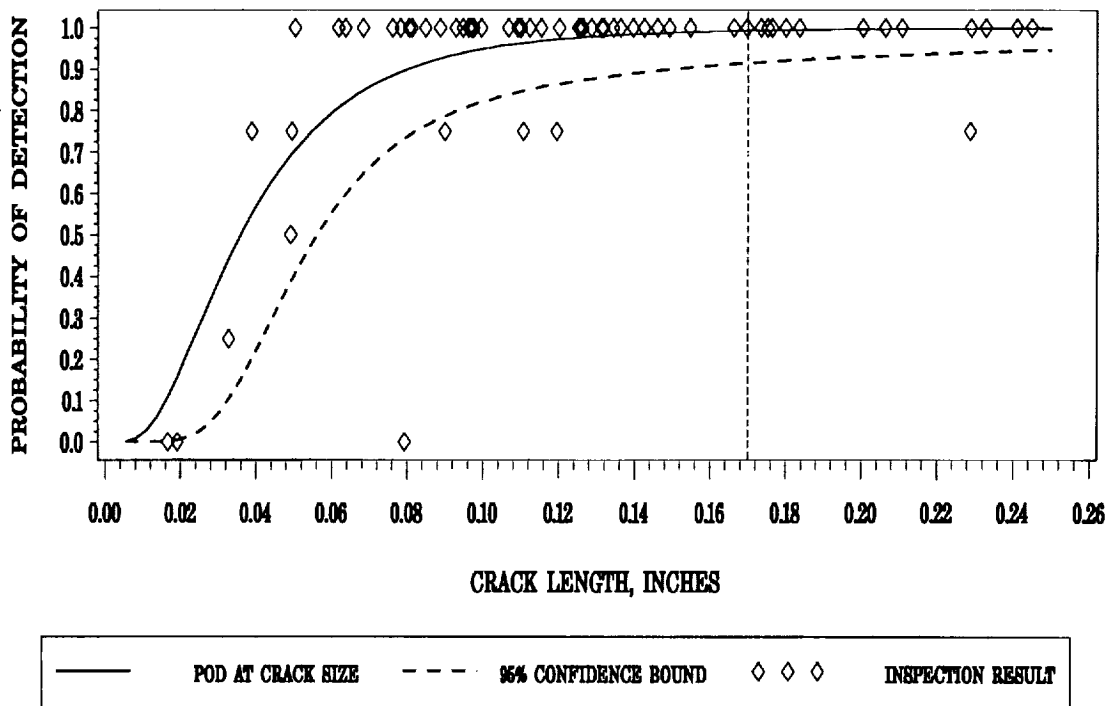
Figure 4. POD(a) for aluminum fastener material—all four inspectors

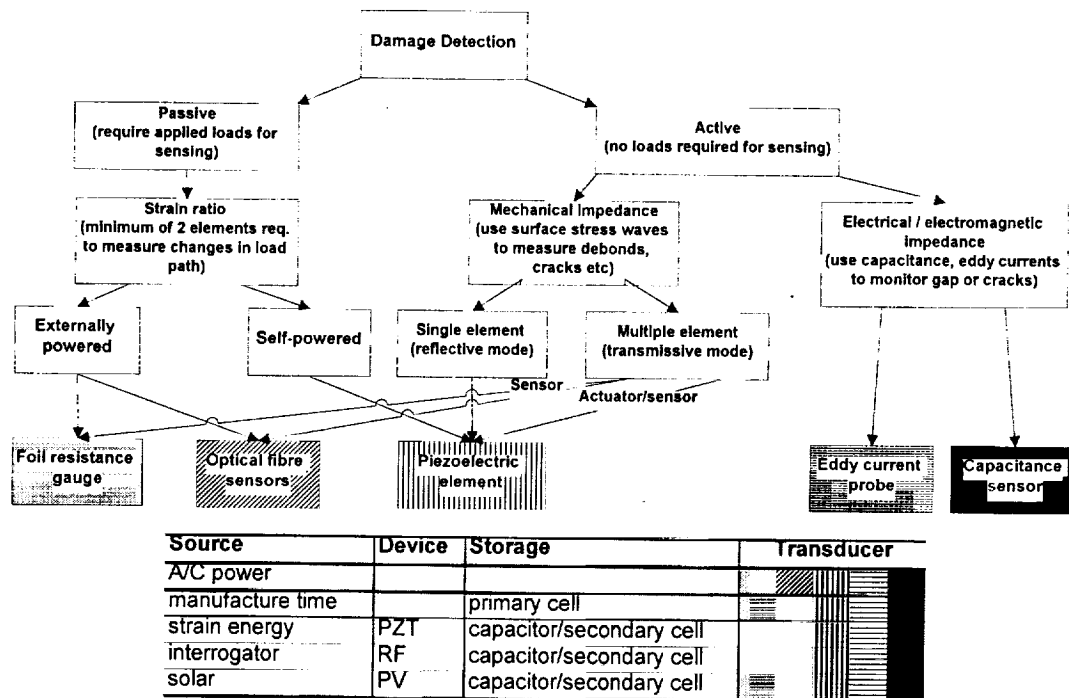
FIGURE 2: Flow diagram showing some more promising damage detection techniques, with possible corresponding transducers and power sources.
