MECHANICAL BEHAVIOR OF SAPPHIRE REINFORCED ALUMINA MATRIX COMPOSITES AT ELEVATED TEMPERATURES

Martha H. Jaskowiak and Jeffrey I. Eldridge
NASA Lewis Research Center
Cleveland, OH

ROOM TEMPERATURE TENSILE BEHAVIOR AND DAMAGE ACCUMULATION OF HI-NICALON REINFORCED SiC MATRIX COMPOSITES

G.N. Morscher*, Case Western Reserve University, Cleveland, OH

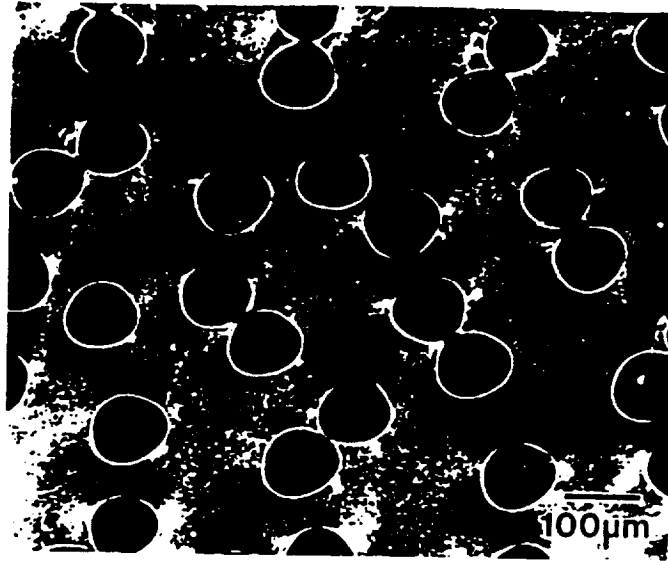
Figure 1. Cross section of as-fabricated composite displaying random distribution of ZrO₂ coated sapphire fibers.

A cross-section of the as-fabricated composite (fig. 1) displays the random distribution of the sapphire fibers. The sol-gel derived ZrO_2 coatings remain intact on the fiber surface after winding and composite fabrication. Throughout the study of these composites it was attempted to keep the fiber volume fractions at a constant level of approximately 30 %. In the current set of composites fabricated for high temperature testing, however, fiber volume fractions were slightly lower than the desired levels. Fiber volume fractions ranged from 25 to 27 %. The thermal stability of the zirconia coated fibers is displayed in fig. 2. Uncoated and zirconia coated sapphire filaments were heat treated under similar conditions and subsequently tensile tested in air at room temperature. Each data point represents approximately 15 to 20 single fiber tests with a 0.64 cm (0.25 in) gauge length. After thermal exposure at 1400°C for 100 hours the coated fibers possess tensile strengths similar to those of the uncoated fibers treated under the same conditions. Therefore, for the temperatures and times studied in this work, the zirconia coatings did not cause any additional degradation of the fiber strength.

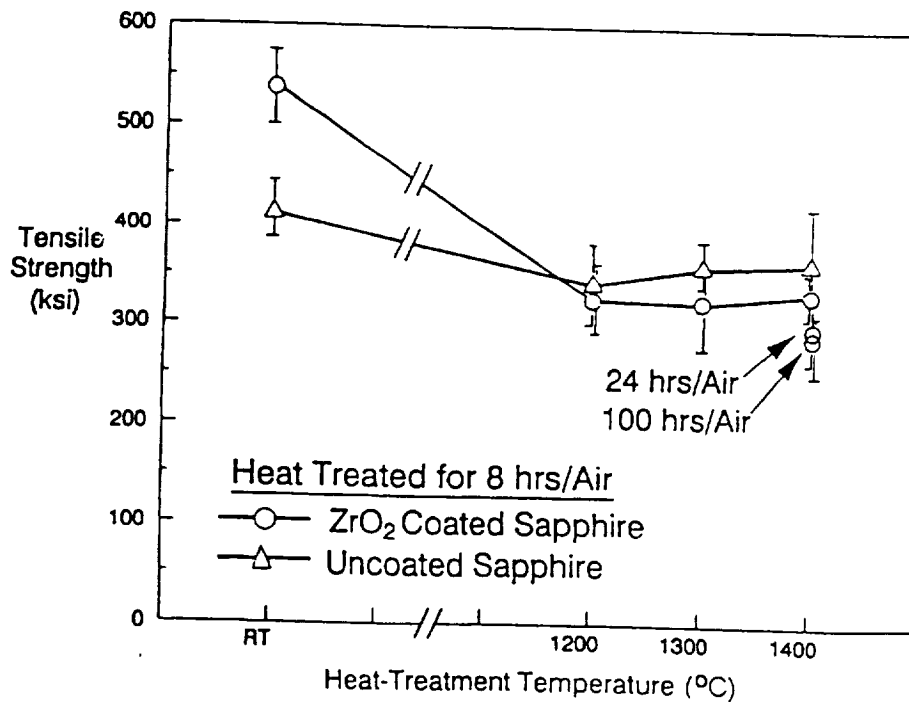
Figure 2. Room temperature residual tensile strengths of ZrO₂ coated and uncoated sapphire fibers after heat treatment in air.

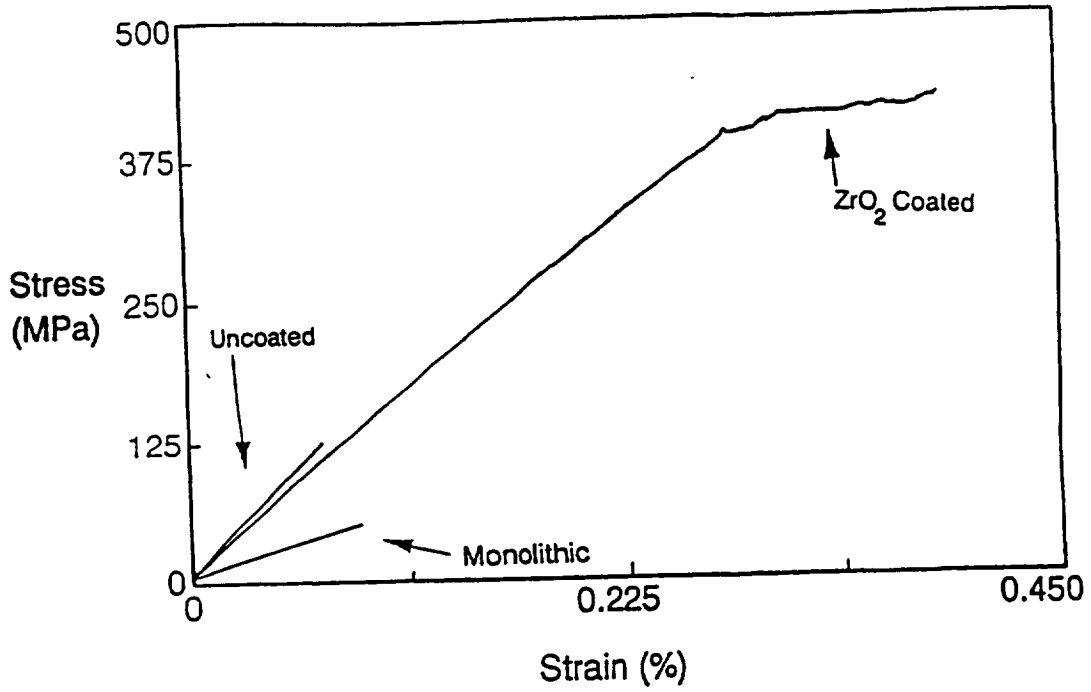
Figure 3. Stress vs. strain curves for room temperature tensile tests of as-fabricated monolithic alumina and alumina matrix composites reinforced with either uncoated or ZrO₂ coated sapphire fibers.

The ability of the zirconia coatings to limit interfacial bonding and therefore improve composite toughness and strength is dramatically represented in the stress versus strain curves of fig. 3. Without fiber coatings the composite fails in a brittle manner with no fiber pull out. Average tensile strength for these composites was 130 ± 49 MPa. The utilization of a zirconia fiber coating in this system resulted in a substantial increase in both composite stress and strain. Average tensile strength rose to 421 ± 36 MPa. Modulus for these composites was 158 ± 9 GPa. Although heat treatment of these composites resulted in grain growth of the zirconia fiber coating, the interface maintained its ability to provide crack deflection and fiber pull out. Composite tensile strength was measured at 306 ± 22 MPa after treatment at 1400°C for 200 hrs in air (fig. 4). This value represents a strength retention of approximately 73 % of their as-produced strength.

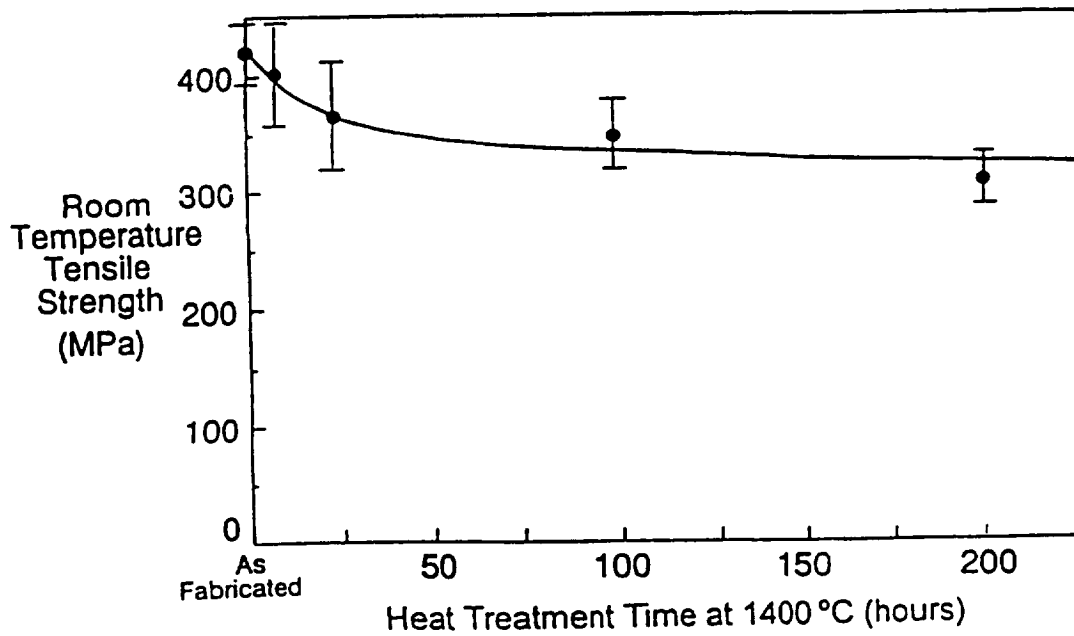
Figure 4. Room temperature residual tensile strengths of ZrO₂ coated sapphire fiber reinforced Al₂O₃ matrix composites after heat treatment in air at 1400°C.

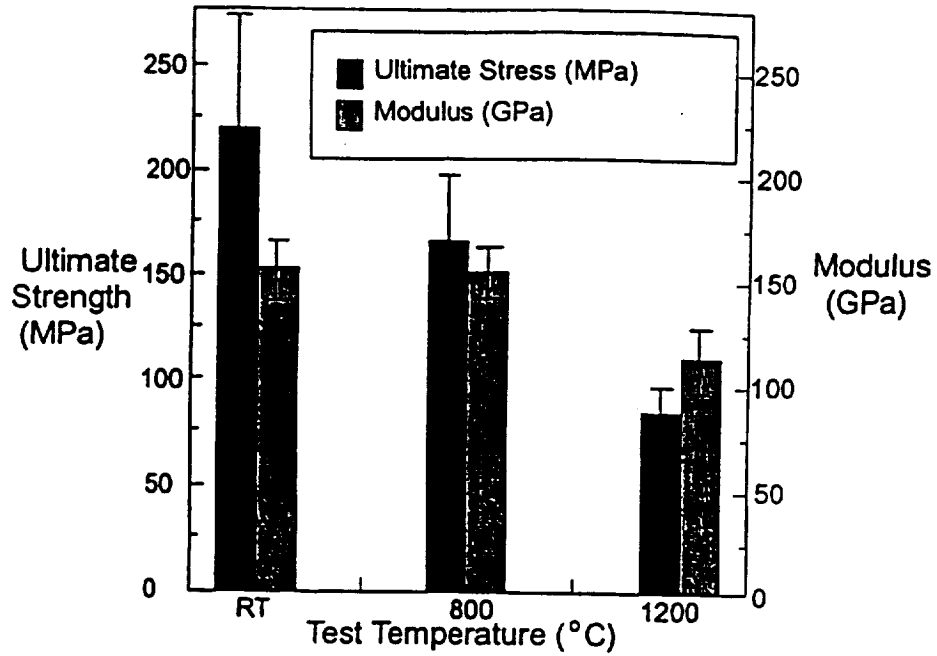
Figure 5. Tensile strengths and moduli of ZrO_2 coated sapphire fiber reinforced alumina matrix composites tested at temperature in air.

Tensile strengths and moduli of the composites tested at room temperature, 800°C and 1200°C are displayed in fig. 5. The as-fabricated tensile strength of these composites, 215 ± 70 MPa, was slightly lower than anticipated. This difference in as-fabricated strengths between these composites and those previously measured is due largely to the lower fiber volume fractions of the composites in this study. Although fiber volume fractions of 30 % or higher were desired, the current fiber volume fractions were on the order of 25 to 27 %, while the previously tested samples had fiber volume fractions of 33 to 35 %. The lower fiber volume fractions were the result of subtle differences in matrix processing which resulted in higher yields from the alumina slurry and thicker tapes. In fig. 5, the composite tensile strength decreases from 215 MPa at room temperature to 86 MPa at 1200°C . Since the composite tensile strength is a fiber dominated property, the decrease in composite strength can be directly correlated with fiber behavior at these temperatures (fig. 6). Sapphire fibers suffer strength losses until they reach a level of approximately 689 MPa (100 ksi) at temperatures beyond 1200°C . It is anticipated that at higher test temperatures (from 1200 to 1400°C), the composites would also maintain a baseline strength similar to the behavior of the fibers.

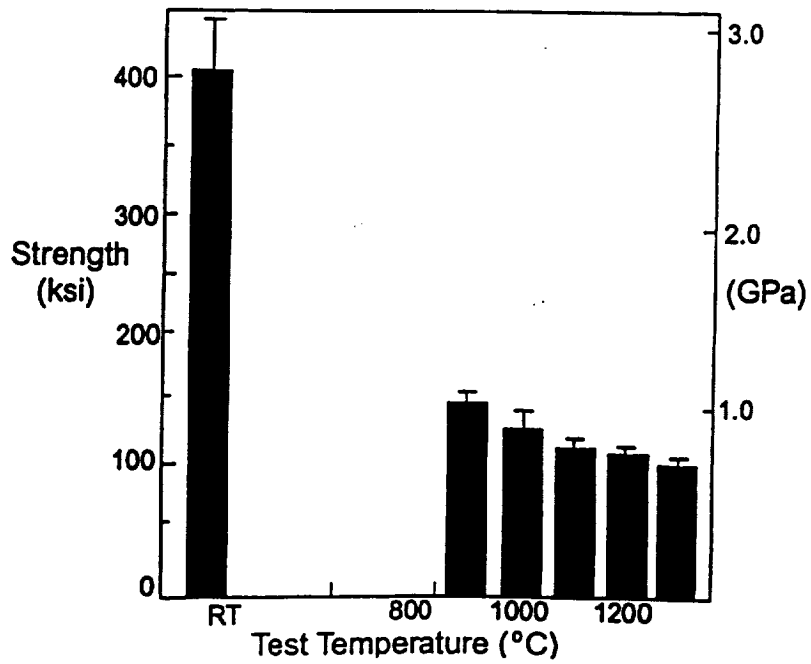
Figure 6. Tensile strengths of sapphire fibers tested at temperature in air.

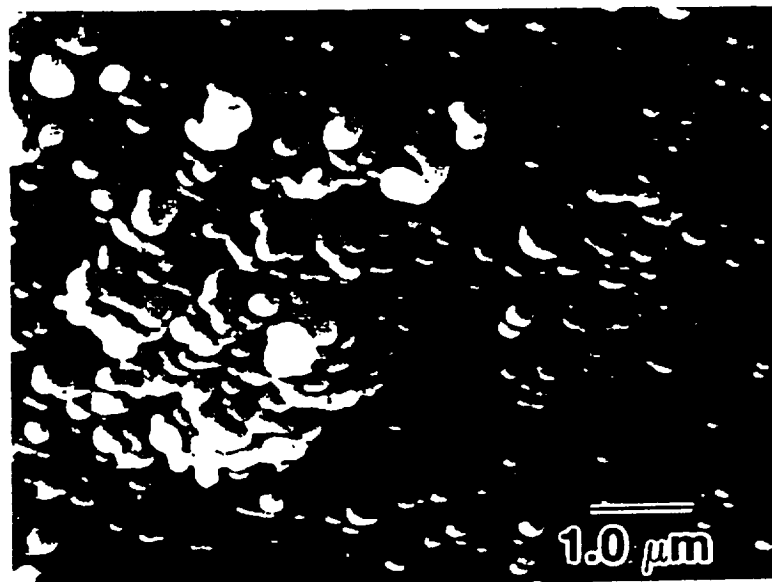
Figure 8. Surface of sapphire fiber pulled out of matrix during composite tensile test. Lighter phase indicates residual ZrO_2 remaining on fiber surface. Very little pitting or surface damage present on fiber after composite testing and fabrication.

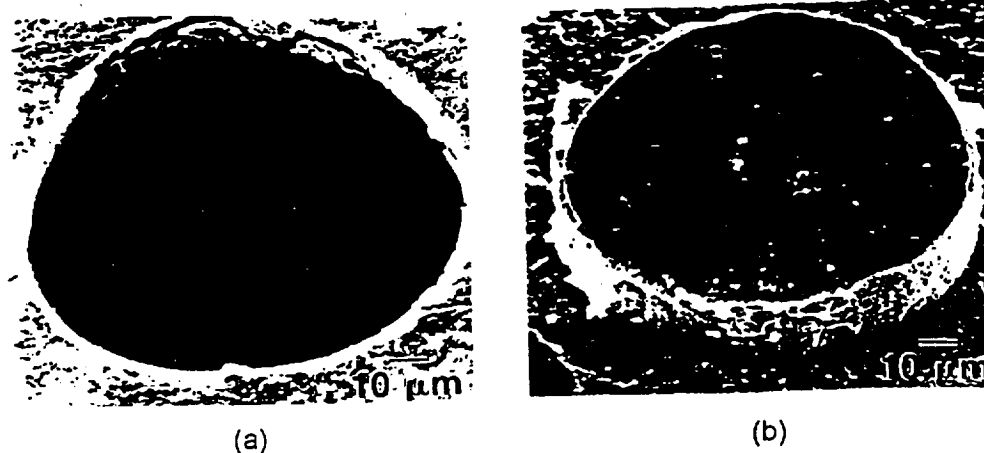
Figure 11. Room temperature fiber push-out test showing both the a) top or pushed in side and b) bottom or pushed out side of the composite.

Fiber push-out tests performed at room temperature resulted in debonding and sliding of the fibers without matrix or fiber cracking (fig. 11). The load versus displacement curve of fig. 12 displays a linear region up to point (1). At this point, debonding begins. The non-linear region of the curve up to point (2) may indicate crack propagation at the fiber/matrix interface. Finally, a linear region after point (3) indicates frictional sliding of the fiber. At room temperature, similar debonding and frictional shear stresses were measured, both in the 50 to 60 MPa range (fig. 13). The average interfacial shear stress measured at 800°C was 62 ± 7 MPa. By using previously derived equations for the case of multiple matrix cracking (ref. 12), and crack spacings of 332 and 208 microns, interfacial shear stresses were estimated as 40 and 55 MPa for the composites tensile tested at room temperature and 800°C, respectively. Both values support the empirically derived values for these test temperatures.

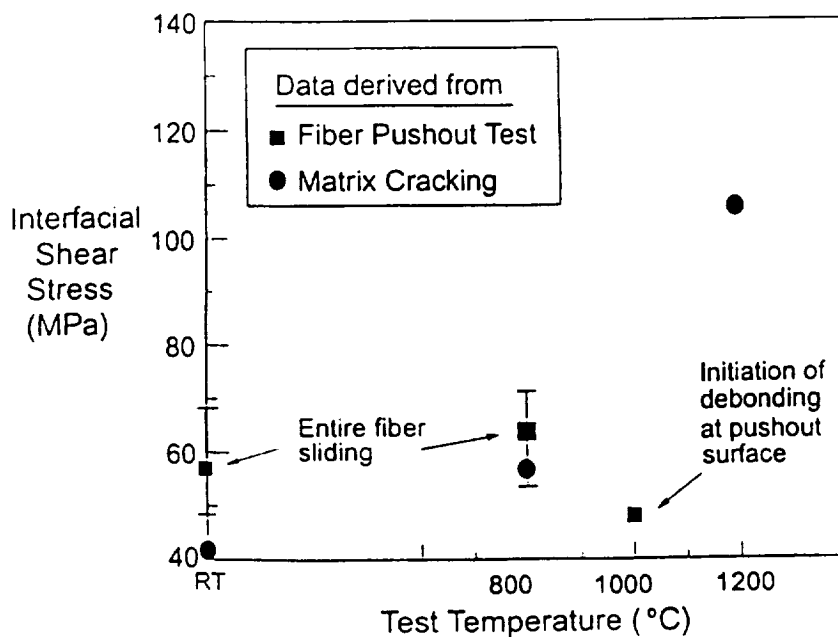
Figure 13. Interfacial shear stress as a function of test temperature. Data derived from either individual fiber push-out tests or matrix crack spacing measured from composite fracture samples tested in tension.

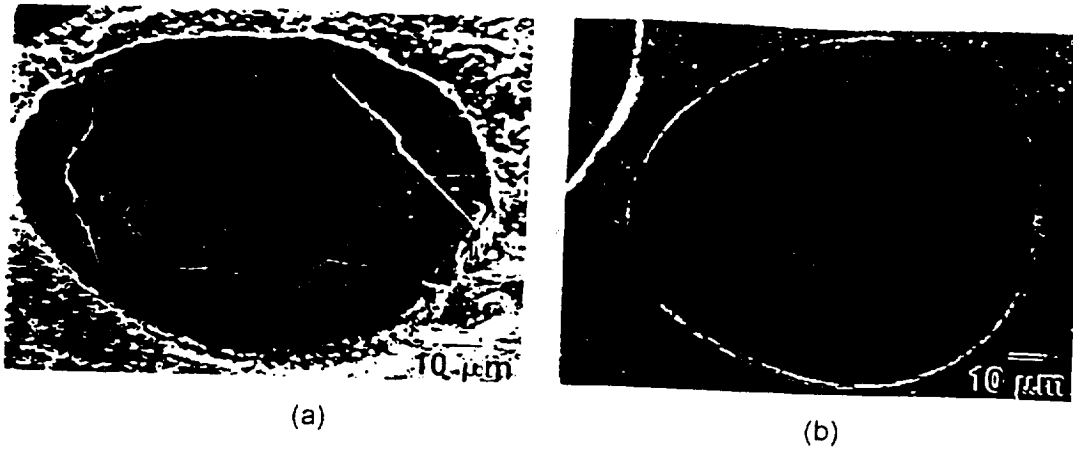
Figure 14 Fiber push-out sample tested at 1000°C; a) pushed in side showing plastic deformation caused by indenter, b) pushed in side showing crack propagation through the ZrO_2 coating

At 1000°C it became impossible to push the fibers out of the matrix because of plastic deformation mechanisms which become active in sapphire at these temperatures. Micrographs of the pushed in side of the fiber show the imprint of the indenter and evidence of possible twinning in the sapphire (fig. 14a). The other side of the push-out sample showed no evidence of the fiber being dislodged or of debonding in the interfacial region. Essentially the fiber was compressed leaving the other side of the sample completely featureless. Careful examination of the fiber from the pushed in side shows that debonding has occurred within the interface (14b). It is believed the initiation of debonding was detectable on the load versus time curve (fig. 15). Plastic deformation that occurred within the sapphire after this point made it impossible to measure further debonding or frictional shear stresses. Therefore the shear stress assigned to the 1000°C push-out tests, approximately 50 MPa, merely represents the initiation of debonding, not sliding of the entire fiber as was the case for the tests at room temperature and 800°C. By further examination of the 1000°C push-out samples in the SEM, it was observed that the zirconia remains capable of producing crack deflection around the fibers (fig. 16). Even though the push-out tests at 1000°C were not capable of providing quantitative information regarding debonding and frictional shear stresses, useful

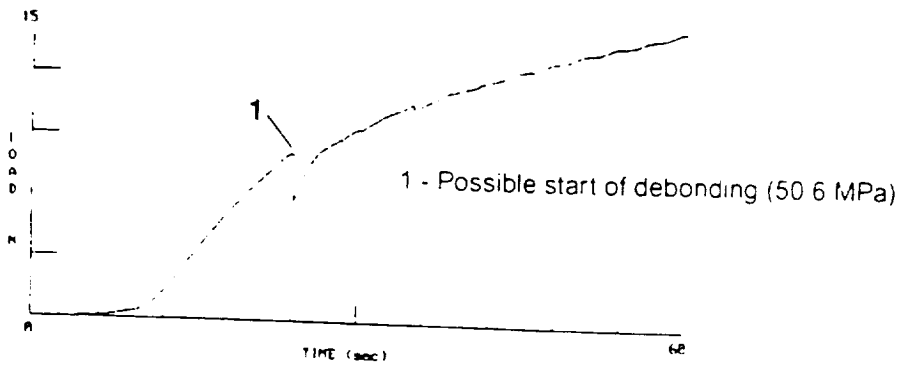
Figure 15 Load versus time curve for 1000°C fiber push-out test. Only initiation of debonding could be identified

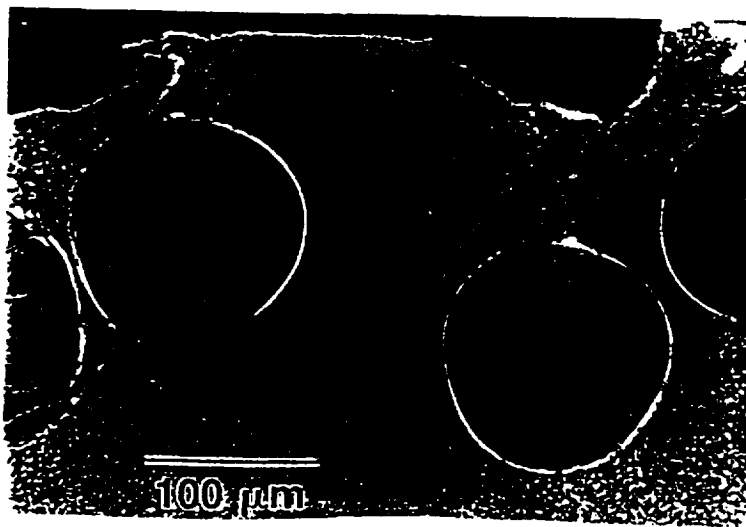
Figure 16 Crack deflection and fiber debonding which occurs during fiber push-out tests at 1000°C

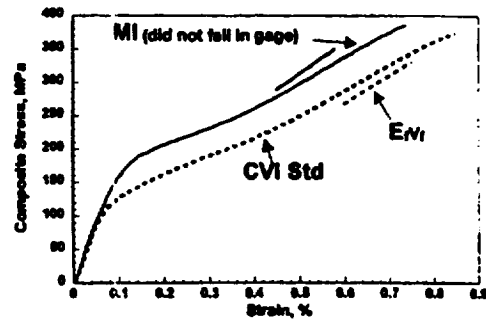
Figure 2: Monotonic stress-strain curves for MI SiC and CVI SiC composites.

Typical monotonic tensile stress-strain curves are shown in Figure 2 for the two composites. The stress-strain behavior is very similar to that shown by other researchers for Nicalon/SiC woven composites^[8-10]. Both composites failed at similar stresses (~ 380 MPa); however, the MI composites always failed in the grips whereas the CVI composites always failed in the gage section. The "knee" in the stress strain curve occurs at a lower stress for the CVI SiC composites and the strain to failure of the CVI SiC composites is greater than the strain to failure of the MI SiC composite. The mechanical properties of the two composites are listed in Table II.

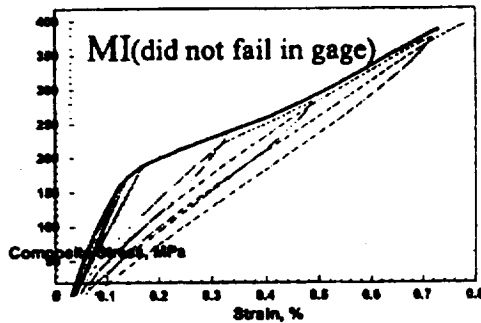
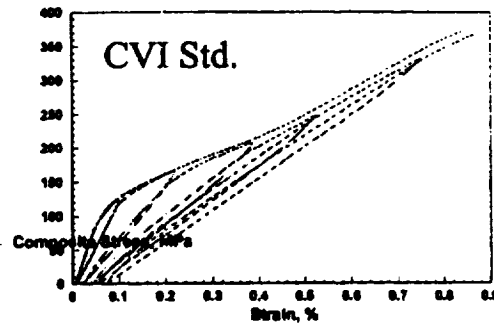
Figure 3: Monotonic and unload/reload hysteresis tensile stress-strain curves for MI (a) and CVI (b) composites.

Figures 3a and b show monotonic and hysteresis stress-strain curves of the two composite systems. The monotonic and hysteresis stress-strain curves are almost identical for both composite systems. The hysteresis stress-strain curves have slightly larger strains for the same stress compared to the monotonic stress-strain curves. For the hysteresis experiments, AE activity occurred in the gage section upon initial unloading and at the end of the subsequent reloading. This indicates a greater amount of damage in the hysteresis specimens^[11] and could account for the increased strain incurred for hysteresis tensile tests.

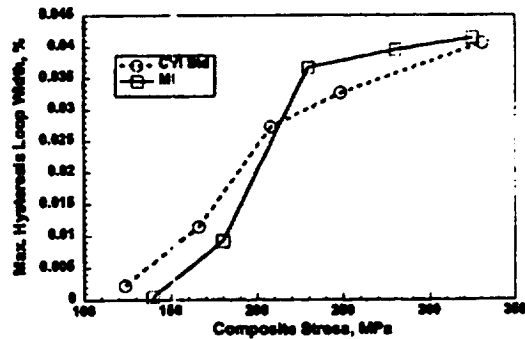
Figure 4: Hysteresis loop width for the two composites versus the peak stress of the hysteresis loop.

The maximum loop width was determined for each unload/reload hysteresis loop at the stress which was half the maximum stress of the specific loop (Figure 4). The onset of 0° cracking is considered to occur when the hysteresis loop width is greater than zero. This occurs at ~ 110 MPa for CVI SiC composites and ~ 140 MPa for the MI SiC composites. It is also interesting to note that the loop width of the MI SiC composites were greater than that of the CVI SiC composites at higher stresses. It was observed from polished sections of failed composites that CVI SiC composites had almost three times the number of cracks of

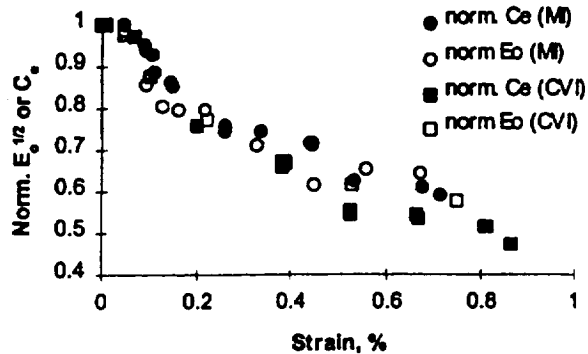
Figure 5: Normalized $E_e^{1/2}$, $(E_e(\epsilon)/E_e(\epsilon=0))^{1/2}$, and normalized C_e , $C_e(\epsilon)/C_e(\epsilon=0)$, plotted versus composite strain for the two composites from unload/reload hysteresis tensile experiments.

Figure 5 for the unload/reload hysteresis tensile tests where E_e was determined from the tangent modulus upon initial unloading of the hysteresis loop⁶⁾. There is excellent agreement between the reduction in modulus and the reduction in the speed of sound for both composites. In fact the modulus and speed of sound decreases are the same relative to the initial modulus (Table II) and speed of sound of the undamaged material for both composites, respectively. This is not too surprising since both composites appear to have reached or nearly reached matrix crack saturation and both composites failed at similar stress levels which would result in a similar overall stress distribution on the fibers over the entire gage length (assuming a constant interfacial shear strength).

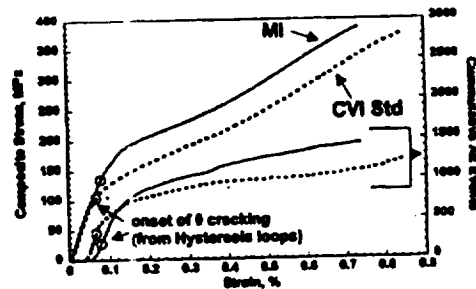
Figure 6: AE activity for monotonic stress strain curves of two composites.

Also noted on Figure 6 is the point on the stress-strain and AE event-strain curves where the onset of 0° cracking was determined (Figure 4). Note that ~ 350 AE events occurred prior to this stress in the CVI material and ~ 200 AE events occurred prior to this stress in the MI material. For the CVI material, the number of AE events occurring prior to the onset of 0° cracks accounts for over 25% of the total number of AE events occurring in the gage section. Evidently, a significant number of microcracks in the matrix and 90° bundles were formed in these materials prior to the extension or formation of cracks which significantly intersect the load-bearing fibers.
