NASA/TM-1999-209824

Liberty Bell 7 Recovery Evaluation and Nondestructive Testing

*Eric I. Madaras and William L. Smith
Langley Research Center, Hampton, Virginia*

December 1999

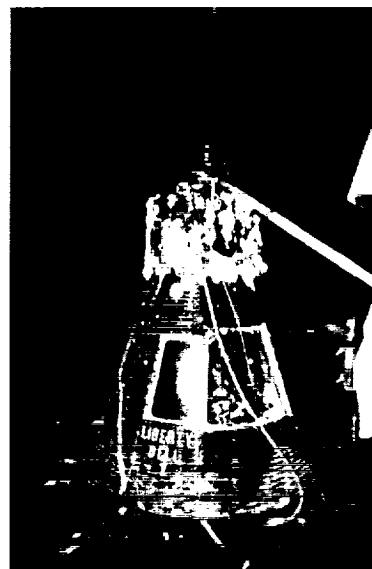
(b) View after being brought to surface.

Figure 1. *Liberty Bell 7* capsule. Photographs courtesy of Discovery Communications Inc.
