## CYCLIC OXIDATION OF FeCrAlY/Al<sub>2</sub>O<sub>3</sub> COMPOSITES

James A. Nesbitt, Susan L. Draper, and Charles A. Barrett  
NASA Glenn Research Center at Lewis Field  
Cleveland, Ohio

### Abstract

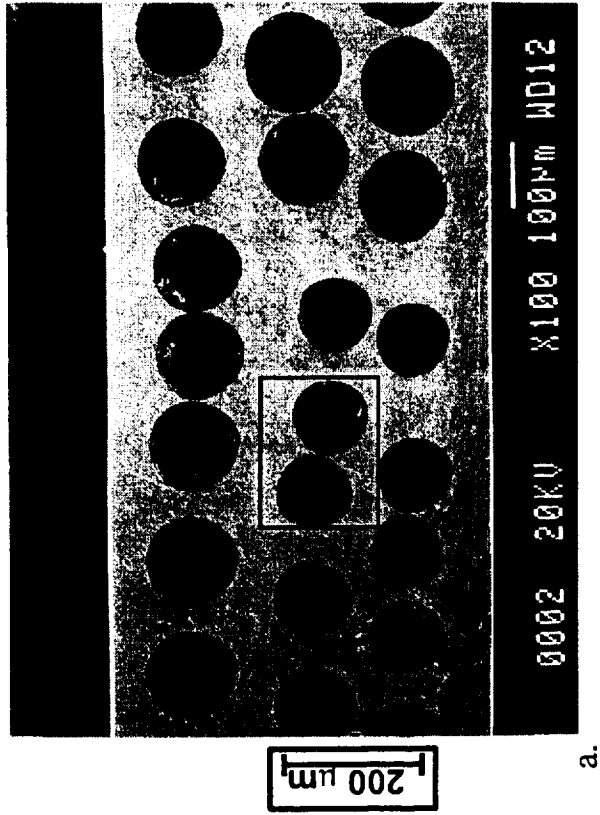
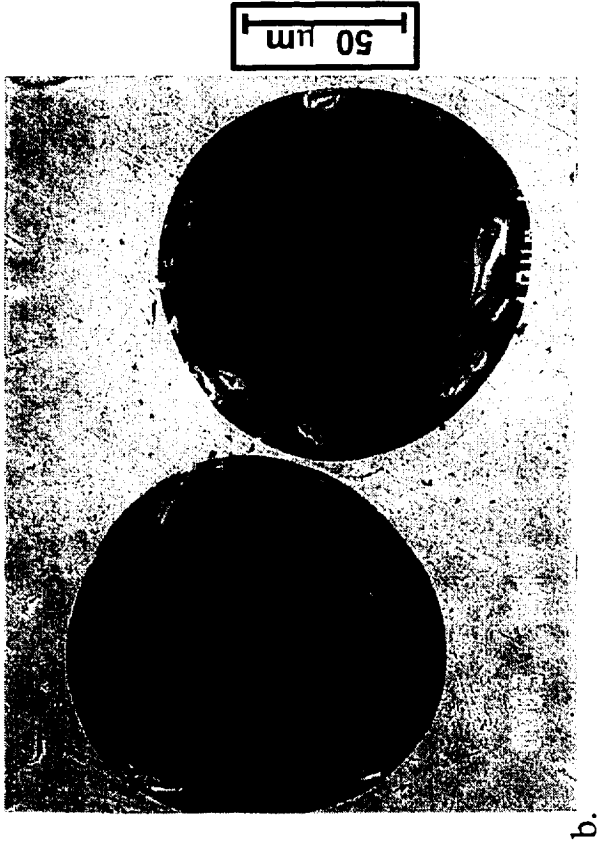
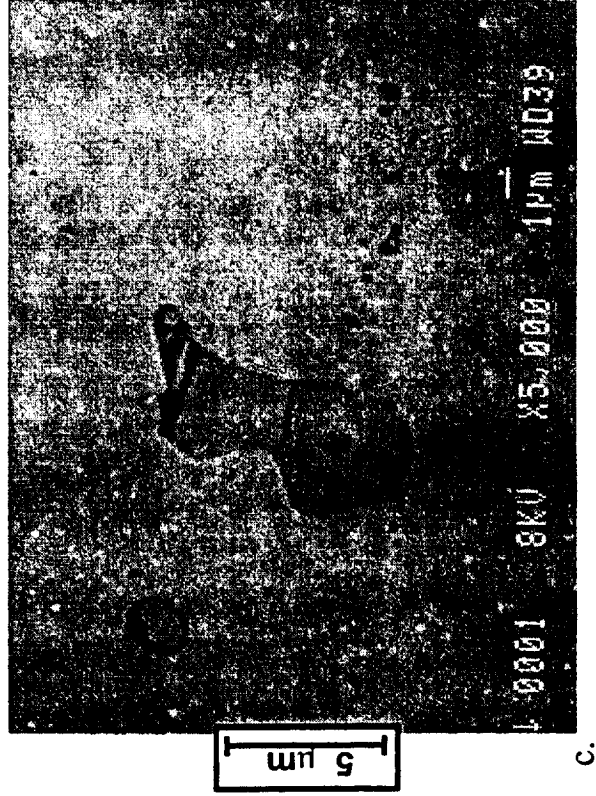
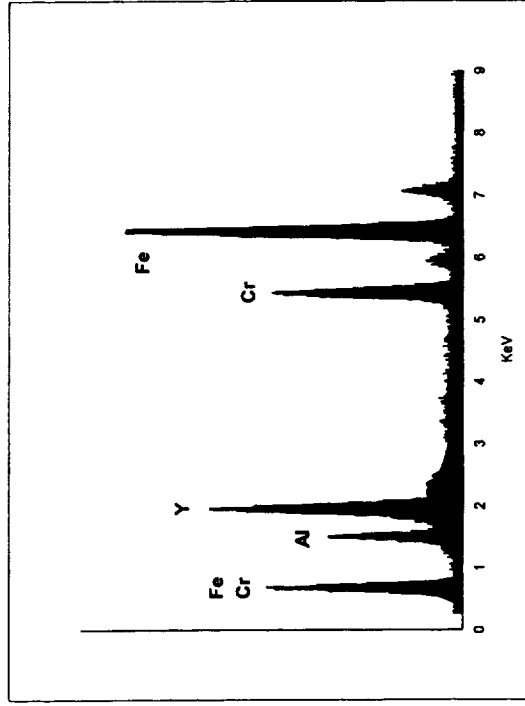
Fig 1 SEM micrographs of (a,b) the polished end of a composite sample showing the 3 plies and a magnified view of the fibers, (c) small Y-rich intermetallic particle in polished FeCrAlY matrix, and (d) EDS spectra of particle.

Fig 1 SEM micrographs of (a,b) the polished end of a composite sample showing the 3 plies and a magnified view of the fibers, (c) small Y-rich intermetallic particle in polished FeCrAlY matrix, and (d) EDS spectra of particle.

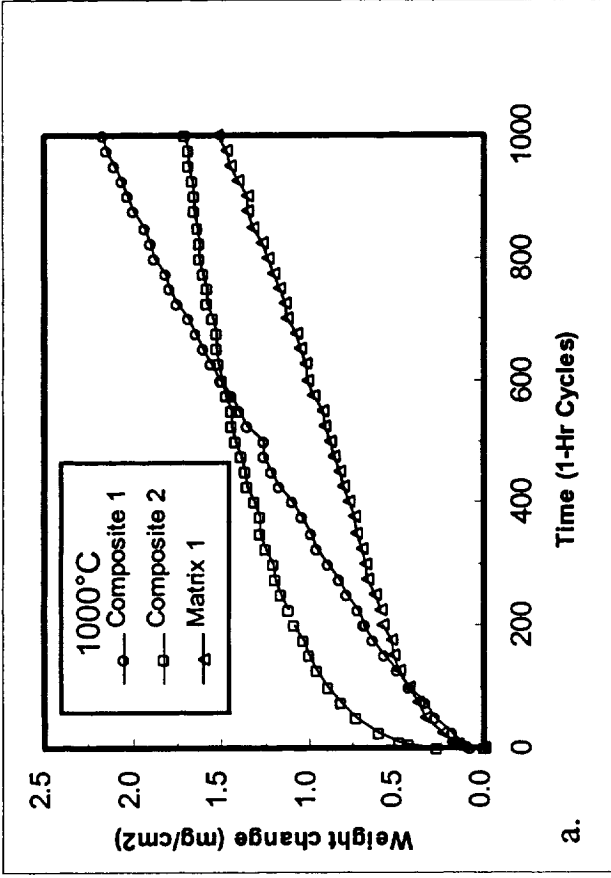
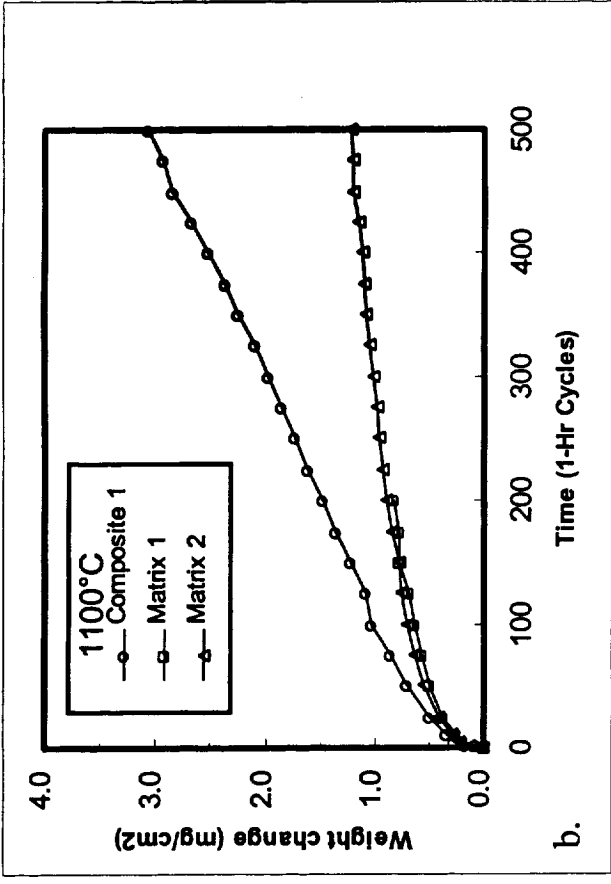
Fig 2 Specific weight change during cyclic oxidation at (a) 1000°C and (b) 1100°C. Mo-contamination in the upper right corner of the Matrix 1 sample tested at 1000°C is shown in (c).

After consolidation, individual samples were cut from the panel into approximately 1.2 x 2.4 x 0.066 cm samples. Samples were cut such that the fibers were aligned along the greater sample length. Hangar holes were machined through the matrix and fibers in one end of the sample (see Fig 2c for the typical sample geometry). The Mo foil, which had diffusion bonded to the panel surface, was removed by chemical etching. All surfaces were polished through 600 grit SiC paper and ultrasonically cleaned in acetone and ethanol. The end of one composite after polishing is shown in Fig 1. The FeCrAlY material was ferritic (BCC) with the presence of an occasional Fe/Cr yttride particle (Figs 1c,d). Energy dispersive spectroscopy (EDS) of the large polished surfaces of composite samples and matrix-only samples indicated some Mo contamination in certain regions of some samples. This Mo contamination produced a very obvious and distinct oxide on these samples which increased the weight change. The weight change for the Mo-contaminated samples is not reported except for a matrix-only sample discussed and shown below.

Specific weight change after cyclic oxidation at 1000° and 1100°C is shown in Figs 2a,b. At both temperatures, the composite gained more weight than the matrix-only samples. At 1100°C, the matrix-only material exhibited parabolic-like behavior (i.e., weight gain proportional to time<sup>1/2</sup>) typical of FeCrAlY materials with good Al<sub>2</sub>O<sub>3</sub> scale adherence. At 1000°C, the matrix-only sample showed an almost linear increase in weight with time after 200 cycles. This behavior is believed due to the Mo contamination and non-protective oxide formation on the corner of this sample (Fig 2c). The nearly linearly weight gains for the composites labeled as "1" in Figs 2a,b can be rationalized as the consequence of extra oxide growth around the exposed fibers and in cracks which developed in the matrix (see below). However, the unusually rapid initial weight gain and the following parabolic-like behavior of composite "2" in Fig 2a is unexplained. XRD of the large sides of the composite and matrix-only samples showed only the presence of  $\alpha$ -Al<sub>2</sub>O<sub>3</sub> on the surface at both temperatures (except for the regions of obvious Mo contamination).

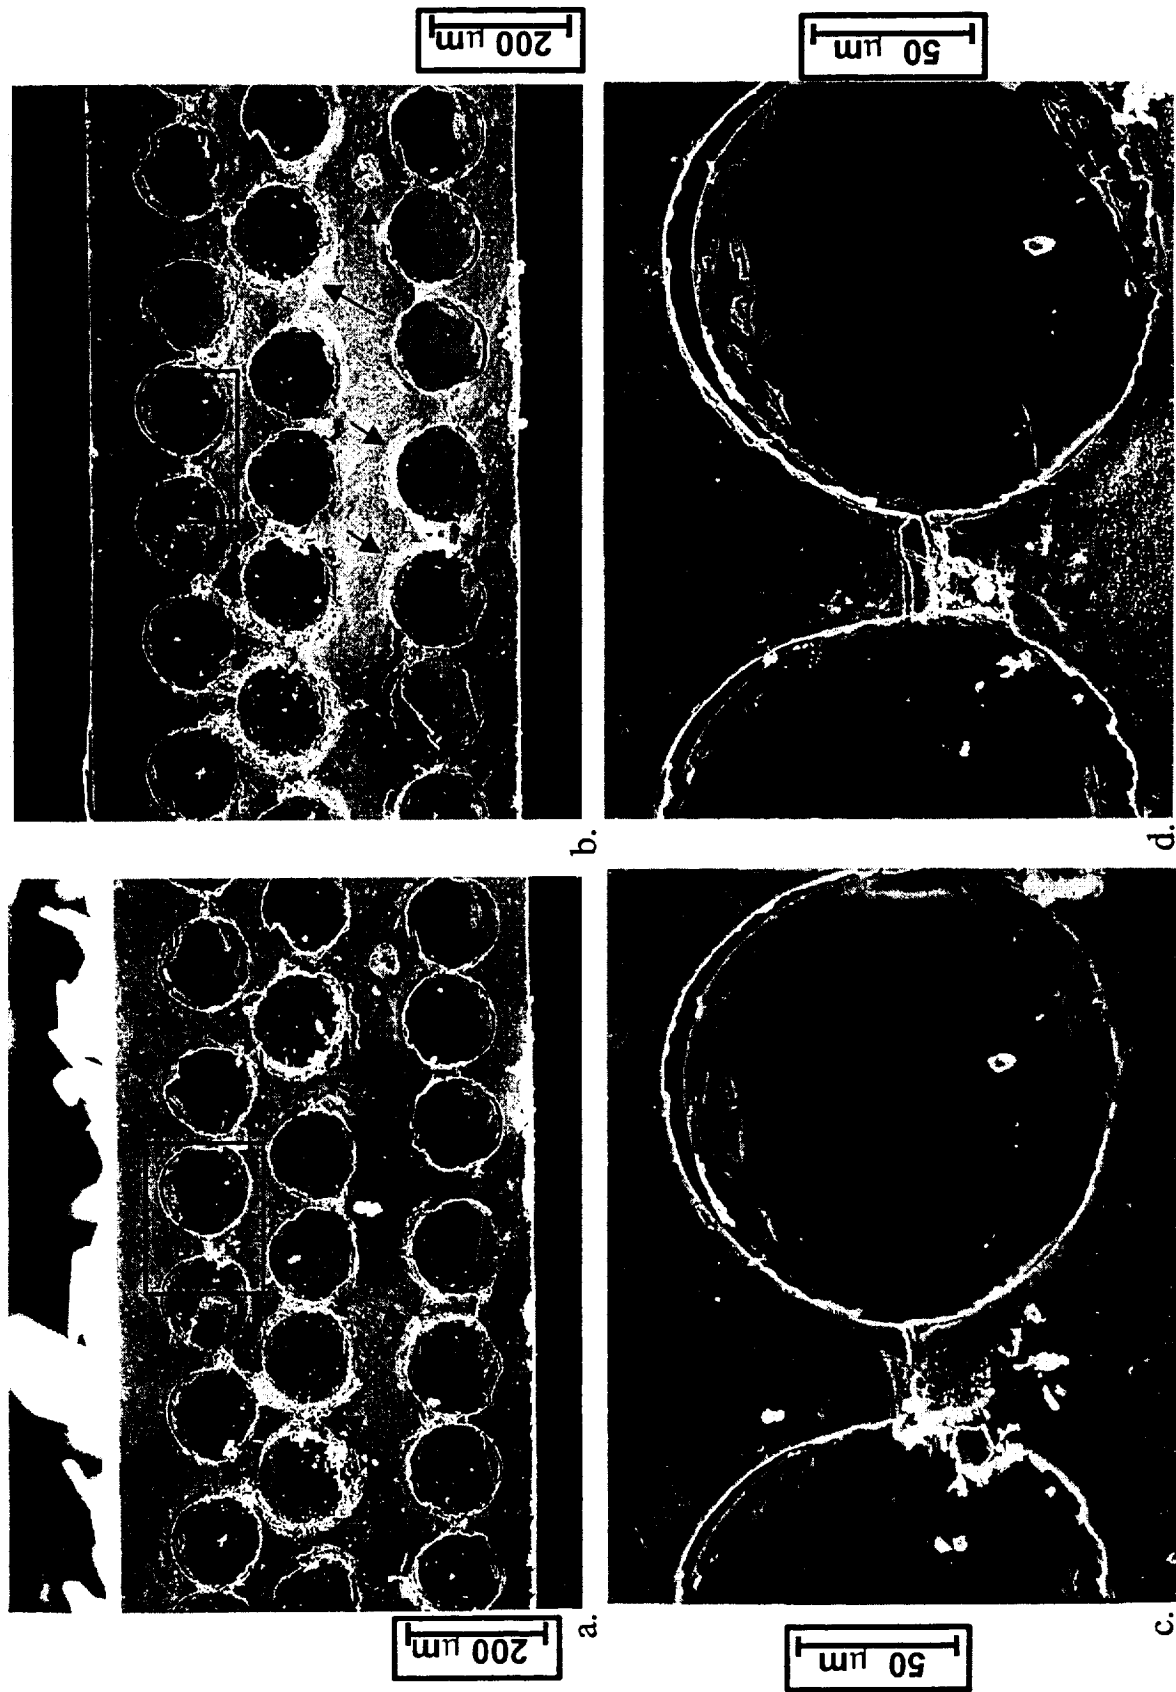
Fig 3 SEM micrographs of the same locations after (a,c) 50, and (b,d) 100 cycles. The location of the same two fibers in (c,d), after 50 and 100 cycles, are shown by the white rectangles in (a,b). Black arrows in (a,b) indicate areas of oxide spallation.

The same location on the end of the same composite sample after 50 and 100 cycles at 1000°C is shown in Fig 3. After 50 cycles, it is apparent that the protective Al<sub>2</sub>O<sub>3</sub> scale had spalled around some of the exposed fibers (see black arrows in Fig 3a). After 100 cycles, the extent of this preferential spalling around the fibers had increased (Fig 3b). It is interesting that most of this spallation had occurred around fibers in the middle ply or on the inner half of the fibers in the outer plies. Only one small area of oxide spallation, not associated with the fibers, was apparent (4 O'clock in Figs 3a,b). The size of this spalled area had not noticeably increased between 50 to 100 cycles. After only 50 cycles, gaps at the fiber/matrix interface were apparent around the outer half of many fibers in the outer fiber plies. The gaps appeared to have increased slightly between 50 and 100 cycles. Lastly, a crack was apparent between the two outer-ply fibers shown in Figs 3c,d. Although from this perspective it is impossible to know whether this crack was only in the oxide scale or penetrated into the matrix, it was apparent with further testing that large cracks between fibers did indeed penetrate into the matrix.

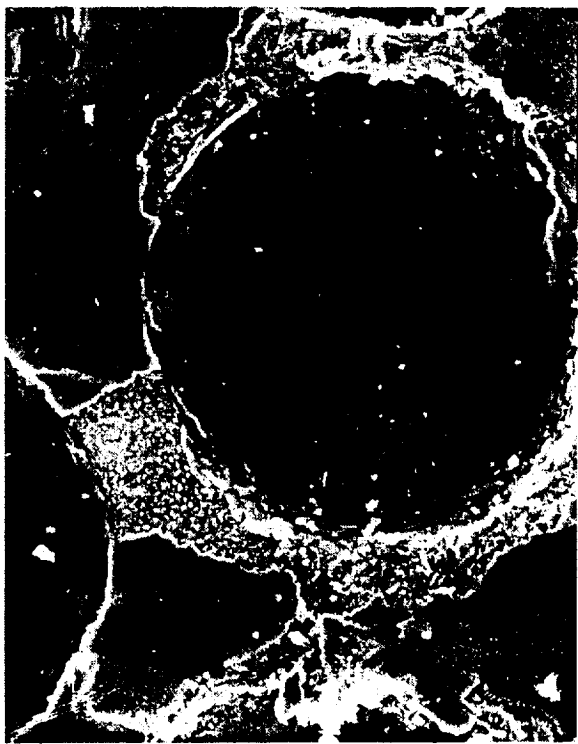
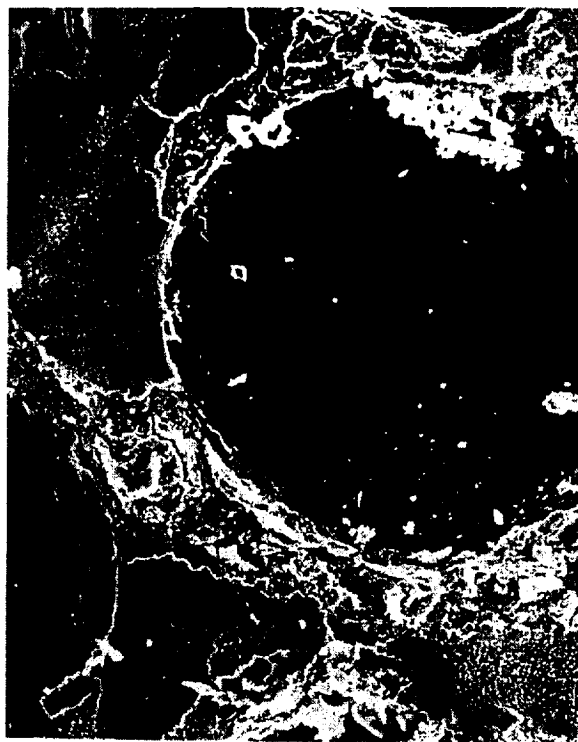
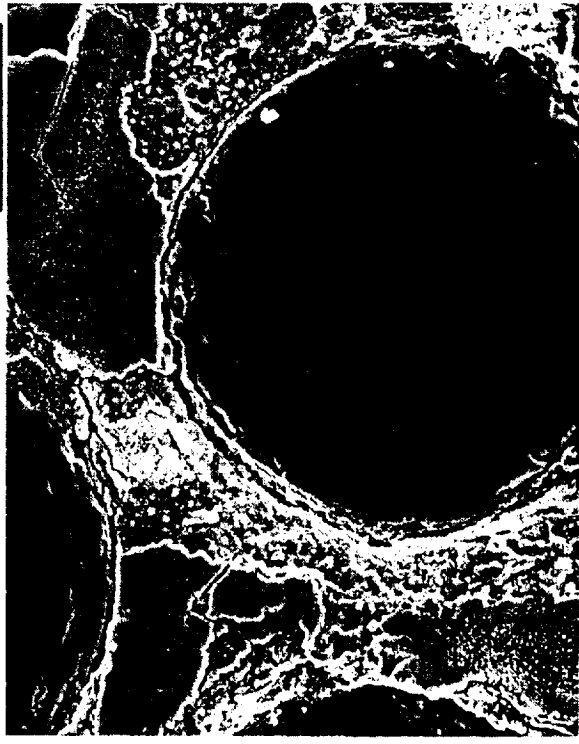
Fig 4 SEM micrographs of the same locations after (a) 50 cycles, (b) 100 cycles, and (c) 1000 cycles, 1000°C.

The micrographs in Fig 4 again show the same fiber located in the middle ply after 50, 100 and 1000 cycles at 1000°C. A region of spalled oxide between the two fibers (11 O'clock) in Fig 4a had been recovered with an oxide film containing a large crack after 50 additional cycles (Fig 4b). Several large regions of "virgin" oxide in Fig 4a contained cracks after longer exposures (e.g., compare the oxide plates at 10 O'clock and 1 O'clock in a, b and c). After 200 and 1000 cycles at 1000°C, some cracks between fibers in the outer plies appeared to link up either around or by having propagated through a fiber (Fig 5). Fe and Cr-rich oxides were sometimes observed to be growing from some of these cracks (Fig 6). Examining the exposed fiber ends from an oblique angle showed that the thermal cycling had caused the matrix to extend beyond the end of many of the fibers, especially those in the middle fiber ply (Fig 7). Cracks, both parallel and perpendicular to the fibers, developed in the large surfaces of the composites (Fig 8).

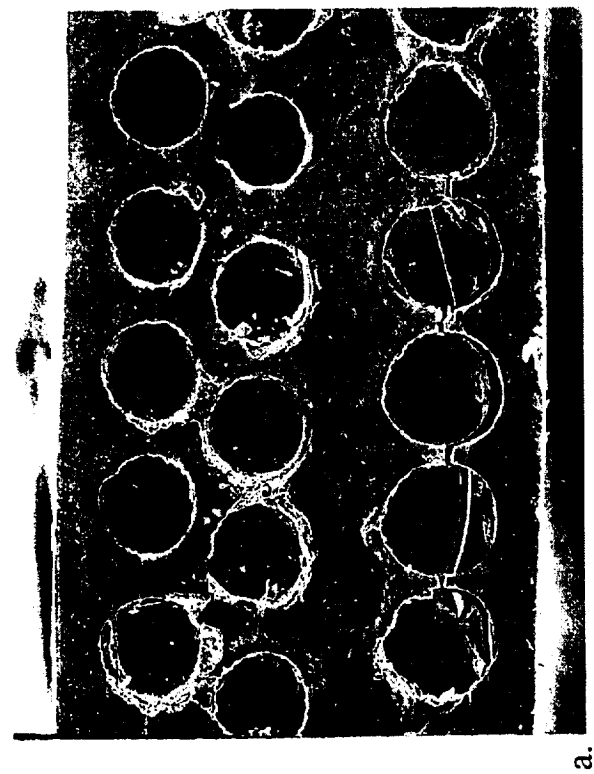
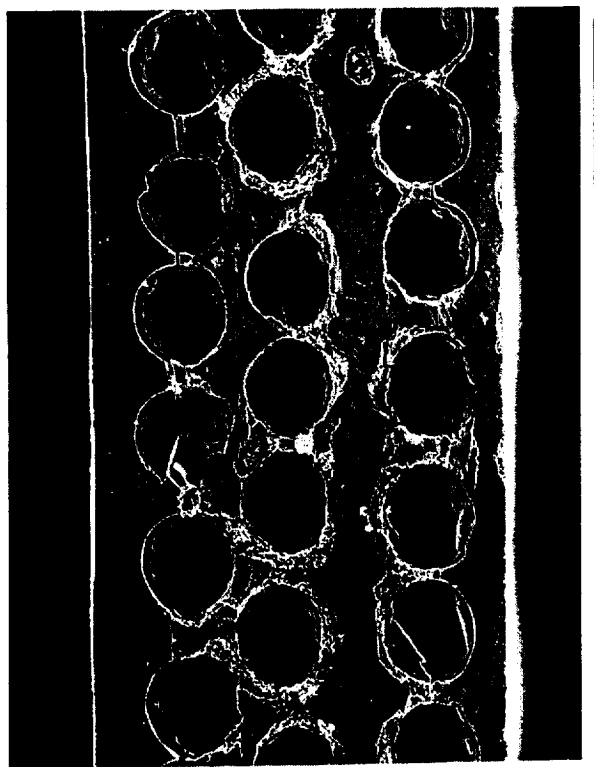
Fig 5 SEM micrographs of the composite after (a) 200 and , (b) 1000 1-hour cycles.

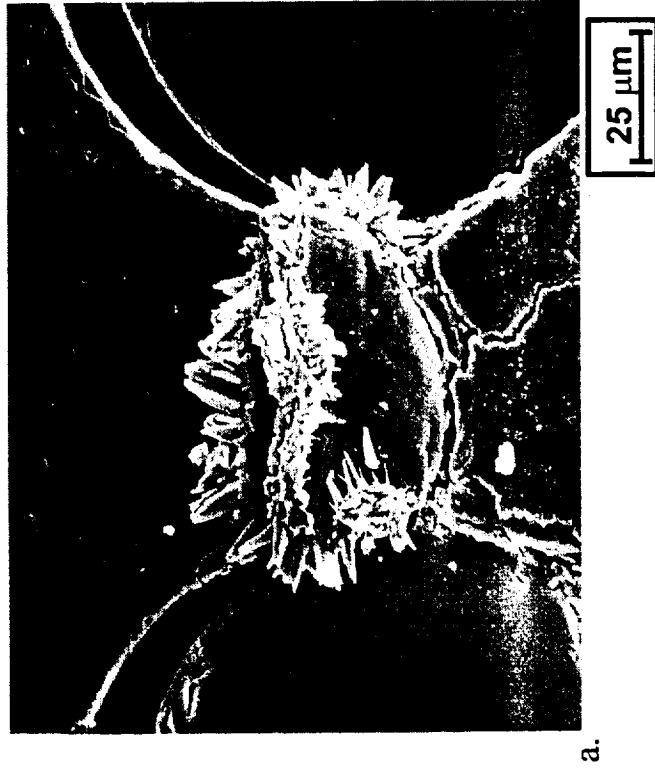
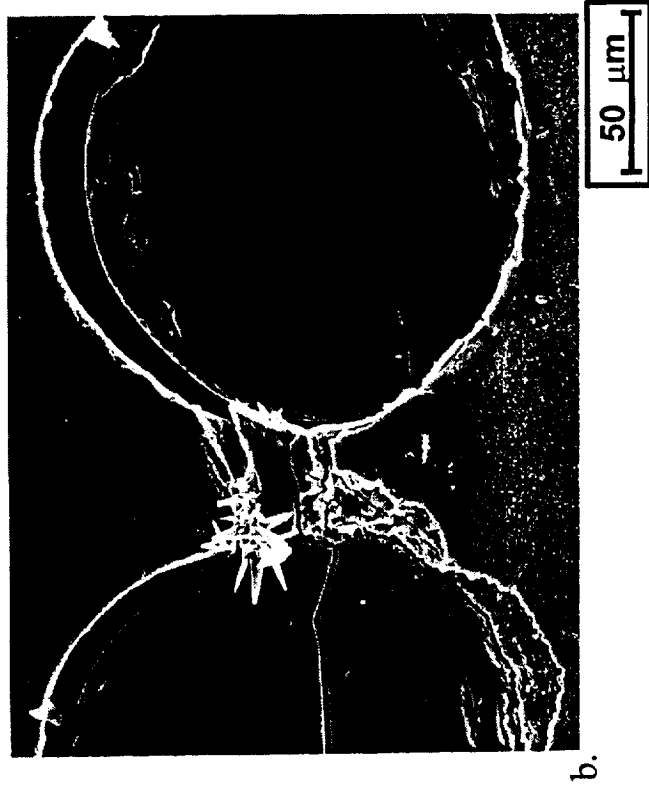
Fig 6 SEM micrograph of the end of the composite showing Fe and Cr-rich oxides growing at the cracks between fibers after 1000 1-hour cycles.

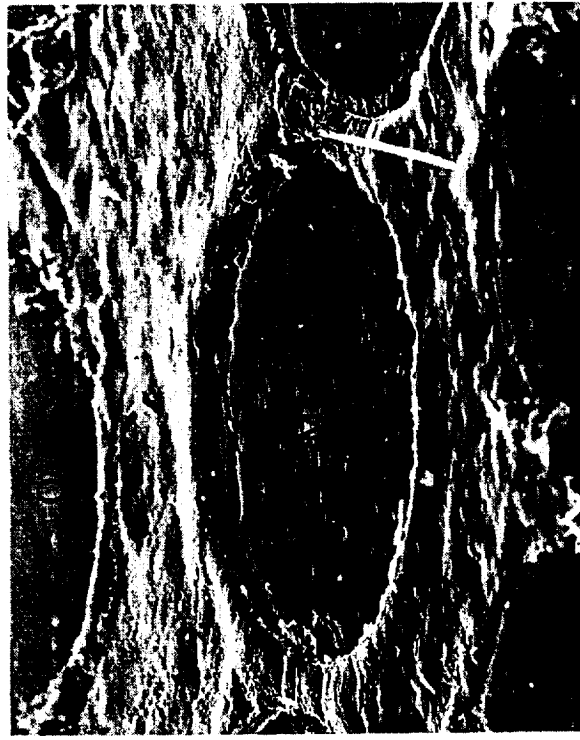
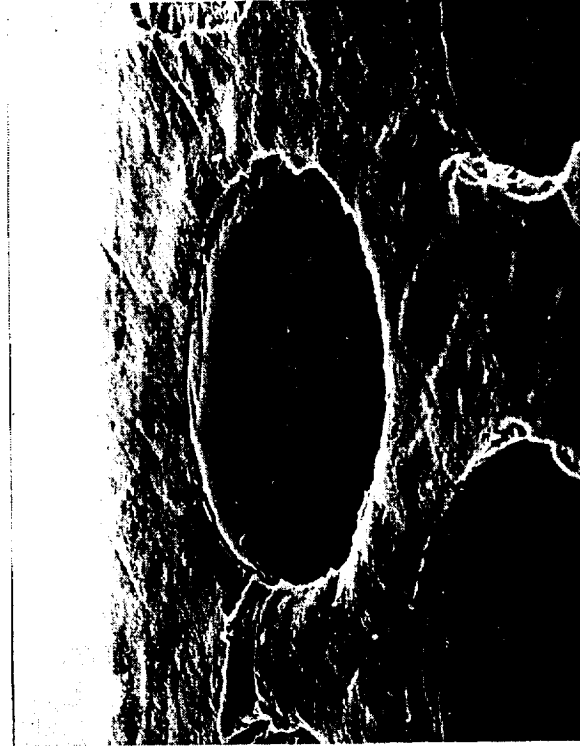
Fig 7 SEM micrographs of the composite after (a) 100 cycles (65° tilt), and (b) 1000 cycles (60° tilt). The letters M and O designate the middle and outer plies, respectively.

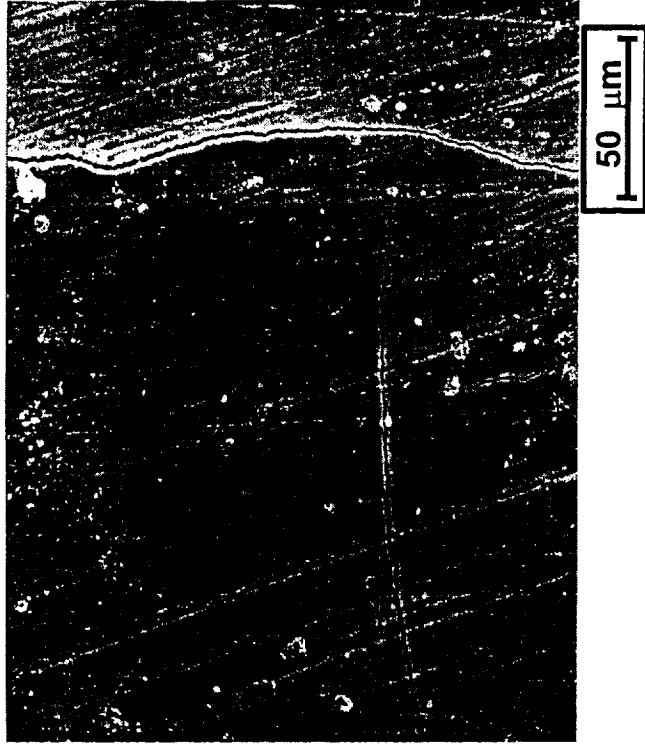
Fig 8 SEM micrographs showing cracks which developed in the large surface of a composite after 1000 cycles at 1000°C. Fiber direction is vertical.

**These cracks were noticed after several hundred cycles. On rare occasion, an Fe and Cr-rich oxide nodule could be observed growing out of the crack.**

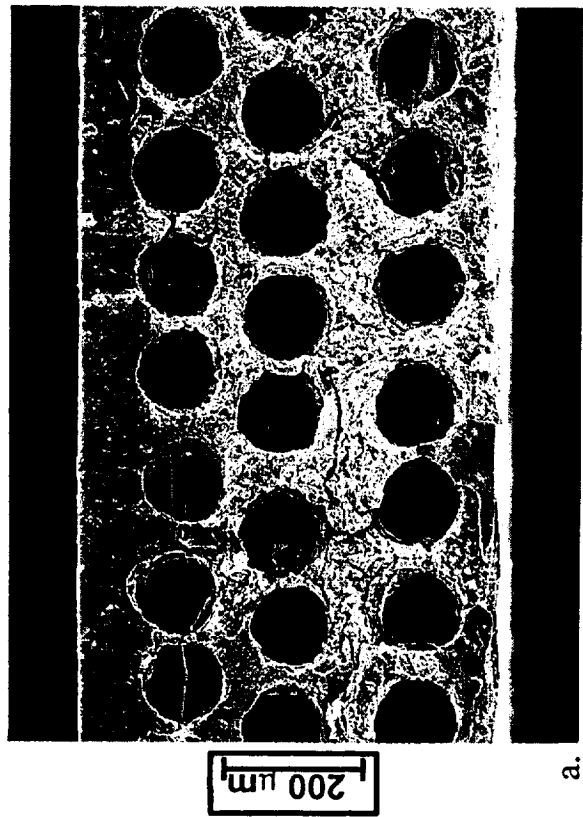
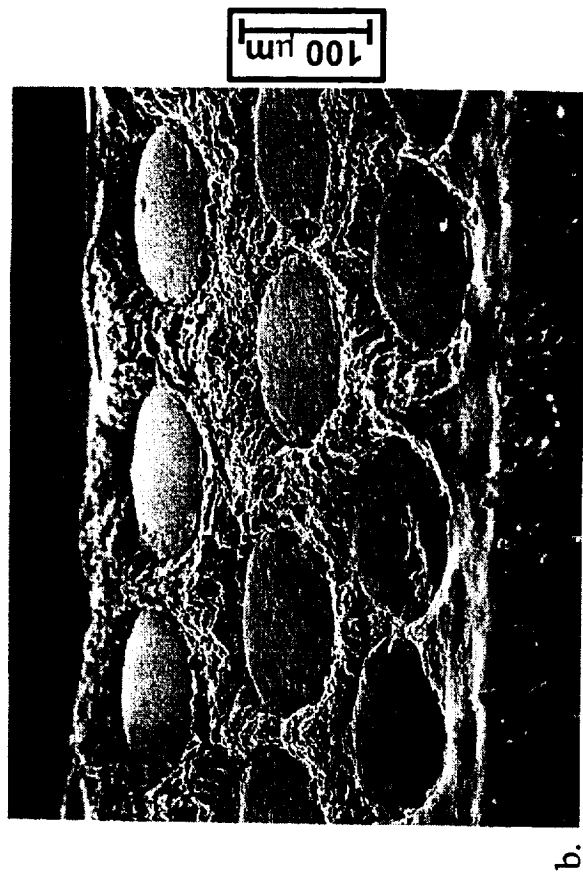
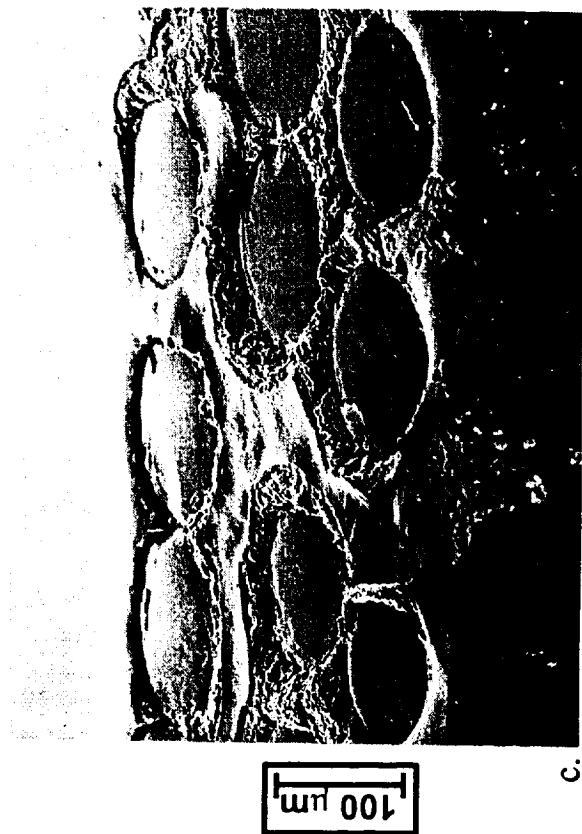
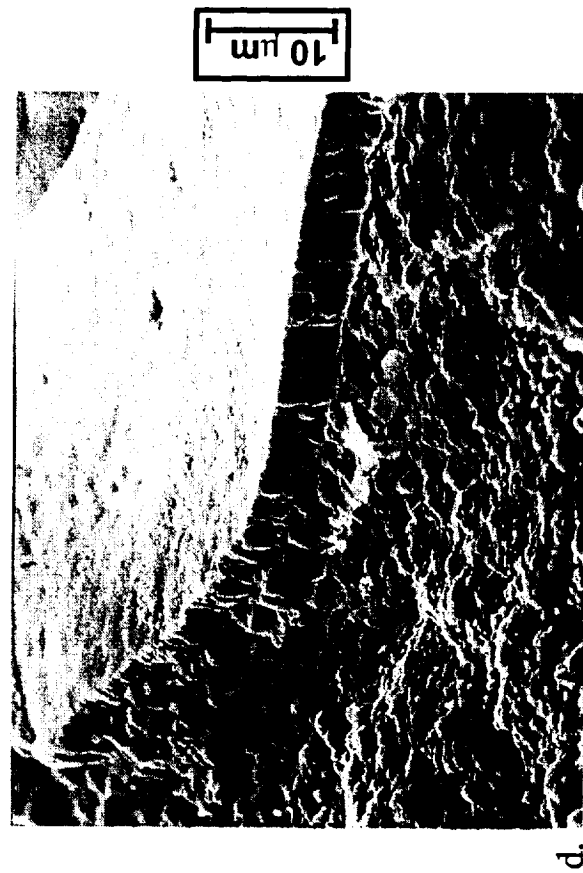
Fig 9 SEM micrographs of the ends of the composite after 100 cycles at 1100°C, (a), no tilt, (b,c,d) 65° tilt.

**After cyclic oxidation at 1100°C, protective scale damage around the exposed fiber ends was more pronounced (Fig 9). The scale damage was again more prominent around the middle ply and the extension of the matrix past the fiber ends was again apparent (Figs 9bc). A cross-sectional view of "virgin" oxide shows a structure with a fine-grained outer layer above larger columnar grains (Fig 9d), typical of  $\alpha$ -Al<sub>2</sub>O<sub>3</sub> scales on FeCrAlY.<sup>7,8</sup> Cracks also developed in the large composite surface exposing what appeared to be multiple oxide layers (Fig 10). Only Al and O were detected by EDS in the open cracks.**

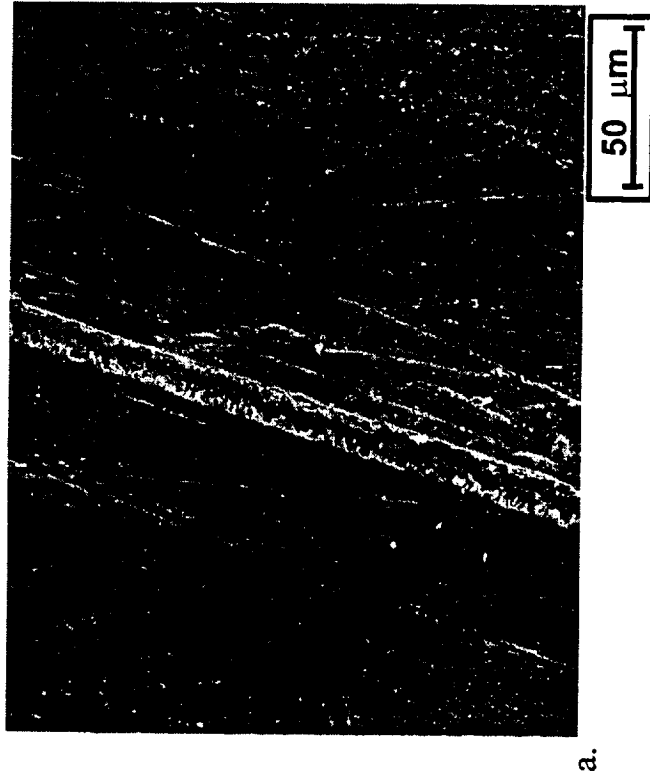
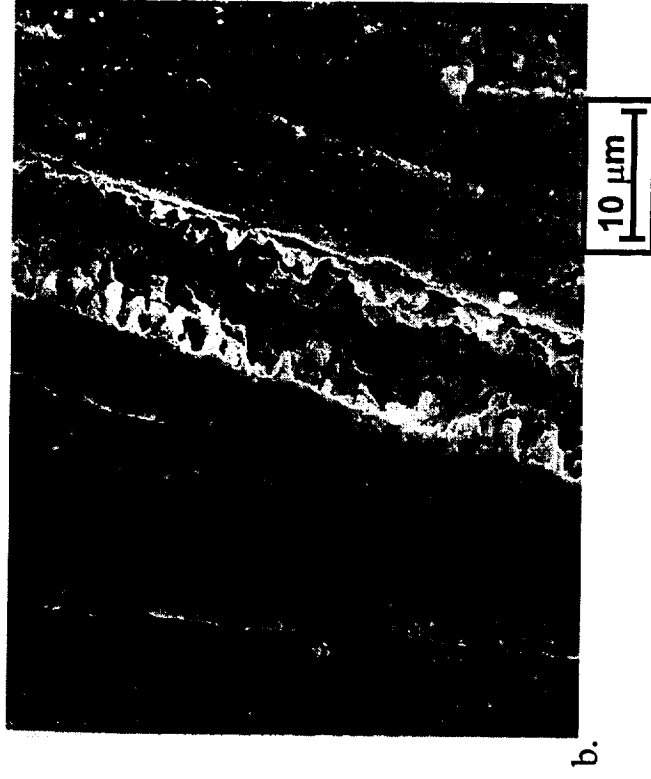
Fig 10 SEM micrographs of a crack in the surface of a composite after 200 cycles at 1100°C. (b) is a magnified view of (a).  
Fiber direction is vertical.

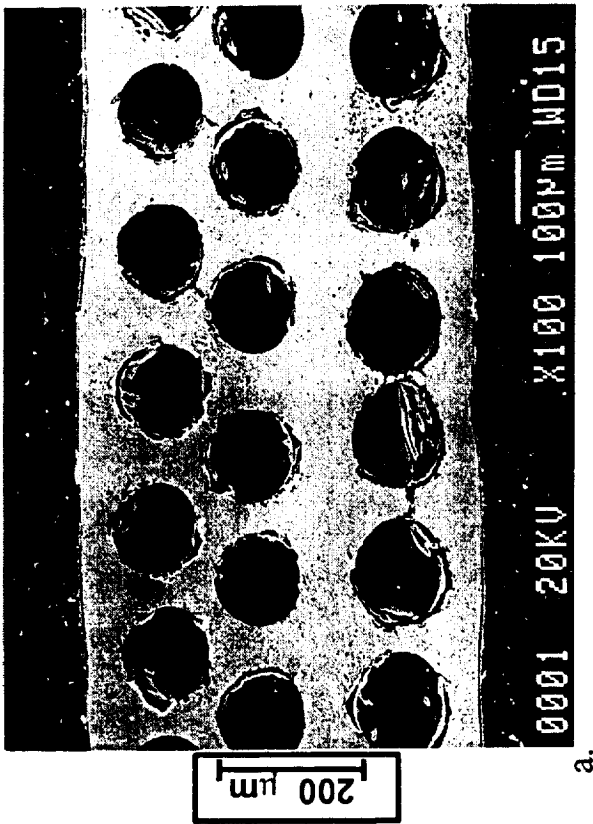
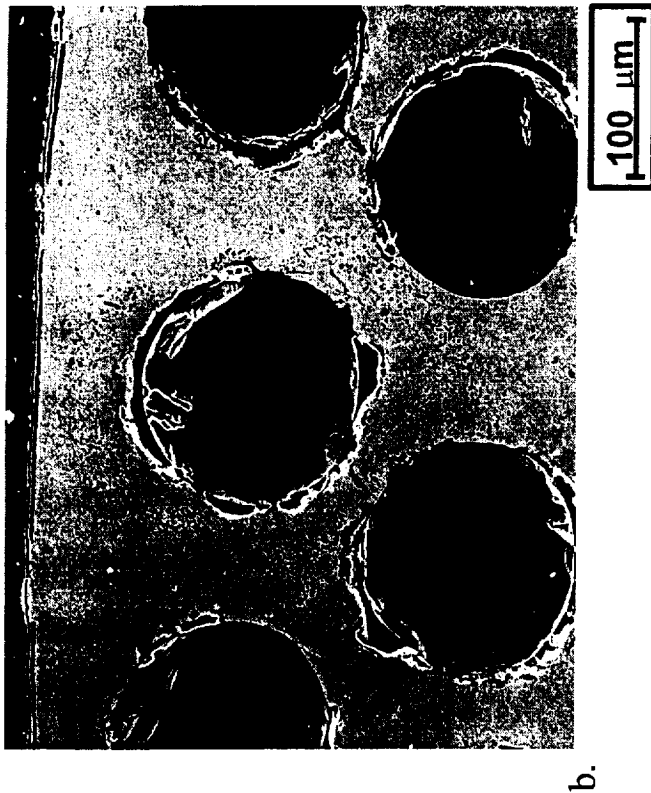
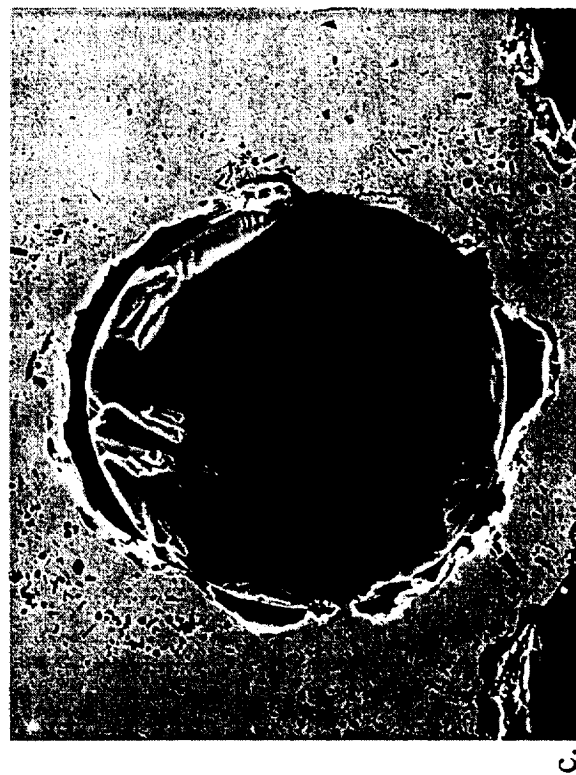
Fig 11 SEM micrographs of polished cross sections of the composite after 1000 1-hour cycles showing oxidation in the gaps between the fiber and matrix and internal oxidation of the matrix around one fiber. (b,c) are magnified views of (a).

Cross-sections made at a quarter and at half the length of the oxidized composites (perpendicular to the fibers) showed oxidation deep within the composite sample. Gaps around the fibers were still present at these locations far from the exposed fiber ends. Significant oxide had formed on the matrix at these gaps (Fig 11). EDS of this oxide layer indicated primarily Al<sub>2</sub>O<sub>3</sub>. In addition, a circular band of internal oxidation was present around some of the fibers (Figs 11b,c). EDS of the fine oxide precipitates also indicated Al<sub>2</sub>O<sub>3</sub>. As expected, the matrix in this internally oxidized region was depleted of Al.
