Restoration of the Hypersonic Tunnel Facility at NASA Glenn Research Center, Plum Brook Station

Mark A. Woodling
Glenn Research Center, Cleveland, Ohio

Prepared for the
38th Aerospace Sciences Meeting and Exhibit
sponsored by the American Institute of Aeronautics and Astronautics
Reno, Nevada, January 10–13, 2000

RESTORATION OF THE HYPERSONIC TUNNEL FACILITY AT NASA GLENN RESEARCH CENTER, PLUM BROOK STATION

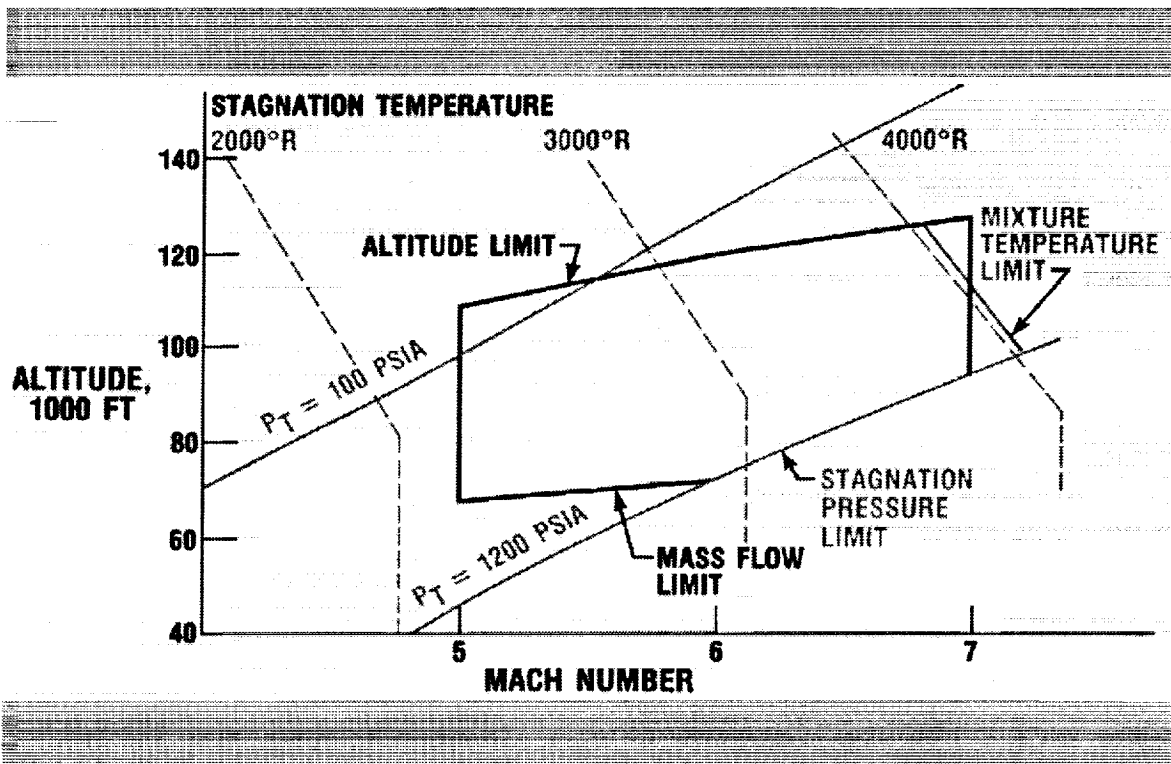
Figure 1.—Hypersonic Tunnel Facility Operating Envelope.

The NASA Glenn Research Center's Hypersonic Tunnel Facility (HTF) is located at the Plum Brook Station in Sandusky, Ohio. The HTF is a blow-down, non-vitiated, free-jet facility capable of testing large-scale propulsion systems at Mach numbers up to 7¹. Hypersonic engines, and other models up to 10 feet in length and 2 feet in diameter, can be accommodated within the test section. Testing features include the ability to provide true temperature, pressure, and air composition for Mach numbers 5 through 7. A large steam-driven ejector evacuates the test cabin and provides altitude simulation. The operating envelope for the HTF is shown as Figure 1. A facility isometric diagram and a component illustration are presented as Figures 2 and 3.

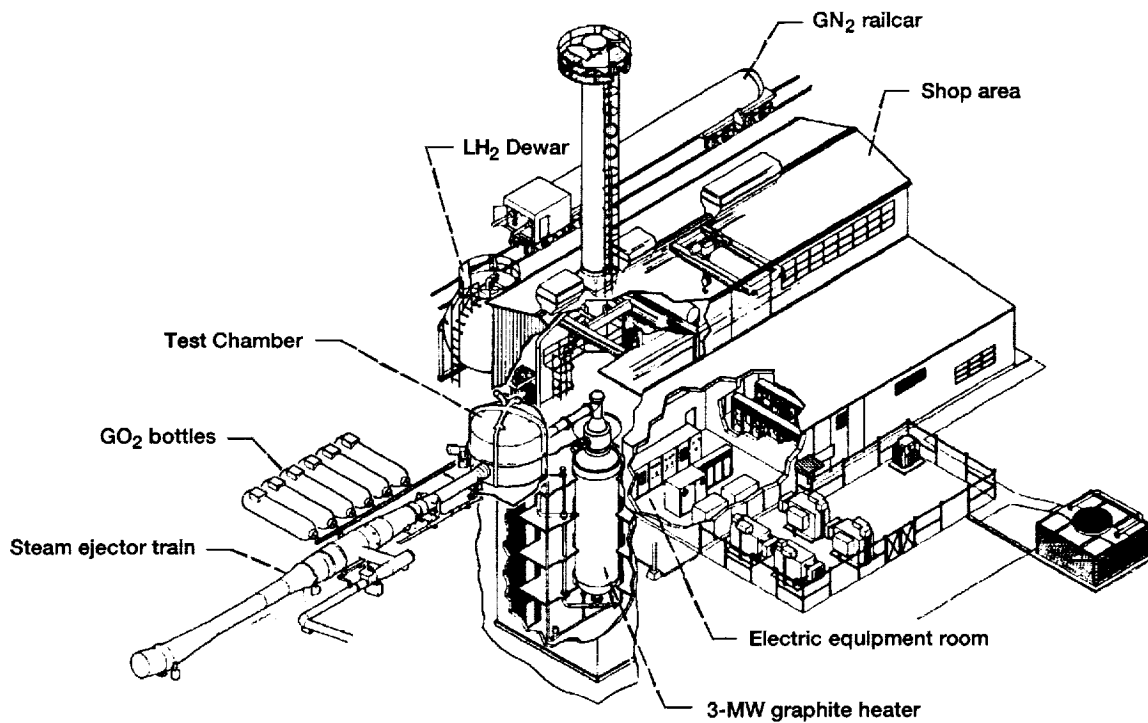
Figure 2.—Hypersonic Tunnel Facility, Isometric View of Facility.

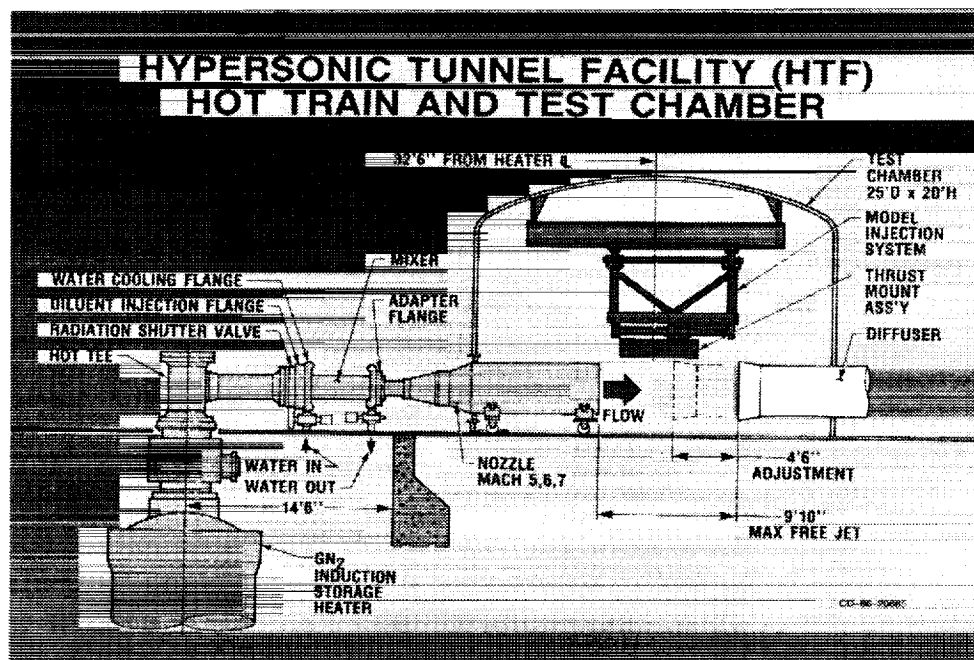
The heated nitrogen gas exits the top of the induction heater and flows through a series of bolted, water-cooled components that are collectively referred to as the "hot train" (see Figure 3). The hot gas flows through the 18-inch bore of these assembled components which consist of:

- A ball valve. This component is used only as a spool-piece, and is not an operational valve.
- The graphite-lined Hot Tee.
- The Radiation Shutter Valve (RSV).
- The Diluent Injection Flange. Three flanges exist, one for each Mach number condition (5, 6, and 7).
- The film cooling flange
- The mixing section.
- The adapter flange.
- The facility nozzle. Three nozzles exist, one for each Mach number condition.

Figure 3.—HTF Component Illustration, Hot Train and Test Cabin.

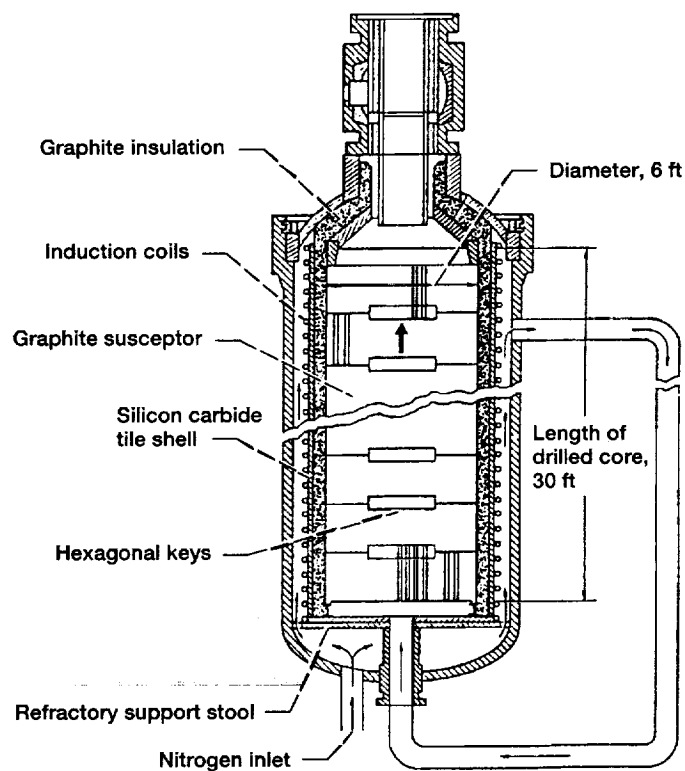
The gaseous nitrogen is ported to a vertically oriented, 3 MW cylindrical induction heater that is approximately 40 ft. in height by 10 ft. in diameter

(see Figure 4). The inductively heated core of the heater consists of fifteen cylindrical, graphite susceptor blocks, stacked one-on-top-of-the-other. Each susceptor block is 6 ft. in diameter by 2 ft. in height, and has 1945 holes (ranging between 0.75" and 1.125" in diameter) drilled axially through the block. As the blocks are stacked to form the core, hexagonal graphite keys are installed at each block interface to orient the drilled holes. The perimeter of each susceptor block is wrapped with a 10 inch thick layer of graphite felt insulation. A cylindrical, 2 inch thick silicon tile wall surrounds the susceptor block/graphite felt core.

A 4-piece, water-cooled, helical copper coil surrounds the susceptor block/graphite felt core and generates the inductive field. Each helical coil is fabricated from 1-5/8 inch diameter copper tubing with a wall thickness of 0.25 inches. Current is passed through the copper cross-sectional area of the tubing, using a 180 hertz, single phase, 750 volt power source. De-ionized water is pumped through the internal diameter to cool the coil and other components within the heater. The induced field resistively heats the outer 4 inches of the susceptor block¹. The remainder of the block increases in temperature as heat conducts radially through the graphite towards the block centerline.

Figure 4.—HTF Gaseous Nitrogen Induction Heater.

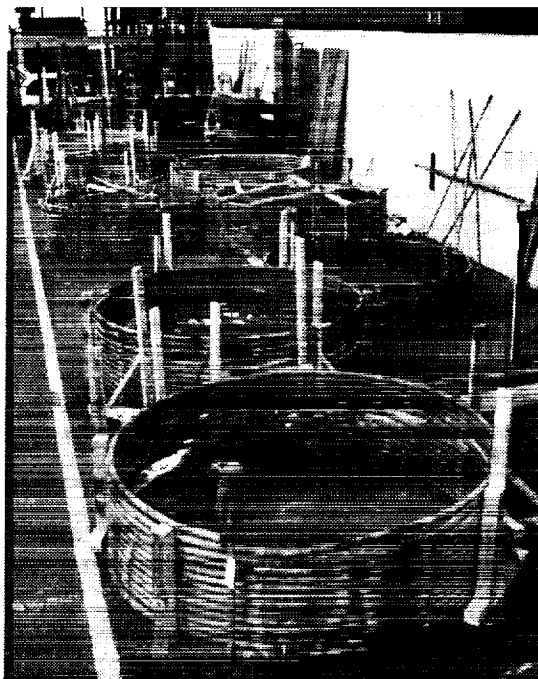
Consequently, each of the four coil sections contained roughly 7 brazed joints (sum total of 29 joints for the 4 coils). When pressure testing was performed on the bare coils, leaks were identified at some of the joints. Based on chemical analysis, it was determined that coil leakage during heater operations could lead to graphite susceptor block degradation⁴.

Figure 5.—HTF induction coils in wood fixtures during joint welding.
Note that each of the four major coil sections have been separated into smaller sections.

The induction coils typically must survive an 80 psig internal operating pressure (cooling water pressure) and a 1,200 psig maximum external pressure exerted by the flowing nitrogen gas. Based upon these conditions, the project team performed ASME B31.3 calculations to determine if the existing joints were structurally sufficient. Upon review of the results, a determination was made to replace every copper brazed joint with a copper welded joint. Since the chemical analysis had recommended that the total water vapor content within the heater be kept below 10 ppm, each joint was 100% x-ray inspected to ensure weld integrity. Figure 5 shows the wood fixtures used to support the coils during the joint welding procedures.

Once the joint welding was completed and the new support studs were welded to the outer diameter of the tubing, the bare coil was leak tested. A plastic tent was built around the coil and filled with gaseous helium. A vacuum was pulled on the internal diameter of the coil, and the contents were analyzed by Mass Spectrometry. The coil sections were then subjected to a hydrostatic test at 1.5 times the maximum operating pressure.

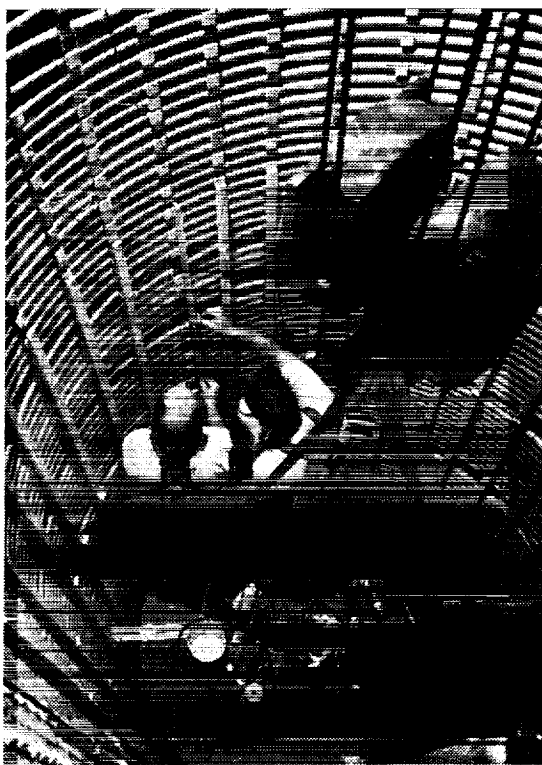
Figure 6.—Refurbished induction coils being installed within the
heater pressure vessel at the HTF site, Plum Brook Station, Sandusky, Ohio.

Figure 6 shows the refurbished coils being installed within the heater pressure vessel. Upon completion of the coil installation, a leak test with helium was performed again to ensure that no damage had occurred during shipping or installation. The de-ionized water inlet and outlet piping was then connected to the coils. As a final check, the entire system was successfully hydrotested again at 1.5 times the maximum operating pressure.

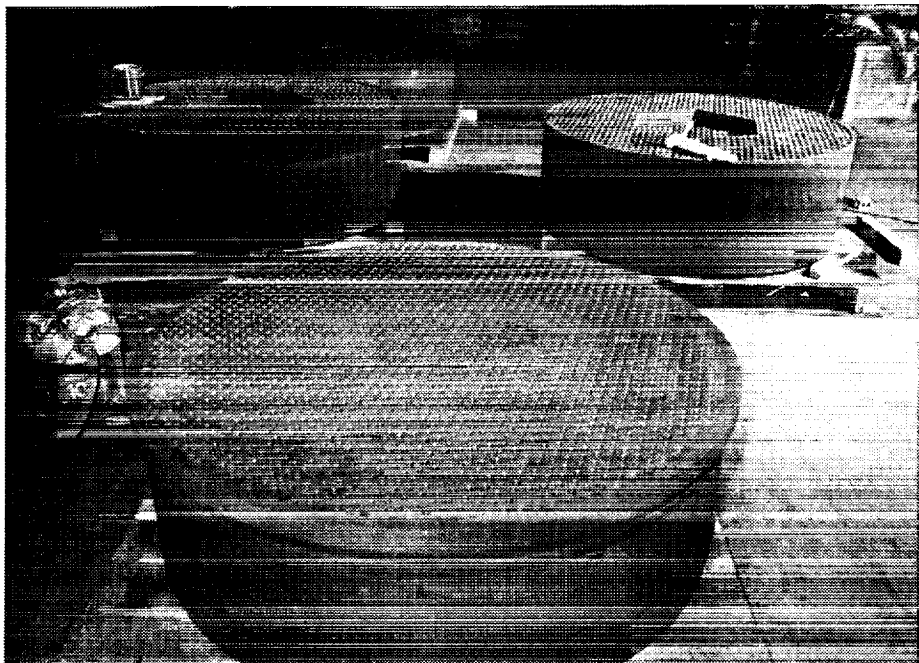
Following the RSV failure, the 15 susceptor blocks were removed from the induction heater. Inspection of the blocks indicated that the two upper-most susceptor blocks had cracks in the webbing between the holes and on the outer surface, and seven susceptor blocks

showed signs of significant perimeter erosion. Also, the graphite transition cone, located at the top of the susceptor core, sustained a deep crack all the way through the thickness of the cone. The six bottom-most blocks did not sustain any damage and were therefore considered to be reusable.

Figure 7.—Newly machined graphite susceptor blocks.

Figure 7 shows several of the newly machined susceptor blocks that were delivered to Plum Brook Station. As previously discussed, prior to installation, each block was wrapped with a 10-inch thick graphite blanket. These blankets were fabricated by stitching together multiple layers of graphite felt material. Figure 8 shows the susceptor blocks wrapped with the blankets. Prior to installation within the heater, the blankets were compressed with perimeter restraints attached to "release strings". Once a block was placed within the heater, the strings were pulled which released the restraints and allowed the blanket material to expand and fill the annular space between the perimeter of the block and the silicon tile wall.

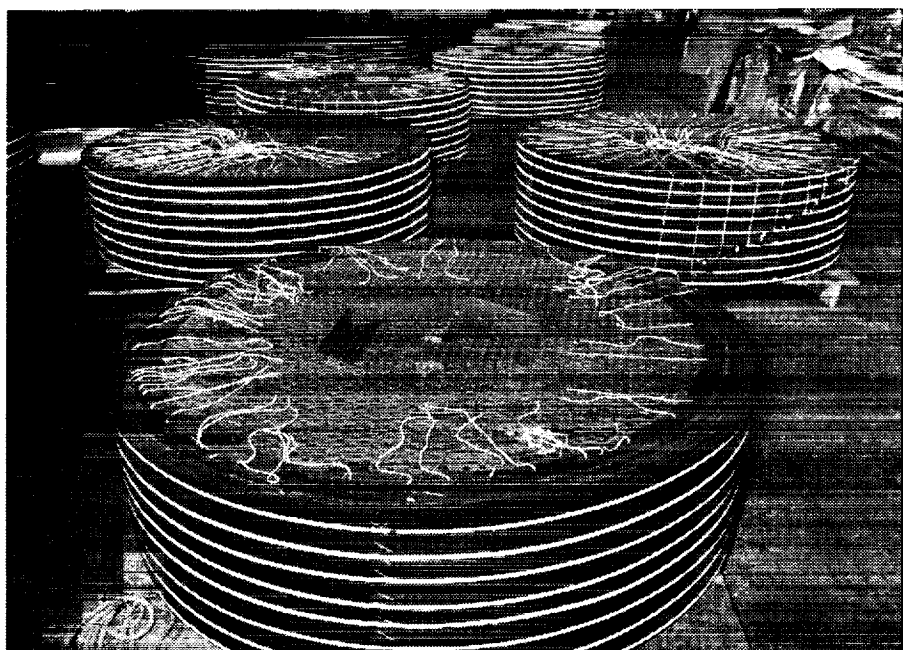
Figure 8.—Graphite susceptor blocks wrapped with graphite blankets.

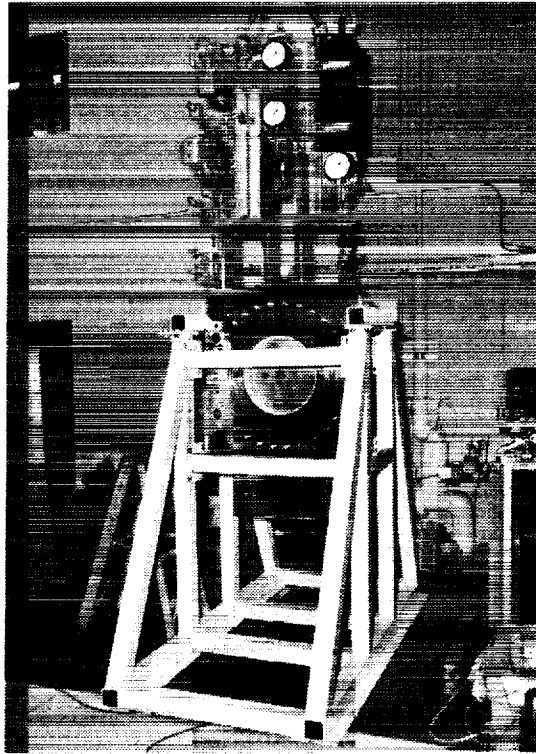
Figure 9.—Redesigned Radiation Shutter Valve (RSV) mounted in a stand for functional testing.

Upon completion of the structural verification testing, valve functional testing was initiated. The actuator package was attached to the valve body and the entire assembly was mounted in a customized stand (see Figure 9). A portable hydraulic unit was used to test and adjust all of the hydraulic functions. The blade travel distance was adjusted to ensure proper seating, and the stroke-time was set to 7 seconds.

Finally, a series of "stroke tests" were performed to check the repeatability of all measurements and to test the O-ring cavity seal gas integrity. By stroking the valve multiple times and then performing a pressure decay test on the O-ring seals, the design team was able to baseline a seal leakage rate to be used for valve operations. Following the stroke tests, the shutter blade was removed and sent to the NASA Glenn Inspection Department. The blade flatness values were base-lined for future comparison and the blade was reinstalled into the valve body. The assembled valve was then sent to Plum Brook for installation into the refurbished hot train (see Figure 10).

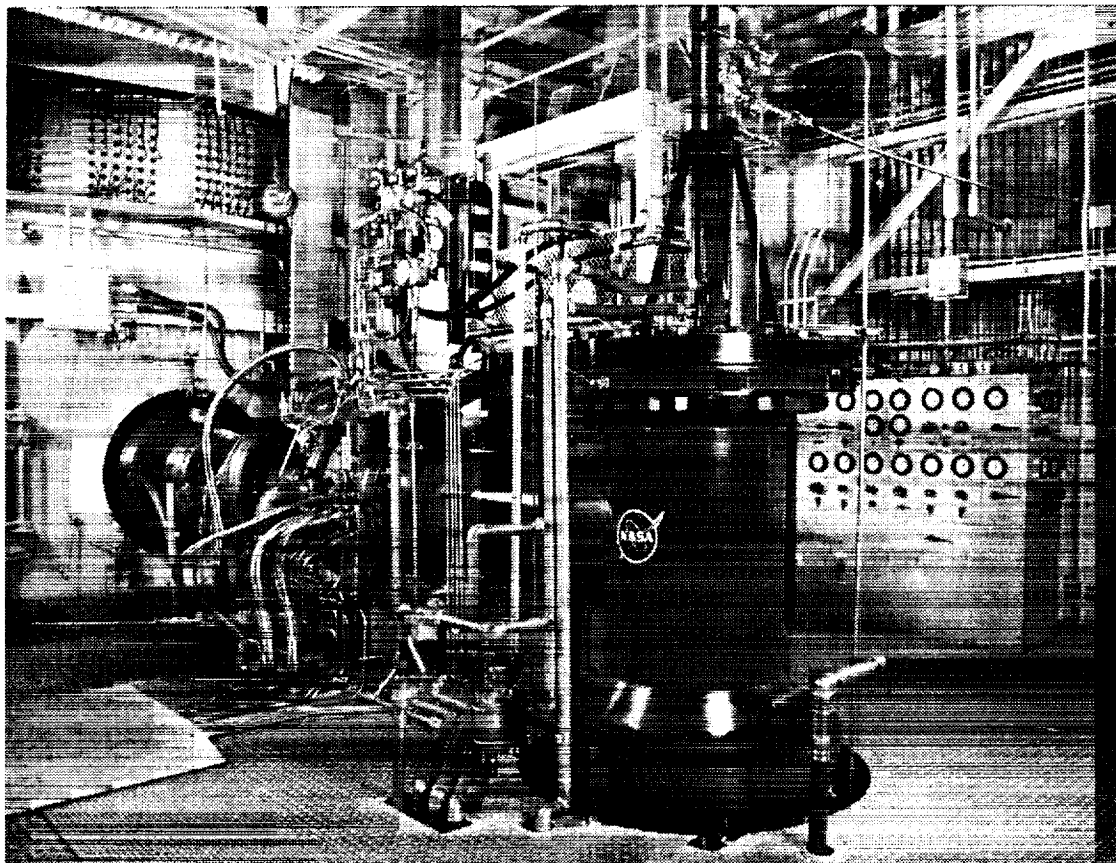
Figure 11.—HTF Hot Train assembly as of January 2000.
(View from behind the Hot Tee, looking towards the Test Cabin)
