A CONTAMINANT ICE VISUALIZATION EXPERIMENT IN A GLASS PULSE TUBE

J.L. Hall and R.G. Ross, Jr.
Jet Propulsion Laboratory
California Institute of Technology
Pasadena, CA 91109

ABSTRACT

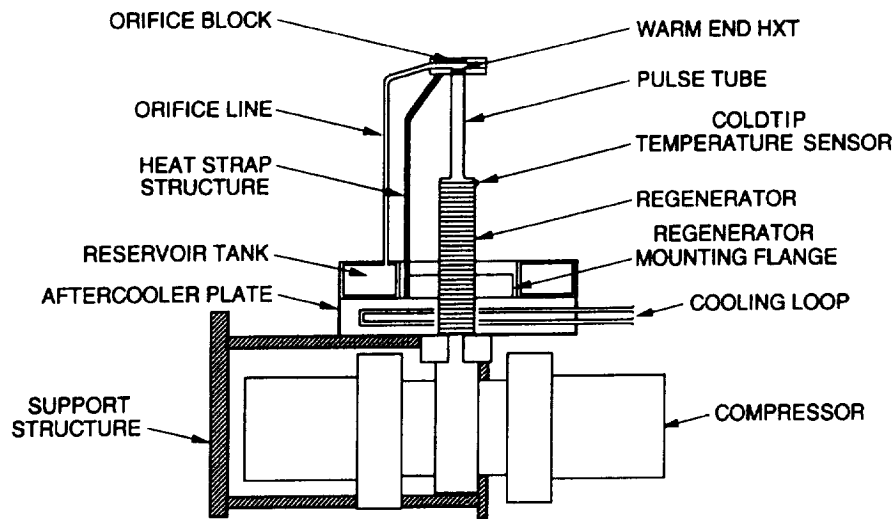
Figure 1. Schematic Diagram of Glass Pulse Tube.

The experiments were performed with a simple orifice pulse tube mounted on a 5-cc Lockheed two-piston back-to-back linear compressor (Fig. 1). The pulse tube consisted of a quartz glass tube with stainless steel end connections. The glass to metal interfaces consisted of flared, grooved joints that were clamped together and sealed with rubber O-rings. The 1.6-mm wall thickness glass tube was comprised of two sections, a 19 mm O.D. lower part that housed the regenerator, and a 10 mm O.D. upper part that was the pulse tube itself. The two tubes were fused together with a smooth shoulder joint. An "L"-shaped copper busbar was used to thermally connect the orifice end of the pulse tube to the cooled reservoir plate. Indium shims placed between the copper bus bar and the pulse tube served the dual purposes of improving the junction heat transfer and increasing the pre-load on the stack to enhance the compression, and hence performance, of the O-rings.

Temperature data were provided by cryodiodes bonded onto the outside of the glass tube at three locations. The middle location, just below the shoulder joint, was defined to be the coldtip temperature for these experiments (see Fig. 1). Compressor input power was measured with a power analyzer and recorded by hand at irregular intervals.

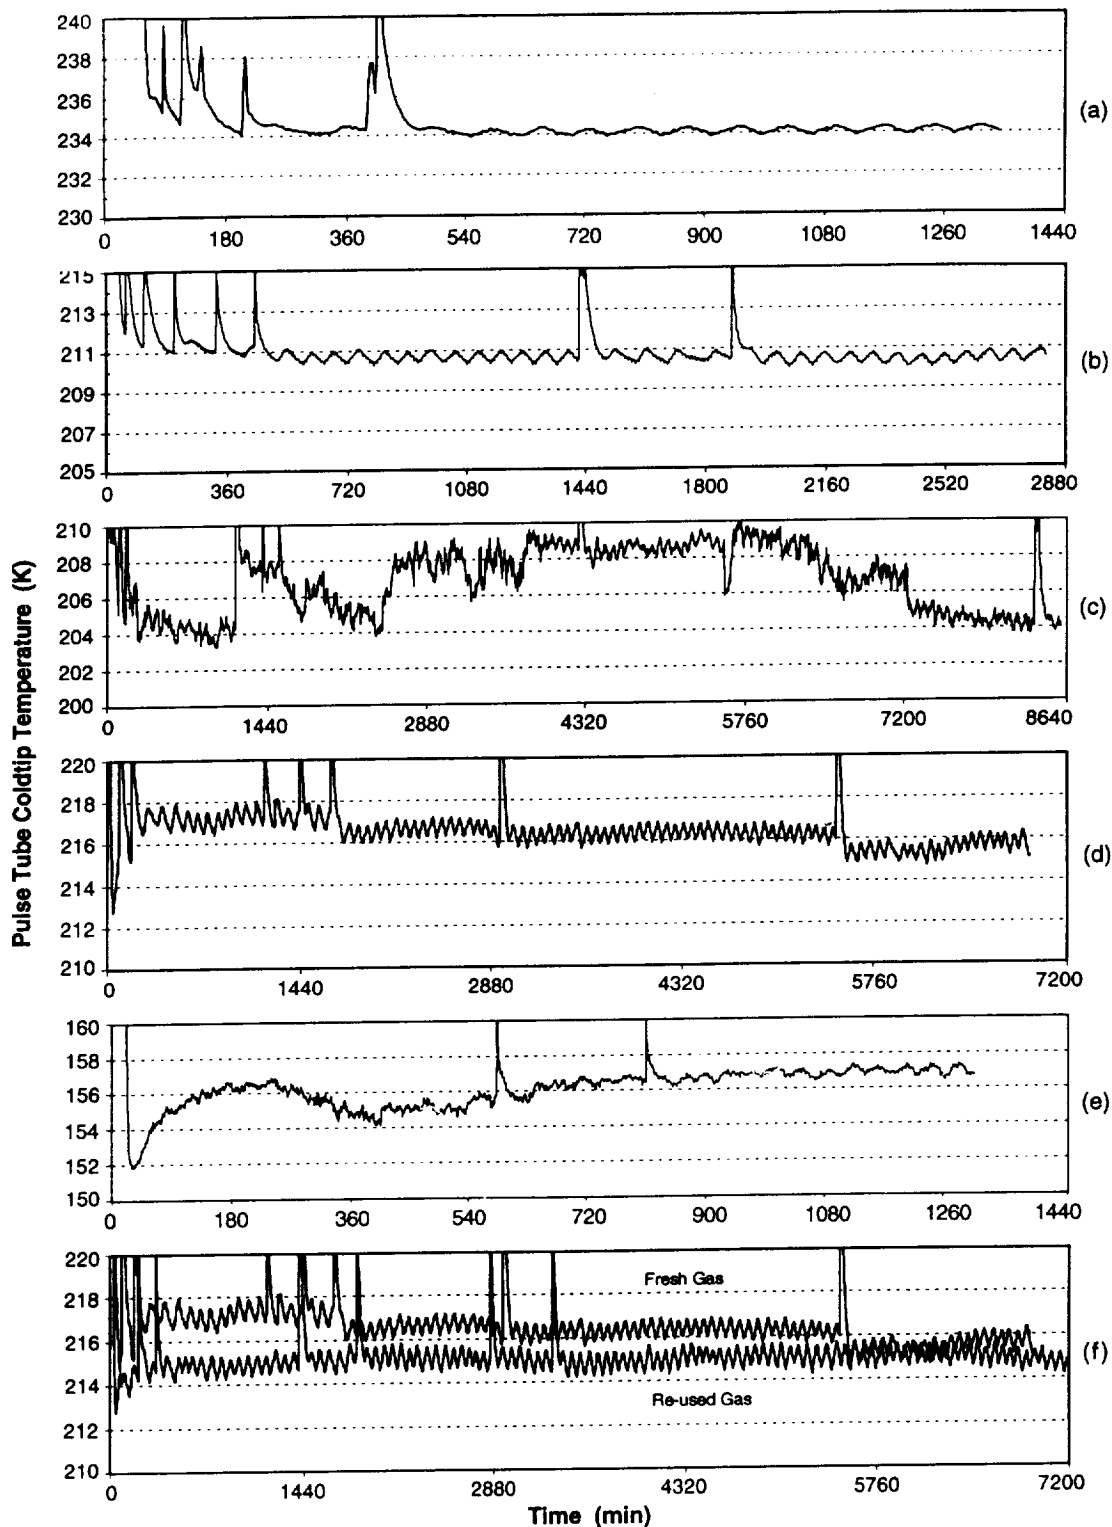
Figure 6. Coldtip temperature versus time traces for selected experiments.

Time traces of coldtip temperature from six different experiments are presented as Figs. 6a through 6f. The first four correspond in sequence to the tests whose photographs

are shown in Figs. 2 through 5. Figure 6e shows data from the lowest temperature experiment in this study, while Fig. 6f compares the data from 6d with a repeat experiment at the same test conditions. All of the plots show temperature spikes at irregular intervals. This is due to the high power camera lamps that were used to illuminate the pulse tube for photography and microscopy. The radiative heat transfer from these lamps was clearly large compared to the nominal parasitic heat load on the uninsulated glass pulse tube. Another feature seen in Figs. 6a, b, d and f is a regular temperature oscillation with an amplitude of 1 K or less. The cause this oscillation is speculated to be temperature fluctuations in the ethylene glycol and water chiller unit that removes heat from the pulse tube.

All of these time traces come from experiments where the compressor piston stroke and heat rejection temperature set point were held constant. Therefore, any change in the mean coldtip temperature can be attributed to internal contamination effects. The data indicate quite strongly that internal frost formation did not necessarily correspond with thermal performance loss. For example, the mean temperature in Figs. 6a and 6b is constant with time despite the large accumulations of frost as seen in the corresponding photographs in Figs. 2 and 3. This constancy was mirrored by compressor power measurements taken at the same time. Conversely, the mean temperature in Figs. 6c and 6d is not constant with time. In Fig. 6c, the mean temperature rises approximately 5 K by mid-experiment, only to decay back to the original value by the sixth day. A similar pattern is seen in Fig. 6d in which there is an initial temperature rise from 213 K to 217 within the first few hours, then a slow decay down to 215 K by the end of the experiment. These temperature movements generally coincided with the internal frost redistributions illustrated in the photographs, namely the formation of a bare spot on the screen in Fig. 4b and the disappearance of the ice shard pile in Fig. 5a. Experiments at lower temperatures, which featured much less internal frost redistribution, showed correspondingly less temperature recovery. For example, a 155 K all-screen regenerator result is shown in Fig. 6e. After a partial temperature recovery at the half-day mark, the temperature climbed back again to a value roughly 5 K higher than the start value.
