# Effects of Conformal Coat on Tin Whisker Growth

## Abstract

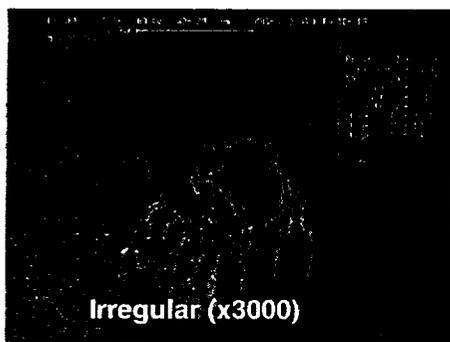
**Figure 3. Four Typical Shapes of Tin Nodules**

On the non-conformally coated side, nodules formed in various shapes, shown in Figure 3. Most of these nodules formed along surface scratches in the tin plating. These thin, tiny scratches are not the scratches that were made intentionally. In fact, relatively few whiskers were observed from the scratches that were made intentionally. Rather, the thin, tiny scratches, possibly resulting from abrasion by the paper within which the specimens were wrapped for shipping by the company that performed the electroplating process, promote almost 90% of the whisker formation observed.

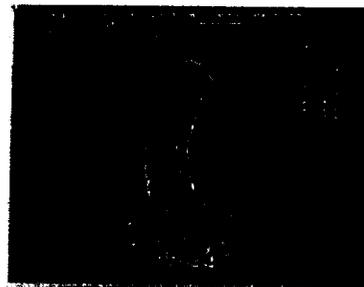
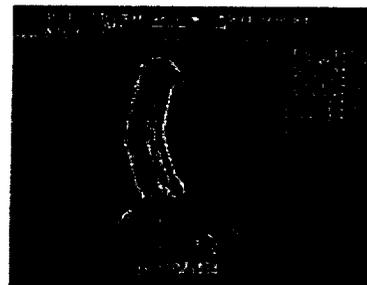
**Figure 4. Nodule Pictures Taken Periodically (x1700)**

Selected nodules were reinspected on a regular basis to determine the growth rate and to monitor the nodule formation process. Figure 4 depicts several stages of the formation of one specific tin whisker nodule.

This particular nodule had an average growth rate of 0.06 mm/year measured at 6 months, which can be compared to the reported growth rate value of 0.92 – 7.3 mm/year [4]. This nodule stopped growing after 6 months.
