NASA/TM—2000-210359

High Cycle Fatigue Crack Initiation Study of Cast Blade Alloy René 125

Introduction

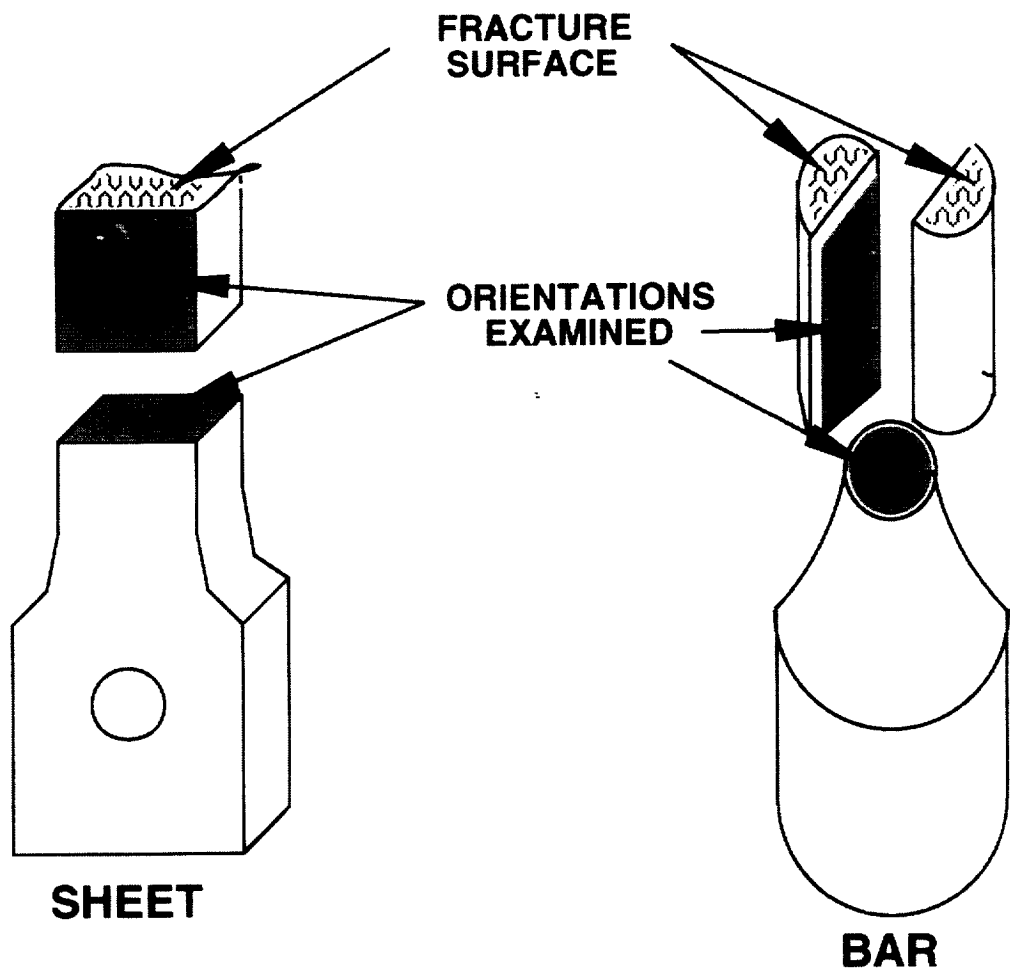
Figure 1. Schematic depicting the location and orientation of metallographic sections. (L) orientation is typically through the fracture surface and parallel to the loading direction. (T) orientation is typically through the specimen thickness and perpendicular to the loading direction.

The microstructures of the various castings were examined using metallographic sections obtained from failed HCF specimens. As shown in Figure 1, orientations both parallel and perpendicular to the specimen loading direction, (designated as (L) and (T) respectively), were examined. The majority of the metallographic sections taken parallel to the loading axis were obtained through the specimen's fracture surface (and at the initiation site) in order to document the presence of various casting defects. Metallographic samples were obtained from both cast sheet and cast bar specimens from each vendor.

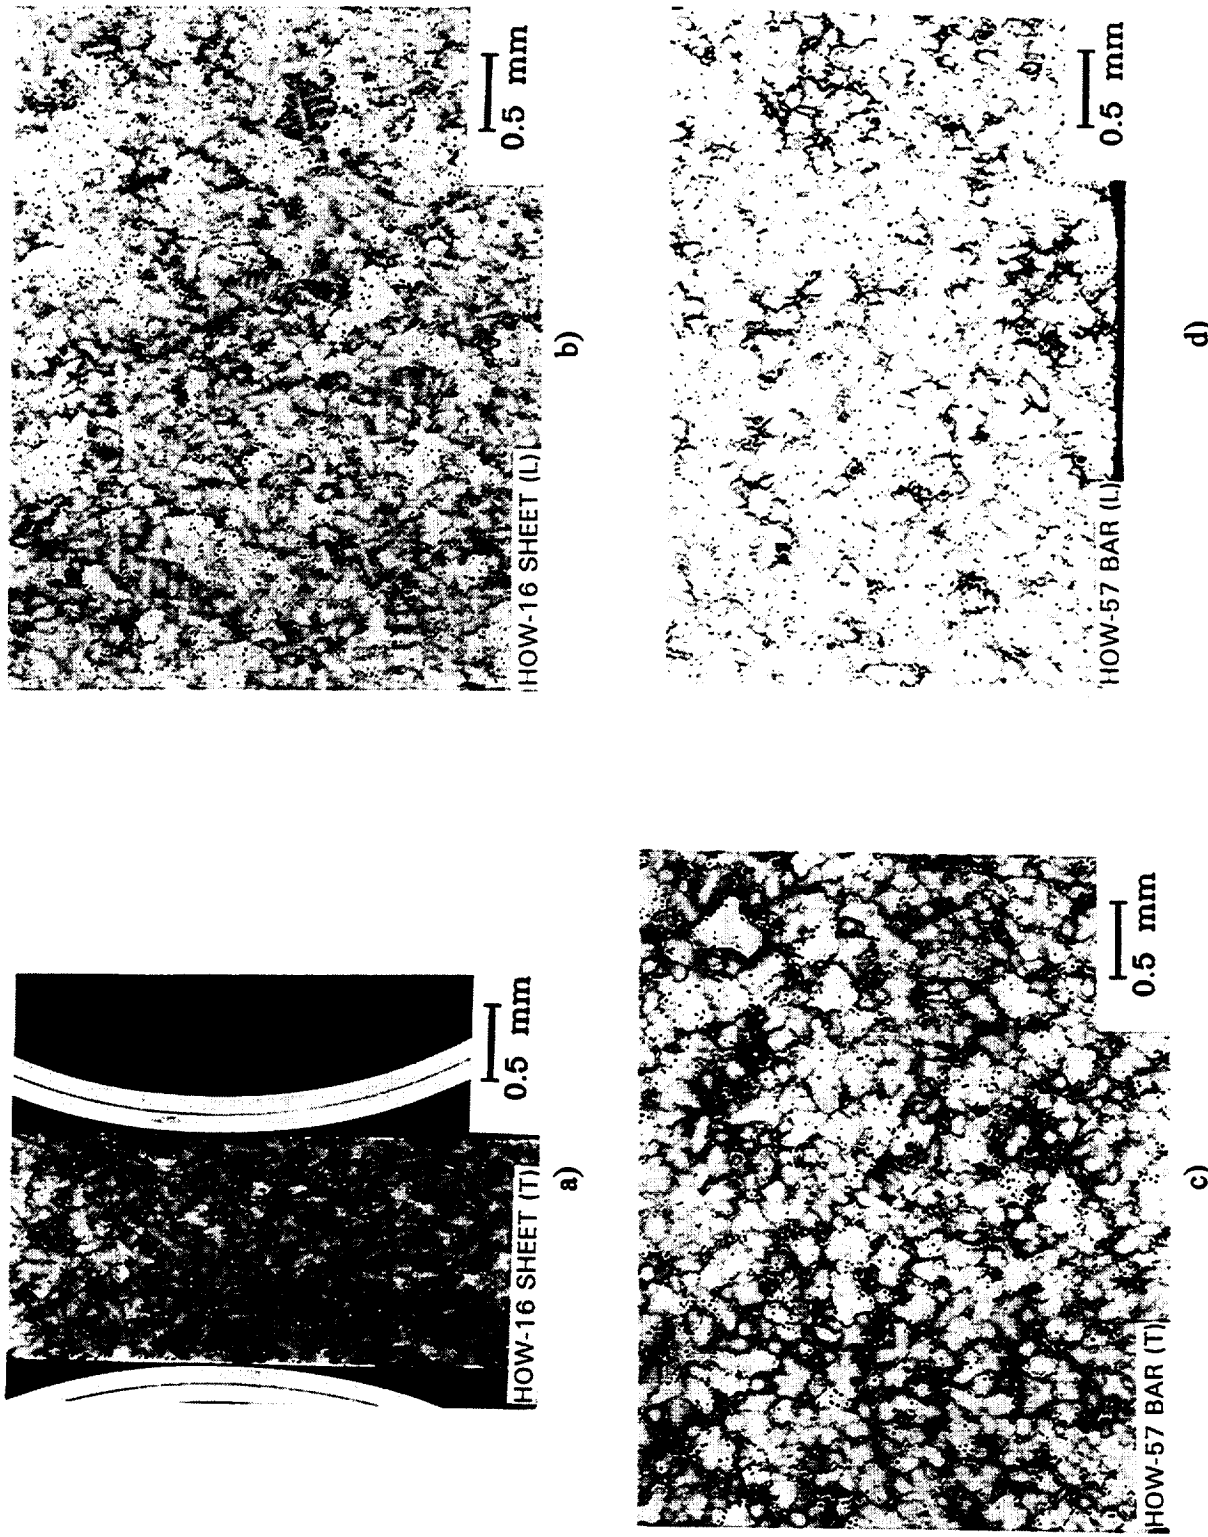
Figure 2. Low magnification view of Howmet cast R125 microstructure, a) HOW-16 sheet (T) orientation, b) HOW-16 sheet (L) orientation, c) HOW-57 bar (T) orientation, and d) HOW-57 bar (L) orientation.

A summary of the microstructures obtained by the various vendors are shown in Figures 2-7. These figures are a combination of low and high magnification micrographs and show representative microstructures of both sheet and bar castings. In general, the microstructure varies significantly among the casting processes. The grain structure obtained in the Howmet castings is equiaxed and cellular in appearance (Figure 3) and finer in comparison to the PCC

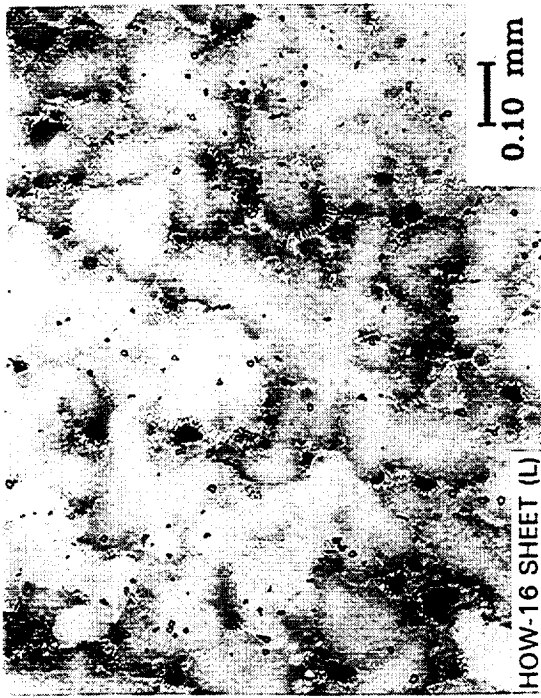
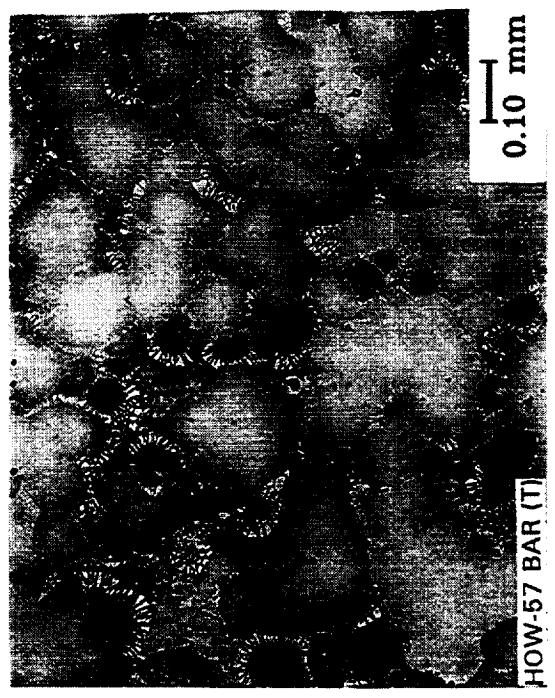
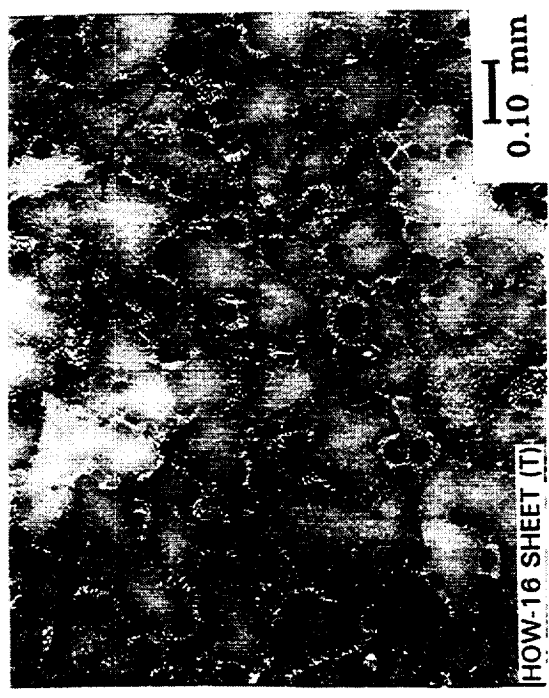
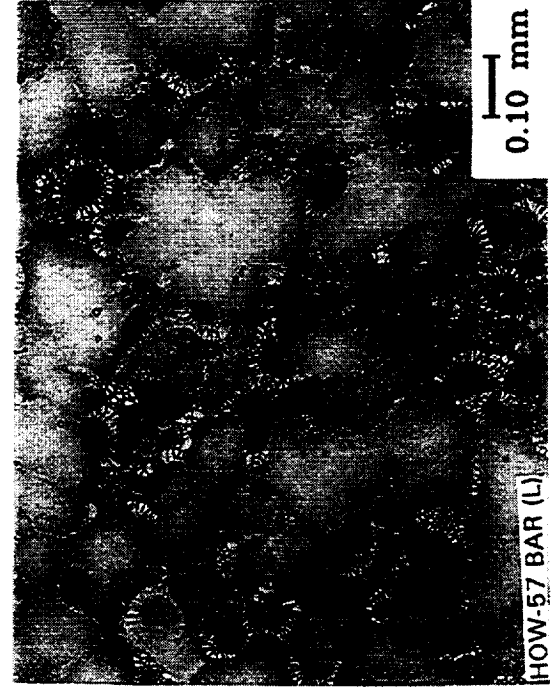
Figure 3. High magnification view of Howmet cast R125 microstructure, a) HOW-16 sheet (T) orientation, b) HOW-16 sheet (L) orientation, c) HOW-57 Bar (T) orientation, and d) HOW-57 bar (L) orientation.

In general, all the castings showed a significant amount of retained eutectic primarily at grain boundaries and interdendritic regions. The Howmet and PCC castings displayed large coarse eutectic structure (Figures 3 and 7 respectively). The Hitchiner castings displayed a more refined eutectic structure (Figure 5). The effect of the eutectic regions on the fatigue properties is not clear. Eutectics have on occasion shown up at initiation sites on crystallographic (111) facets, however, it should be noted that local regions associated with eutectics are also likely to include chemical segregation and micro porosity which can also initiate failure. The size and distribution of the retained and cooling γ' was very similar for all the castings (Figure 8). All castings show significant amount of cooling γ' .

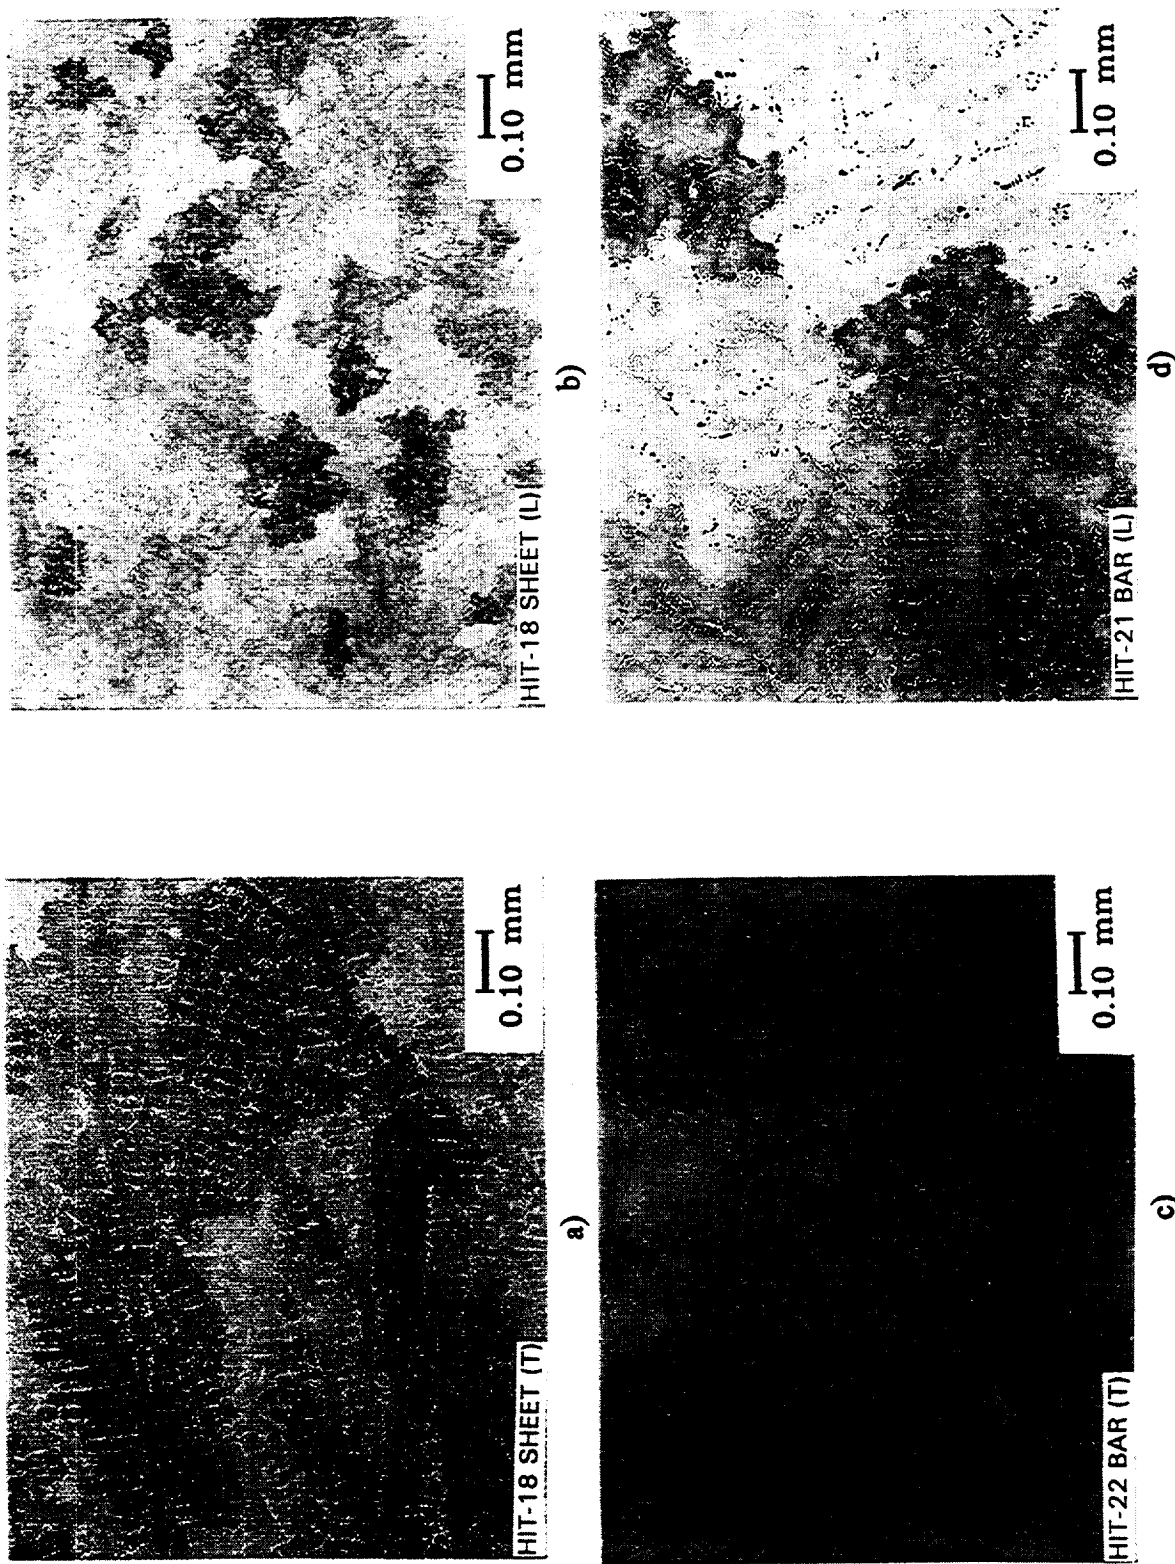
Figure 5. High magnification view of Hitchiner cast R125 microstructure, a) HIT-18 sheet (T) orientation, b) HIT-18 sheet (L) orientation, c) HIT-22 bar (T) orientation, and d) HIT-21 bar (L) orientation.

and Hitchiner castings which typically displayed large dendritic grain structure (Figures 5 and 7). The dendritic structure in the Hitchiner castings (Figure 4) is also much finer in comparison to the PCC castings (Figure 6) which display a coarse microstructure. The grain structure in the Hitchiner castings was also columnar (Figure 4c), whereas the PCC grain structure was primarily equiaxed (Figure 6c).

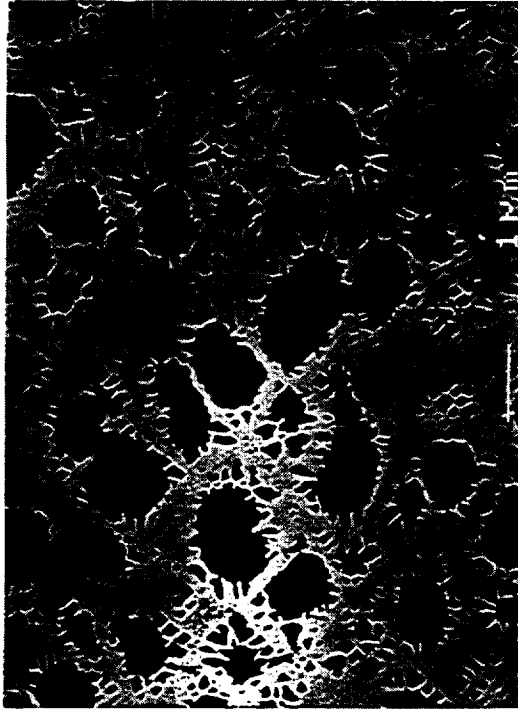
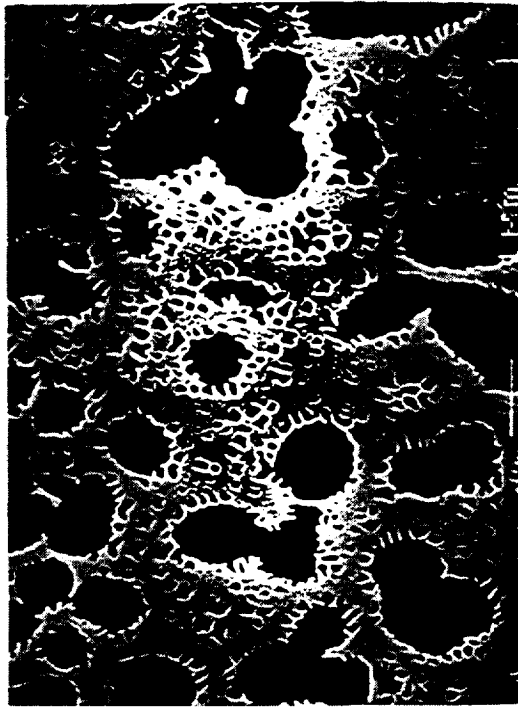
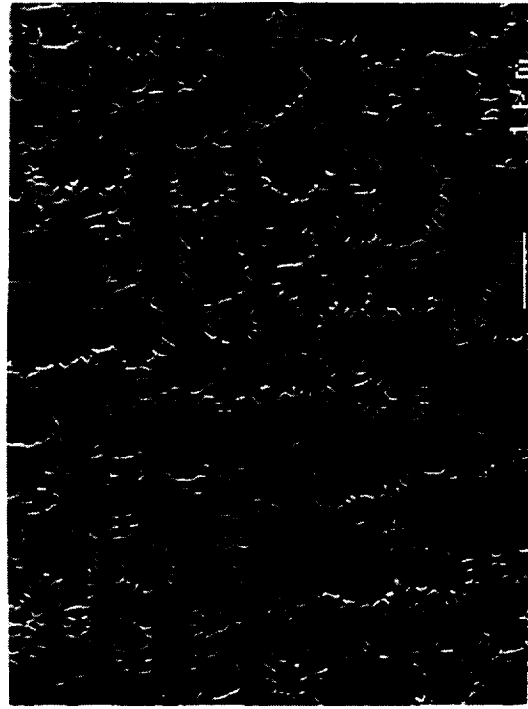
Figure 8. Precipitate morphology of retained and cooling γ' for various bar castings, a) HIT-22 bar, b) PCC-33 bar, and c) HOW-16 sheet, having the optimum heat treatment.

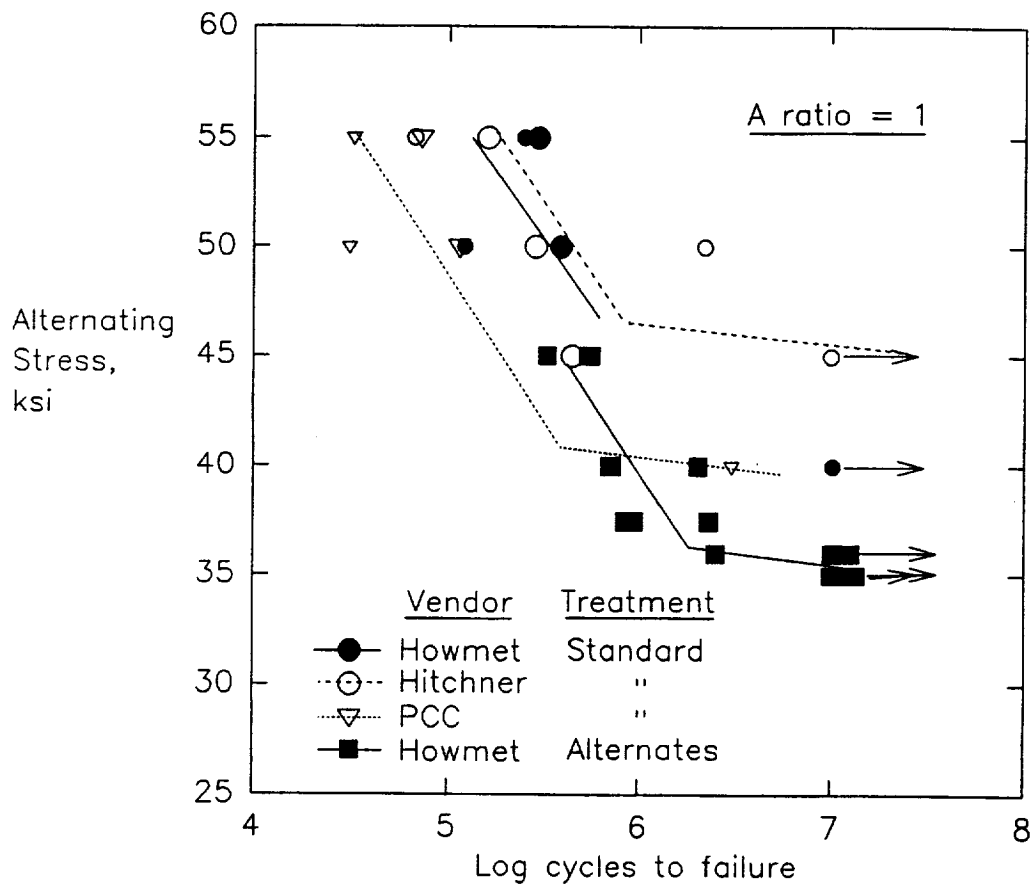
Figure 11. HCF life of cast alloy R125. Data shown is from bar castings manufactured by three different vendors, Howmet, Hitchner, and PCC. Large symbols represent 1400°F, small represent 1000° F. Also shown (solid square) is the HCF life for the alternate heat treatments.

The HCF life results of the bar specimens are shown in Figure 11. The data obtained from the sheet specimens were not plotted because they were plagued by failures at the loading pins (9 out of 18 test specimens). It is obvious from Figure 11 that HCF lives for the alternate heat treatments were significantly reduced in comparison to the HCF lives for the optimum heat

treatment even though the tensile properties were in general somewhat improved. The 10^7 cycle runout stress was about 35 ksi for the alternate heat treatments in comparison to 45 ksi for the optimized heat treatment. Furthermore, the HCF life among the alternate heat treatments did not seem to be affected by the heat treatments. As it will be shown by the fractography results, failure to HIP at 25 ksi resulted in significant porosity which dominated the initiation of failure and significantly reduced HCF life.

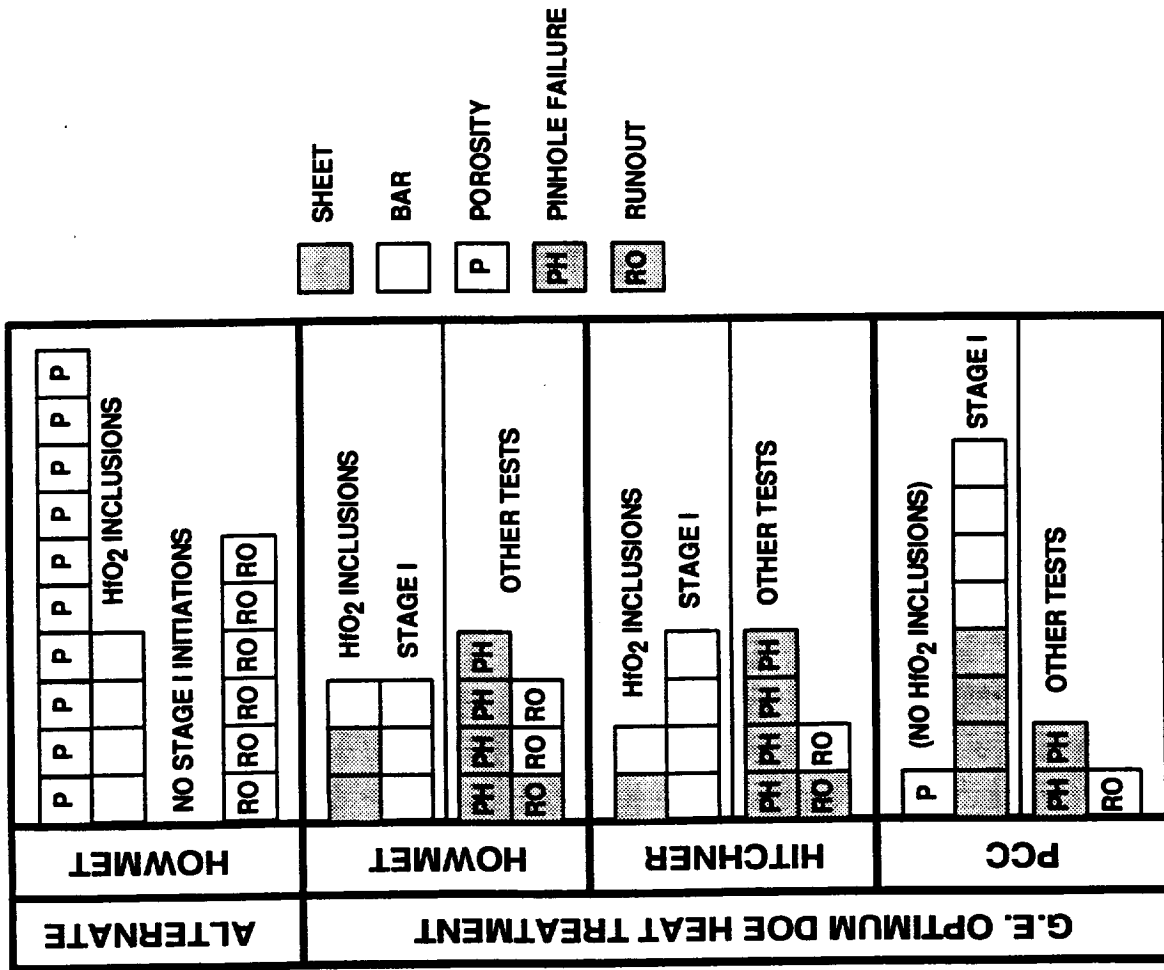
Figure 12. Comparison of the type of HCF initiation sites observed in R125 bar and sheet castings based on the manufacturer and regardless of testing conditions. Note each block represents one specimen, and also no distinction is made between the alternate heat treatments.

The HCF crack initiation characteristics exhibited by this alloy are typical of cast Ni-based superalloys and can be classified in two general categories: initiation from defects and Stage I crack initiation. An overview of the initiation sites leading to failure is shown in Figure 12.

Initiations from HfO_2 inclusions were found in specimens from Hitchiner and Howmet, but none were observed in the PCC specimens. The Howmet castings had the most failures initiated by HfO_2 inclusions (Figure 12). Furthermore, the remainder of the Howmet HCF specimens from the alternate heat treatments that did not initiate cracks at pores, also initiated cracks from HfO_2 inclusions.

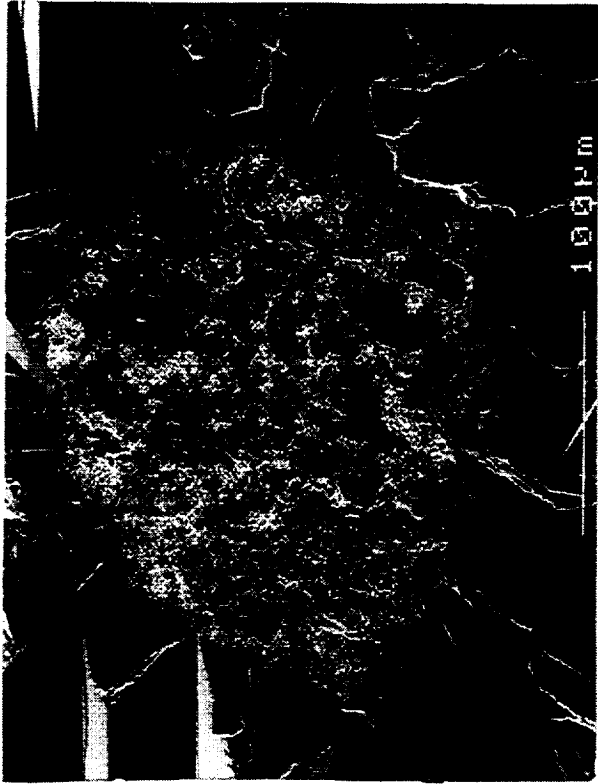
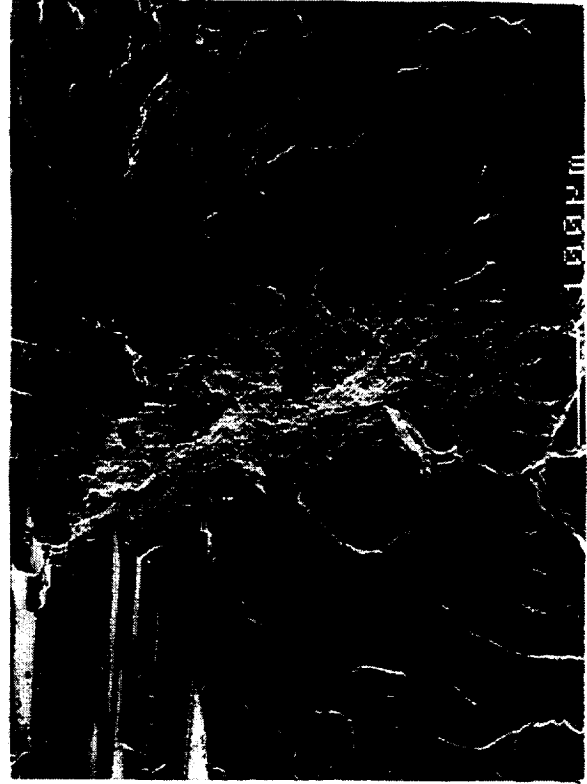
Figure 13. Typical defects found in cast R125 which resulted in HCF initiation and failure, a) HfO_2 inclusion in Howmet sheet specimen, b) large HfO_2 inclusion in Hitchiner sheet specimen, c) HfO_2 inclusion in Howmet bar specimen, d) HfO_2 inclusion in Hitchiner bar specimen.

In general, failure from HfO_2 inclusions was more prevalent in the sheet specimens. Failure from inclusions were also more likely to occur at the 1400°F test temperature and the higher stress conditions (55 ksi). Typical morphologies of the observed defects are shown in Figures 13 and 14. The data is inadequate to definitively identify the role of inclusions on HCF life for these castings and testing conditions. However, inclusions in general are detrimental to fatigue life. For example, in the Howmet bar specimens tested at 1400°F, the specimen tested at 50 ksi (in which failure initiated at an HfO_2) inclusion had about half the life of the specimen tested at 55 ksi (which failed from a Stage I crack). Similarly, the presence of unhealed porosity is very damaging to HCF life.

Stage I initiations are classified as initiations that occur strictly on (111) crystallographic facets and in the absence of inclusions. This distinction is made because there are occasions where inclusions and porosity initiate failure along (111) planes however these initiations are governed primarily by the presence of the inclusion, (Figure 13c). Three type of Stage I related initiations were observed in this alloy:

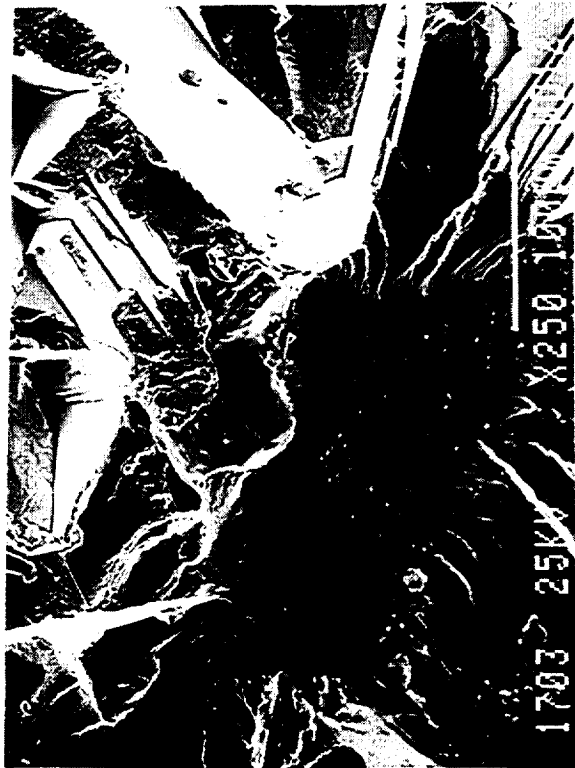
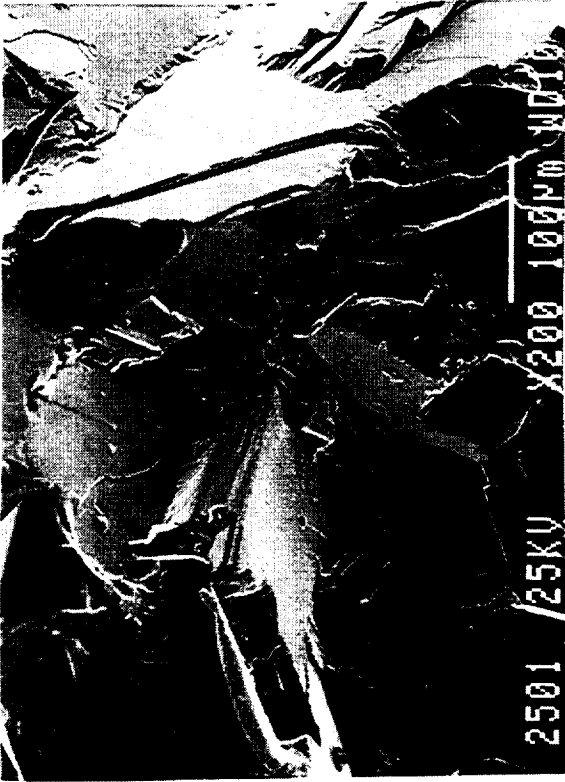
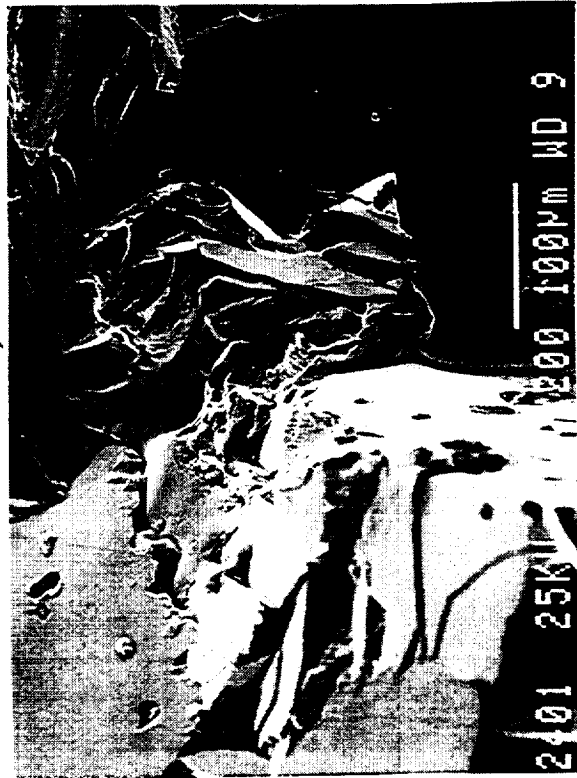
Figure 14. Typical porosity initiations, a) ,b) , and c) as a result of lower HIPping pressure in the alternate heat treated material, and d) the only pore failure observed in the optimum heat treated.

Porosity was the primary initiation site for all the Howmet test specimens that were given the alternate heat treatment. As seen in Table V, 10 out of 14 HCF failures were initiated at porosity.

As indicated previously, the HIPing pressure for the alternate heat treatments was 15 ksi (instead of 25 ksi), and even though the HIPing was performed at a higher temperature (2250°F) than the optimized heat treatment (2165°F) it did not compensate for the lower HIPing pressure. Only one porosity initiated failure was observed for the specimens subjected to the optimized heat treatment. This implies that HIPing at 25 ksi heals most of the porosity.

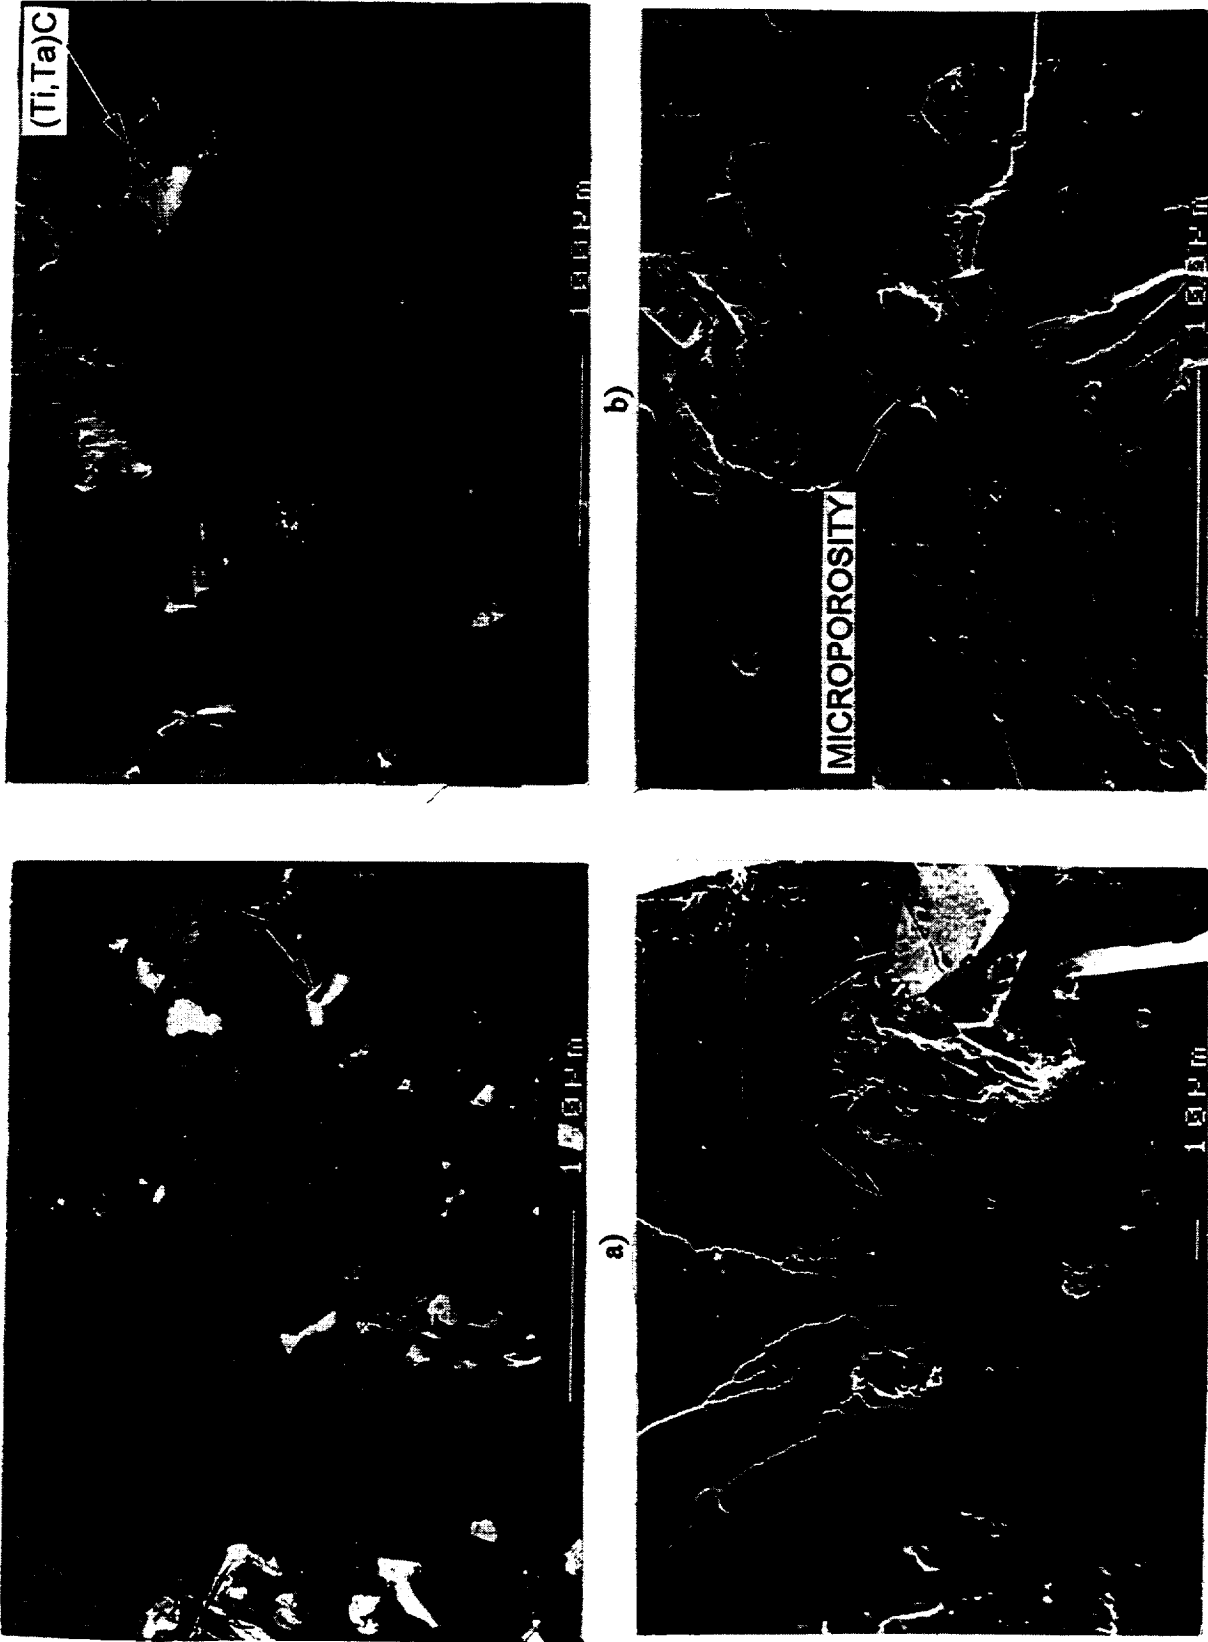
Figure 15. Typical Stage I initiation sites, a) HfC initiated facet in PCC sheet specimen, b) (Ti,Ta)C initiated facet in PCC sheet specimen, c) eutectic and/or micro-pore initiated facet in PCC bar specimen, d) micro-pore initiated facet in Hirschner bar specimen.

Typical Stage I failure sites are shown in Figure 15. In this alloy, carbide related failures on (111) planes were most common. Both HfC and (Ti,Ta)C were present at initiation sites, and at about the same frequency. Micro-porosity and eutectic related Stage I cracks and strictly (111) planar failures were less common. These failures however, were more difficult to discern because of the abundance of eutectic present in this alloy. In general, Stage I initiations were more common at the 1000°F test temperature and in the bar specimens. For example, all bar specimens tested at 1000°F failed from Stage I initiations. Under these conditions, the Howmet specimens exhibited the best HCF life. This may be partially attributed to the fact that the Howmet castings also exhibited the finest grain structure.

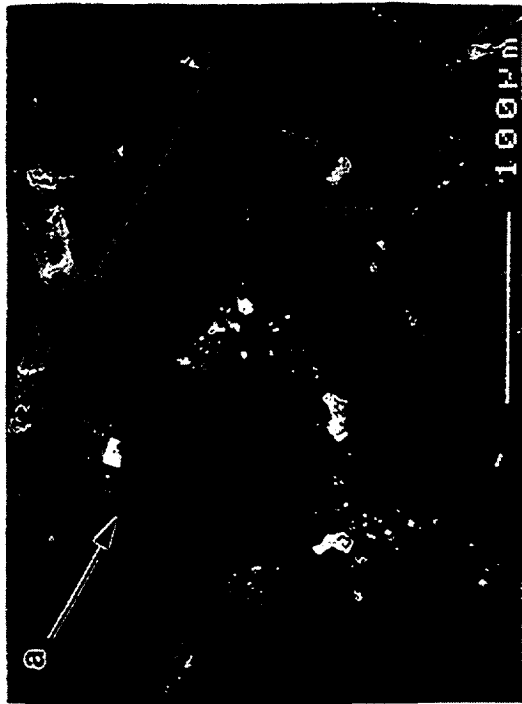
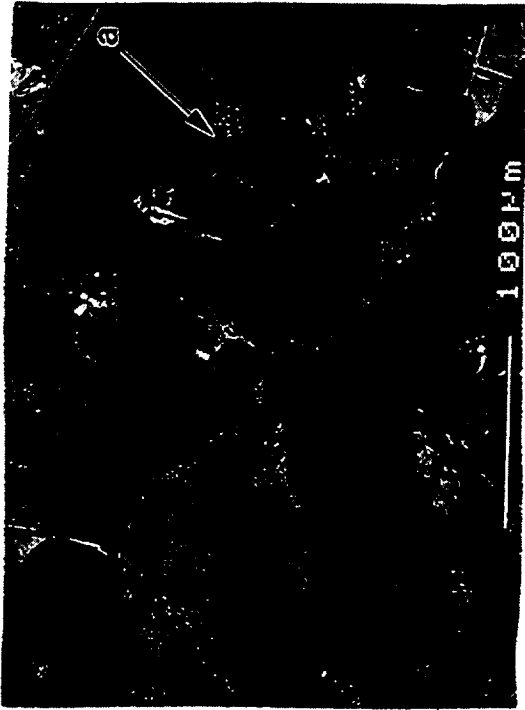
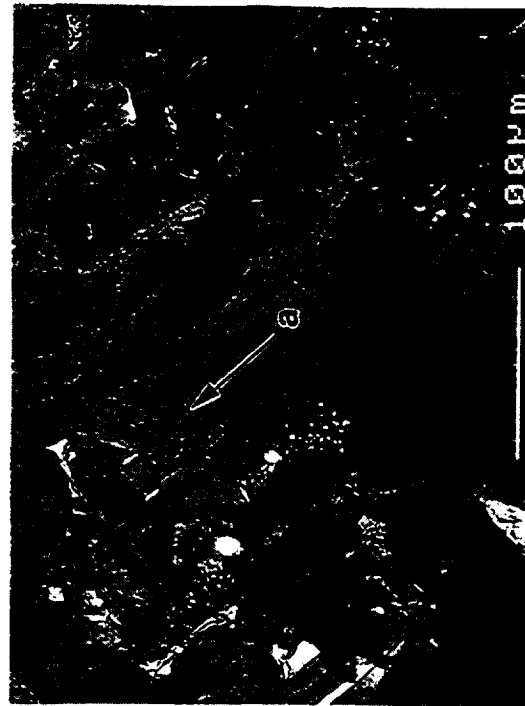
Figure 16. Typical slow crack growth fracture morphology, a) Howmet specimen, b) Hitchiner specimen and c) PCC specimen.

Slow, stable crack growth in all cases occurred transgranularly. The crack path generally displayed little or no tortuosity (Figure 16). In the Hitchiner and PCC specimens which displayed large grain structure stable crack propagation commonly occurred on (111) crystallographic facets (Figure 17 and 18a and b). Some crack propagation along crystallographic facets was also observed in the Howmet casting, however, these facets were typically smaller (Figure 18c). Fast crack growth and overload typically occurred through interdendritic regions and occasionally intergranularly, with a much more tortuous crack path which followed along eutectics and fragmented carbides (Figure 19).

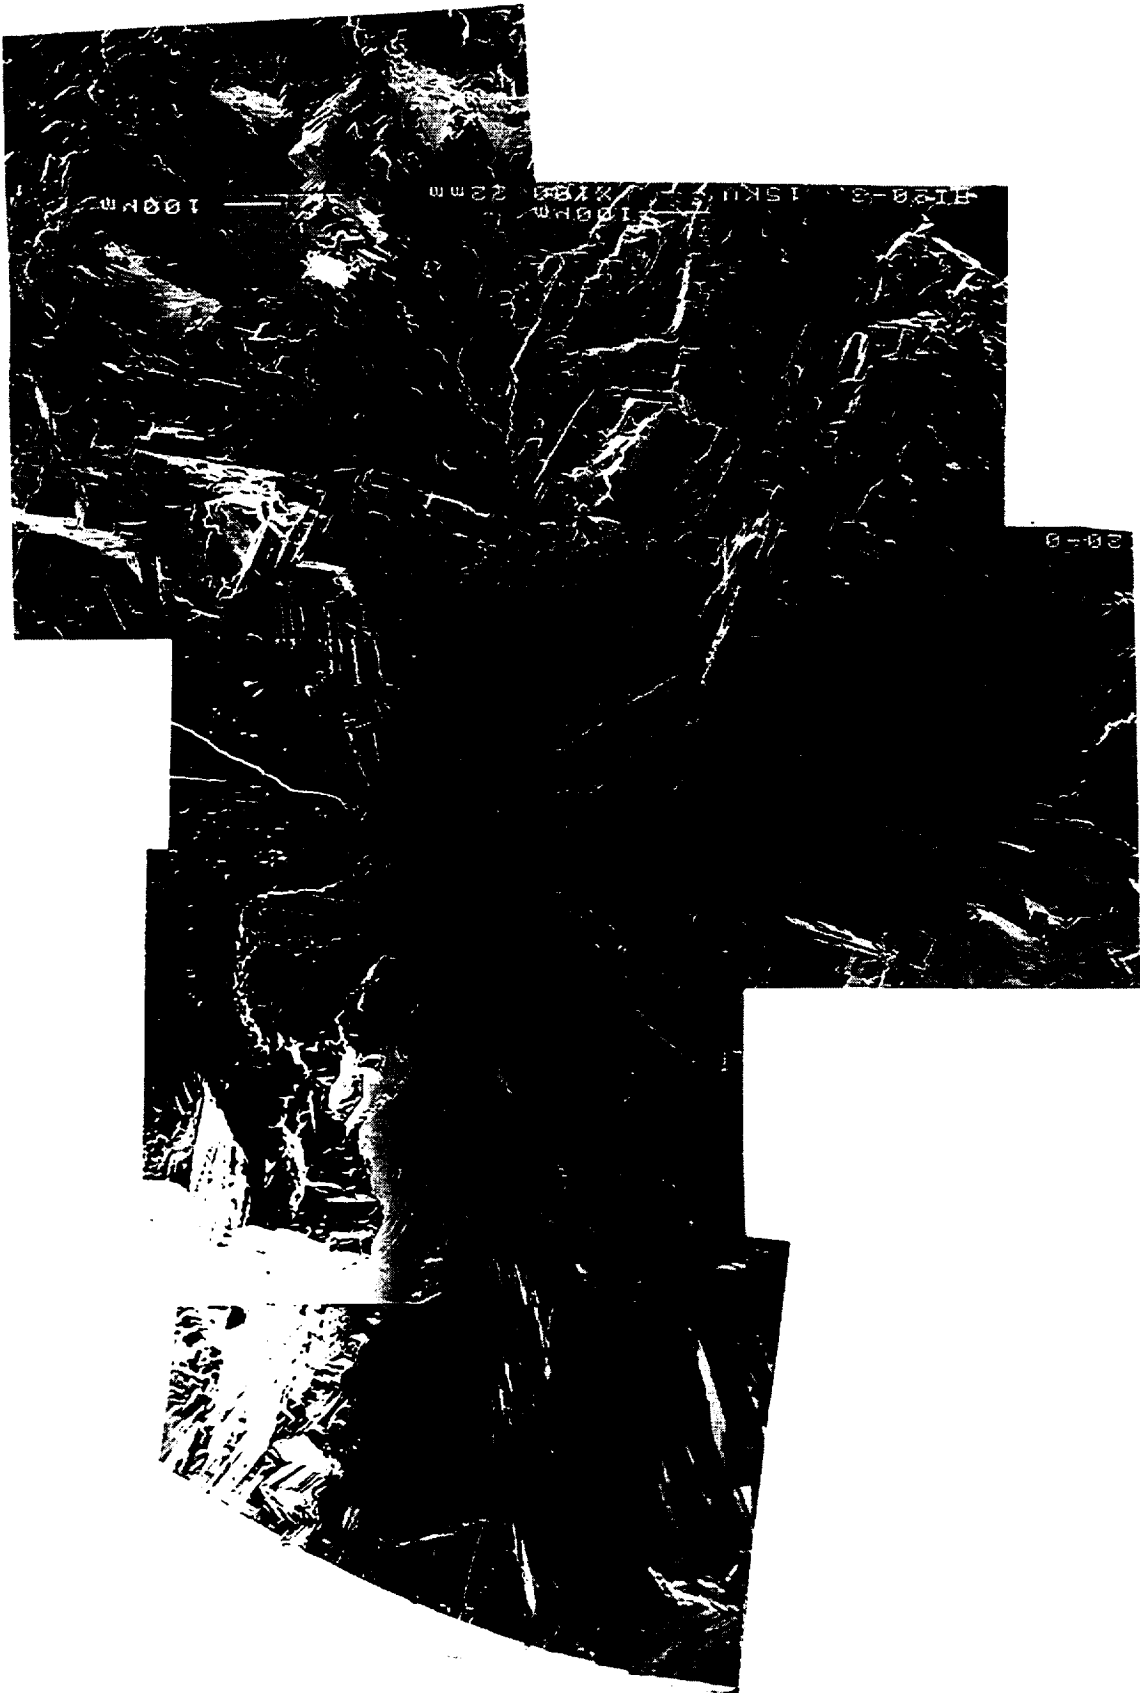
Figure 17. Extensive Stage I stable crack propagation, typically found in Hitchiner and PCC specimens with large grain structures.

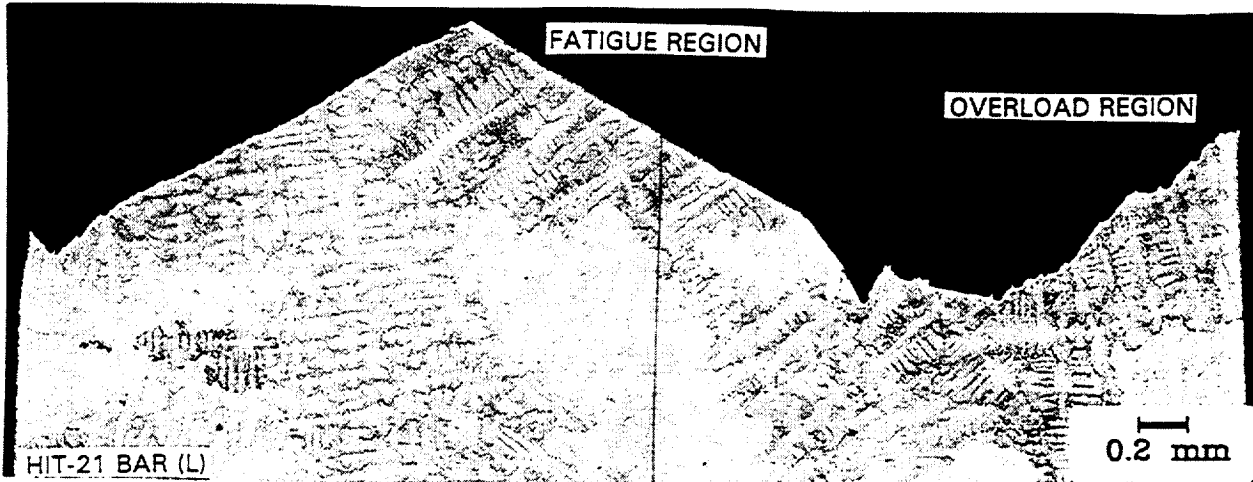
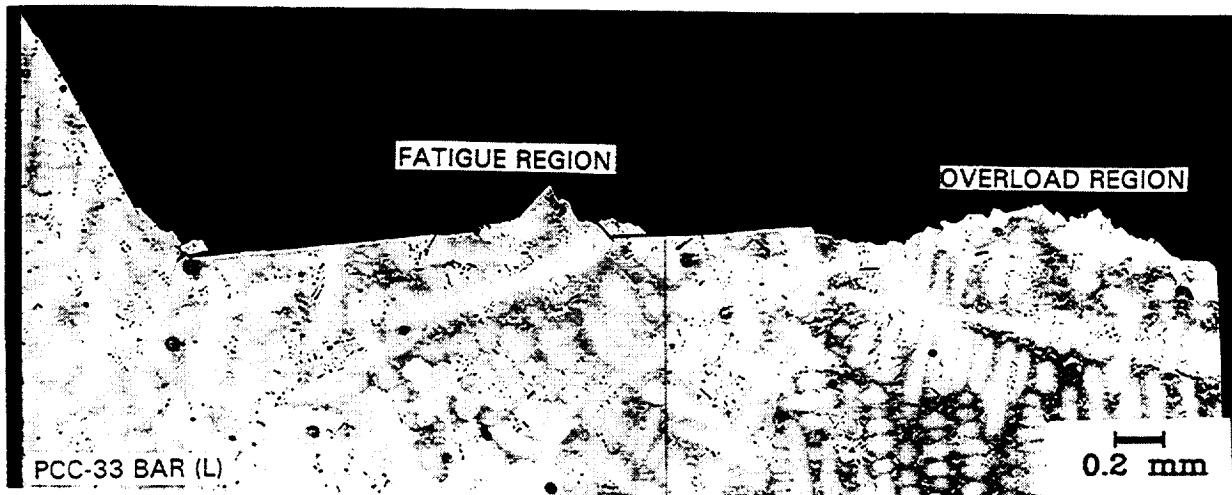
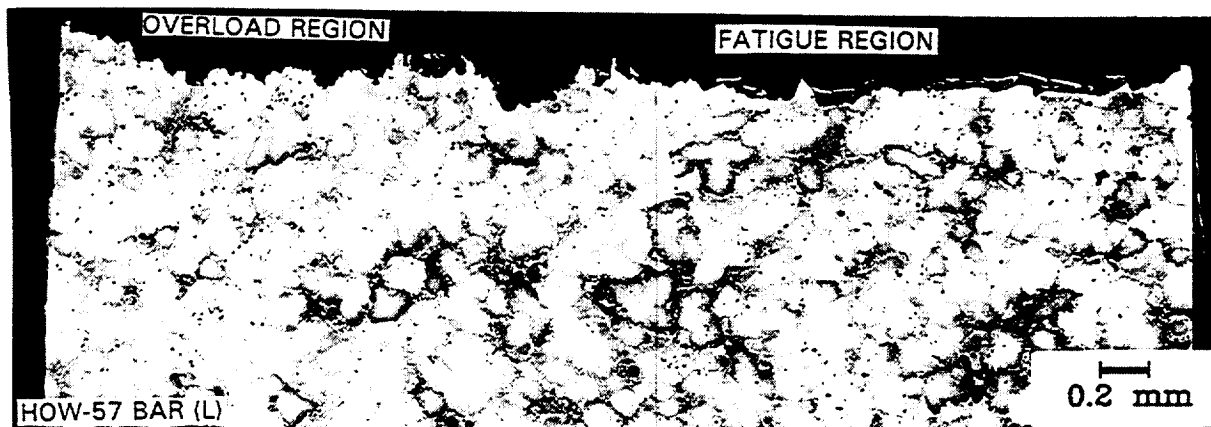
Figure 18. Metallographic sections through the fracture surface of a) Hitchiner, b) PCC, and c) Howmet bar specimens.

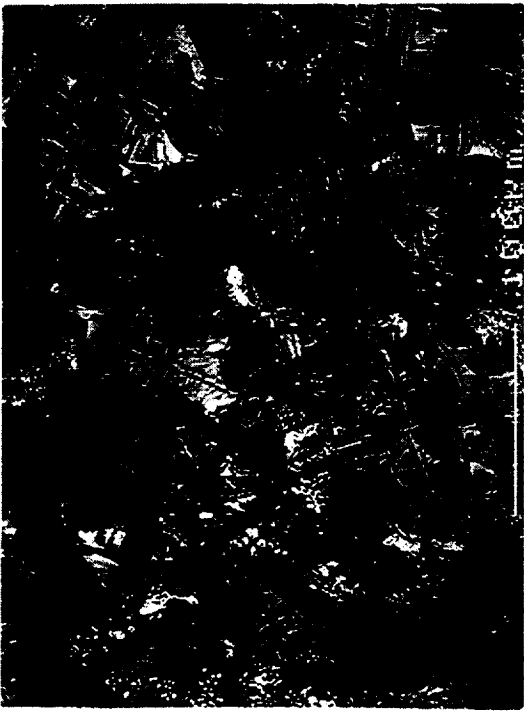
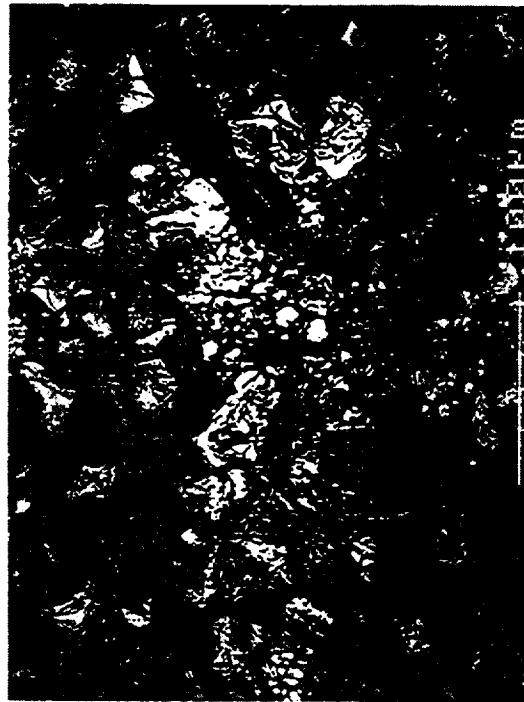
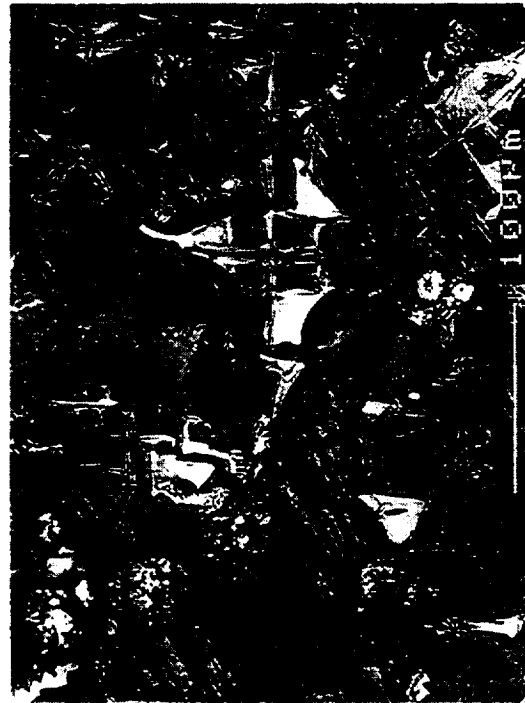
Figure 19. Typical fast crack growth and overload fracture surface morphology, a) Howmet specimen, b) Hitchiner specimen and c) PCC specimen.
