## THE ROLE OF BEARING AND SCAN MECHANISM LIFE TESTING IN FLIGHT QUALIFICATION OF THE MODIS INSTRUMENT

### ABSTRACT

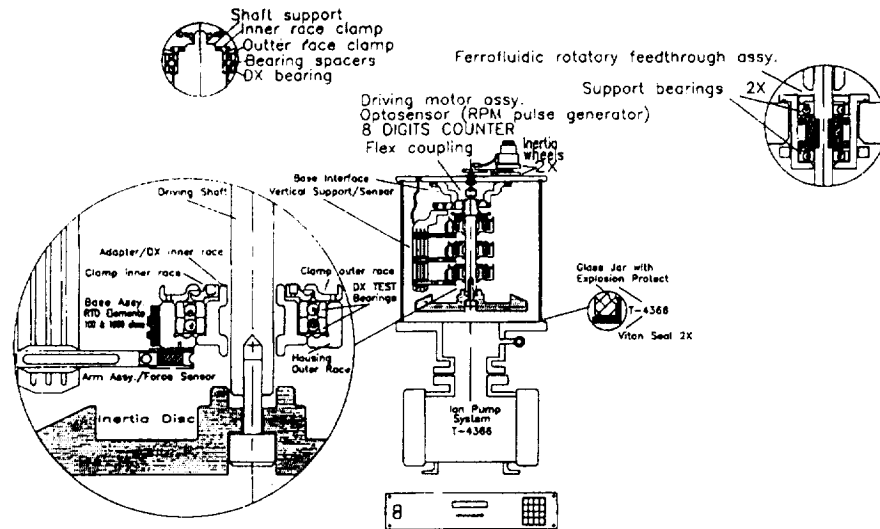
Figure 1 – Test Station

In each test station, three flight quality, 440C steel, 66.675 mm (2.625 inch) outer diameter, 50.800 mm (2 inch) inner diameter, DF duplex pair bearings with a 165 N (37 pound) preload were used. The bearings, phenolic laminate retainers, and sintered nylon reservoirs were lubricated in accordance with flight requirements. The test station is illustrated as Figure 1. Each bearing pair was contained in its own clamp/housing. The housings also contained lubricant reservoirs. Station II and III housings were fitted with inner and outer race heaters. A strain gauge was mounted on a cantilever beam supporting each bearing enclosure to measure the torque. The inner races of three duplex pairs were driven by a common drive shaft. Instantaneous torque readings were recorded every 15 minutes. The monthly average of these readings was plotted over the life of the test (see Figure 2). One telemetry platinum resistance thermometer (PRT) was mounted to each bearing outer race housing. Two control PRTs (Stations II and III only) were also mounted to each bearing housing (one on the outer race and one for the inner race). All testing was performed under vacuum. Although all the Pennzane lubricant was tested in the boundary lubrication regime, the acceleration factor was established as similar calculated specific film thickness ( $\lambda$ ) in all three-test stations. This method was used as an arbitrary way of creating an accelerated lubrication life test. Three duplex pairs of bearings were tested in Station II at 72 RPM and 45°C, in Station III at 50 RPM and 37°C and 22°C and in Station IV at 20.3 RPM and 23°C.

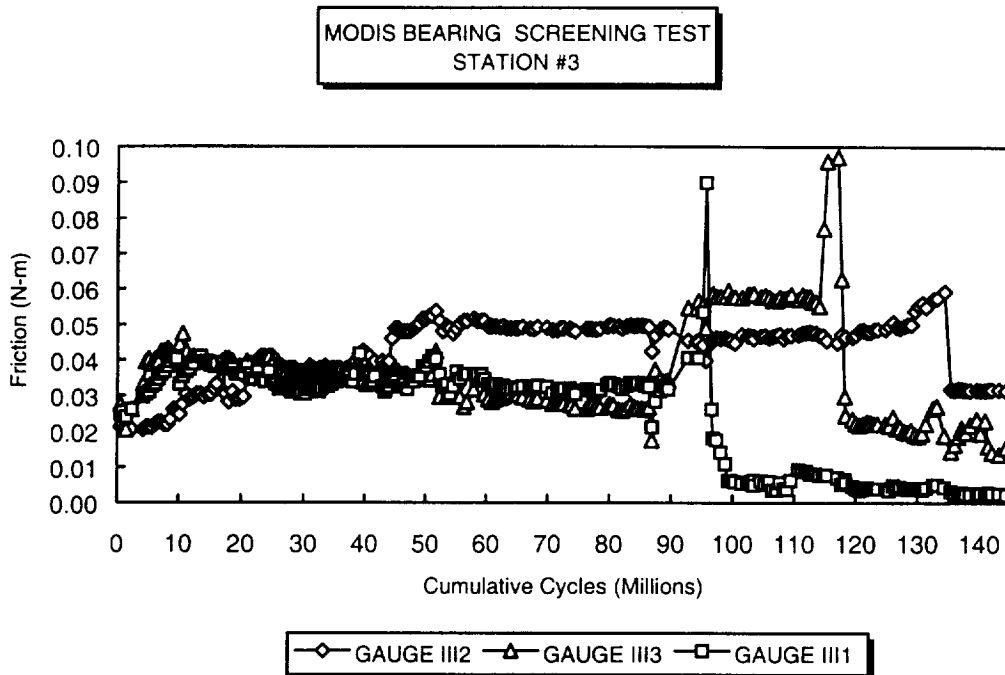
**Figure 2 – Torque vs. revolutions for upper pair bearings (III1), middle bearings (III2), and lower bearings (III3)**

Bearing life test Station III results were reported at the 34<sup>th</sup> Aerospace Mechanisms Symposium (Ref. 1). Bearings in this station indicated consistent operation well past 57 million revolutions until a suspected heater malfunction occurred at 88 million cycles (Figure 2). The test continued until 144 million revolutions were achieved, then it was switched off, and disassembled.

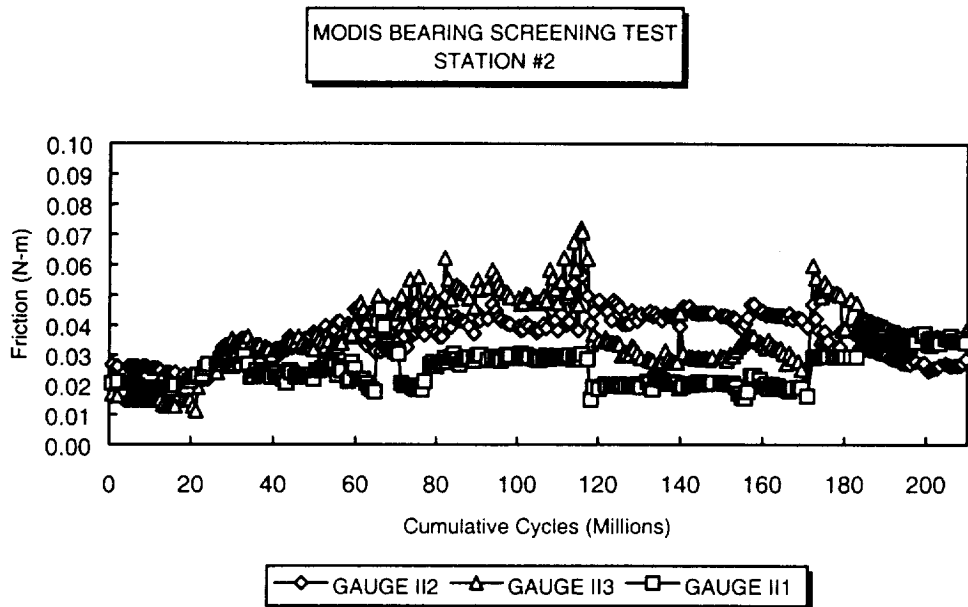
**Figure 3 – Torque vs. revolutions for upper pair bearings (II1), middle bearings (II2), and lower bearings (II3)**

Average torque data is shown in Figure 3 for Station II. Intermittent jittering of the upper bearing pair housing was observed toward the end of testing. Torque characterization with and without visible vibration is shown in Figures 4 and 5.

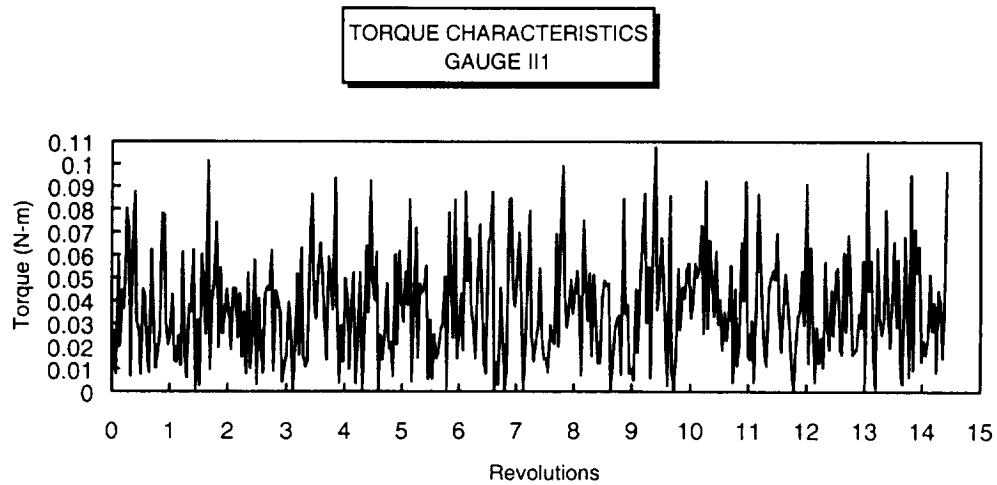
**Figure 4 – Torque characterization for Station II upper bearing pair with visible vibration**

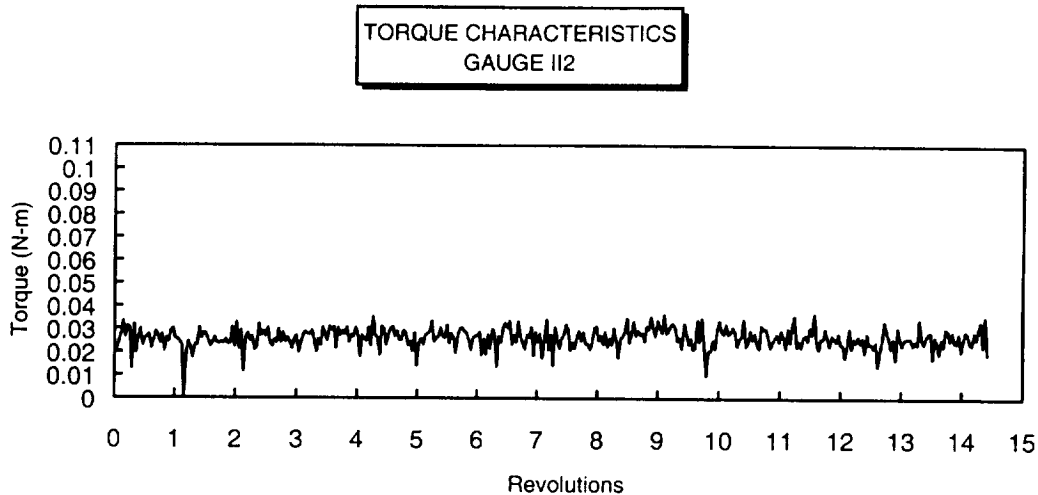
**Figure 5 – Torque Characterization for Station II Middle Bearings without Vibration**

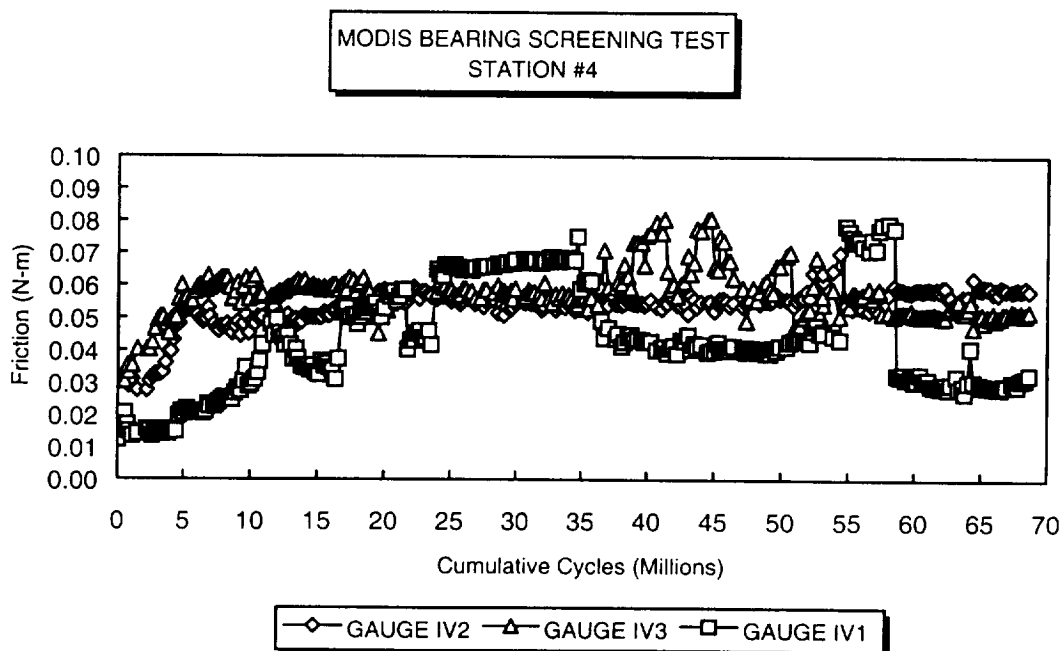
**Figure 6 – Torque vs. revolutions for station IV upper pair bearings (IV1), middle bearings (IV2), and lower bearings (IV3)**

Station IV operated for 68 million cycles at 20.3 RPM or operational speed. This station operated at room temperature and exhibited vibration that randomly affected the bearings at different times. The vibration was visible and varied with intensity. At times there was no vibration noted on any of the bearings. Torque history for all bearing pairs appears in Figure 6.

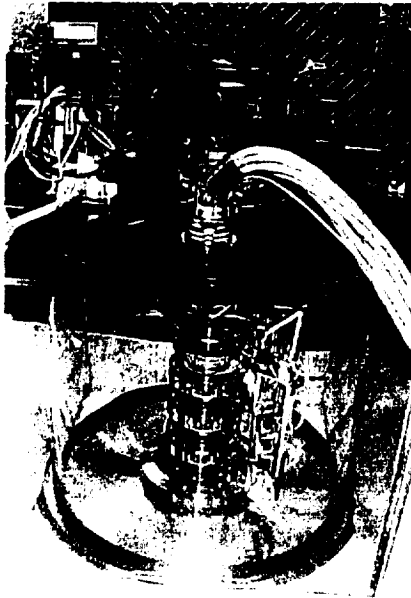
**Figure 7 – Test station prior to disassembly**

Upon completion of 209 and 68 million cycles for Stations II and IV, respectively, the stations were disassembled. Photographs were taken throughout the disassembly and inspection process. A test station prior to disassembly is shown in Figure 7. The complete shaft and all bearing components were removed from the test station and transported to a class 100 flow bench in a class 100,000 clean room for further inspection.

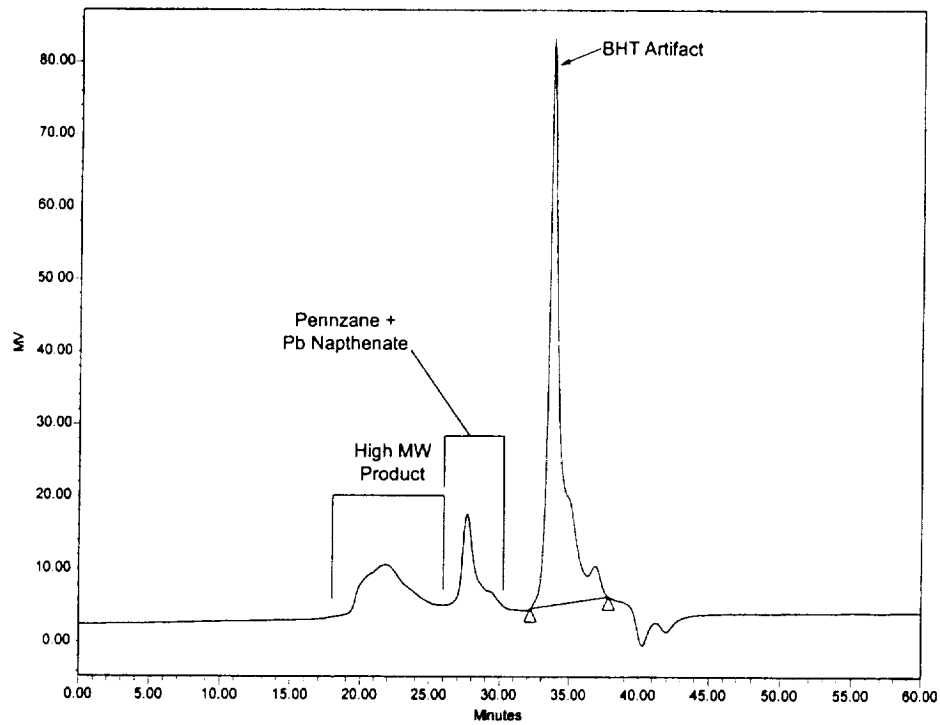
Figure 12 – Size exclusion chromatogram from extracted lubricant from cage 4-012

Raman and Infrared analyses of the lubricant indicated the standard signature for non-degraded Pennzane. XPS, SEM, and EDAX showed the normal elemental composition for 440C steel. The most striking demonstration of lubricant degradation was observed in some bearings as a thickened lubricant deposit with almost grease like in consistency. These deposits occurred on both races and on the cage. For the SEC analysis, the cages were all weighted and then extracted using tetrahydrofuran (THF). The solution was then concentrated and injected into a size exclusion chromatograph. An example from bearing 4-012 appears in Figure 12. The detector signal is plotted as a function of molecular weight (MW). Several peaks are evident. The negative peaks at low MW are injection peaks. The peak at 195, which occurs in all samples, is an artifact from a preservative in the mobile phase (THF). The next peak represents the degraded Pennzane compound. The higher MW peak at about 1300 represents the primary Pennzane material as well as a contribution from the lead naphthanate. The broad high MW peak centered about 18,000 represents polymerized lubricant. This high MW peak does not occur in unused samples.

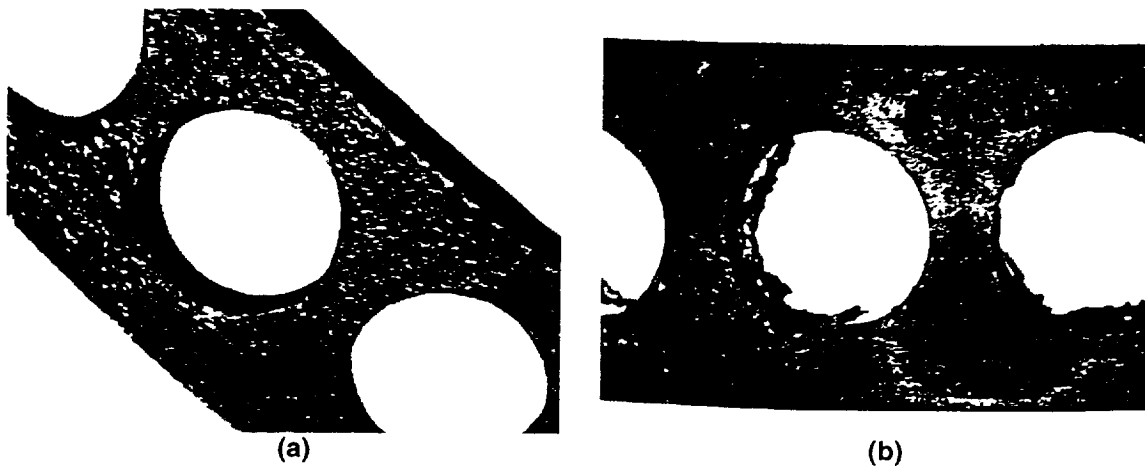
Figure 13 – Photograph of extracted cage from 4-002A (a) and 4-015A (b)

The weight of extracted lubricant varied from bearing to bearing with the smallest amount being about 9 mg from cage 4-015 and 49 mg from cage 4-002A. This compares to the nominal amount of 75 mg impregnated at build up. In addition, dark residues were observed on cages 4-002A, 4-005A, 4-006A and 4-015A. Photographs for these two cages after THF extraction appear in Figures 13a and 13b.

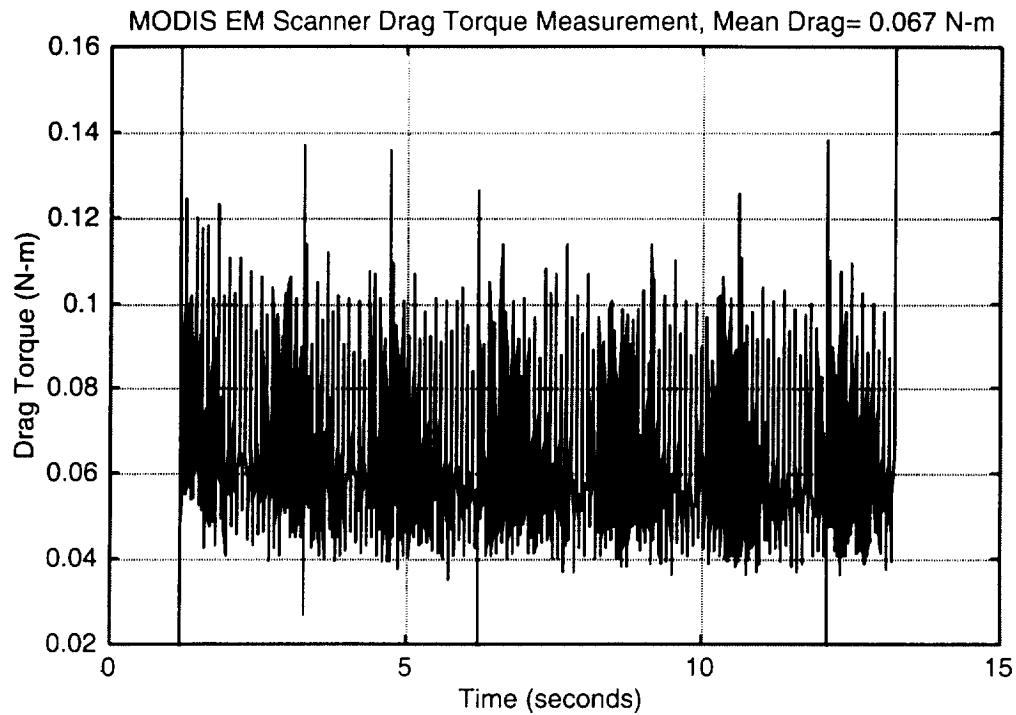
**Figure 14 – MODIS EM Scanner Steady State Drag Torque.**

Figure 14 documented the running or steady state drag torque of the EM scanner, which had an average value of .067 N-m (9.4 oz-in). During this test, the EM unit maintained the required rotation rate of 20.3 rpm with phase-lock control. The beginning-of-life requirement for this value was .11 N-m (15 oz-in), which was met. The current limit on the PFM and FM-1 MODIS units was about one amp for the flight condition which indicated that the beginning of life torque margin for the scanner was greater than 20.

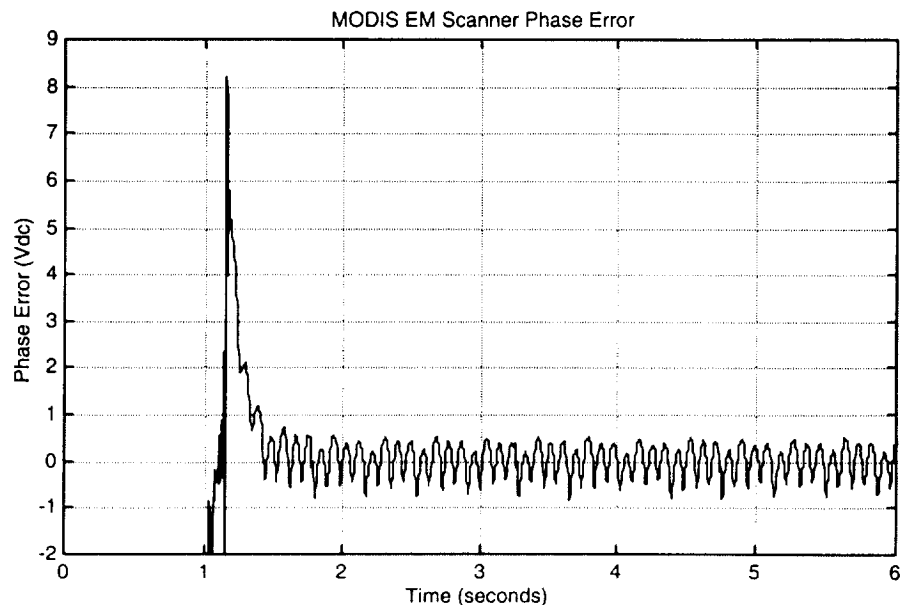
**Figure 15 – MODIS EM Scanner Phase Error.**

Figure 15 documented the measured phase error signal of the EM scanner under turn ON and steady state conditions. When the scanner was initially turned on, there was a large error signal generated between the commanded rate and the actual rate, shown by the indicated spike shortly after turn-on. The phase-lock circuitry was designed to reduce the error between the commanded rate and the actual rate over a given time, therefore the error signal reduced shortly after turn-on to a value of about 1 volt peak-to-peak. This was equivalent to a phase error of about 20 micro-radians under steady state scanner rotation.

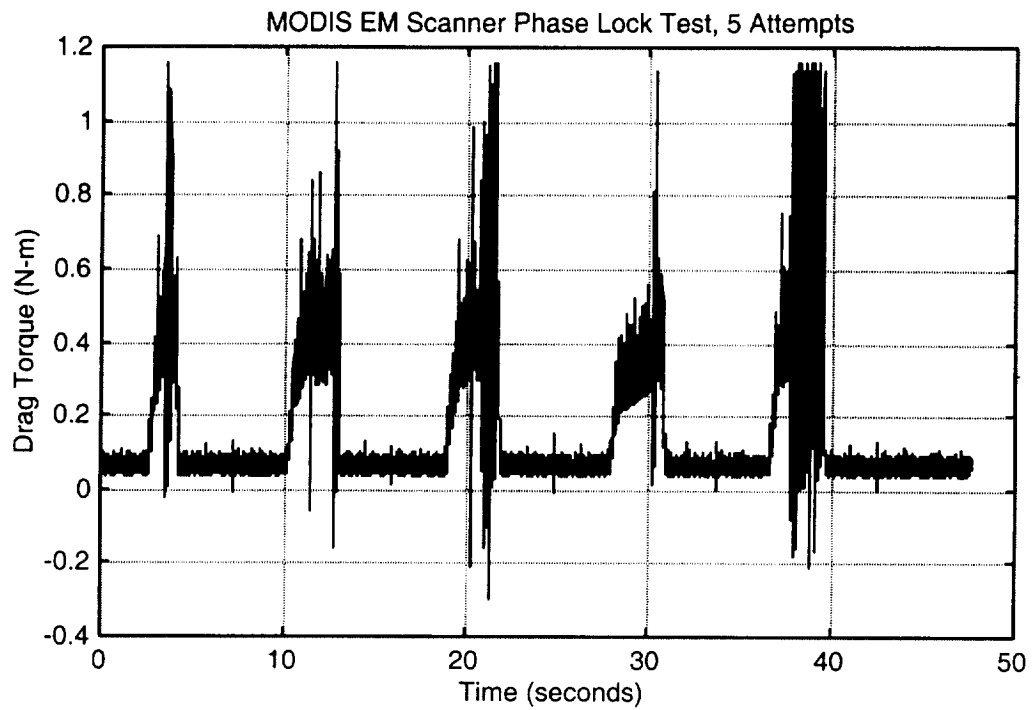
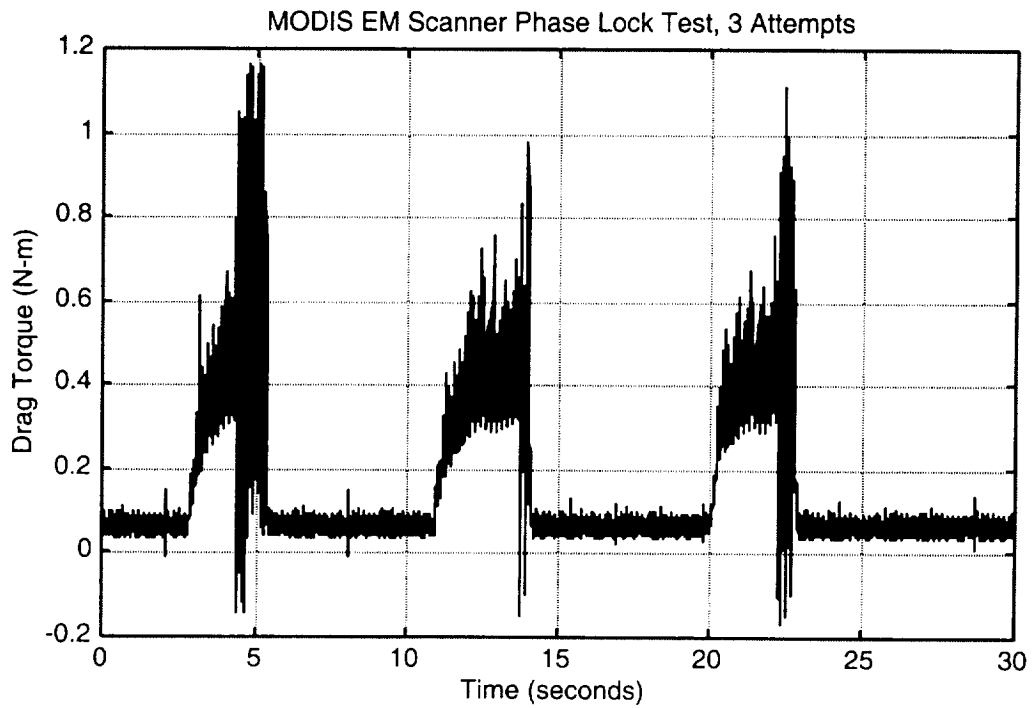
Figure 16 – MODIS EM Scanner Phase Lock Test 1.

Figure 17 – MODIS EM Scanner Phase Lock Test 2.

In Figures 16 and 17 eight attempts to bring the EM scanner out of phase lock by increasing the external drag torque on the drive system were shown. Due to the limitation of the test setup, the external drag was increased manually and the LED on the EM scanner electrical control (METS) box was observed to go out indicating the scanner was out of phase lock. The two figures also showed maximum drag torque where the scanner went out of phase lock. This drag torque compared to the maximum available torque of the scanner motor established the margin that existed for being in phase lock for the EM scanner unit. When the transient drag torque events on Figures 16 and 17, were omitted, retrieving and averaging the maximum drag from the eight attempts indicated that the drag at which point the scanner phase lock was lost occurred at about .71 N-m (100 oz-in). The PFM and FM-1 units had a scanner actuator current limit of about one amp from their power supplies, which indicated a margin on phase lock of about 200% at the beginning-of-life. This meant that the PFM and FM-1 unit scanners had about three times the available torque capacity in their scanner drive systems to maintain scanner phase lock.

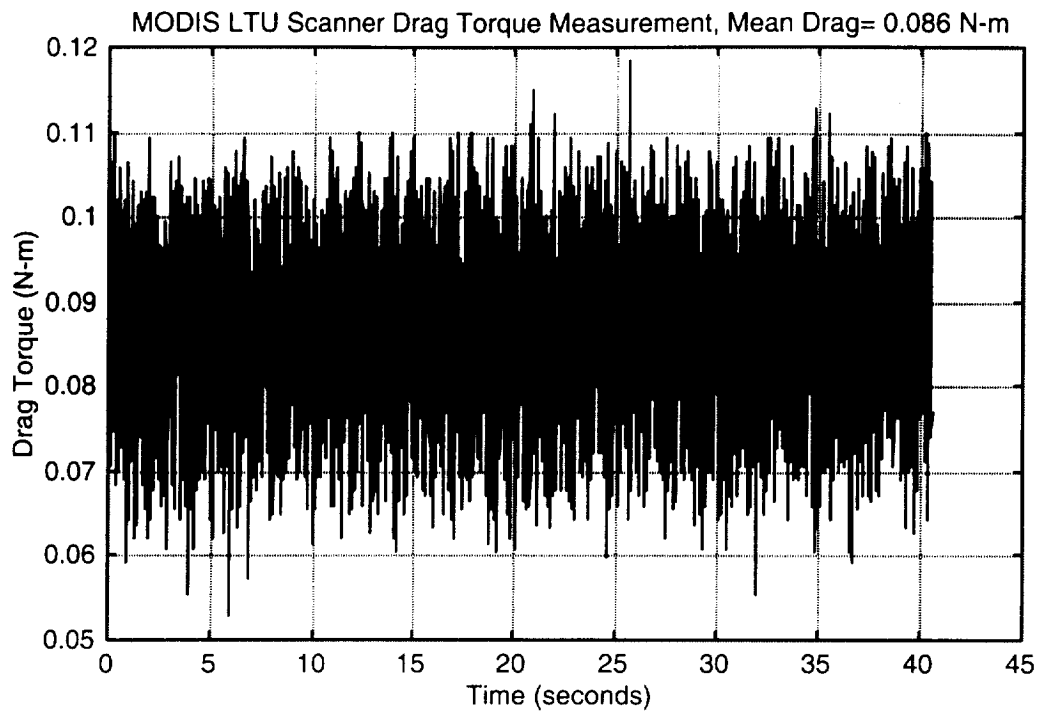
**Figure 18 – MODIS LTU Scanner Steady State Drag Torque.**

Figure 18 documented the running or steady state drag torque of the LTU scanner which had an average value measured of about 0.086 N-m (12.2 oz-in) after running more than one mission lifetime of 58 million cycles in vacuum. During this test, the LTU unit maintained the required rotation rate of 20.3 rpm with phase-lock control. The measurement indicated that at the end of (one mission) life, the torque margin for the scanner was greater than 20.

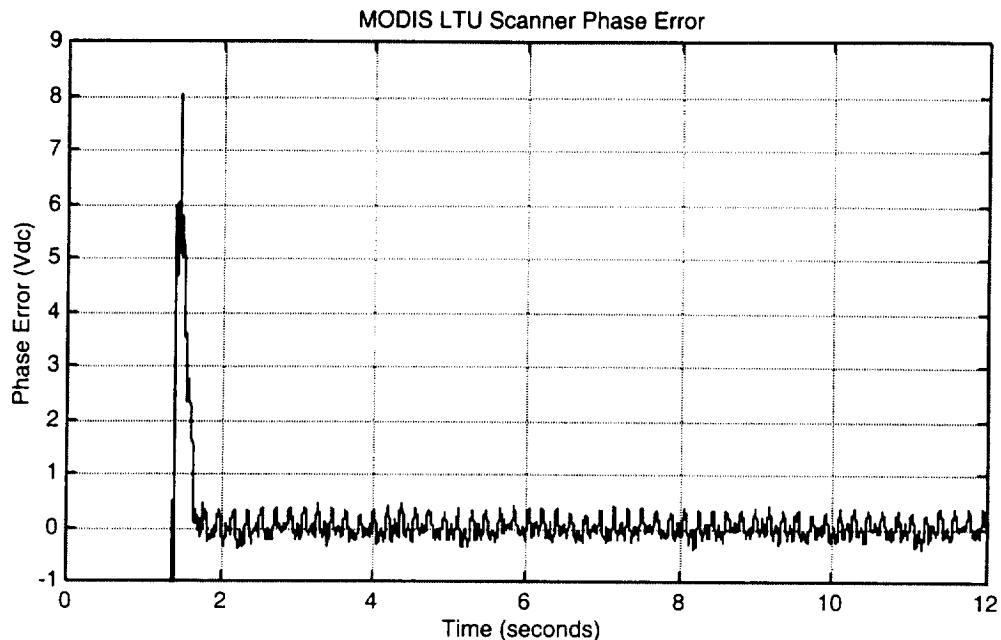
**Figure 19 – MODIS LTU Scanner Phase Error.**

Figure 19 documented the measured phase error signal of the LTU scanner under turn ON and steady state conditions. Similarly as with the EM unit system, when the LTU scanner was initially turned on, there was a large error signal generated between the commanded rate and the actual rate, shown by the indicated spike shortly after turn-on. The phase-lock circuitry was designed to reduce the error between the commanded rate and the actual rate over a given time, therefore there was a reduction in error signal shortly after turn-on to a value of about 0.5 volt peak-to-peak. This was equivalent to a phase error of about 10 micro-radians under LTU scanner steady state rotation.
