MIR SOLAR ARRAY RETURN EXPERIMENT: POWER PERFORMANCE MEASUREMENTS & MOLECULAR CONTAMINATION ANALYSIS RESULTS

ABSTRACT

A solar array segment was recently removed from the Mir core module and returned for ground-based analysis. The segment, which is similar to the ones the Russians have provided for the FGB and Service Modules, was microscopically examined and disassembled by US and Russian science teams. Laboratory analyses have shown the segment to be heavily contaminated by an organic silicone coating, which was converted to an organic silicate film by reactions with atomic oxygen within the orbital flight environment. The source of the contaminant was a silicone polymer used by the Russians as an adhesive and bonding agent during segment construction. During its life cycle, the array experienced a reduction in power performance from ~12%, when it was new and first deployed, to ~5%, when it was taken out of service. However, current-voltage measurements of three contaminated cells and three pristine, Russian standard cells have shown that very little degradation in solar array performance was due to the silicate contaminants on the solar cell surfaces. The primary sources of per

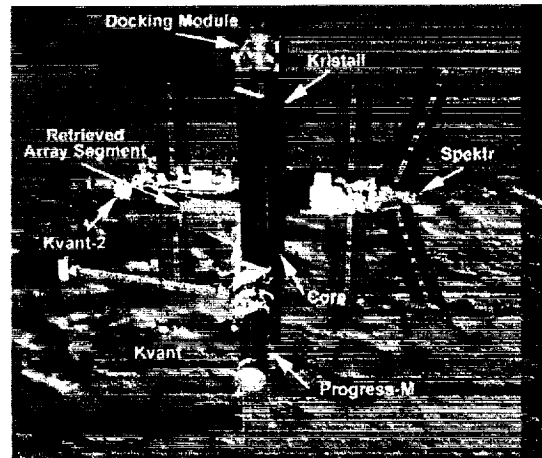
Figure 1. Photograph of Mir Space Station taken during the STS-79 mission showing the location of the solar segment that was retrieved during STS-89.

The location of the non-articulating PV array on the Mir core module from which the Russian segment was removed is shown in Figure 1. This array is located directly above the Kvant-2 module and is extended outward from the Mir core module in a direction parallel to the "Sofora" truss on the Kvant-1 module. The returned segment (see Figure 1) was deployed during a Russian EVA on June 16, 1987. Following 125 months of exposure to the orbital space environment, the array was removed from the Mir core module by Russian cosmonauts on November 03, 1997.

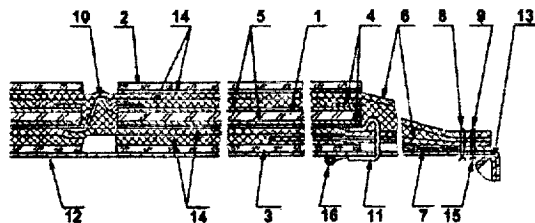
As shown in Figure 2, the front side of the solar cell (item 1) is bonded to a layer of glass cloth, which is tightly woven and impregnated with a silicone

Figure 2. Fragment of the photoelectric part of Russian BSD 37KE Solar Array design.

adhesive. The glass cloth is, in turn, bonded to the backside of the cover glass (item 2) with this adhesive. The rear side of the solar cell is bonded to second layer of glass cloth, which is also tightly woven and impregnated with the same adhesive. The glass cloth is, in turn, bonded to the backside of the OSR (item 3) with the silicone adhesive. The purpose of the OSR is to reject heat from the solar cell attached to its surface and to minimize heat input from the backside of the solar panel when it is exposed to reflected or direct sunlight. A third layer of fabric mesh (item 7) extends beyond the outside perimeter of the array assembly. This last layer of tightly woven glass fabric, which is used to provide additional stiffness, is located between the second layer of glass cloth (item 6) and the OSR. This layer of reinforcement cloth is stretched and bonded to the solar panel outer support frame (item 13) with an organic silicone adhesive.

The polymer backside net cloth (item 12) consists of a large open-weave organic fabric that covers and protects the optical solar reflectors. This fabric, which is coated with a BF-4 organic adhesive (item 15), is physically attached to the solar array assembly with organic threads (items 8 and 9) between the cells that penetrate and tie all three interior fabric layers together to enhance their mechanical strength properties. The electrical wires (item 16) that connect the cells are located in gaps between the cells which are filled with an organic silicone potting compound. The polymer backside net cloth, which supports the array assembly during ground tests and deployment operations, is also stretched and bonded to the solar panel outer support frame (item 13) with the same organic silicone adhesive.

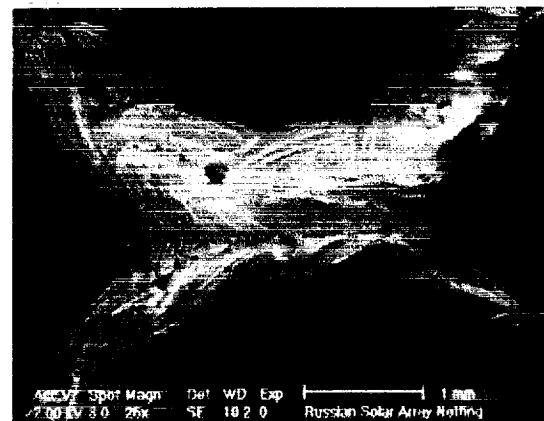
removed from the solar array panel. As indicated by these images, it was heavily coated with a brittle silicate crust. The individual fibers that comprise the fabric can easily be seen in Figure 6 through an opening in the silicate crust that has coated the surface of the net cloth.

Figure 6. High-resolution SEM image of silicate contaminate film over organic fibers on backside of net cloth.

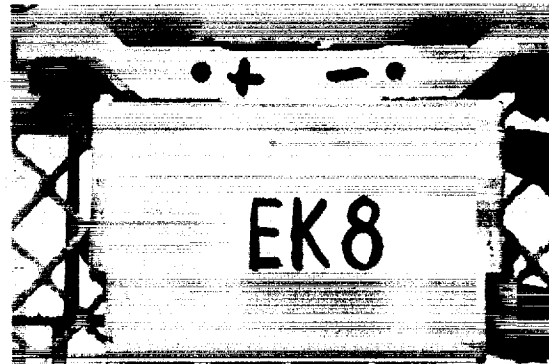
The non-uniform colorations of the handrail and power diode box are easily visible in Figures 7 and 8, respectively. The shadow pattern resulted from the protective grid cover (see Figure 5) that was mechanically attached to the backside of the panel and shielded areas of box from ultraviolet radiation and direct impingement of atomic oxygen. Previous studies² have identified similar shadowing phenomenon on LDEF surfaces where silicone contaminants were shadowed from atomic oxygen and UV exposure.

Figure 8. Over diode box cover on back of Solar Array showing shadowing pattern resulting from the overlying grid cover.

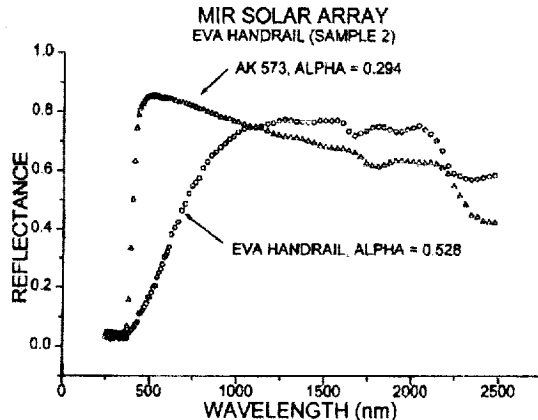
The solar absorptance of this coating (Figure 9) increased from an initial value of 0.294 when it was new, to a final value of 0.528 when the ground-based measurements were made. This change represents an increase of 80% over the 10-year period of orbital exposure.

Figure 9. Spectrophotometer measurements of the Mir Solar Array Handrail.

To evaluate the optical performance of the solar array components, solar absorptance measurements were obtained from the solar cells, handrail, diode box, and other structural components of the array using a laboratory spectrophotometer. The results of these measurements are summarized in Figures 9 and 10 for the handrail and a solar cell comprising the array, respectively.

The optical properties of the AK-573 paint degraded significantly during its exposure to silicone contamination, atomic oxygen, and UV radiation.

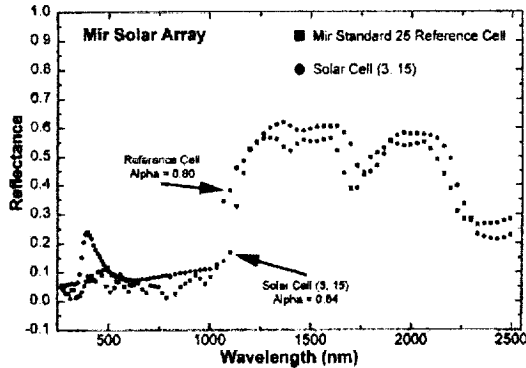
From the reflectance data given in Figure 10, it may be concluded that the optical transmittance (1.0 - optical reflectance) of the cover glass remained very

Figure 10. Spectroreflectometer measurements of a MIR photovoltaic cell.

close to 90% over the wavelength range 0.35 - 1.0 μm (350 - 1000 nm). These measurements also show the solar reflectance of the cell increases appreciably in the wavelength range 1.0 - 2.0 μm (1000 - 2000 nm), which is representative of the far "infrared" portion of the solar spectrum.

Thus, the silicate contaminant layers on the surface of the cover slides do not appear to have appreciably backscattered the incident solar radiation, which

would have degraded the optical performance of the solar cell. These measurements indicate these cells continue to absorb well in the visible and near infrared wavelength regions, and to reflect well within the far infrared region of the solar spectrum.

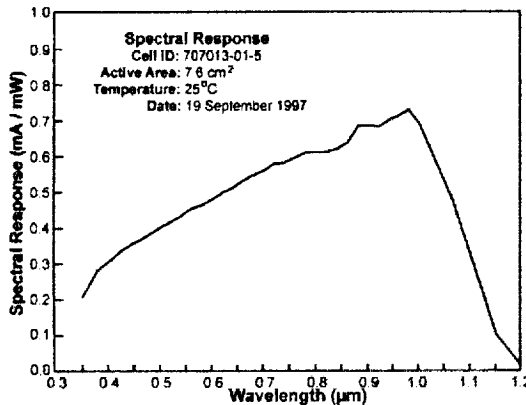
The spectral response of a typical solar cell is shown in Figure 11 as a function of wavelength over the wavelength range 0.35 - 1.20 μm . Note from this Figure that the spectral response of a typical silicon solar cell begins at 0.35 μm and continues to increase linearly until it peaks at 1.00 μm . The cell response to solar radiation (sunlight) then falls off dramatically from 1.0 - 1.20 μm .

Figure 11. Spectral response of a typical solar cell.

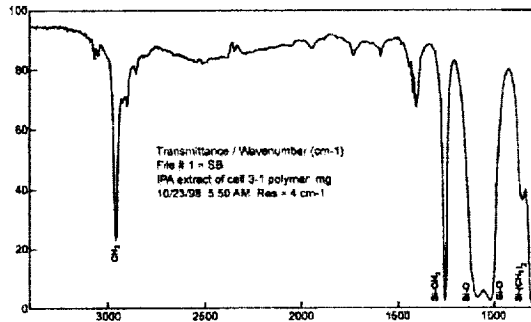
of this adhesive polymer is shown in Figure 13. The position and depth of the absorption bands in this spectrum indicate that this material is an organic methyl silicone.

Figure 13. Infrared transmission spectrum of the solar cell silicon polymer adhesive.

constituents can easily be converted to an inorganic silicate by means of atomic oxygen attack in LEO, thus fixing the contaminant film to the surface and preventing its re-evaporation. This would explain the absence of carbon and the presence of the silicate coatings that formed on the front and back surfaces of the Mir solar cells, and on the handrail, hand holds, and backside netting during extended periods of atomic oxygen exposure.

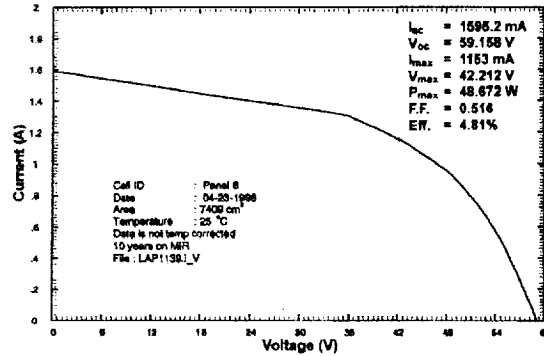
The Russian PV panel that the US team retained for its investigations was sent to the NASA Glenn Research Center for visual examination, electrical continuity tests, and power performance measurements. During these evaluations, the orbital space performance of the PV panel and its solar cells were determined using a Spectrolab Large Area Pulsed Solar Simulator (LAPSS). The current-voltage (I-V) characteristics of the PV panel are summarized in Figure 14. From these tests, the overall power conversion efficiency of this panel was determined to be 4.8% at an operating temperature of 25° C. The Russian science team has estimated that the efficiency of the panel when it was new and first deployed was ~12 percent.

Figure 14. Current-voltage characteristics for Panel 8 of the Mir solar array.

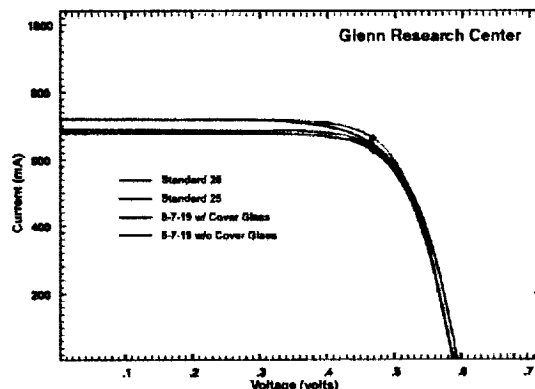
The current-voltage measurements for two Mir standard cells and one contaminated flight cell (Cell 8-7-19) with and without its cover glass are shown plotted against each other in Figure 15. As indicated by measurement values in this Figure and the values summarized in Table 1, the power conversion efficiencies of the cells with their cover slides removed (10.90%-11.41%) and with their cover slides intact (10.97%-11.11%) compare very favorably with the efficiencies (11.43%-11.80%) of the pristine, uncontaminated (unflown) Russian standard cells. It was determined from these measurements that the degradation in solar cell performance due to contamination (with film thicknesses varying from 0.2 - 5.0 μm) was negligible (~0.58% during an orbital exposure of 10 years).

Figure 15. Current-voltage comparison of two Mir standard cells and a contaminated solar cell with and without its cover slide.

A comparison of the current-voltage characteristics of three contaminated cells, both with and without their

cover slides, to the characteristics of three pristine, Russian standard cells, has shown there to be very little degradation in solar array performance due to the presence of the inorganic silicate contaminants on the solar cell surfaces. The principal sources of the remaining degradation (53%) in performance is attributed to either "thermal hot spotting" or electrical arcing, orbital debris and micrometeoroid impacts, and possibly to degradation of the solar cells and their interconnects by radiation damage from high-energy protons and electrons.
