Effects of Heat Treatment on the Ballistic Impact Properties of Inconel 718 for Jet
Engine Fan Containment Applications

J. Michael Pereira and Bradley A. Lerch
National Aeronautics and Space Administration
Glenn Research Center
Cleveland, Ohio 44135

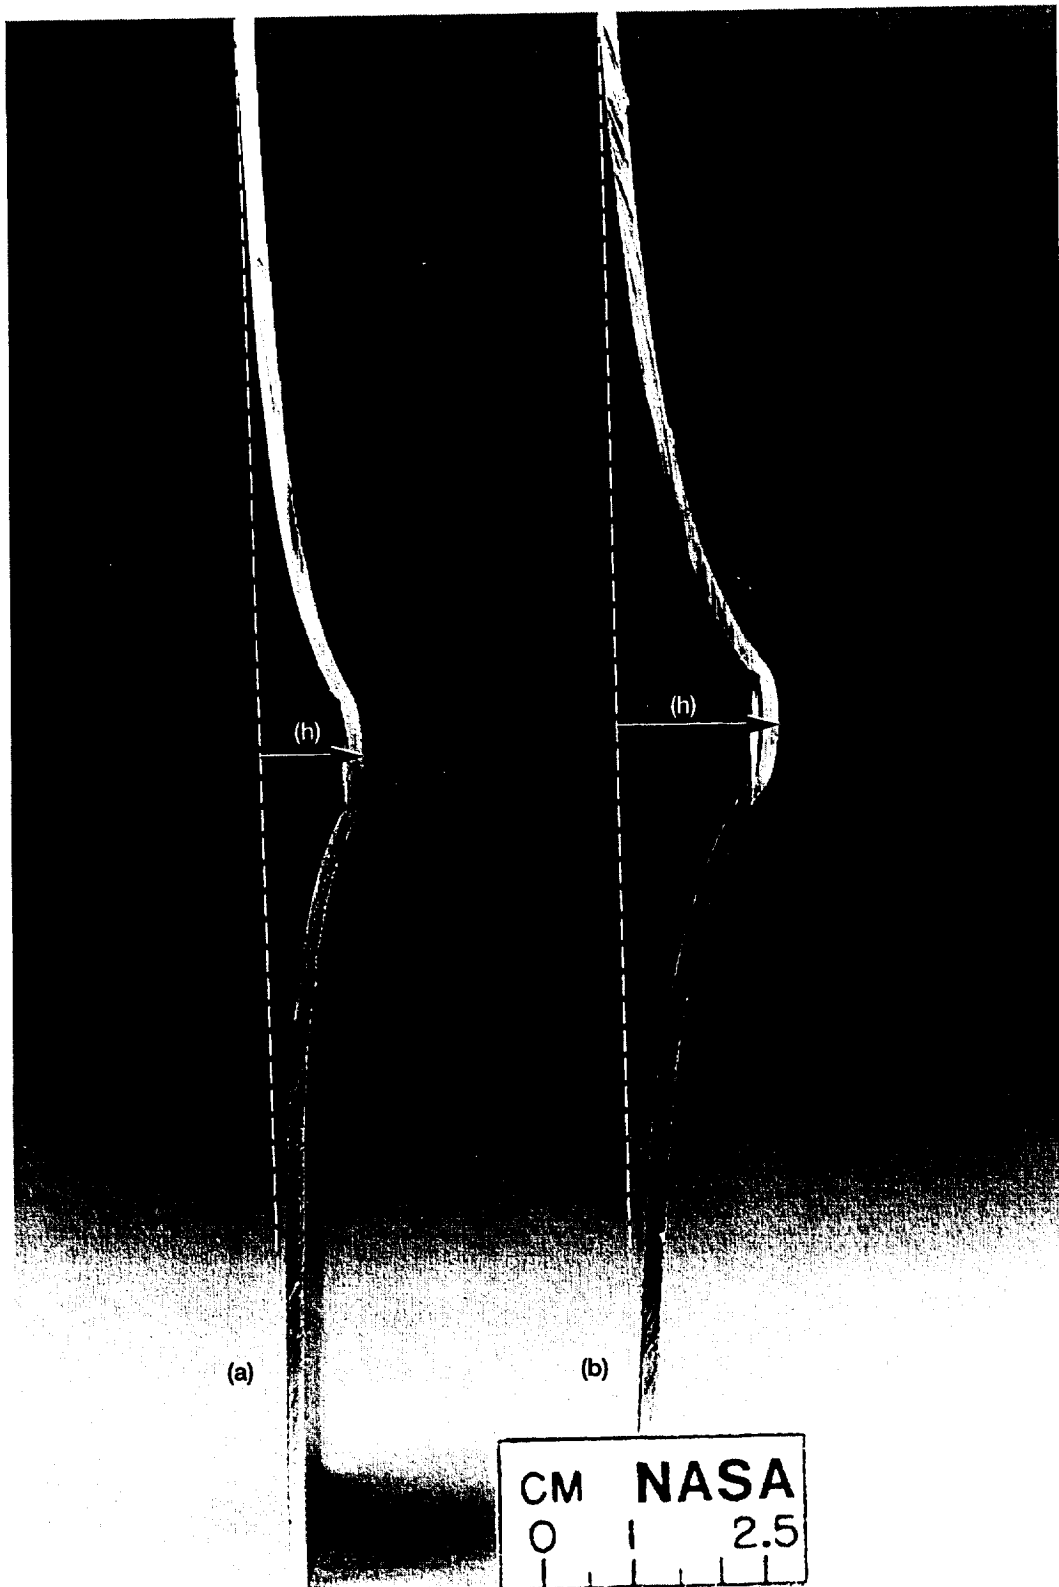
Metallographic examination of the specimens showed that for both sets of heat treating conditions, the impact produced a circular band of shear deformation extending from the corners of the projectile at the impacted surface to the back surface of the plate at an angle of roughly 45° from the plate normal (Fig. 10). There was significantly more overall deformation in the annealed specimens than the aged specimens as shown by the amount of deflection in Fig. 11. There was essentially no permanent deformation in the projectiles. Microscopic examination (Fig. 12(a)) showed that the annealed specimen exhibited what appeared to be an intense deformation band originating from the corner of the projectile impact. This band was somewhat ill-defined in structure and extended in width over ~10 grains. In nonperforated samples, the band did not reach the back face of the plate. A higher magnification of this band (Fig. 12(b)) shows that this was not a true band, but rather a collection of intensely deformed grains, which etched darker than the surrounding grains. The surrounding grains were also heavily deformed, but not to the extent of those in the band. A microhardness profile was taken across the band. Vicker's hardness ranged from ~260 (100 HRB) in areas far removed from the band (yet still in the deformed region) to a hardness of ~400 (41 HRC) in the band itself.

The results show that annealed In-718 has superior impact resistance to the aged material. The annealed material can absorb more plastic deformation before penetration occurs. This is evident from the deflection measurements in Table V and shown visually in Fig. 11. The large deflections in the annealed specimens, as illustrated in Fig. 4 produced some undesirable features in the experiment. Because of the large deflections, the boundary conditions may have had some effect on the results. Preliminary tests using 15 and 30 cm apertures in the impact test fixture showed no significant differences in the measured ballistic limit, but the overall deflections could have been effected. Also, while the projectile impacted the specimen with normal incidence, failure in the specimen was not always symmetrical, and often a plug partially separated, forming a flap. This is illustrated in Fig. 4. While this may be an artifact caused by some interaction with the boundaries it is not unusual for this type of behavior to occur. Woodward [12] noted that in plugging failures several bands are observed to nucleate and propagate independently, leading to asymmetry in the failure region.

The annealed material appears to better absorb energy by diffusing the macroscopic shear zone over a wider area (Fig. 12). Whereas Fig. 12 indicates that a diffuse macroshear band is formed, high magnification examination of this area revealed that bands *per se* are not formed. Instead, the grains in this area of intense shear are just more heavily deformed and therefore etch darker than the surrounding grains. This is also indicated by the microhardness profiles, which revealed a higher hardness in the "band" region, typical of more work hardening (plastic deformation) and agrees with hardness readings taken near shear bands in other materials [25 to 28]. At least at low magnification, these apparent bands appear similar to those observed in brass [29 and 30] and copper [30 and 31]. In these cases more homogeneous bands formed under isothermal conditions associated with necking during tensile tests. Broad and diffuse bands were also observed in copper under punch-loaded conditions [32].
