# **Aluminum Lithium Alloy 2195 Fusion Welding Improvements with New Filler Wire**

**AMPET 2000  
Huntsville, AL**

*Carolyn Russell  
NASA  
Marshall Space Flight Center  
Huntsville, AL.  
256-544-2705  
carolyn.russell@msfc.nasa.gov*

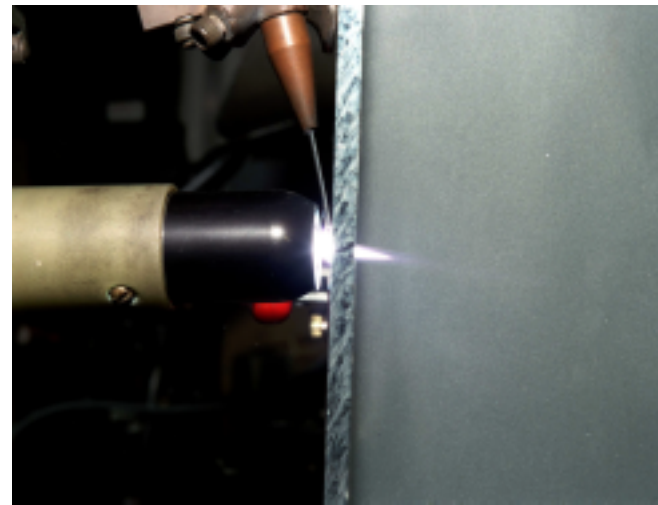
**Variable Polarity Plasma Arc Welding**

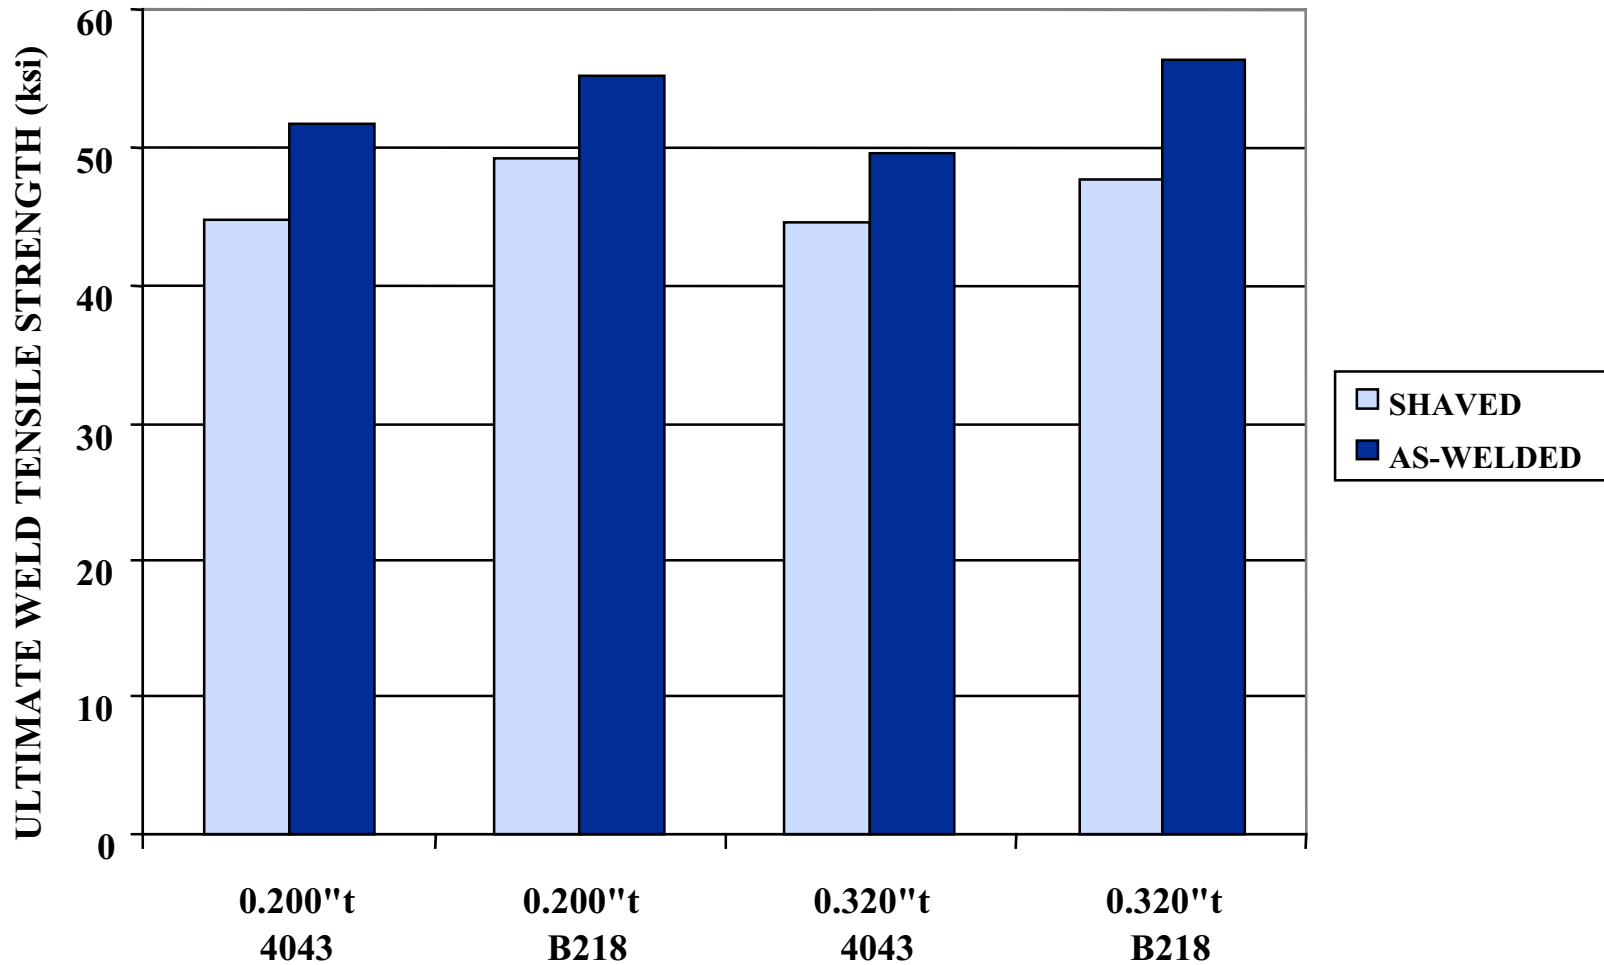
### 2195T8M4 VPPA Weld Ultimate Tensile Strength

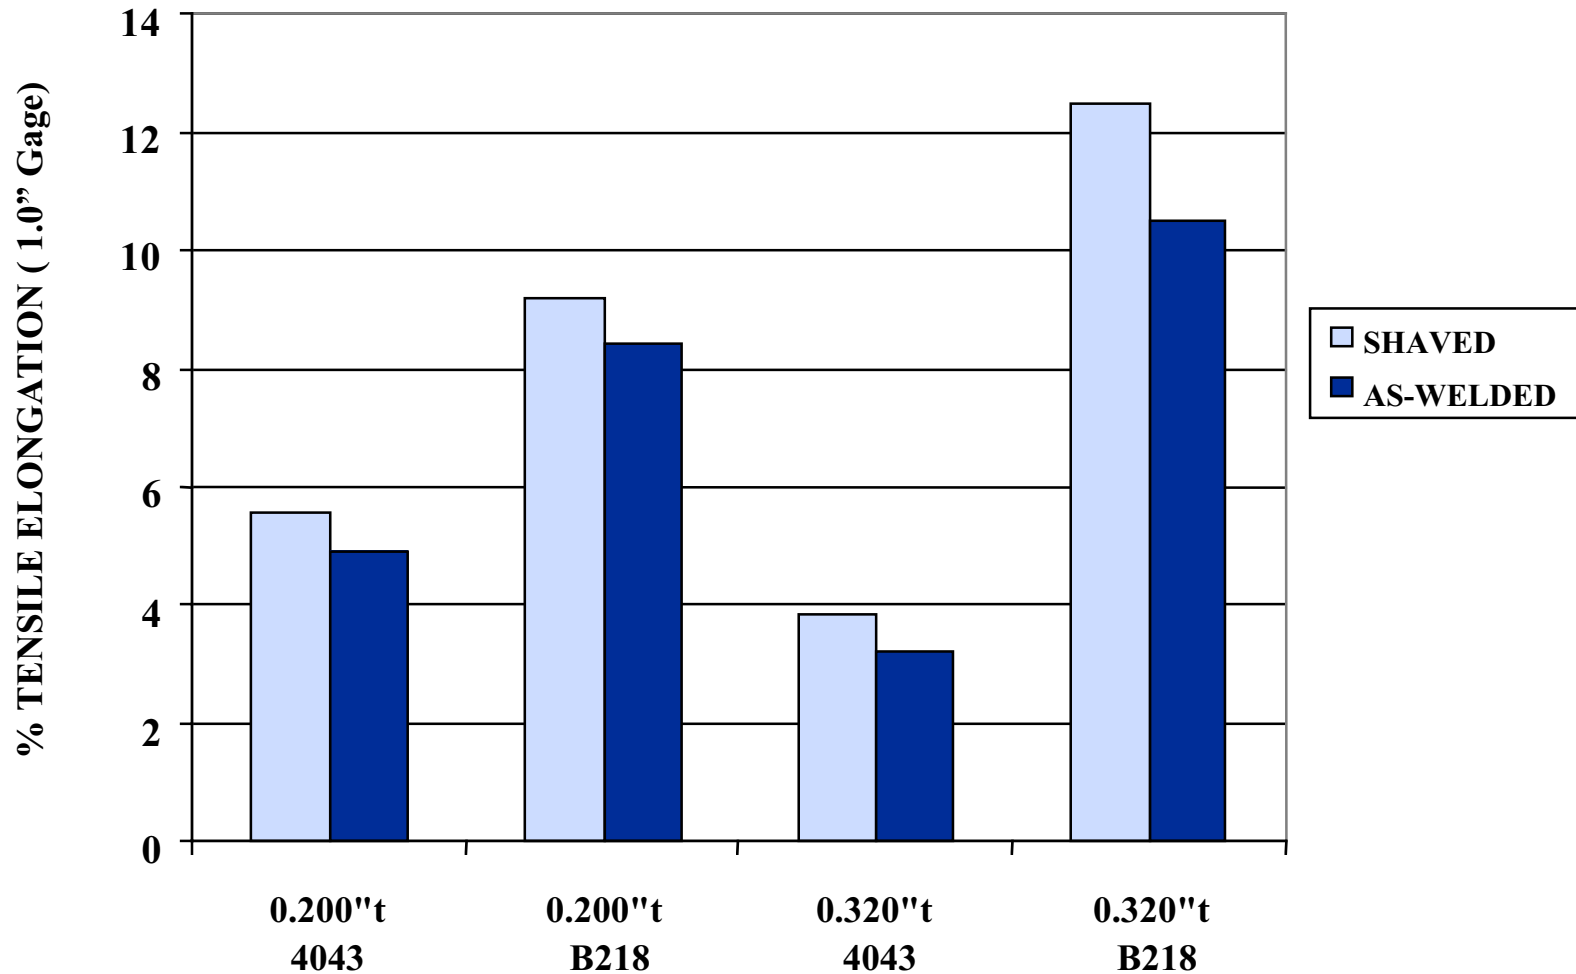
### 2195T8M4 VPPA Weld Tensile Elongation

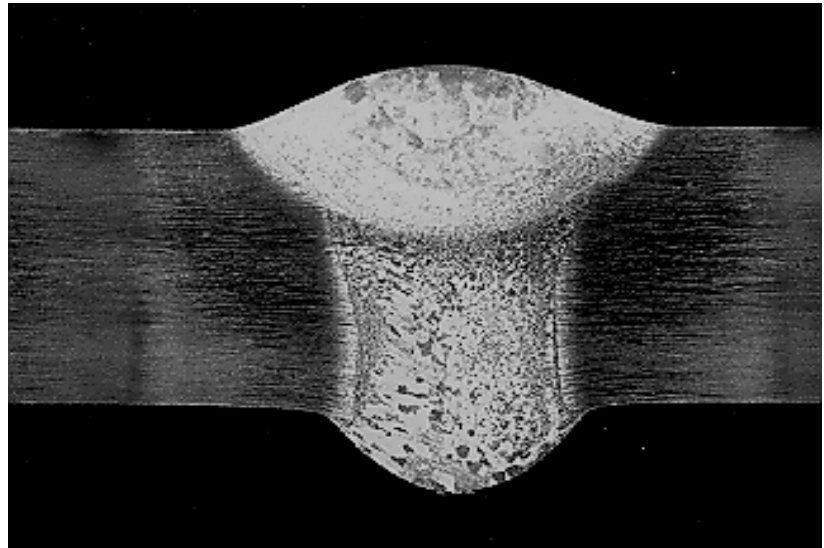
0.320t 2195 PLATE TO 2195 PLATE VPPAW

**4043 WELD FILLER WIRE**

**10X Original Magnification**

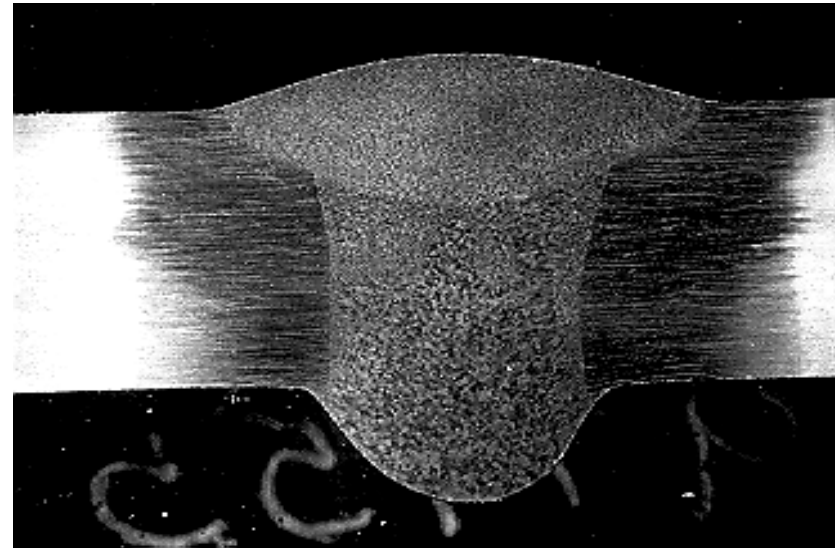
**B218 WELD FILLER WIRE**

**10X Original Magnification**

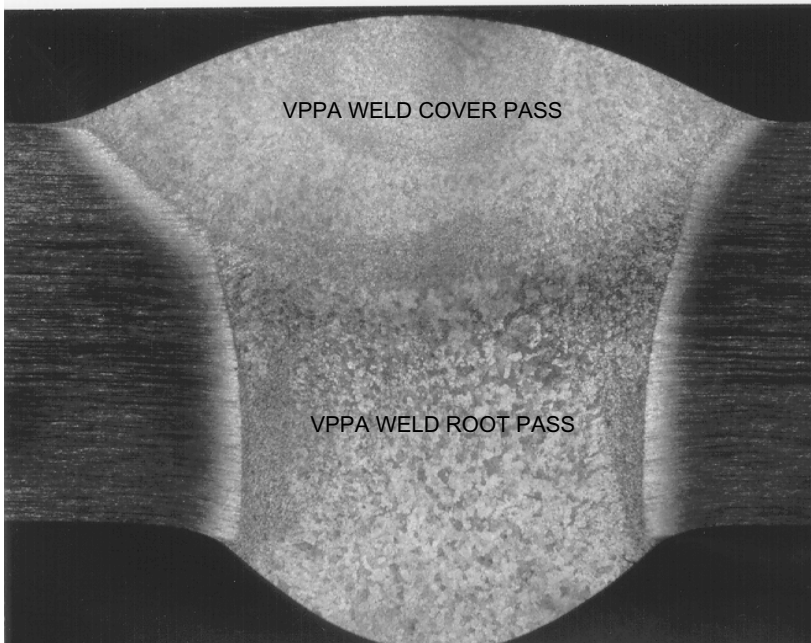
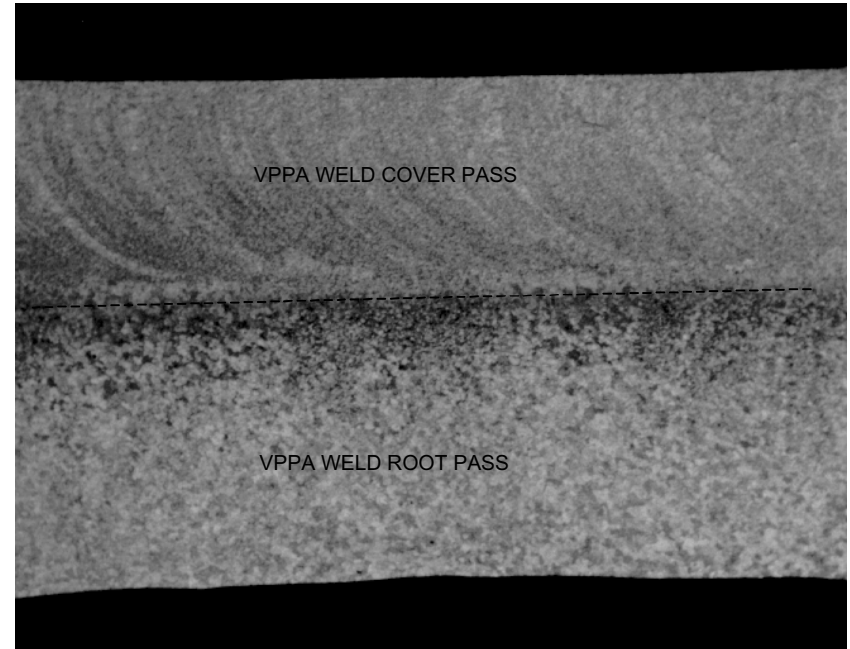
## B218 VPPA Weld Grain Structure

0.200t 2195 PLATE TO 2195 PLATE VPPAW

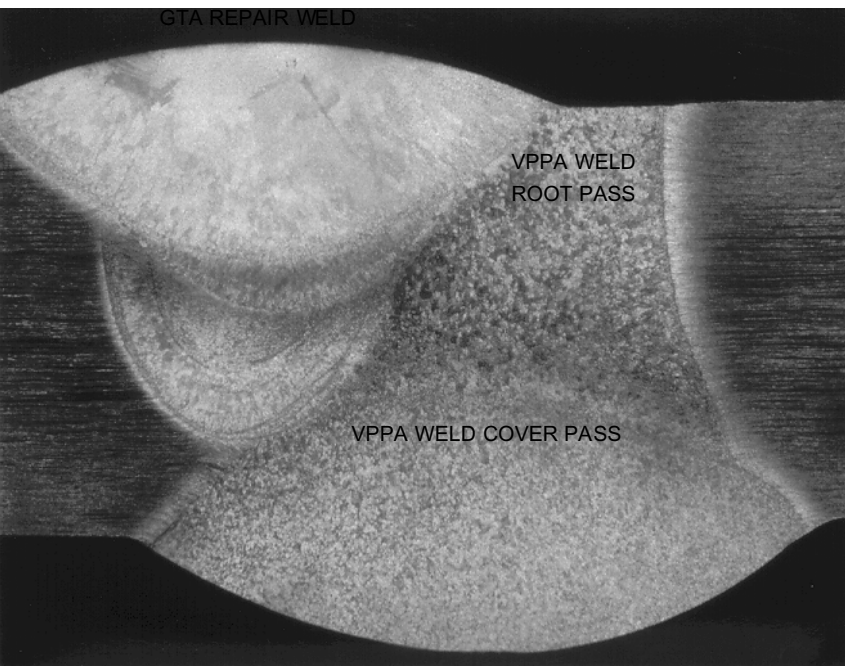
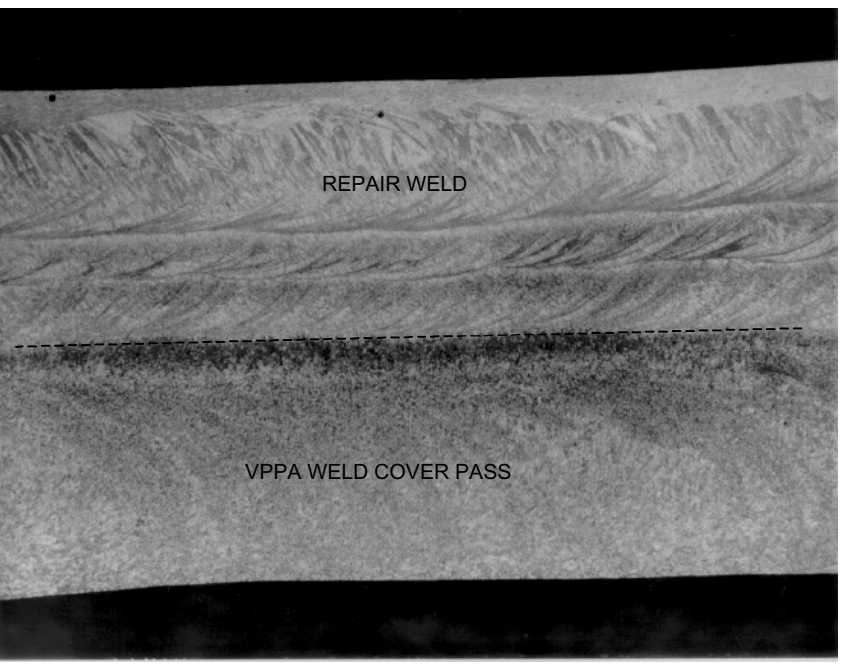
## B218 GTA Repair Weld Grain Structure

### R1 GTA Repair 0.200t 2195 PLATE TO 2195 PLATE VPPAW

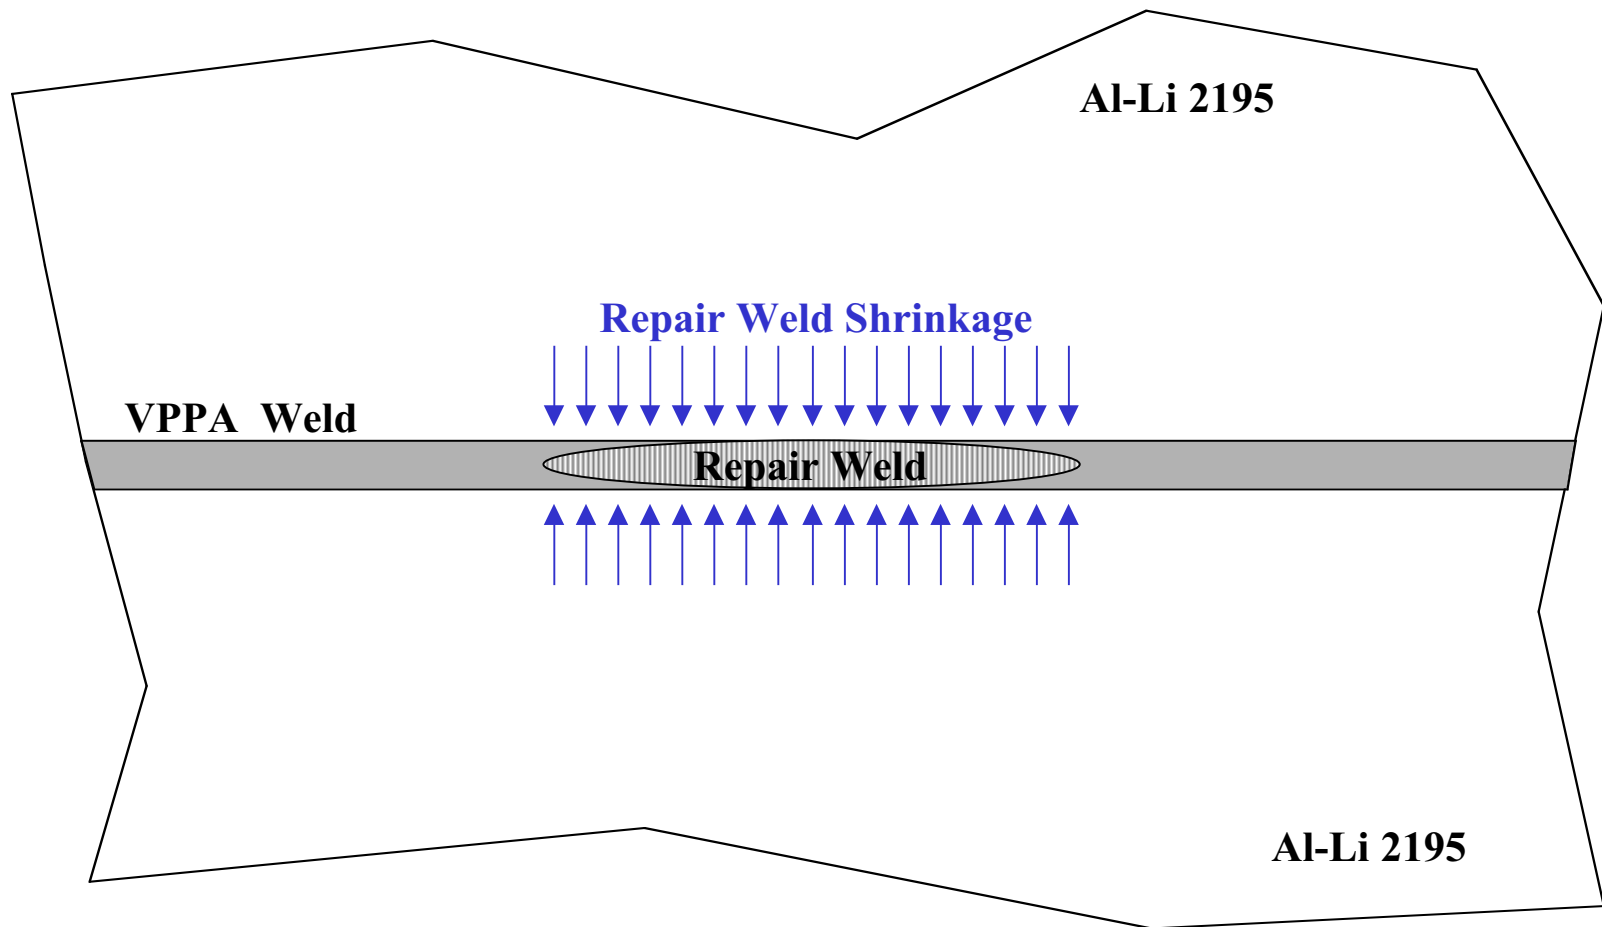
### 2195 Repair Weld Residual Stresses

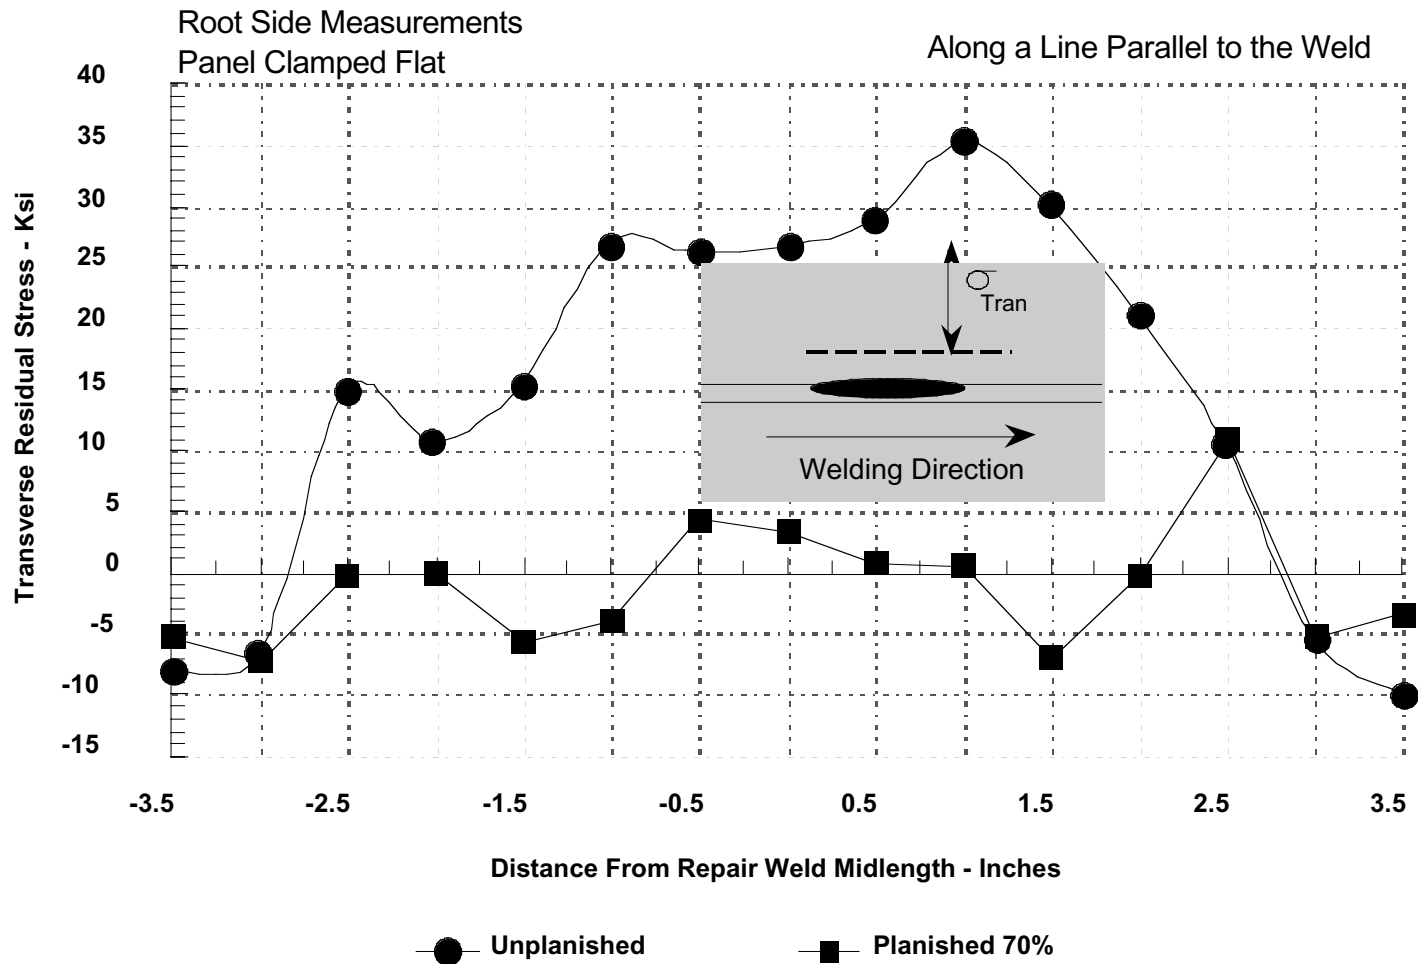
## 2195 Repair Weld Residual Stresses

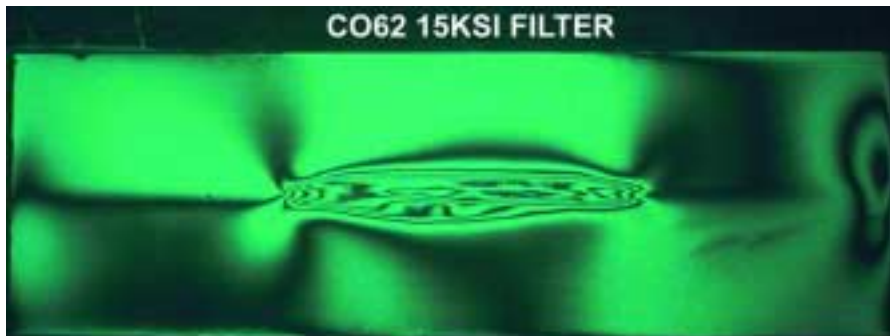
R5 GTA Repair 0.200t 2195 PLATE TO 2195 PLATE VPPAW

**Photostress of Unplanished Repair Weld**

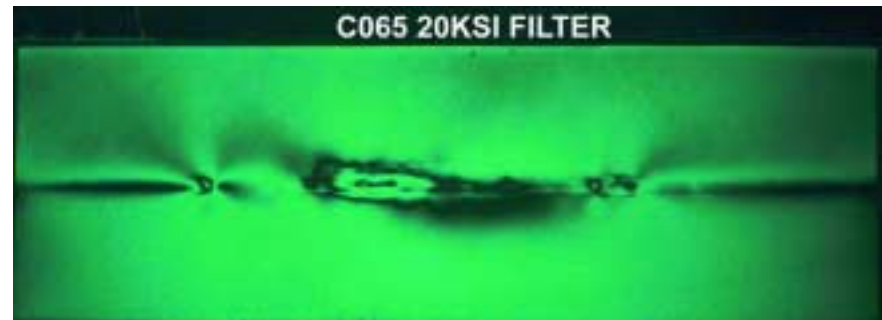
**Photostress of Planished Repair Weld**

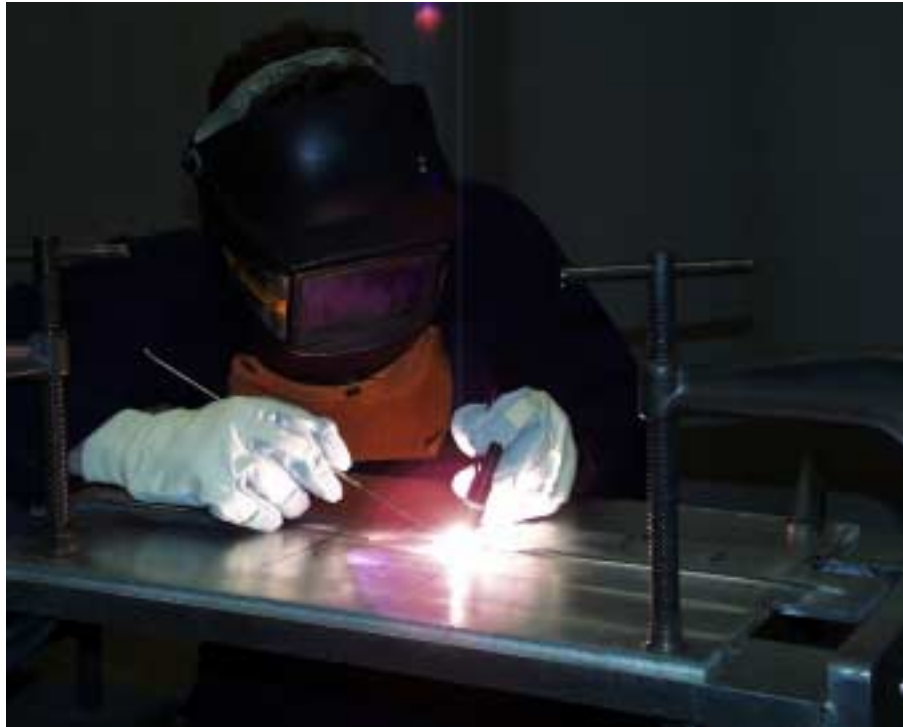
- 14" X 24" Standard Repair Weld Panel

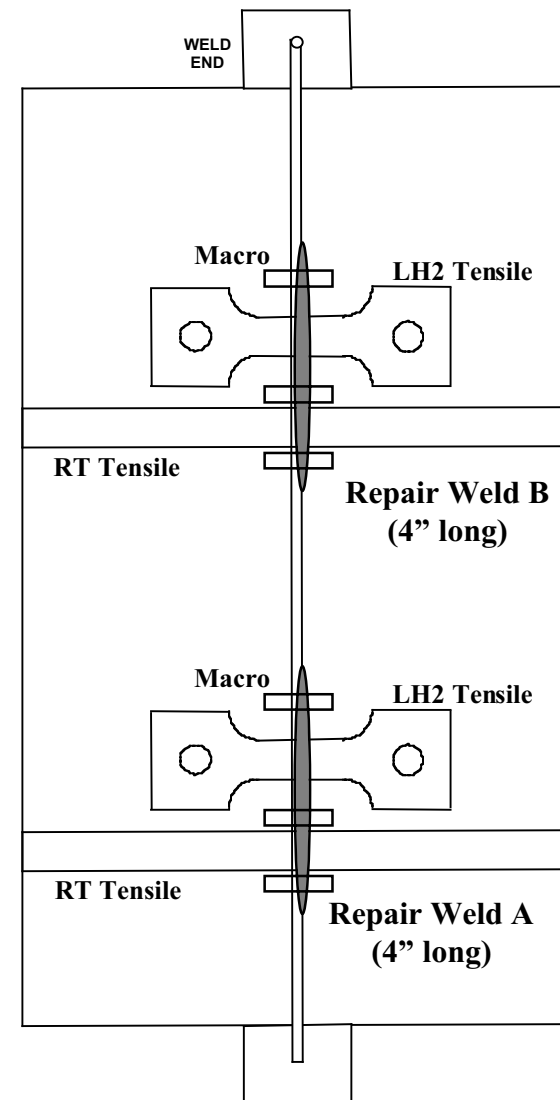
Manual GTA Repair Welding

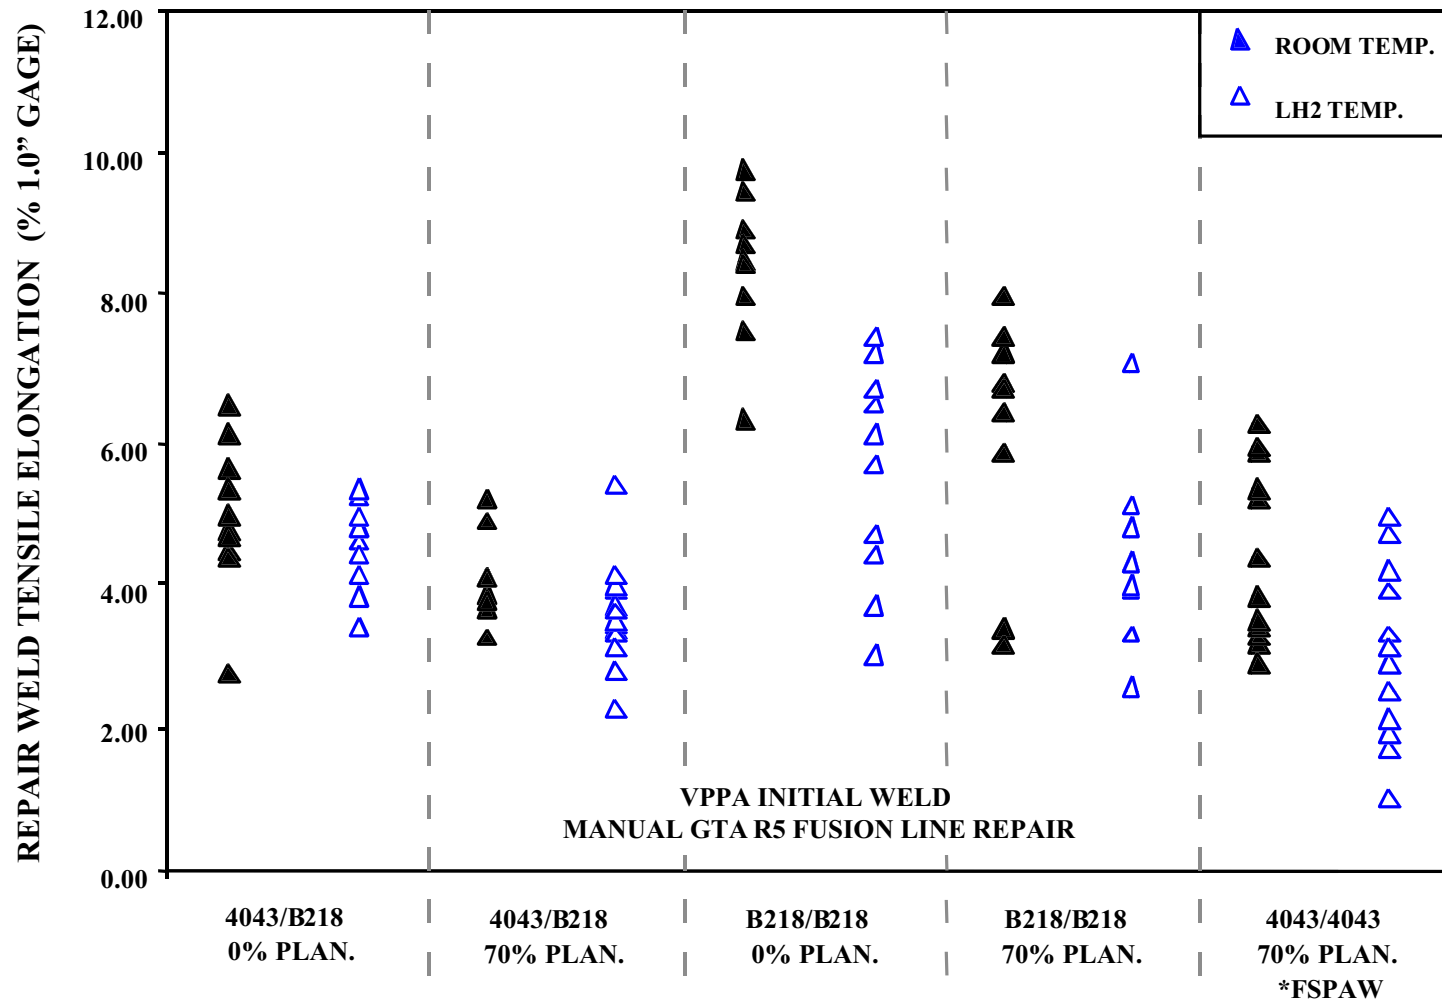
### 0.200"t 2195T8M4 Repair Weld Ultimate Tensile Elongation - Coupon Level

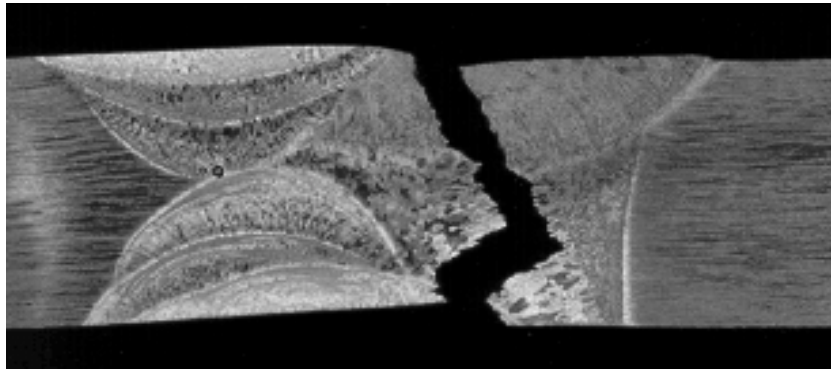
- 4043/B218 0% Planished

7X Original Magnification

**C008-RT02**  
**RT Tensile Test**  
**36.2 ksi / 2.74%El. 1" gage**

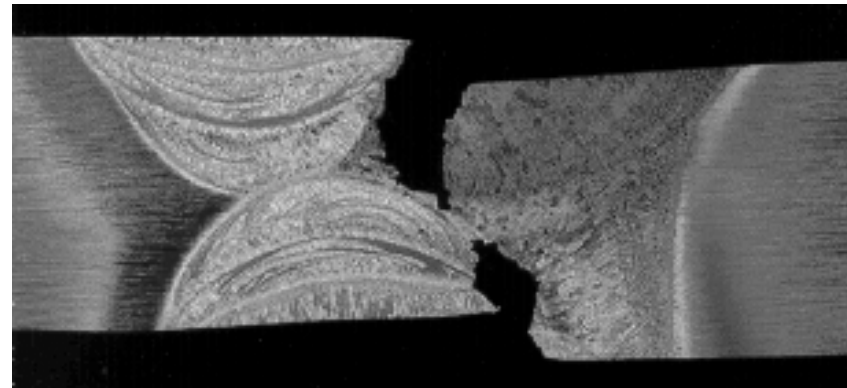
**C009-CT01**  
**LH2 Temp. Tensile Test**  
**62.5 ksi / 3.4%El. 1" gage**

7X Original Magnification

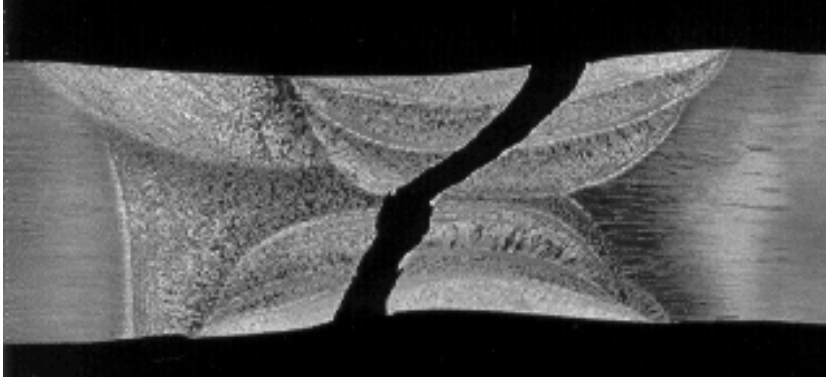
- B218/B218 0% Planished

7X Original Magnification

**C080-RT01**  
**RT Tensile Test**  
**45.2 ksi / 9.75%El. 1" gage**

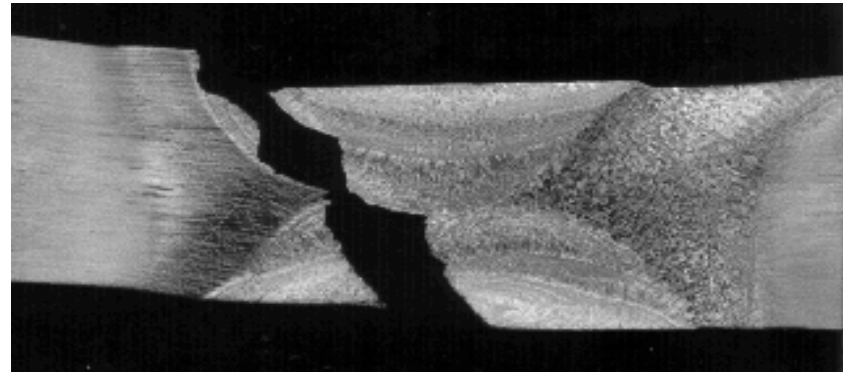
**C080-CT01**  
**LH2 Temp. Tensile Test**  
**68.1 ksi / 7.40%El. 1" gage**

7X Original Magnification

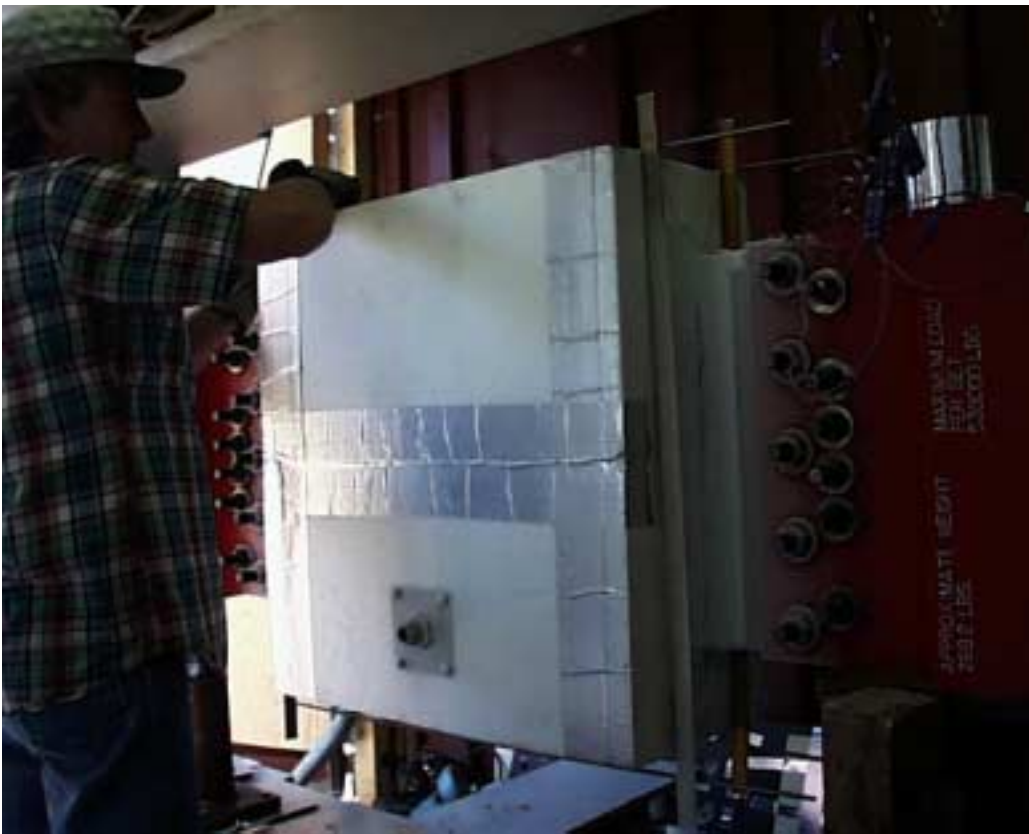
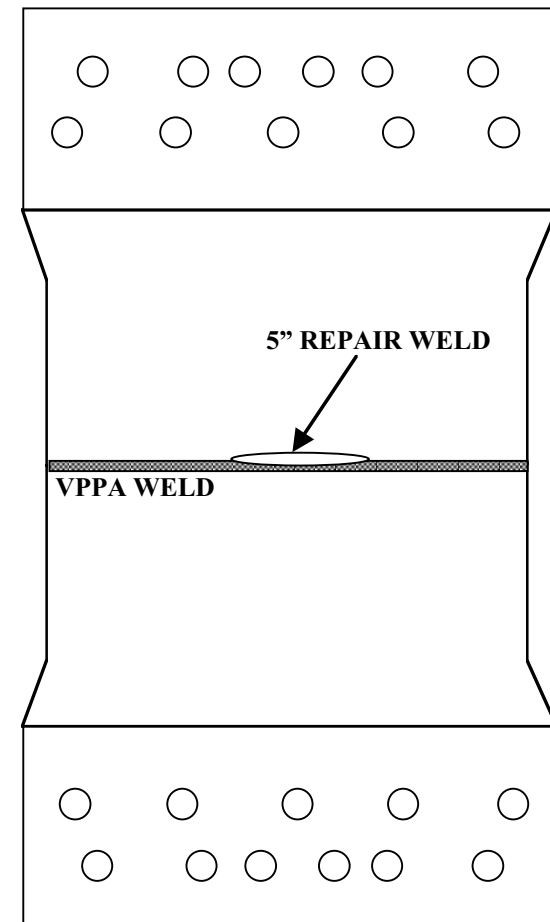
### VPPA/ GTA Repair Weld Structural Simulation Panel Evaluation

- 19" X 48" Repair Weld Wide Panel

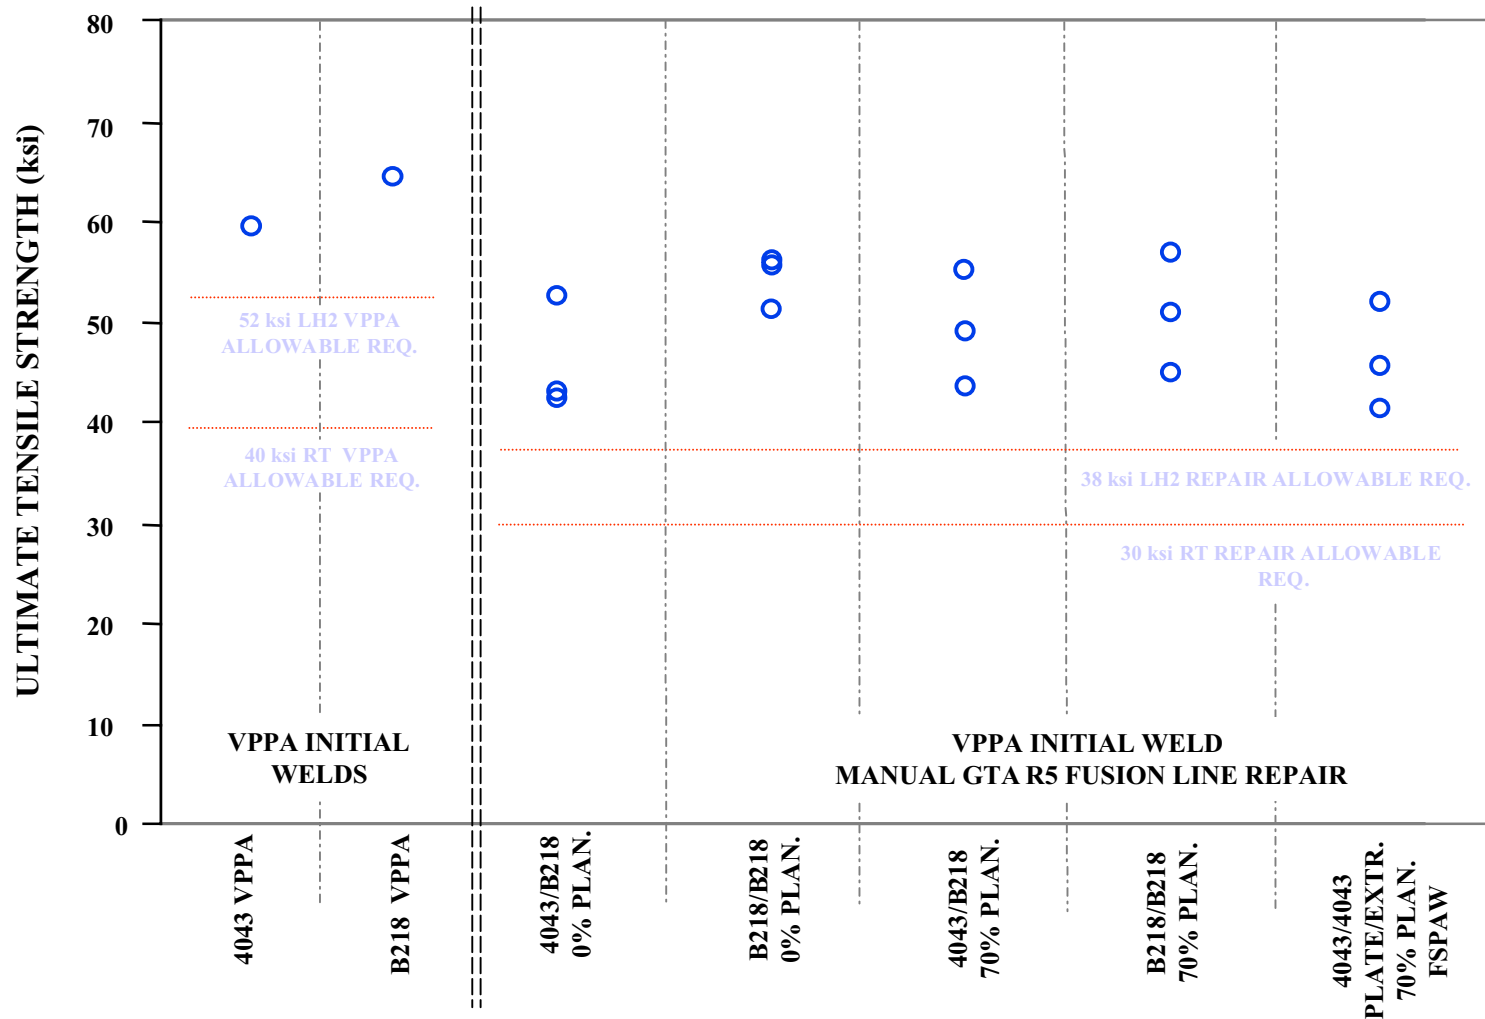
## 0.200t 2195T8M4 Structural Simulation Panel Weld Tensile Strength (-423°F)

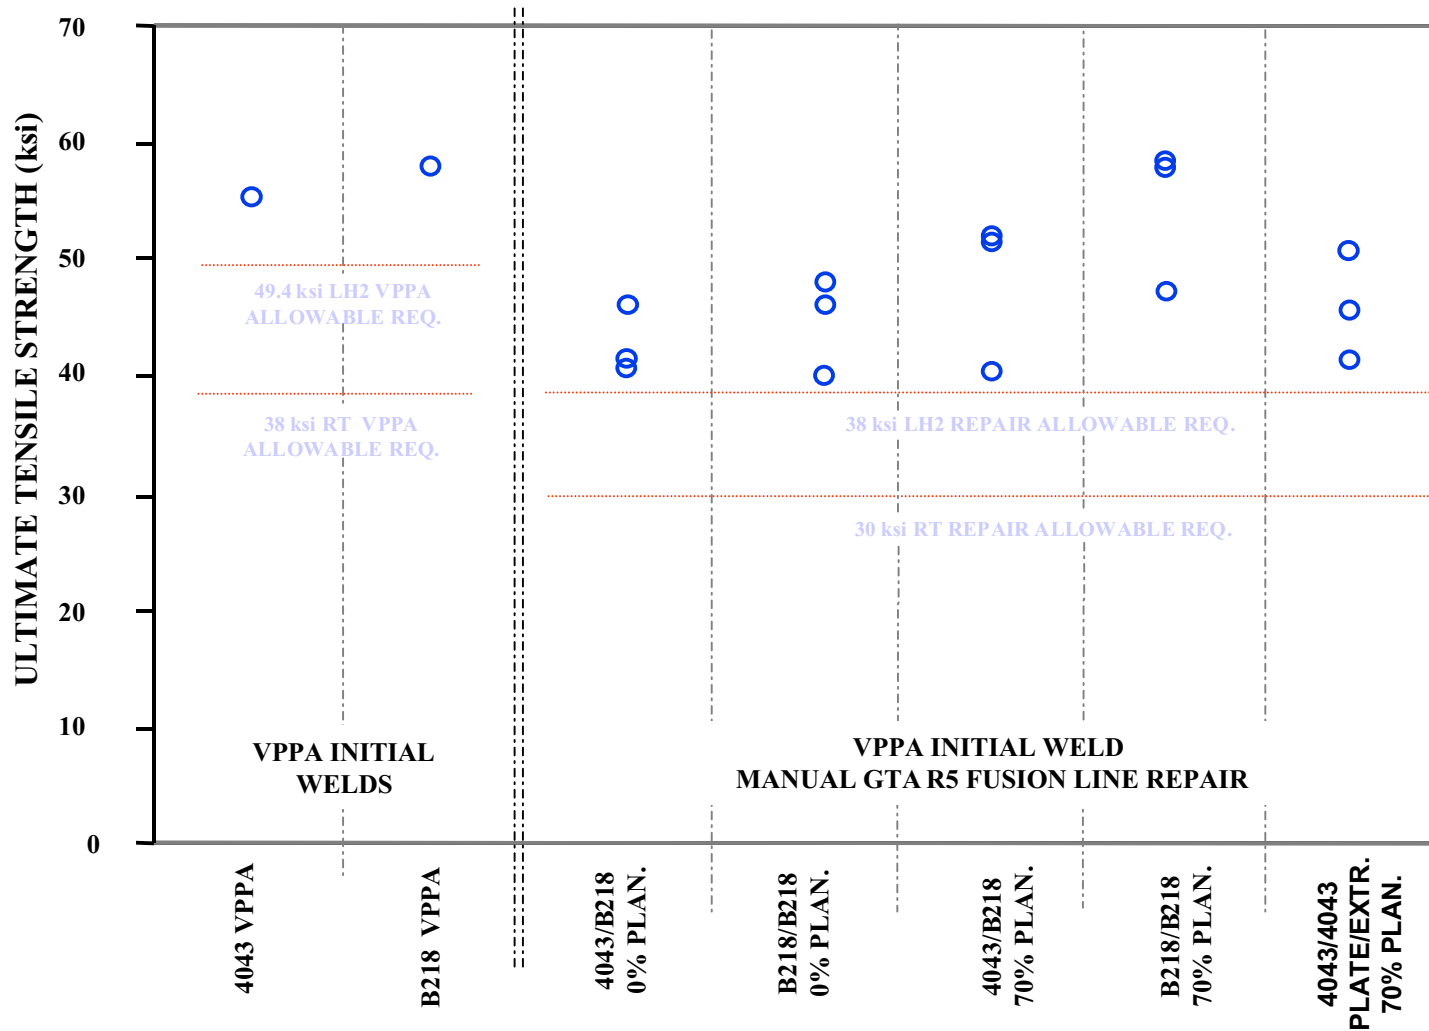
### 0.320t 2195T8M4 Structural Simulation Panel Weld Tensile Strength (-423°F)

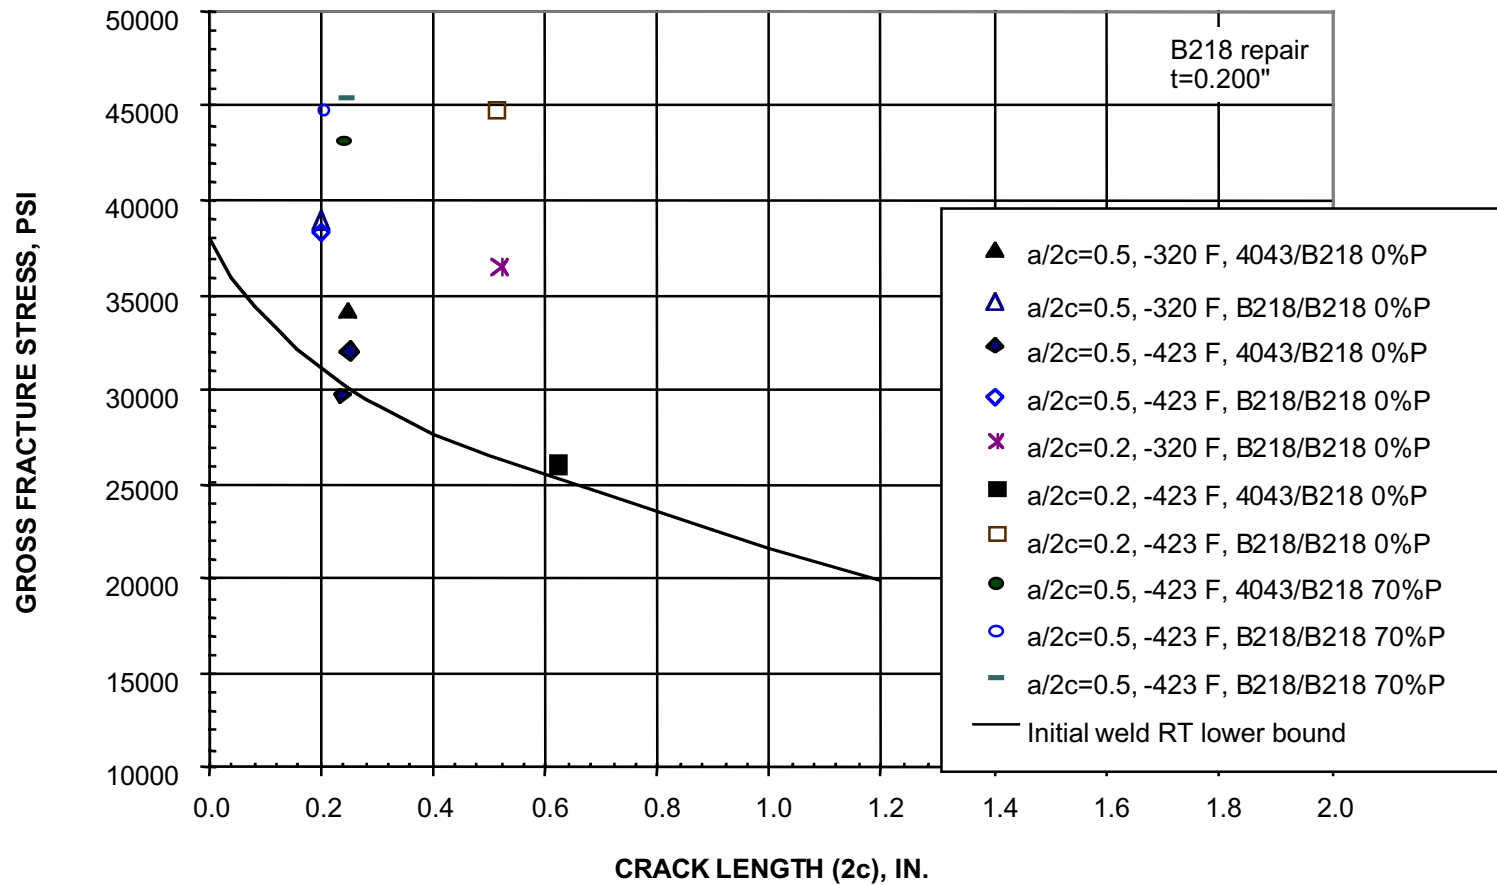
### 0.200t 2195T8M4 VPPA/GTA Repair Weld Simulated Service Fracture Toughness

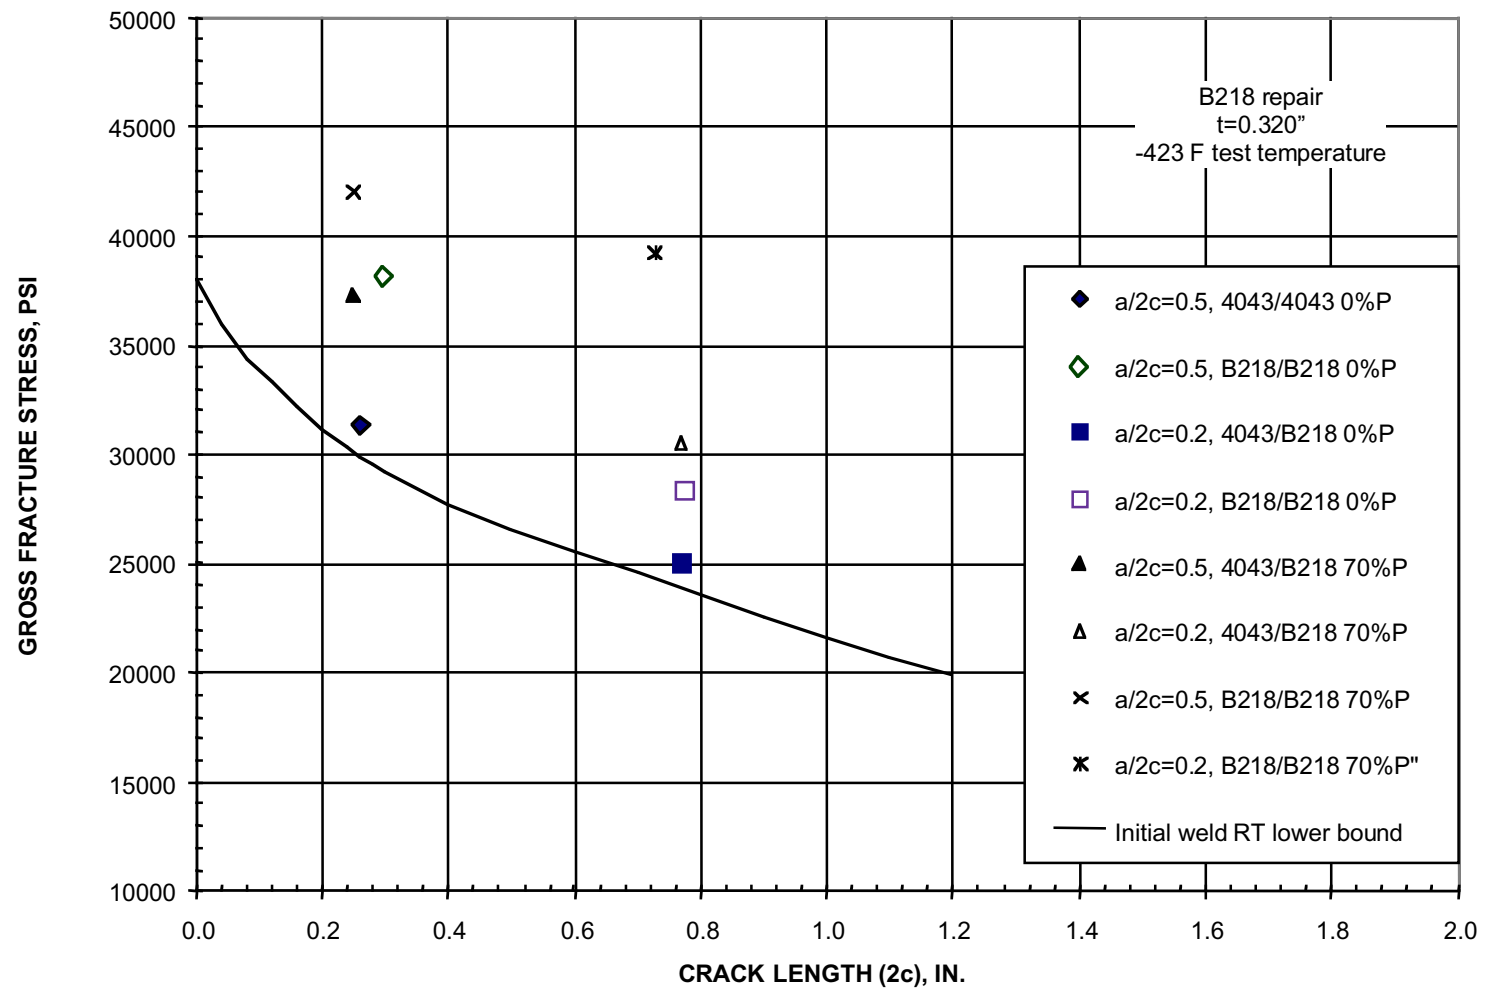
### 0.320t 2195T8M4 VPPA/GTA Repair Weld Simulated Service Fracture Toughness
