4th Conference on Aerospace Materials, Processes, and Environmental Technology

Manufacturing Challenges Implementing Material Changes for the Super Light Weight External Tank

A Welding Process Perspective

Super Lightweight External Tank

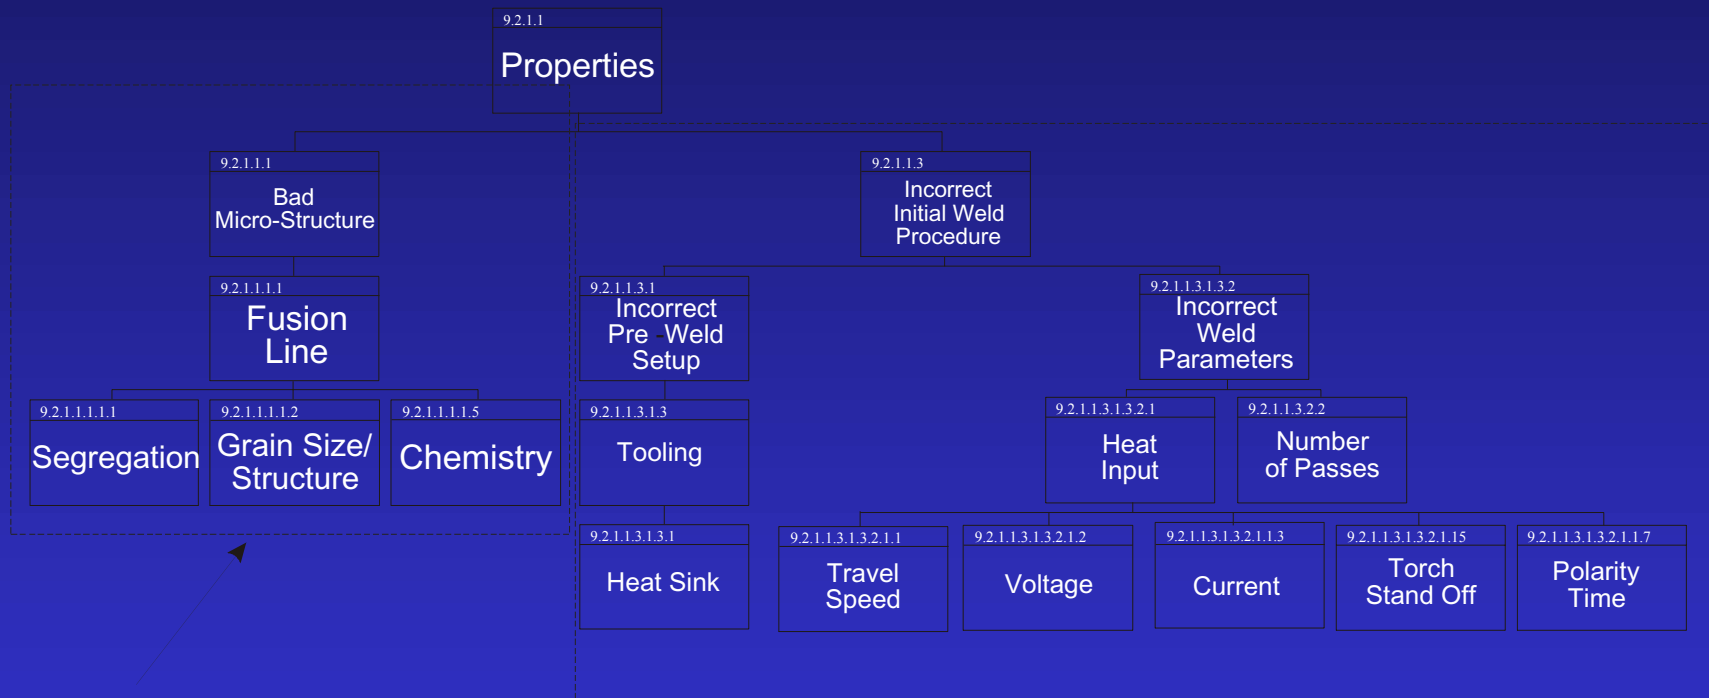
Initial Weld Fault Tree Entries with Contributor "Yes"

The Initial Weld Fusion Line Microstructure was determined to be a major contributing factor for repair weld cracking.

The Initial Weld procedure and parameters were minor contributors as they affect "Time-at-Temperature" which contributes to the amount of segregation that occurs.

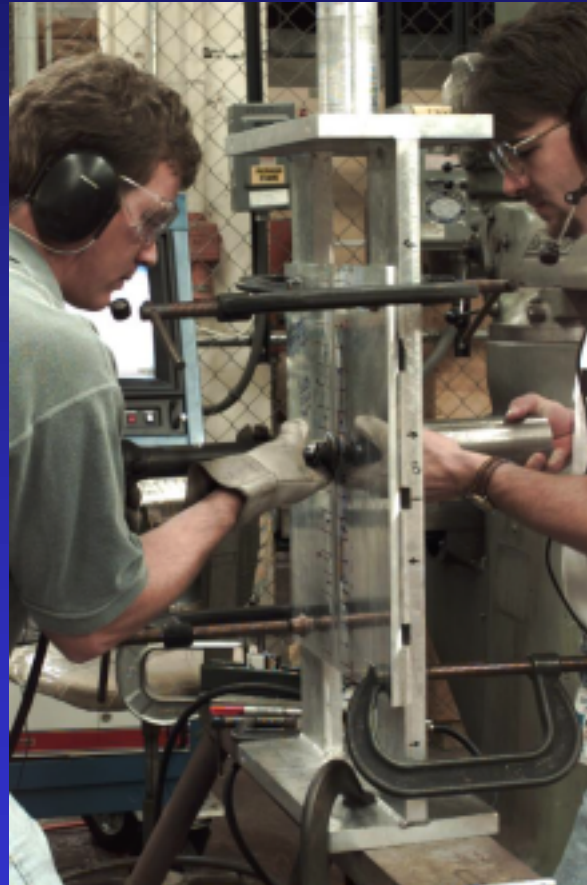
- Planishing Required for all 2195 weld repairs
- Relieves Tensile residual stresses
- Drives Compressive stresses into repair
- Allows for stress redistribution around repair

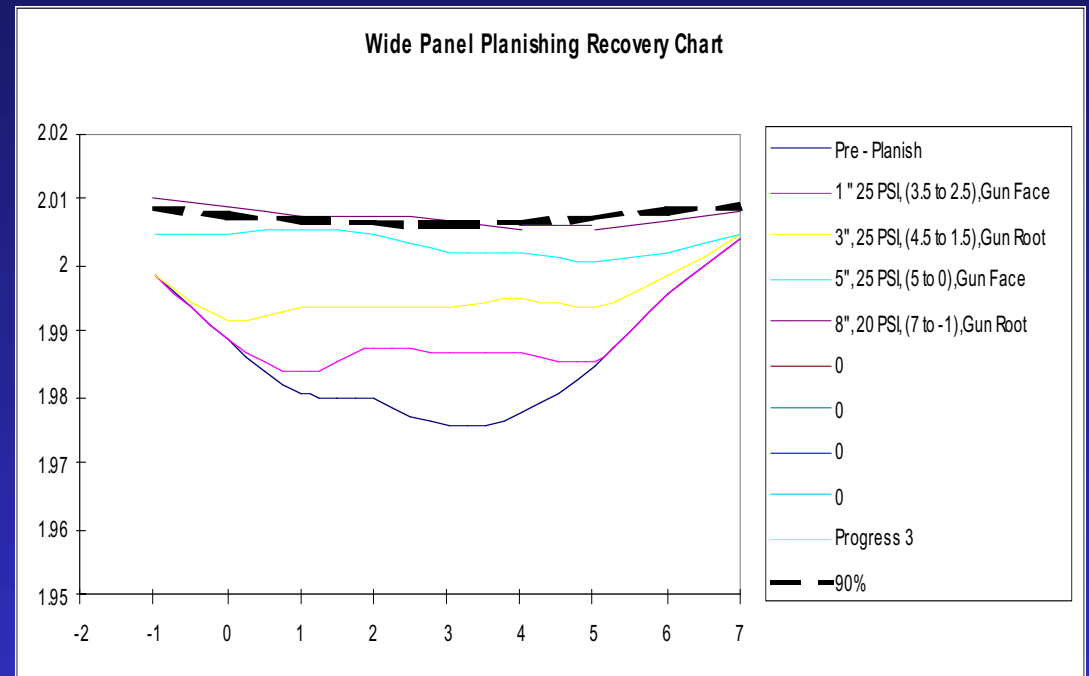
New Metrics Developed for Planishing

- Planishing originally used on ET for distortion removal
- No metric existed other than removal of distortion
- Transverse Shrinkage Reduction Became new metric
- Adequate Strengths developed with 70% to 110% recovery

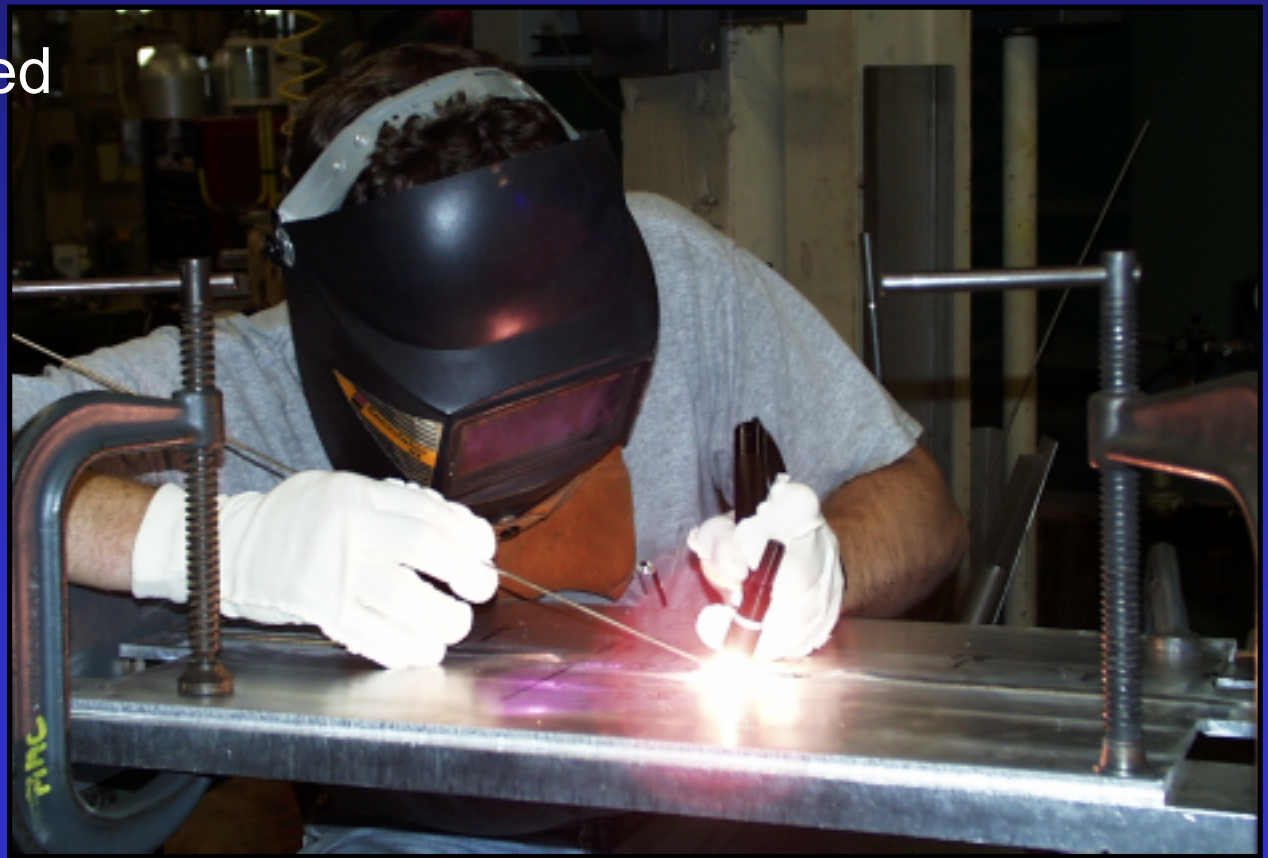
Manual Welder Training

- Smaller Grinds
- “Fast Hand” Technique
- Continuous wire feed
- Special Start/Stop Technique

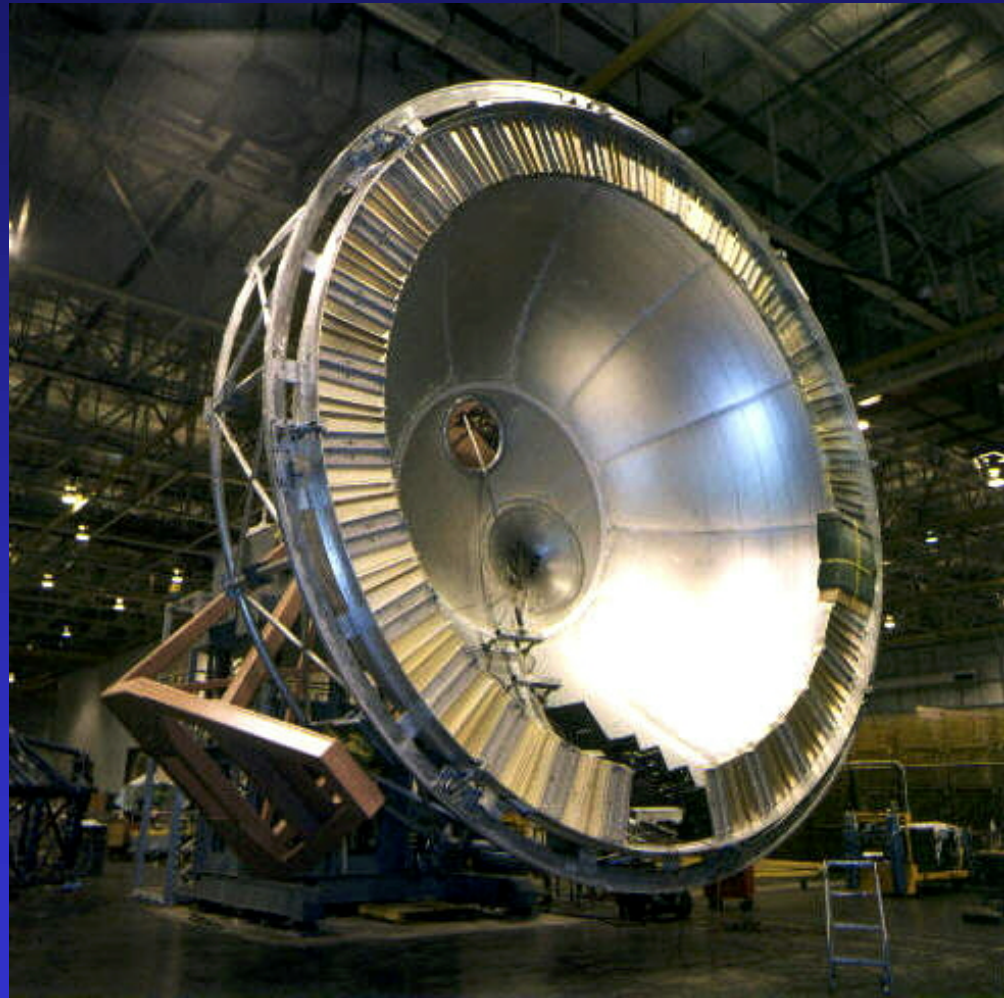
Special Tooling for Weld Repairs

- Flat Position
Determined Optimal
Repair Position
- Vertical Position as a
maximum case
without defects

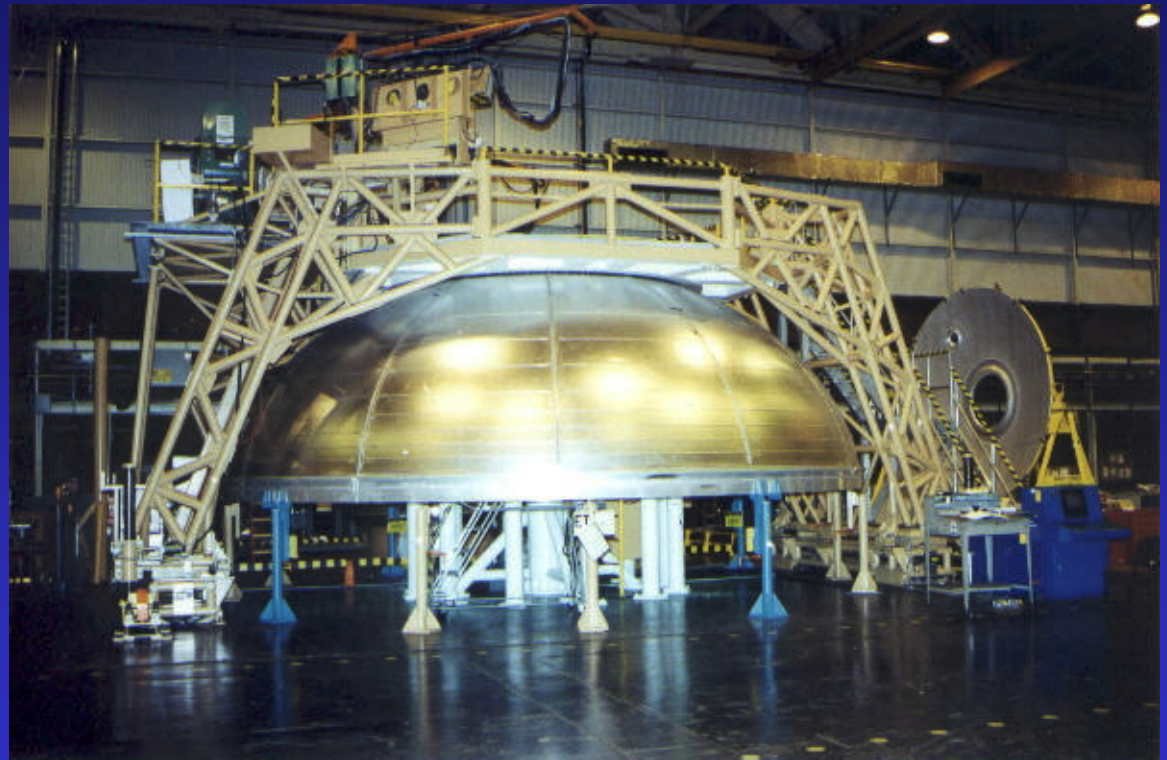
Dome Cap to Body Weld Tool

- Oxygen Tank Dome Cap most challenging weld
- Hydrogen Dome Cap a close second.
- Peaking at intersections creates welding challenge
