# Effects of Heat Treatment on the Ballistic Impact Properties of Inconel 718 for Jet Engine Fan Containment Applications

J. Michael Pereira and Bradley A. Lerch  
Glenn Research Center, Cleveland, Ohio

National Aeronautics and  
Space Administration

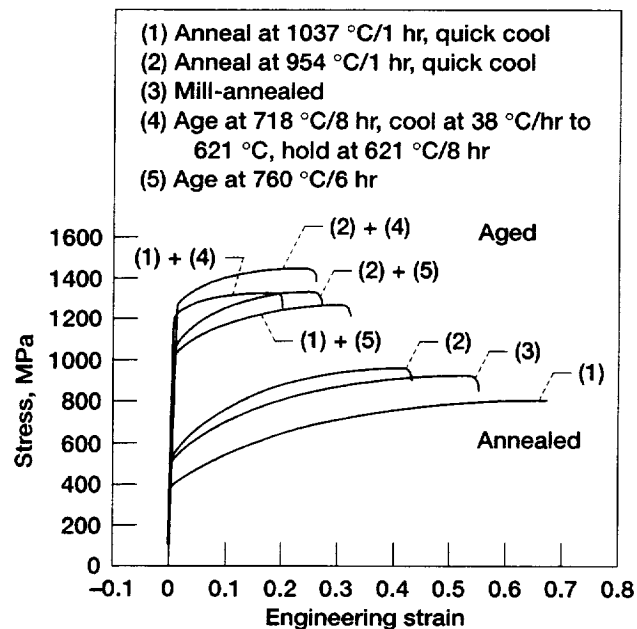
The tensile curves are shown in Fig. 1. The data fell into two categories; moderate strength and high strain to failure (annealed), and high strength with moderate ductility (aged). Based on the results of these tensile tests, the three conditions A, B and C, shown in Table 3, were chosen for use with the ballistic impact tests. In addition, impact test results were compared with those from a previous study [20] on the same material. In the study of Ref. 20, the material was treated as shown by condition D in Table 3. The microstructure of the In-718 plates consisted of equiaxed grains (Fig. 3) with occasional carbide particles. The average grain sizes were an ASTM 6 for the 1.0 mm, ASTM 4 for the 1.8mm, and ASTM 9 for the 2.0 mm thick materials. The annealed and aged materials of the same thickness had identical grain sizes.

Figure 1.—Effect of heat treatment on the room temperature tensile behavior of In-718 sheet specimens.

For the initial heat treatment study, the quasi-static stress-strain curves fell into two groups (Fig. 1). The annealed material exhibited moderate strength and high elongation while the annealed plus aged material exhibited high strength and moderate elongation. The hardness for these materials was measured to be ~90 HRB for the soft, annealed materials and 45 HRC for the harder, aged materials (C and D). The figure includes the three conditions used in the subsequent impact tests, as well as the heat treatment condition used in Ref. 20. It should be noted that the curve in Fig. 1 designated by "(2) + (4)" was taken from tests on the material from the present study heat treated in the same way as in Ref. 20. However, it is expected that the material with condition D used in Ref. 20 would have a similar response to this.

The static toughness, as measured by the area under the stress-strain curve, is greater for the annealed material than the aged, as shown in Fig. 1. The improvement in impact resistance of the annealed material is consistent with general guidelines for designing containment systems that correlate larger areas under the static stress-strain curve

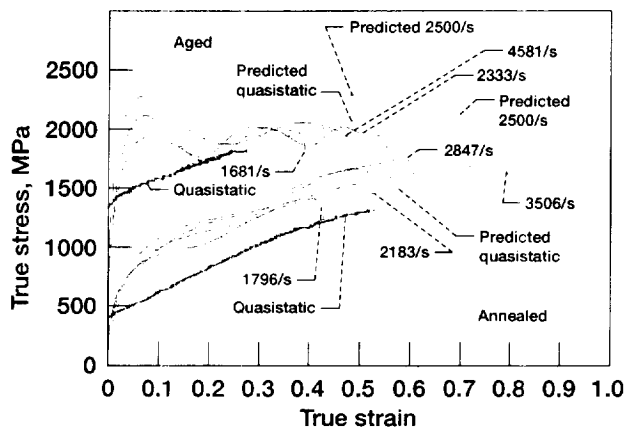
In a separate study, quasi-static and high strain rate compression testing was conducted on In-718 in conditions A and C [21]. These tests were conducted using a 19 mm diameter split Hopkinson Bar. Specimens were circular disks with a diameter of 6.35 mm and a thickness of 3.18 mm. Tests were conducted in the strain range of 1600 to 5000 /sec. The results of these tests are shown in Fig. 2. Like the quasi-static tensile data there is a marked difference in the response of the material in the two conditions. An important feature is the significantly greater strain hardening behavior of the material in the annealed condition.

Figure 2.—Effect of heat treatment on the room temperature quasi-static and high strain rate compression behavior of In-718 from ref. 21. Also shown is the stress-strain behavior of the two material conditions predicted by the Johnson-Cook model for the quasi-static case and for a strain rate of 2500/s.

The data of Fig. 2 were used to determine the room temperature material constants for the strength component of the Johnson-Cook model [22] for the In-718 in the two different conditions. The Johnson-Cook model is an empirically based representation of the flow stress defined as

For the annealed material, the parameters were determined to be  $A = 400$  MPa,  $B = 1798$  MPa,  $n = .9143$ , and  $C = .0312$ . For the aged material the parameters were determined to be  $A = 1350$  MPa,  $B = 1139$  MPa,  $n = .6522$  and  $C = .0134$ . Figure 2 shows the correlation between the Johnson-Cook model with the above constants and the quasi-static tensile data. Also shown is the predicted response from the model at a strain rate of 2500/s.

At high strain rates there is essentially no strain hardening in the aged In-718, as shown by the flat curves in Fig. 2. This differs from the quasi-static behavior which exhibits a good amount of strain hardening. This behavior is also different from the annealed material which has a large amount of strain hardening, even at high strain rates. The Johnson-Cook model was able to reproduce the quasi-static behavior of both material conditions and could predict the high strain rate data from the annealed material. However, the model was unable to predict the high strain rate data for the aged material.

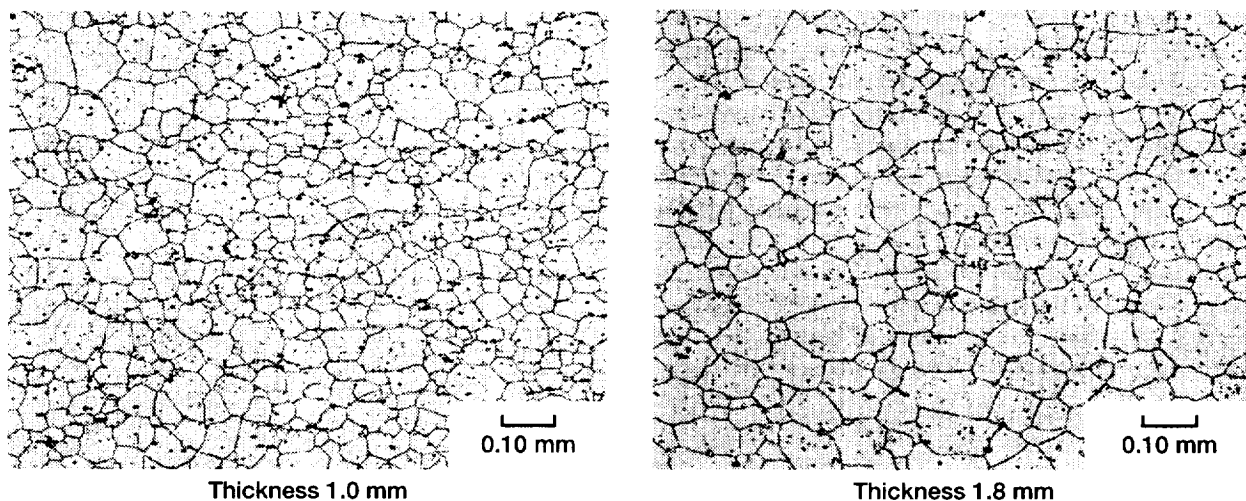
Figure 3.—Microstructure of Inconel 718 after annealing at 1038 °C.

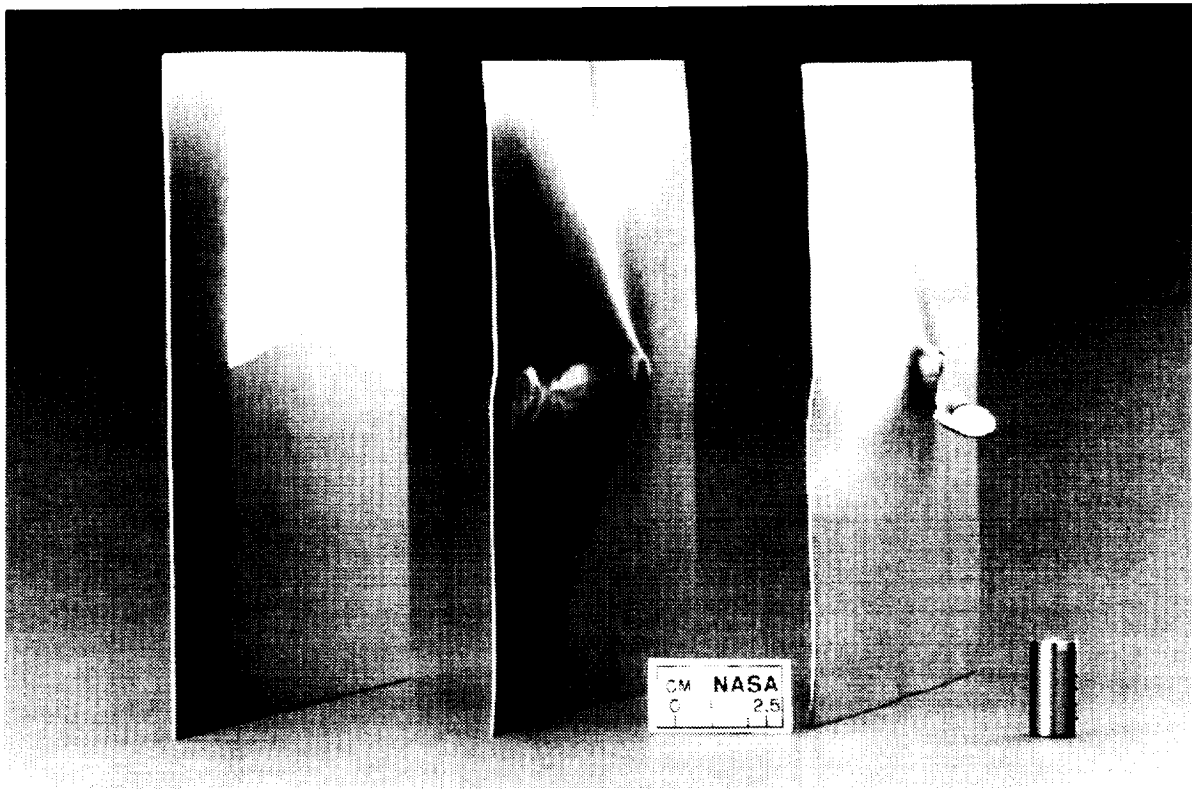
Figure 4.—Typical test specimens in the initial, nonperforated and perforated conditions.

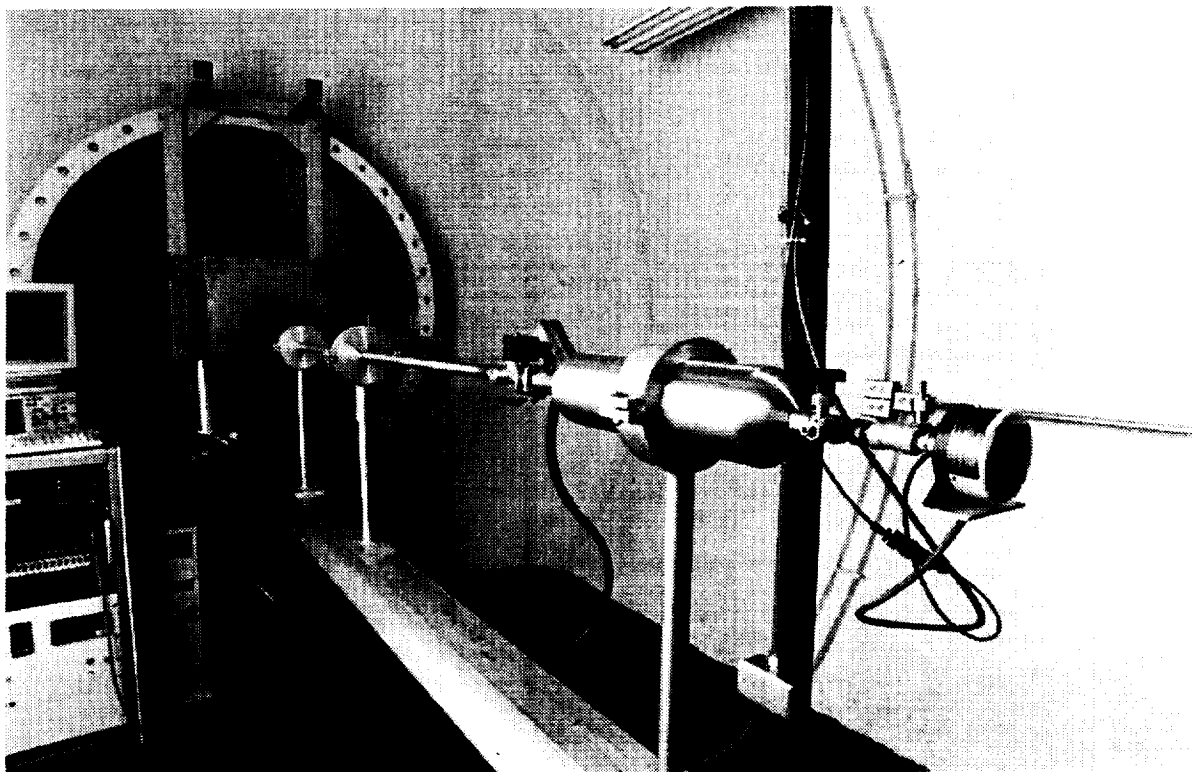
Figure 5.—50 caliber gas gun facility.

During impact of a containment system by a fan blade large structural deformations occur. To study any relationships that may exist between material properties and impact response relevant to the problem at hand, the target and projectile dimensions and velocities used in this study were selected to allow relatively large structural deformations while maintaining a controlled experiment. Ballistic impact tests were conducted on specimens of all three thicknesses shown in Table 1. The 1.0 and 1.8 mm impact specimens were treated according to the three conditions shown in Table 3. The 2.0 mm impact specimens were only tested in the mill annealed condition (Condition B). The impact specimens were 17.8 cm (7 in.) square panels and were centered and clamped over a 15.24 cm (6 in.) square hole in a 1.27 cm (0.5 in.) thick steel plate. Typical impact specimens are shown in Fig. 4. Specimens used in Ref. 20 were 35.5 cm (14 in.) square panels, centered and clamped over a 30.5 cm (12 in.) square hole in a 1.27 cm (0.5 in.) thick steel plate.

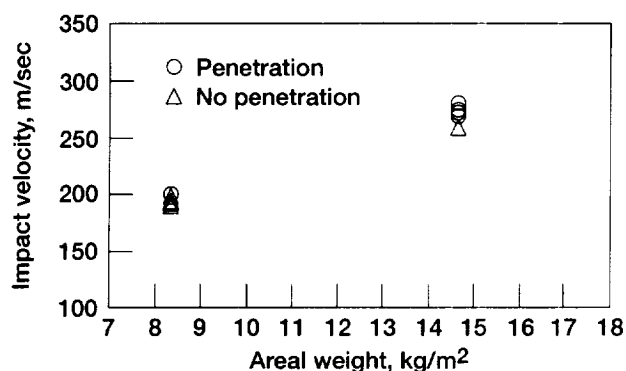
Figure 6.—Impact velocity and penetration results for Inconel 718 annealed at 1038 °C—Condition A.

Table 5 lists the velocities and results of the impact tests, as well as a measure of the resulting deflection that occurred. Impact test velocities for each of the thickness and heat treatment conditions is shown in Figs. 6 to 8. The ballistic limit for each condition extracted from these data is shown in Table 6, and includes the ballistic limit for heat treatment D, taken from Ref. 20. In this table, areal weight refers to the weight per unit area of the material, or simply the product of the density and the thickness. This is a relevant measure for fan containment systems since, in general, the overall geometry of the system will be similar, irrespective of the material used. A plot of these data is shown in Fig. 9 and includes the penetration velocity for the 2 mm thick plate in the mill annealed condition (B). For all thicknesses, the annealed material with a lower hardness, moderate strength and higher elongation had superior impact energy absorbing properties compared to the aged material with a higher hardness, higher strength and moderate elongation. For the 1.0 mm thick specimens there was an average increase of 33 percent in the ballistic impact energy of the annealed over the aged material. For the 1.8 mm thick material the average increase was 25 percent. This is contradictory to results in the literature for high velocity impacts [3 and 4] where it was found that high hardness materials exhibited greater impact resistance.

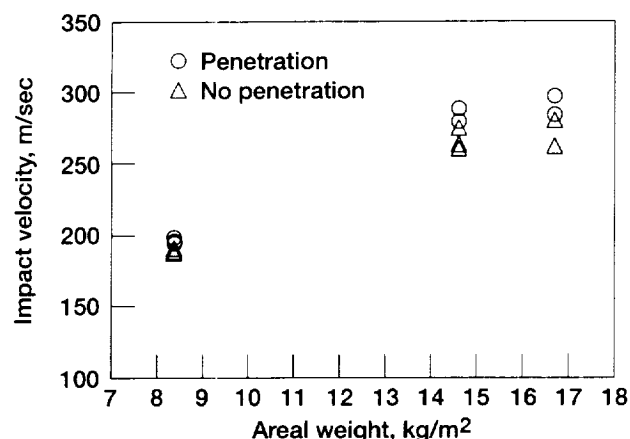
Figure 7.—Impact velocity and penetration results for Inconel 718 in the as-received condition—Condition B.

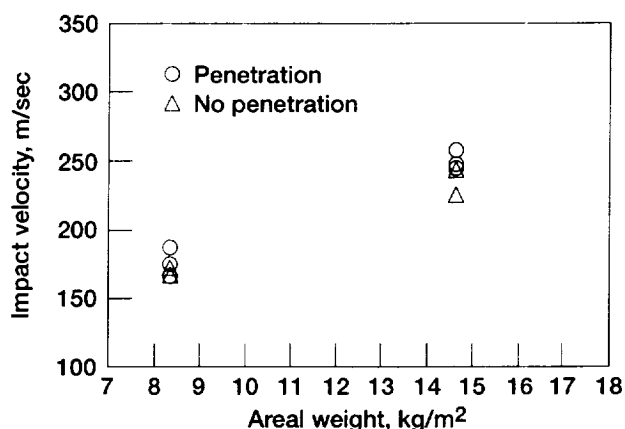
Figure 8.—Impact velocity and penetration results for aged Inconel 718—Condition C.

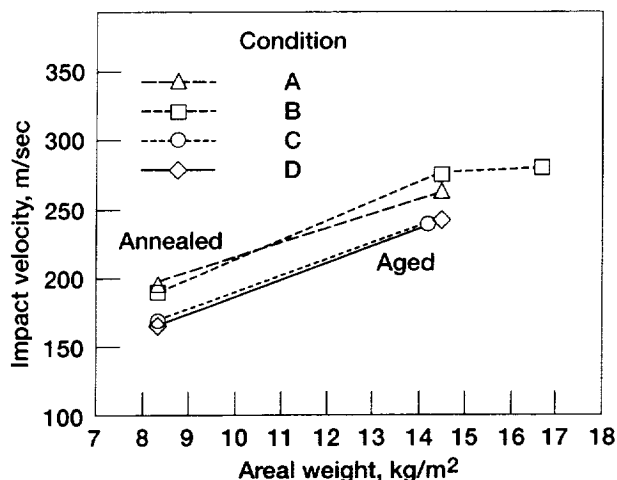
Figure 9.—Impact velocity and penetration results for Inconel 718 as a function of areal weight and heat treatment.

Shear localization can also result from the geometry of the specimen and target and the constraints placed on them [34]. It can be seen in Fig. 9 that for the mill-annealed material, the increase in penetration velocity slowed as the thickness of the specimen increased. A possible explanation for this is that the greater bending stiffness of the thicker (2 mm) panel constrained the amount of deformation that could take place. This in fact can be seen by the reduction in the deflection measurements in Table 5. This result is consistent with the model of Bai and Johnson [16] which predicts that as the thickness of the plate increases, the energy absorbed per unit thickness begins to level off. Metallography revealed no difference in the deformation structure as these specimens also contained broad, diffuse bands just like the other annealed samples. The thickest material did have a smaller grain size (ASTM 9 compared to an ASTM 6 for the intermediate thickness), but this is not believed to have reduced the slope of the curve. It is possible that the reduction in the slope of the curve was simply experimental variation since the thick material was from a different study and was added here just for completeness. Examination of additional thicknesses, especially greater than 2.06 mm, would have helped to clarify whether the slope of the curve continues to increase with increasing thickness, or if it levels off as suggested in Fig. 9. However, the existing impact facility was unable to produce the velocities required to penetrate thicker plates.

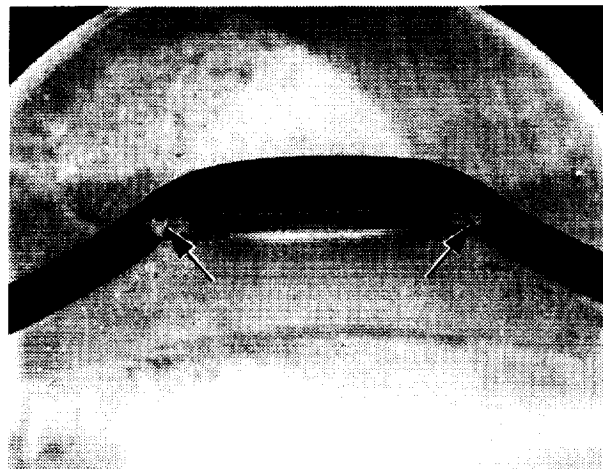
Figure 10.—Shear deformation pattern in impacted specimen.

Metallographic examination of the specimens showed that for both sets of heat treating conditions, the impact produced a circular band of shear deformation extending from the corners of the projectile at the impacted surface to the back surface of the plate at an angle of roughly 45° from the plate normal (Fig. 10). There was significantly more overall deformation in the annealed specimens than the aged specimens as shown by the amount of deflection

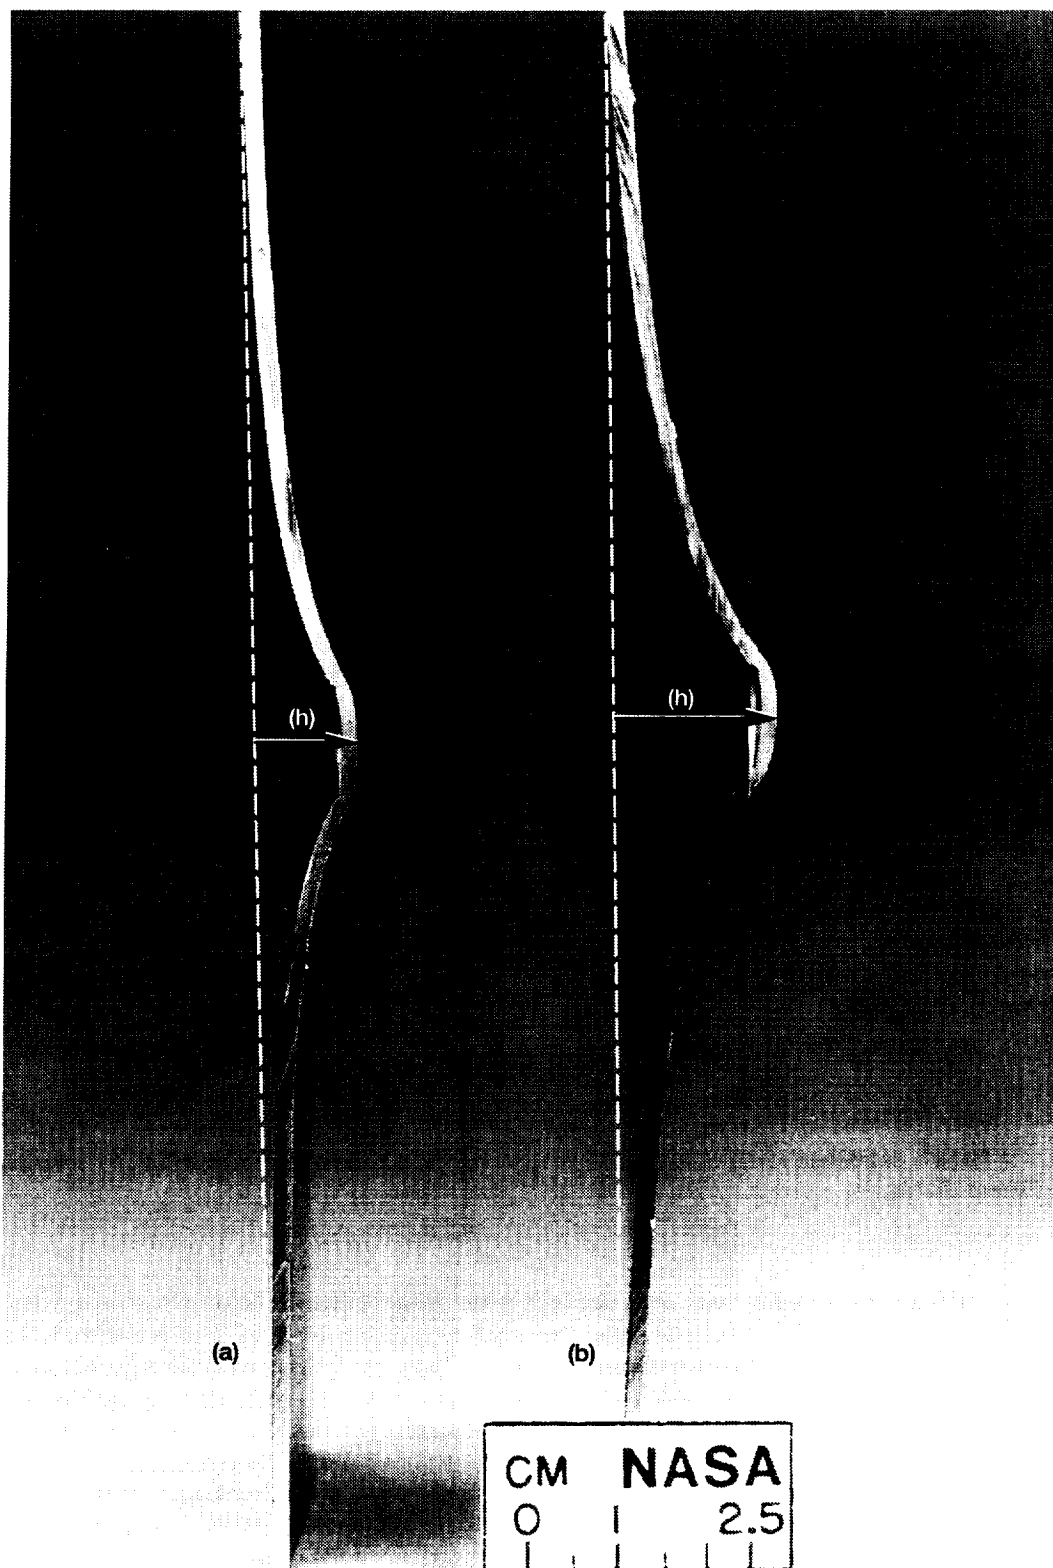
Figure 11.—a) Comparison of overall deformation in aged specimen. b) Annealed specimen. Each specimen was impacted at a velocity slightly below its ballistic limit.

in Fig. 11. There was essentially no permanent deformation in the projectiles. Microscopic examination (Fig. 12(a)) showed that the annealed specimen exhibited what appeared to be an intense deformation band originating from the corner of the projectile impact. This band was somewhat ill-defined in structure and extended in width over ~10 grains. In nonperforated samples, the band did not reach the back face of the plate. A higher magnification of this band (Fig. 12(b)) shows that this was not a true band, but rather a collection of intensely deformed grains, which etched darker than the surrounding grains. The surrounding grains were also heavily deformed, but not to the extent of those in the band. A microhardness profile was taken across the band. Vicker's hardness ranged from ~260 (100 HRB) in areas far removed from the band (yet still in the deformed region) to a hardness of ~400 (41 HRC) in the band itself.

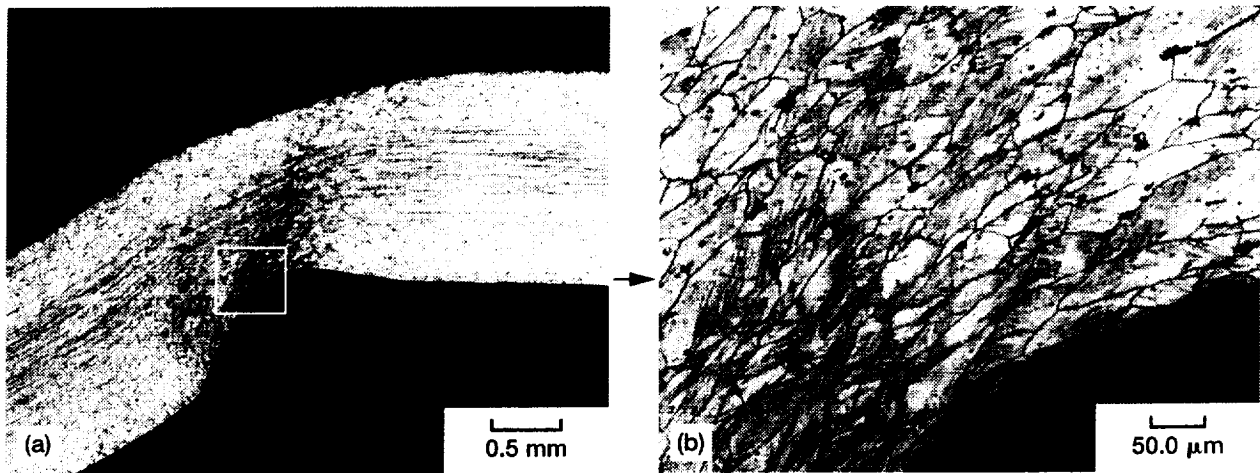
Figure 12.—a) Region of intense shear deformation in annealed specimen. b) Higher magnification shows a collection of intensely deformed grains rather than highly localized shear bands.

The annealed material appears to better absorb energy by diffusing the macroscopic shear zone over a wider area (Fig. 12). Whereas Fig. 12 indicates that a diffuse macroshear band is formed, high magnification examination of this area revealed that bands *per se* are not formed. Instead, the grains in this area of intense shear are just more heavily deformed and therefore etch darker than the surrounding grains. This is also indicated by the microhardness profiles, which revealed a higher hardness in the "band" region, typical of more work hardening (plastic deformation) and agrees with hardness readings taken near shear bands in other materials [25 to 28]. At least at low magnification, these apparent bands appear similar to those observed in brass [29 and 30] and copper [30 and 31]. In these cases more homogeneous bands formed under isothermal conditions associated with necking during tensile tests. Broad and diffuse bands were also observed in copper under punch-loaded conditions [32].

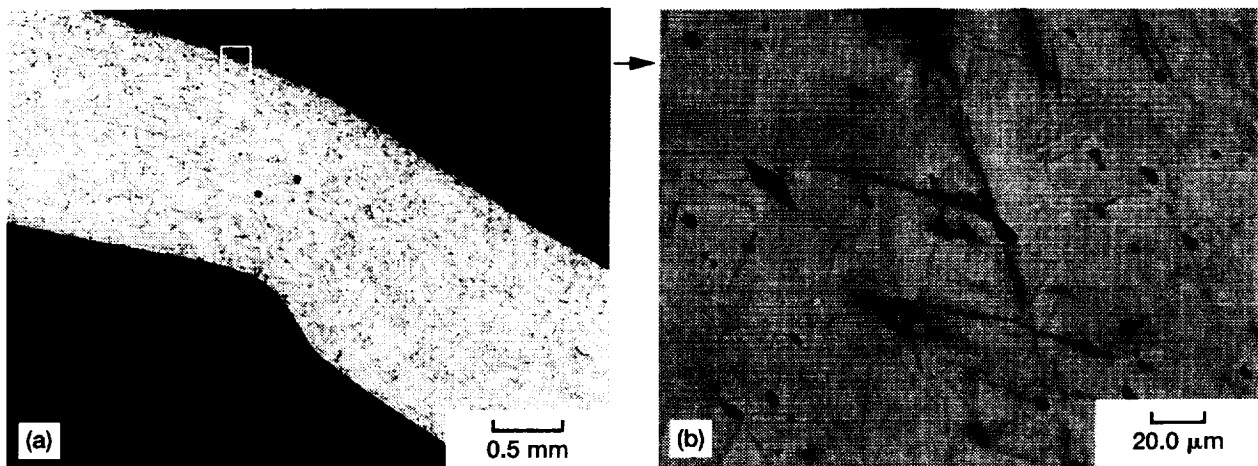
Figure 13.—a) Region of intense shear deformation in aged specimen. b) Higher magnification shows highly localized shear bands.

The aged samples had a much finer deformation structure as shown in Fig. 13. Attempts to bring out visible shear bands were limited. This was partially due to the multitude of fine slip bands in each grain and partially due to the poor etching characteristics of the aged samples. At areas of intense shear (i.e., projectile impact corners), some evidence of well-defined macroscopic bands was observed, but these were generally short and narrow, often connecting carbide particles. Compared to the apparent bands observed in the annealed material (Fig. 12), the bands in the aged material were much narrower, and often multiple bands could be observed in one grain. Similar microhardness profiles were performed with similar results to those in the annealed material. However, the hardness values were higher in all locations due to the fact that the material was originally aged. The hardness ranged from 400 (41 HRC) remote from the shear zone to 500 (49 HRC) in the shear zone.

In contrast, the aged material does show narrow shear bands, thus constricting the later stages of deformation to thin zones, typical of adiabatic shear bands [33]. It has been suggested [25 and 34] that shear localization increases with decreasing strain hardening and increasing strength, both of which are exhibited by the aged material. This would explain why the aged material has definite shear band formation and the annealed material does not. Additionally, aged In-718 deforms by the shearing of ordered precipitates [35]. During this process, the precipitates are reduced in size within the slip plane, as successive dislocations approach and shear the precipitates. Consequently, slip within this active plane is easier than on a neighboring inactive slip system. This would encourage shear bands to be narrow. The annealed In-718 does not have ordered precipitates and therefore slip on an existing system can only get more difficult due to dislocation tangles (work hardening). The zone of deformation spreads to neighboring, weaker planes forming a broad diffuse band. For adiabatic shear to occur, the amount of softening due to the local temperature increase must equal the rates of strain and strain rate hardening [36]. Softening can be assisted by precipitate shearing. The annealed material shows significantly greater strain hardening behavior under high strain rate conditions. Therefore, based on the above discussion, as well as the model of Bai and Johnson [16] discussed in the introduction, one would expect the aged In-718 to have more of a tendency to form adiabatic shear bands than the annealed.

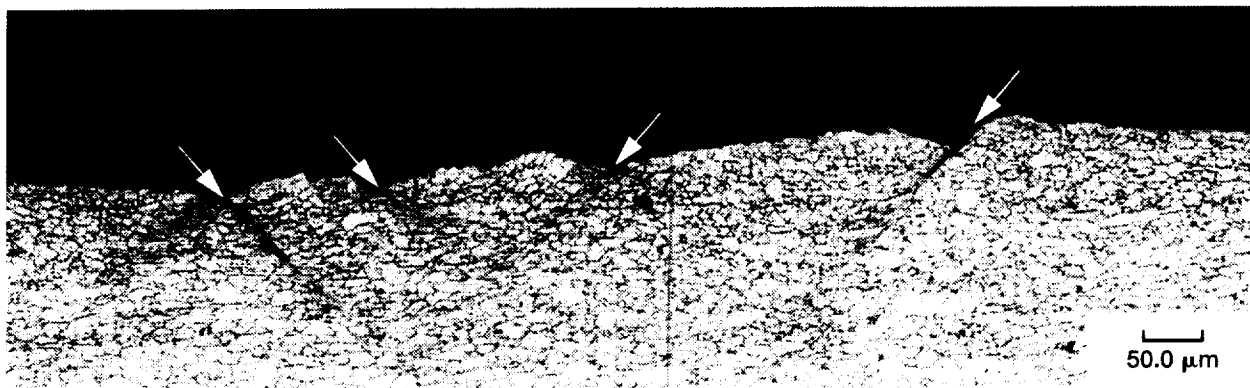
Figure 14.—Notches on back surface produced by high tensile stresses and the resulting shear bands.

Close examination of the back surface of both the aged and annealed materials revealed shear bands at 45° angles to the surface of the plate and at multiple locations near the plug. Shear bands caused a V-notch at the surface of the plate (Fig. 13). In specimens that were not perforated, cracks were observed emanating from the notches and propagating along the shear bands. These were the only evidence of cracking in the nonperforated specimens. Similar notches and shear bands have been observed in explosively bonded In-718 [23].

critical velocities do not propagate completely through the thickness. On the back side, shear bands form causing notches on the surface (Fig. 14). Cracks often form within these bands probably due to the high tensile stresses on the back surface. Cracking presumably occurs from the front surface as well, but it was never observed in the nonperforated samples. One can assume that if the velocity is high enough to cause cracking on the front surface, the projectile will perforate the plate. Therefore, front side cracking could be used as a critical condition for predicting failure in these tests. Since the cracks on the back surface will also propagate, there is a competition between the front and back side cracks. This often led to a chiseled-shaped fracture surface. Jones et al. [13] observed similar failure behavior in aluminum alloys when impacted by flat faced cylindrical projectiles, where failure on the proximal surface lead to complete failure across the plate thickness. In contrast, they found that for mild steel, which has a high adiabatic shear strength [16], impact failure under similar conditions is dominated by material failure on the distal side.
