MICROWAVE ANISOTROPY PROBE LAUNCH AND EARLY OPERATIONS

James R. Ó'Donnell, Jr., Ph.D., Stephen F. Andrews, Scott R. Starin
Flight Dynamics Analysis Branch

NASA Goddard Space Flight Center
Greenbelt, MD 20771 USA

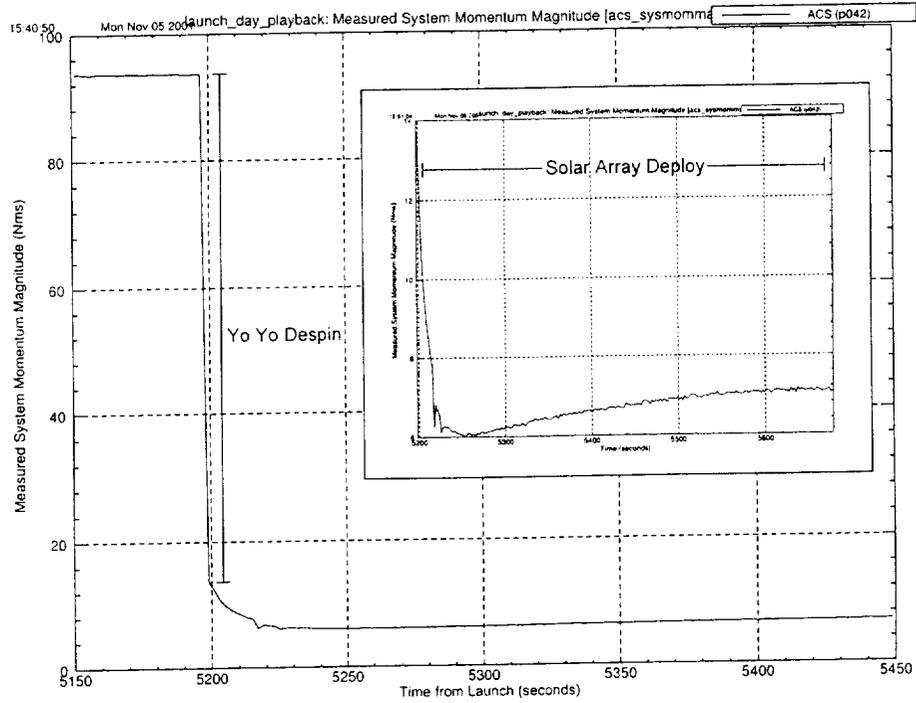
Figure 1: System Momentum Magnitude at Separation

After a thruster pulse test was performed and the Z axis gyro bias removed, MAP's Delta H Mode was used to dump its separation momentum. After 5 seconds, the mode timed out and returned to reaction wheel control, reducing the system momentum from 7.0 to 0.75 Nms.

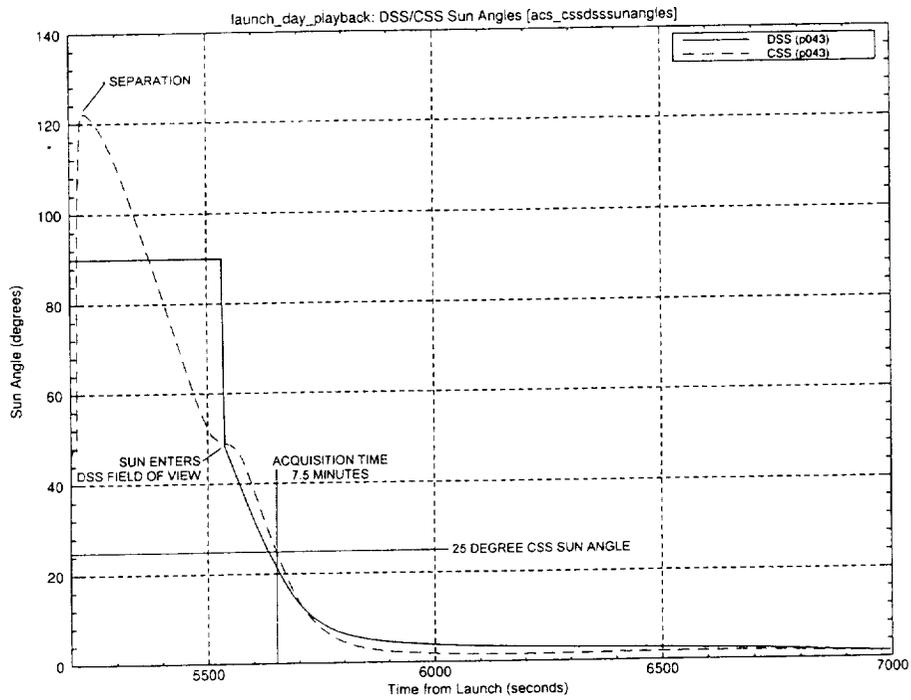
Figure 2: Sun Angles at Separation

Figure 2 shows the coarse and digital sun sensor (CSS and DSS) measured sun angles at separation. Note that the sun was out of the DSS field of view until 5530 seconds of the plot. The spacecraft acquired the sun within 7 minutes of separation. The spacecraft was declared separated and safe on the sun at 21:26. The first ACS activity after this was to power on the two Lockheed Martin AST-201 Autonomous Star Trackers (ASTs), in order to quickly determine that the trackers would successfully track stars and output attitude quaternions. First AST 1 and then AST 2 was powered on. After an expected power up delay, both trackers began to track stars and reported consistent attitude quaternions. However, as the spacecraft rotated at 0.1°/second (because of a Z axis gyro bias loaded pre-launch), both trackers endured periods of lost track. AST 1 was able to recover on its own, but AST 2 needed to be reset from the ground at 22:34. It was determined that this problem was related to the tracker seeing stray light from Earth limb; as MAP's altitude increased, the problem did not recur.

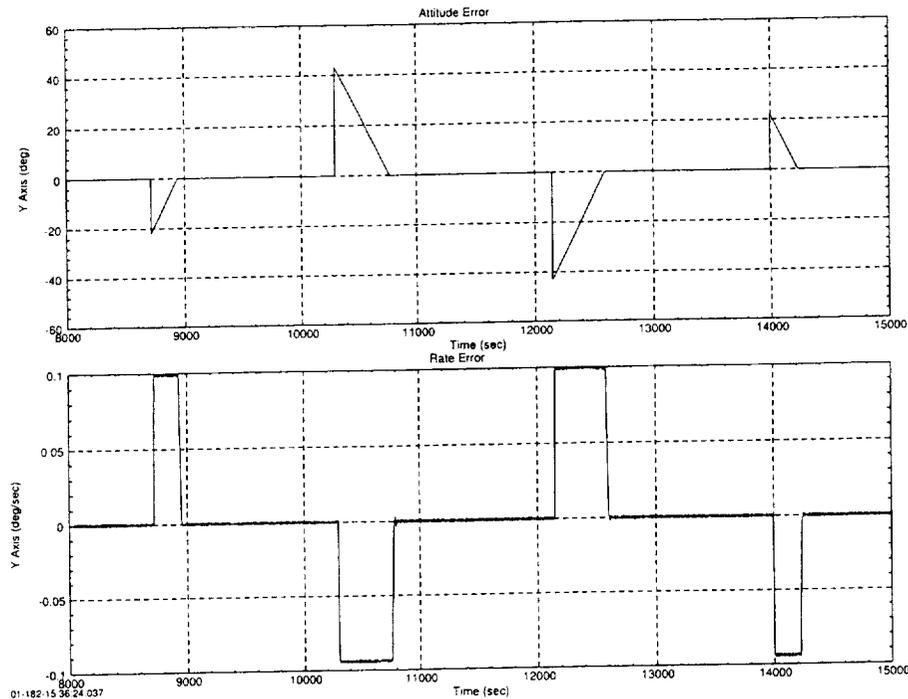
Figure 3: Y Axis Gyro Calibration Slews

The TARA calibration slews were performed the day after launch. The spacecraft had to be slowly slewed about one axis at a time for as large a slew as possible. At the end of each slew the spacecraft was held for at least an hour to collect AST and other sensor data that would be used for the calculation of gyro scale factors and alignments. Because of MAP's 22.5° sun angle constraint needed to thermally protect the science instrument, slews in the X and Y axes were limited to 44° . There were a total of 10 calibration slews; starting and ending in a sun pointing attitude with the slew sequence about each: $+22^\circ$, -44° , $+44^\circ$, -22° first about the X and then about the Y axis, and $\pm 90^\circ$ slews about the Z axis. Figure 3 shows the Y axis attitude error and rate associated with the Y axis calibration slews; note that the slew rate for these slews was reduced from the Inertial Mode nominal value of $0.5^\circ/\text{second}$ to $0.1^\circ/\text{second}$. The sensor data from these slews was saved and post-processed to develop new alignment matrices and scale factors for the TARAs. There were no anomalies during the slews. The next day, the new TARA parameter data was loaded onto the spacecraft. The calibration series of slews was repeated to verify the new parameters.

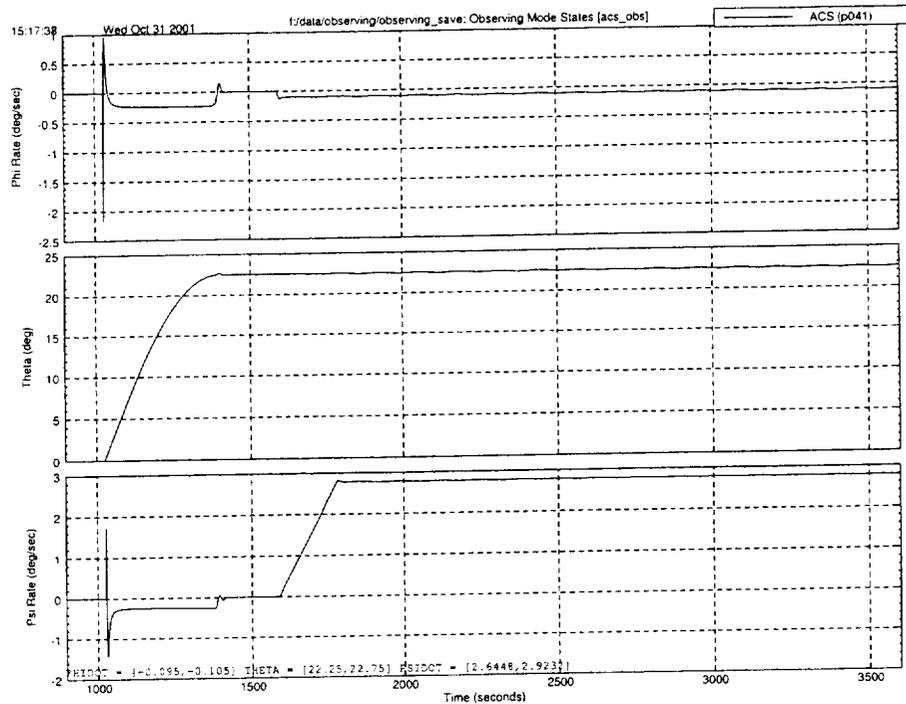
Figure 4: Initial Observing Mode Spinup

Figure 4 shows the Euler states—the precession rate, the scan angle, and the spin rate—during the initial spin-up into Observing Mode. Because sensor calibration parameters had not yet been calculated and uploaded to the spacecraft, Observing Mode performance during these initial tests did not satisfy the ACS requirements; this was expected until all sensor calibrations were completed.

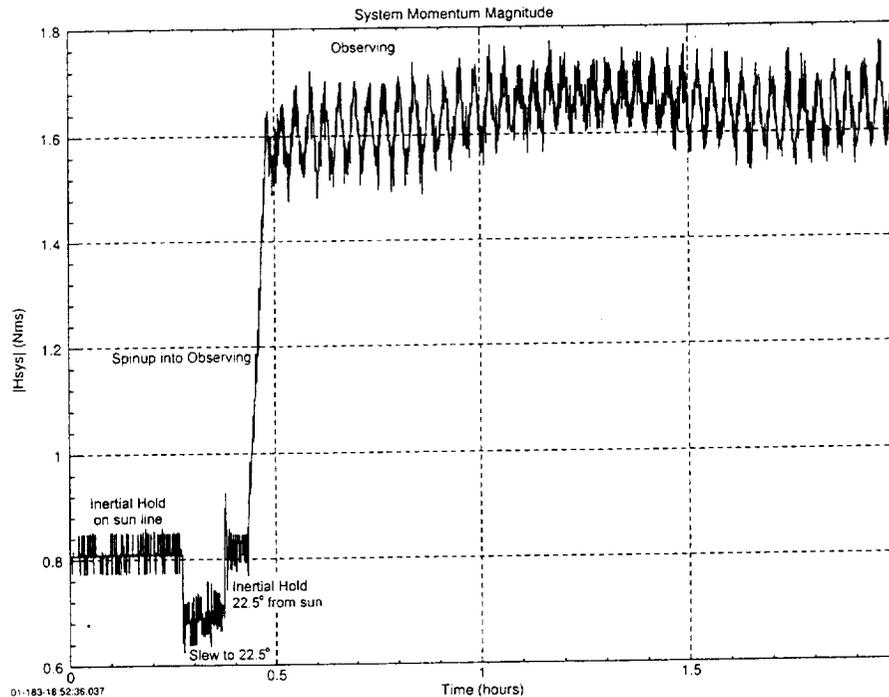
Figure 5: Measured System Momentum Magnitude Entering Observing Mode

MAP's system momentum measurement is derived from the spacecraft rates, as measured by the configured rate source (normally the gyros), and the reaction wheel speeds, as measured by the tachometers. Over short periods of time, the system momentum magnitude remains constant, so the highly varying value in Observing Mode showed that there was a problem with one or both

of the measurements. Because the measured spacecraft rates are passed through the Kalman filter, it was unlikely that those values were significantly in error. So, the most likely problem was in the tachometer measurement of the reaction wheel speeds. Some error in the tachometer measurement, or in the tachometer measurement compared to the gyro rate measurement, was causing three distinct error effects in the system momentum measurement: a measurement bias, a sinusoidal spin rate error, and a sinusoidal precession rate error.

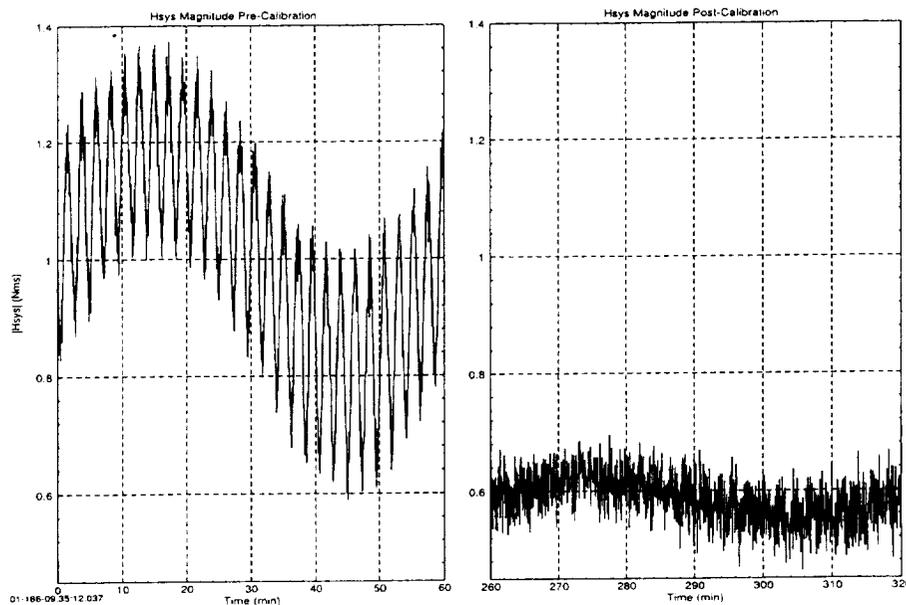
Figure 6: System Momentum Magnitude Pre- and Post-RWA Tach Calibration

By comparing the system momentum magnitude when MAP was stationary to its mean value in Observing Mode, an approximate RWA tachometer scale factor error of 4% was determined. However, the presence of the spin rate component of the measurement error made it apparent that the tachometer scale factors were also in error relative to one another. The tachometer scale factors were calibrated by analyzing flight data and comparing it with data from the MAP high fidelity (HiFi) simulator. It was then possible to compare the actual and ideal RWA tachometer measurements and to calculate a scale factor error for each wheel of 2.4%, 4.2%, and 4.5%, respectively. New scale factors were calculated and uploaded to the spacecraft; Figure 6 shows the Observing Mode system momentum magnitude measurement immediately before and after the upload. The lingering precession rate component of the measurement error can be traced to a small time difference between the body rate and wheel speed measurements; this error is also present in the HiFi simulation system momentum measurement.

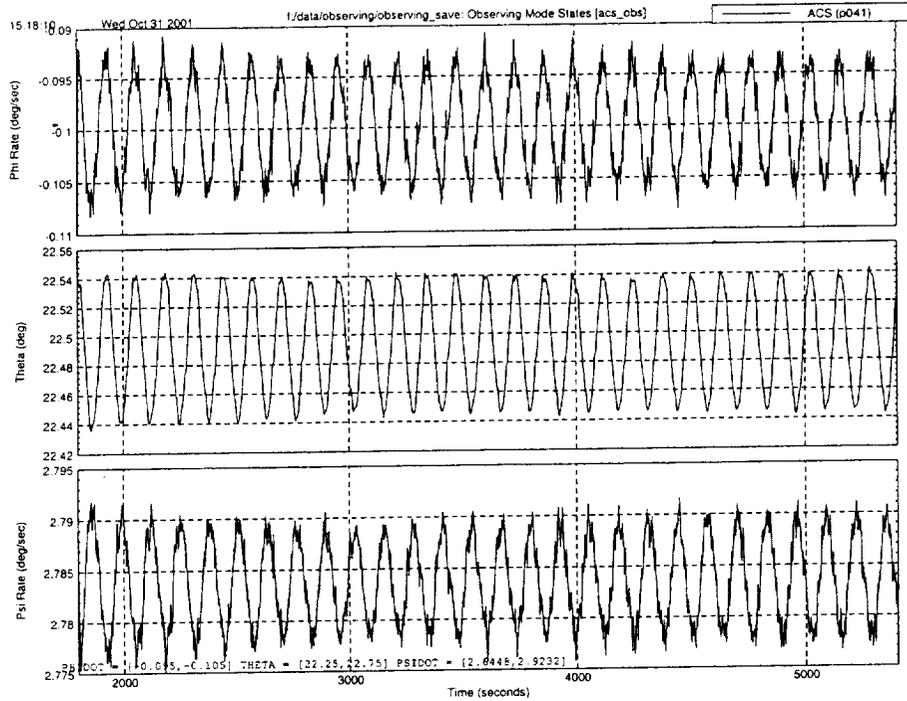
Figure 7: Pre-Calibration Observing Mode Performance

Figure 7 shows the Observing Mode performance from the initial Observing Mode checkout, before any sensor calibrations had been performed and/or uploaded to the spacecraft. The final

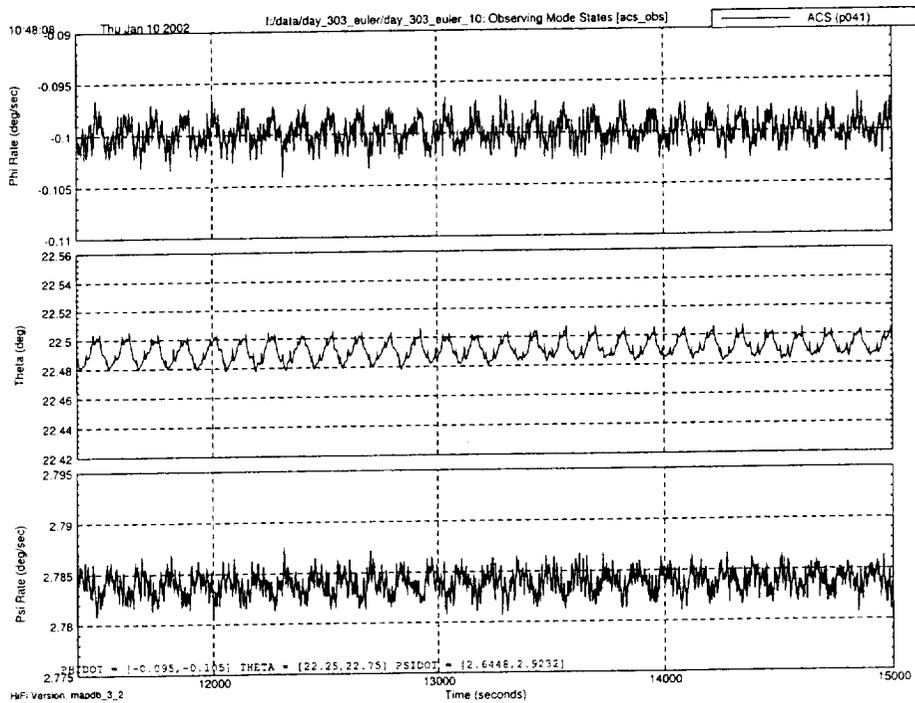
Figure 8: Post-Calibration Observing Mode Performance

alignments and calibrations were uploaded on August 7, 2002, followed by nominal values for the onboard Kalman filter parameters. These values were tuned for the nominal operating range of the sensors and were not as large as the values used at launch, which assumed uncalibrated and misaligned sensors. Figure 8 shows the resulting performance of the mode (using the same scales as the plots in Figure 7). It can be seen that the performance is significantly improved. Table 1 shows the pre- and post-calibration Observing Mode performance, verifying that the control mode met its requirements after all of the sensor calibrations were performed.

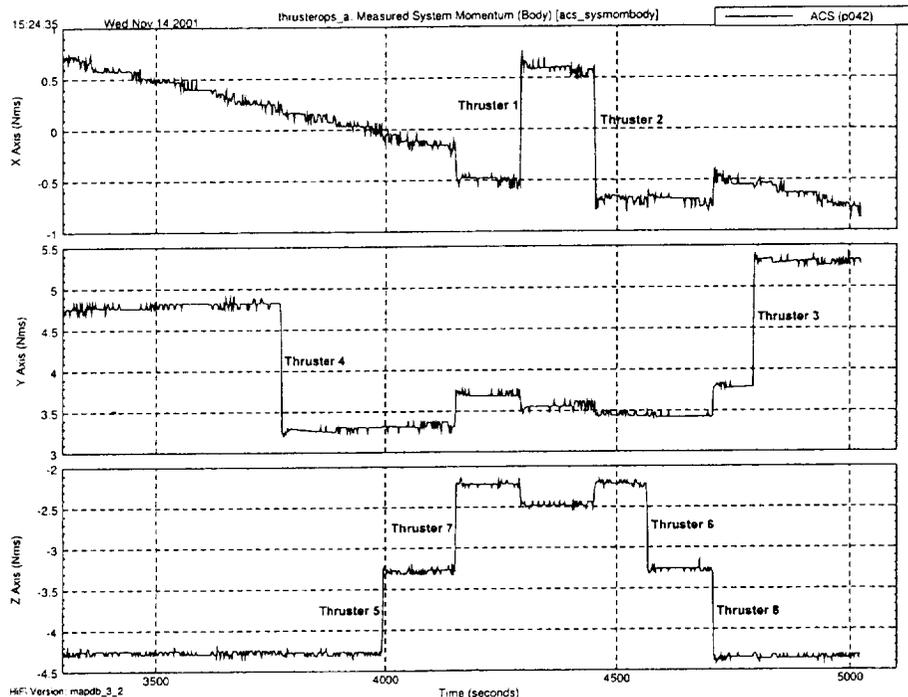
Figure 9: Thruster One-Shot System Momentum Effects

A specific order for the thruster tests was determined by the ACS team so that the tests would tend to decrease rather than increase the system momentum. Figure 9 shows the system momentum magnitude difference caused by the first round of thruster one-shots. As each thruster was fired during the first round of tests, the momentum changes were only 65–75% of the expected values. The propulsion team did not find these results to be of concern, surmising the low value to be caused by the initial lack of hydrazine between the thruster seats, and explained that the rationale for running the test twice took this effect into account. The second round of tests produced results that were similar to the first round. This strengthened the belief in a different theory, that the 400 millisecond thruster firings were not enough for the thrusters to reach a steady-state thrust, so the proof of correct thruster function was actually the consistency of test results rather than 100% torque comparisons. The thruster one-shot test was repeated the next day using the other attitude control electronics (ACE) box. From the standpoint of thruster performance, this test was successful, though it did cause an unexpected FDC failure into Safehold Mode, which will be described later in this paper.

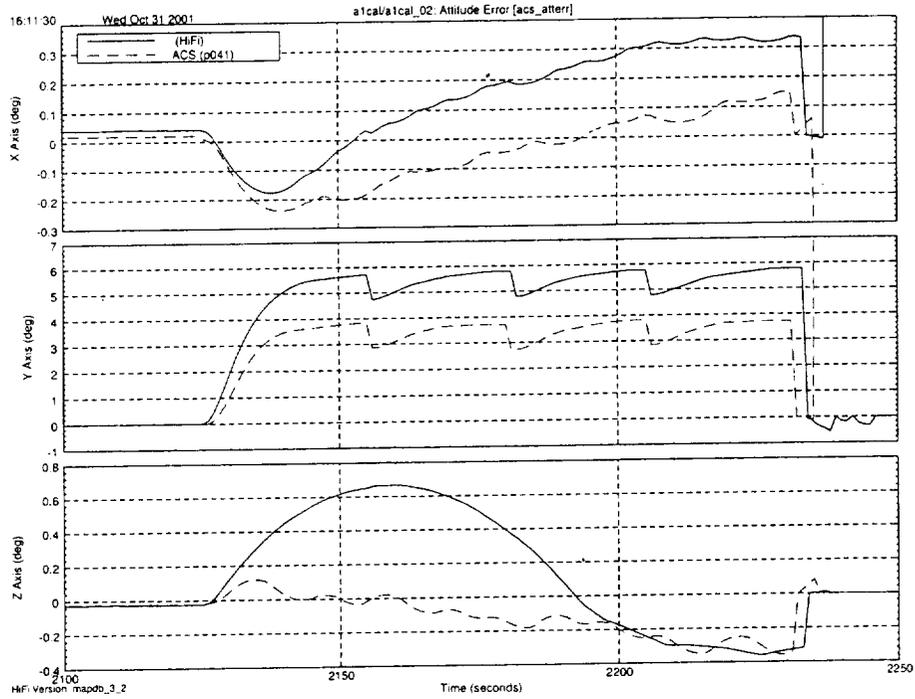
Figure 10: +X Cal Predicted and Actual Attitude Error (Pre-Calibration)

Figure 10 shows the attitude error from the first Delta V calibration burn, along with the expected performance as determined from HiFi simulation. The performance was much better than expected, with a thruster 4 duty cycle of 28% and a Y axis attitude error just under 4°. This was potentially good news—the lower duty cycle meant less fuel usage along with the smaller attitude error—but there was some concern about finding a viable explanation for the better performance. After analysis, a CM 2.785 cm from its predicted value and a thruster plume 50% of expected was found to allow accurate predictions of thruster mode performance. Figure 11 shows the actual vs predicted performance of the burn after calibration, with much better concurrence.

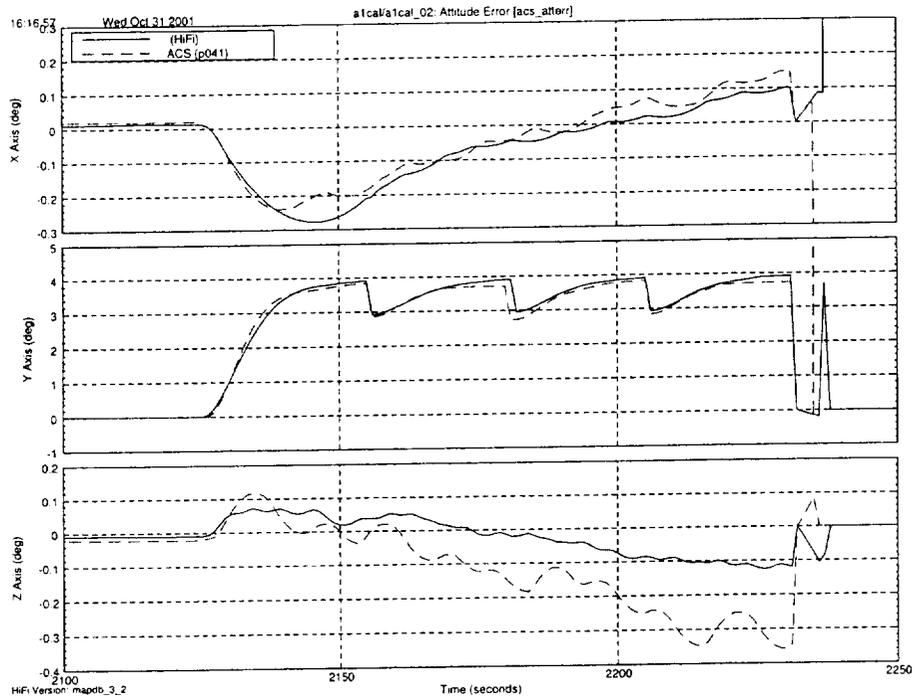
Figure 11: +X Cal Predicted and Actual Attitude Error (Post-Calibration)

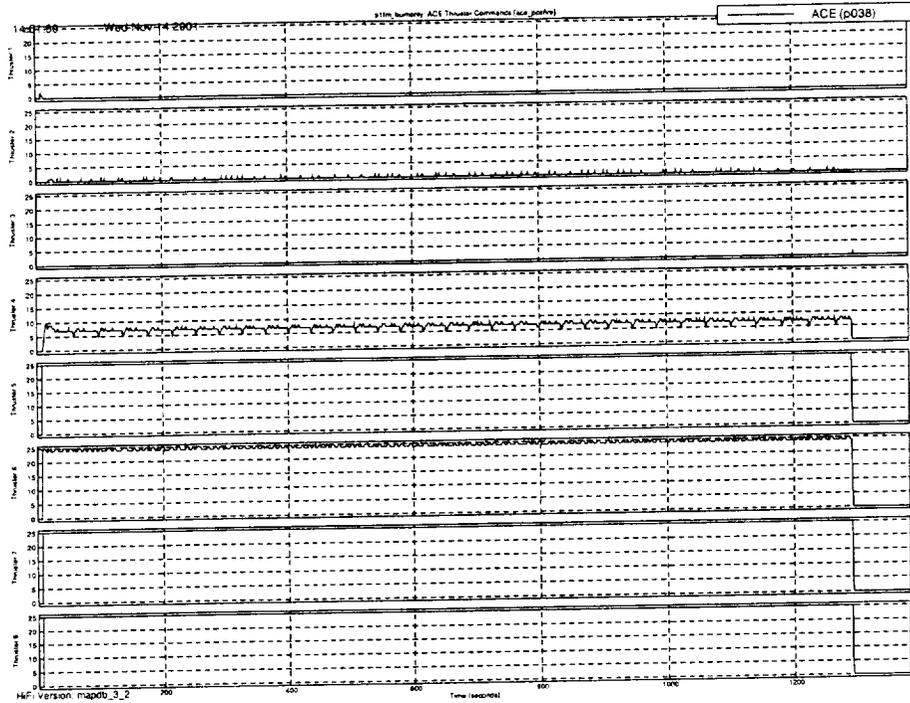
Figure 12: Perigee Maneuver 1 Thruster Commands

Figure 12 and Figure 13 show the thruster commands and attitude error flight data from the first perigee maneuver, a 20 minute burn that was the longest performed. As shown, the thruster 4 duty cycle and attitude error performance were consistent with that seen in the calibration burn. Except for some excitement due to the “anomalous force”, which is described in the next section, the first perigee maneuver proceeded nominally, both from an ACS and a trajectory point of view. The remaining orbit maneuvers at the second and third perigee and the final correction maneuver were also nominal and put MAP on a good trajectory for its encounter with the moon and its path to L₂.

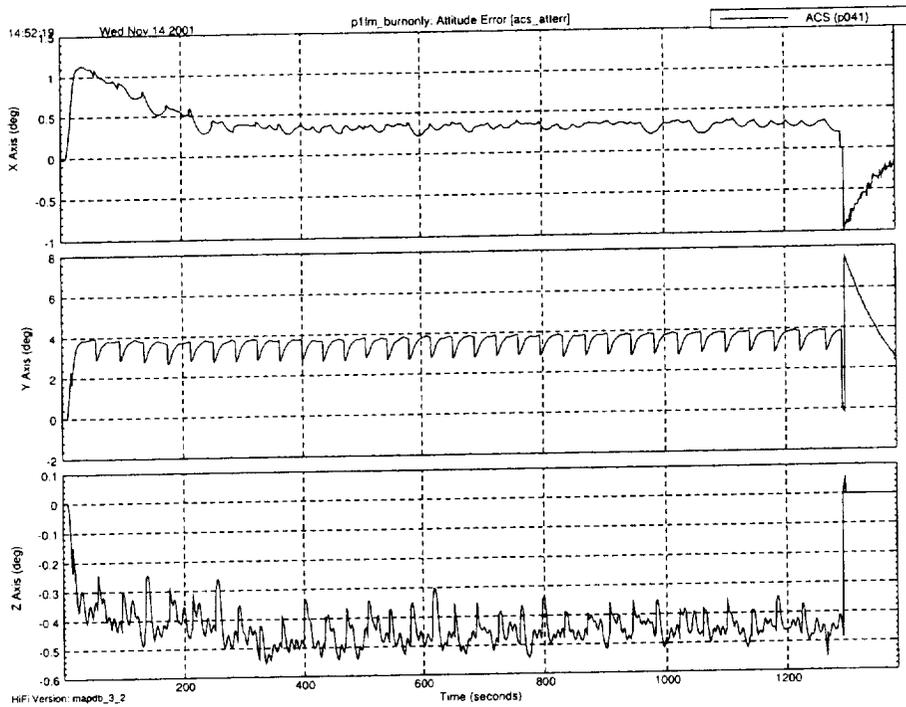
Figure 13: Perigee Maneuver 1 Attitude Error

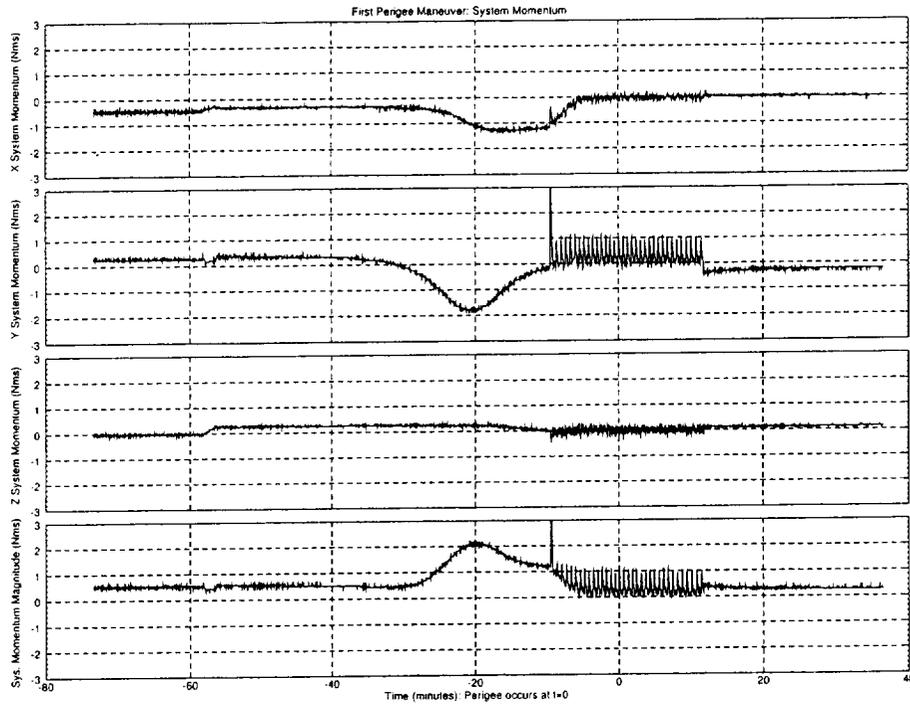
Figure 14: System Momentum Profile, Perigee Maneuver 1

During the first perigee maneuver, the system momentum increased rapidly for about 10 minutes, going from 0.5 Nms to 2.1 Nms. Figure 14 shows the P1 momentum profile; the time axis displays number of minutes until perigee. Because Delta V mode can only manage a limited range of system momentum values, onboard FDC nominally aborts a maneuver at a value of 5 Nms, and there were concerns at P1 that this would happen. Hurried preparations were made to disable this FDC and possibly manually abort the maneuver. As shown in Figure 14, the system momentum peaked before any problem with the burn would have occurred.

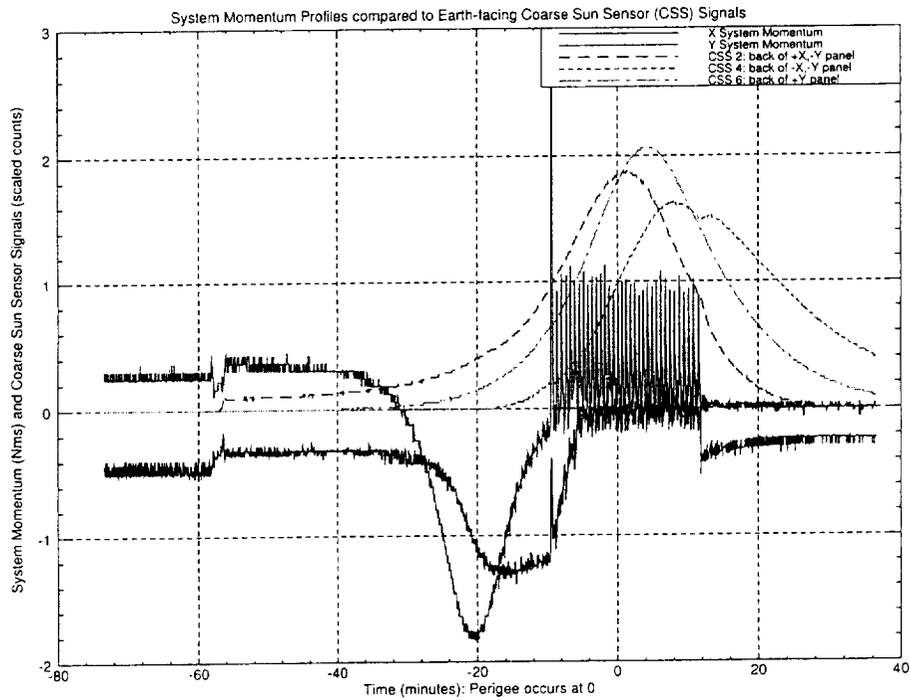
Figure 15: System Momentum and CSS Profiles, Perigee Maneuver 1

Figure 15 shows the outputs of three backward facing CSS eyes superimposed over the X and Y momentum profiles for P1. As expected, the torques appeared to occur as the three dark-side CSSs were illuminated by Earth albedo during the perigee approaches. Furthermore, the order of illumination—first CSS 2, then 6, then 4—indicated a correspondence between albedo varying across the cold side of the solar shield and the sequence of anomalous torques. Subsequent analysis by the thermal and science teams confirmed the possibility of this explanation and further predicted that the anomalous force would reoccur to a lesser degree at each perigee; as percentages of the change seen at the first perigee the predicted value was 35% at P2 and 15% at P3. As shown in Figure 16, the flight data collected at P2 and P3 agreed with this prediction.

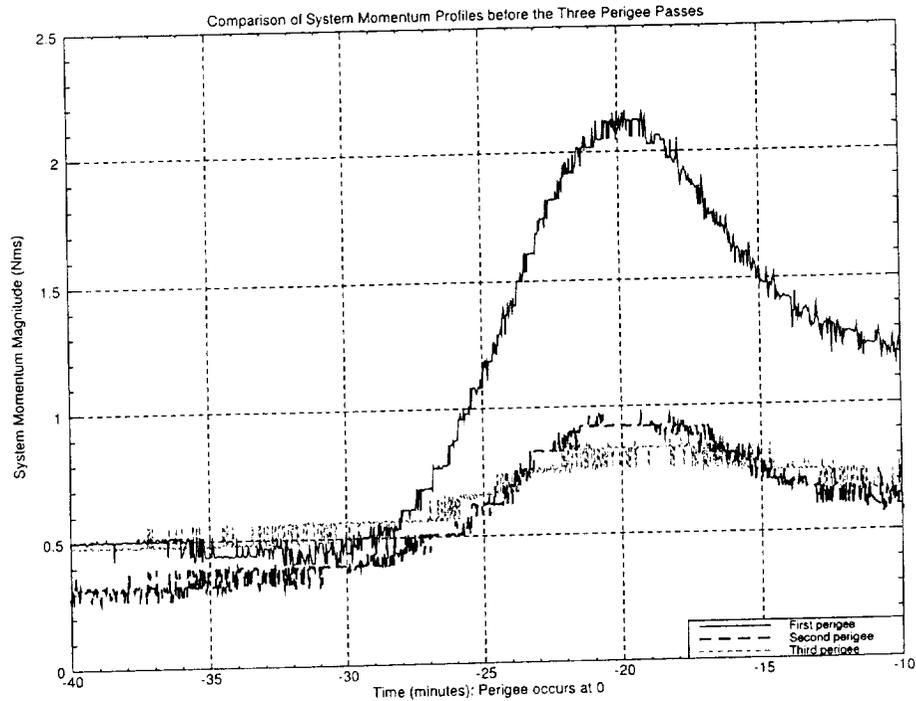
Figure 16: System Momentum Profile, All Perigee Maneuvers

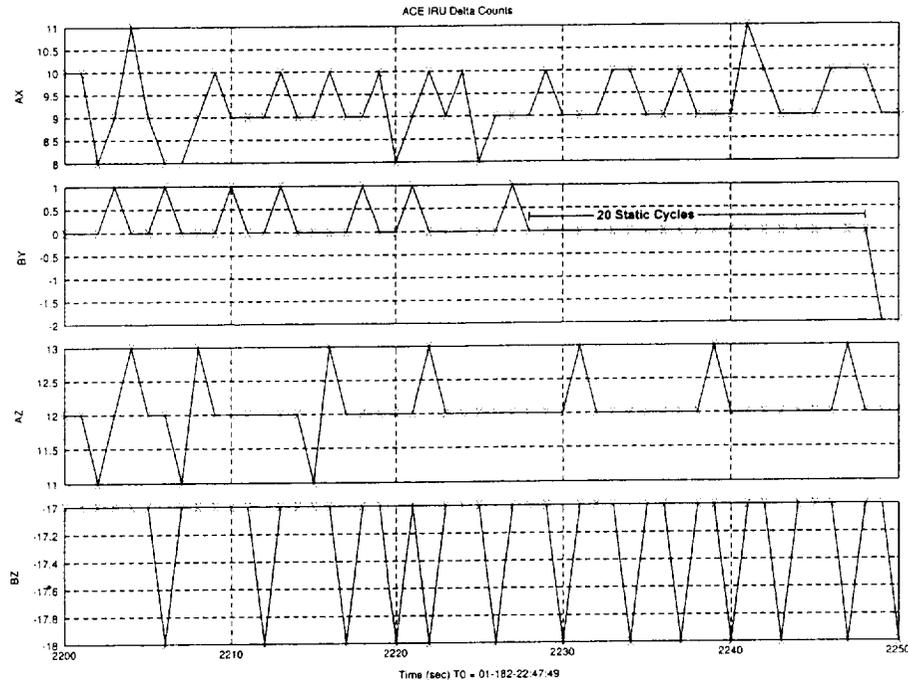
Figure 17: IRU Counts Leading to Safehold Entry

of thruster 7, the fire command appeared to have no effect on system momentum, possibly indicating a problem with the LMAC ACE thruster 7 driver. Instead, telemetry indicated that the Static Gyro Data FDC had tripped, causing the ACS to switch into Safehold on the other ACE (known as the MAC ACE). A review of the command timeline shows that the LMAC ACE thruster 7 was enabled successfully just before the FDC tripped, but the FDC trip caused ACS to switch control and communications to Safehold on the MAC ACE before the thruster fire command was sent. Since the thruster enable and thruster fire commands were sent to different ACEs, the thruster was not fired.

Since Safehold was working correctly, the team focused on determining the cause of the FDC failure. An investigation of telemetry from both ACEs showed that they both appeared to be working correctly. A closer inspection of the gyro data prior to Safehold showed the actual cause of the perceived gyro anomaly. Since the Sun Acquisition controller allowed for a subtle, slow oscillation as the disturbance caused by each thruster one-shot was damped out, the $2^\circ/\text{hour}$ Y axis gyro bias actually cancelled the spacecraft rate for more than 20 seconds, appearing as 0 counts of rate output for that period of time. The Static Gyro FDC was watching for 20 seconds of 0 counts for spacecraft rate as a sign of faulty gyro input, since disturbances would be expected to cause some rate variation over such a long period. The problem would not occur in other modes, since the higher performance that was required by those modes necessitated a higher bandwidth, thus eliminating the slow oscillation. Figure 17 shows the 20 consecutive static gyro counts on the Y axis gyro. Once the cause of the anomaly was determined, the spacecraft was reconfigured to its pre-Safehold state and the Static Gyro FDC threshold increased to 120 seconds, to lessen the chance of it tripping accidentally in the future.
