Safety Grooving

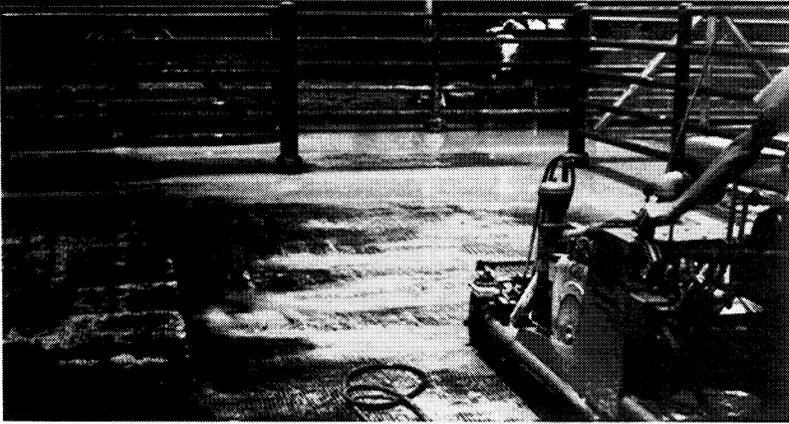
At left, a machine equipped with diamond blades is cutting grooves in the concrete holding pen of a California cattle ranch as an animal safety measure. Concrete surfaces are regularly employed for sanitary purposes in pen and feeding areas, but in time the surface finish wears smooth and becomes slippery. This gives rise to the danger that valuable cattle may fall and be seriously injured or killed; it happens often enough to pose a major problem for cattle ranchers and dairy farmers. Operators of such facilities, in the U.S. and abroad, have found safety grooving an effective remedy.

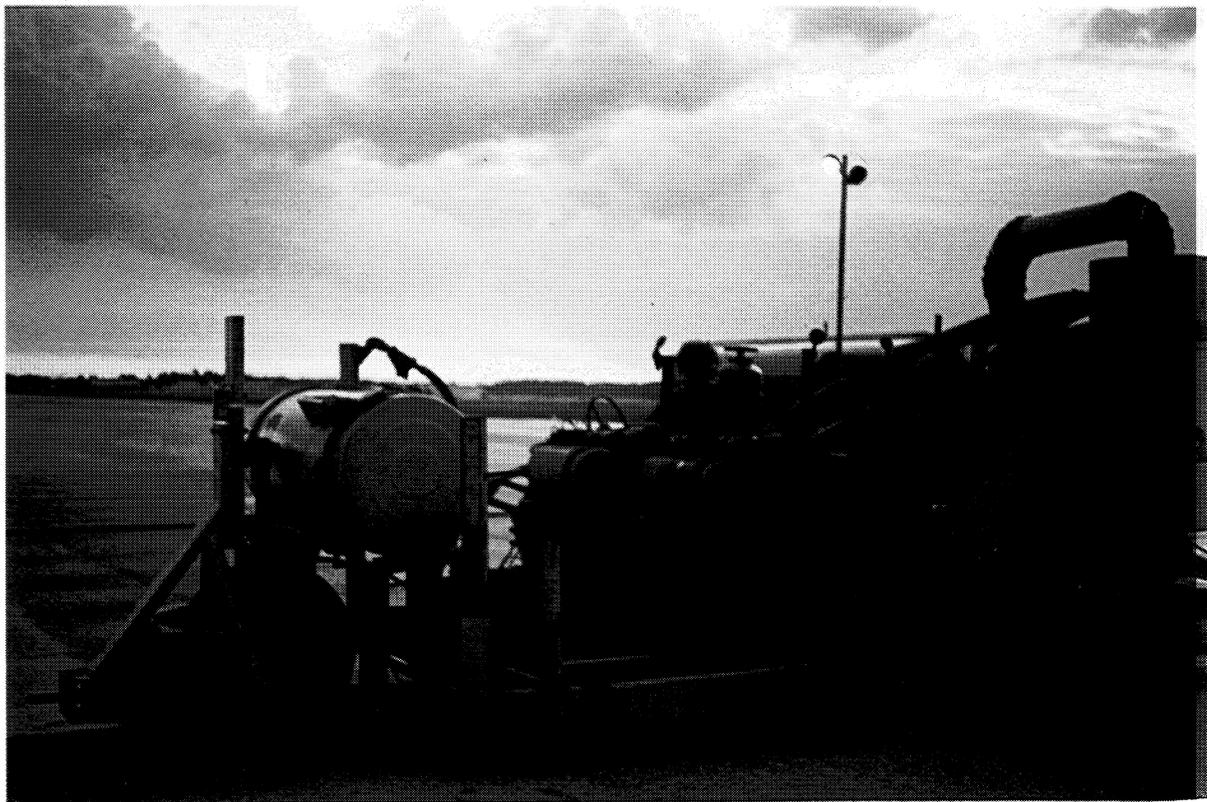
in the U.S., Canada, Europe and Asia. The process is typified in the bottom photo, opposite page which shows a runway being grooved at Daytona (Florida) Airport. In a survey of U.S. airport managers conducted by IG&GA, 91 percent of the respondents said they would recommend runway grooving as a valuable maintenance/safety improvement.

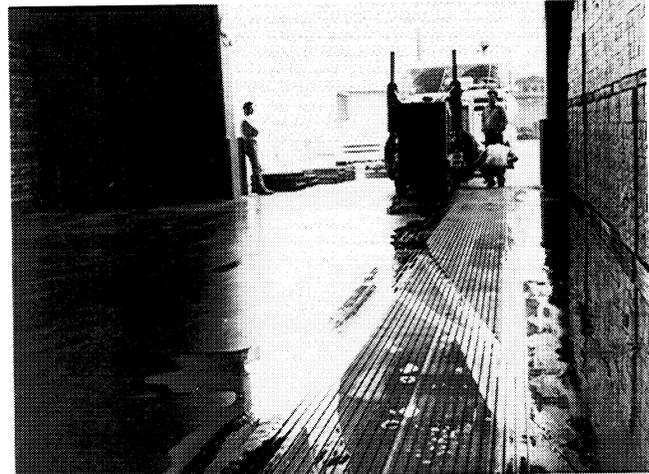
of countries in Europe and Asia; the middle photo, opposite page shows a grooving machine cutting longitudinal channels in a section of Japan’s Tohoku Expressway.

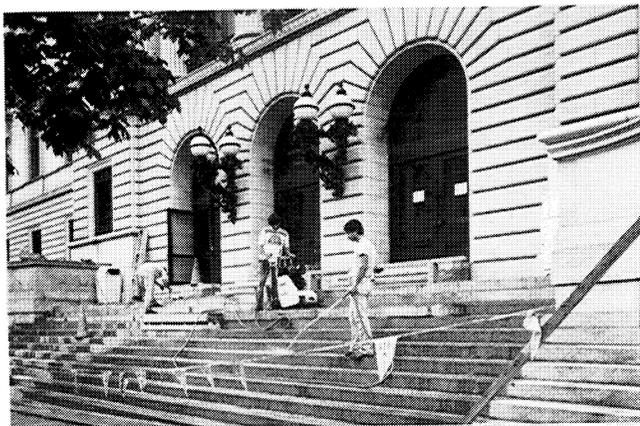
In the last five years, the success of runway/highway safety grooving has inspired a wide range of new applications and caused the members of the IG&GA to develop new types of diamond-bladed grooving machines, smaller and lighter because they must be operated on narrower surfaces and maneuvered in tight quarters. An example is the machine being used at left, where the granite steps of a Philadelphia school are being grooved to keep students from slipping and falling in wet weather. Among other examples of grooving outdoor surfaces for pedestrian safety are sidewalks, playgrounds, parking lots, service stations, car washes, railroad station platforms and swimming pool decks. Indoor grooving examples include the slippery-when-wet entrance to a West Coast bottling plant (above) and occasionally slick working areas in refineries, factories, warehouses, meat packing facilities and food processing plants.
