Failure Morphologies of Cyclically Oxidized ZrO_2 -Based Thermal Barrier Coatings

James A. Nesbitt, Dongming Zhu*, Robert A. Miller and Charles A. Barrett

NASA Glenn Research Center
Cleveland, OH 44135

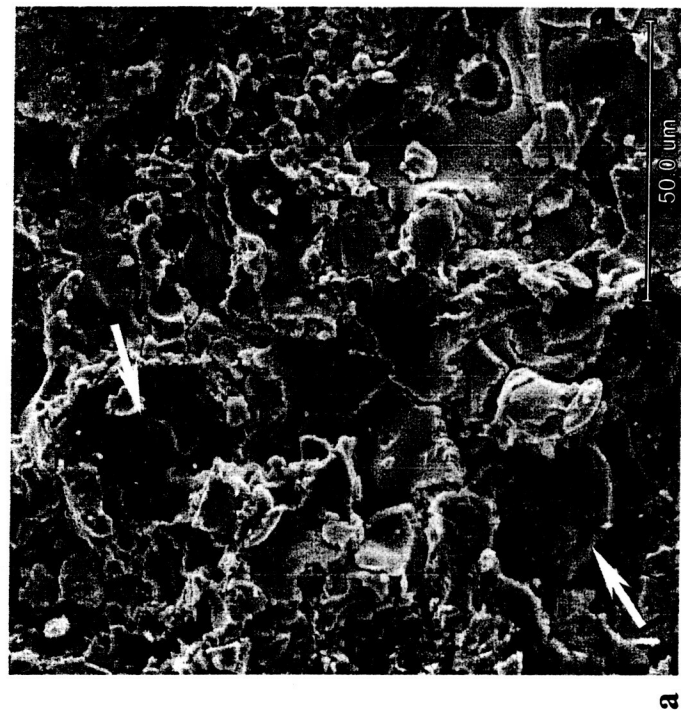
Figure 7. (a) SEI and (b) BSE images of the same location on the bond coat fracture surface on the baseline coatings. Dark regions in (b) are TGO. The BSE image shows that the fracture path cuts through the alumina TGO to expose bond coat asperities (white arrows in a). The asperities are oxidized in the current figure since they appear dark in the BSE image (b). Primarily intersplat fracture through the top coat is evident.

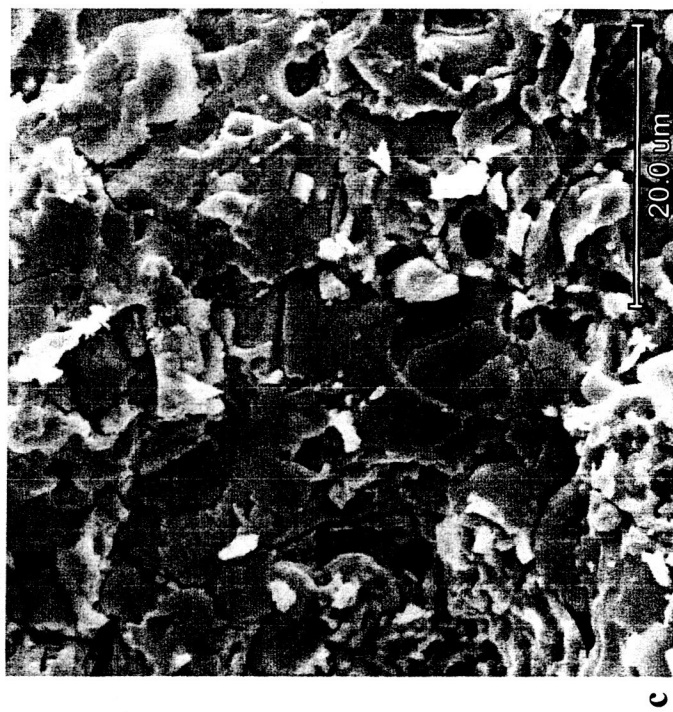
Figure 14 SEI image showing primarily fracture along splat boundaries. Bond coat fracture surface (a) ADV-26A (b) ADV-12 and top coat fracture surface (c) ADV-26B.

On each of the advanced coatings, there was significant evidence of fracture along splat boundaries when viewing either the bond coat or top coat fracture surfaces (Figure 14). However, in each of the advanced coatings, there were also regions with the irregular, shaped oxide structures easily distinguished from the smooth, splat morphology (Figure 15). This irregular shaped morphology was somewhat similar to that observed in the baseline alloys (Figure 8b). Comparison of the EDS spectra from the irregular morphology and the smooth splat morphology gave some indication that the irregular shaped oxide was higher in dopant content, particularly Yb, however, this enrichment was small and wasn't observed uniformly in all regions examined. Further analysis by electron microprobe of the polished cross-sections might confirm any compositional inhomogeneity.

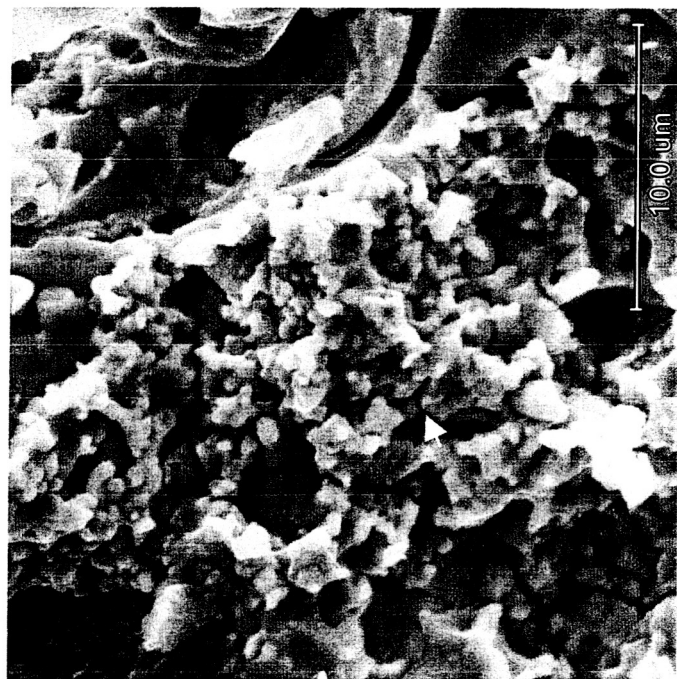
Figure 15 (cont.) (e) SEI image showing the irregular-shaped oxide structure on the top coat fracture surface of ADV-26B. (f) Higher magnification of (e). White arrows indicate the irregular-shaped oxide, black arrows indicate smooth intersplat boundaries.
