SURFACE CRACKING AND INTERFACE REACTION ASSOCIATED DELAMINATION FAILURE OF THERMAL AND ENVIRONMENTAL BARRIER COATINGS

Dongming Zhu, Sung R. Choi, Jeffrey I. Eldridge, Kang N. Lee and Robert A. Miller

NASA John H. Glenn Research Center
21000 Brookpark Road, Cleveland, OH 44135

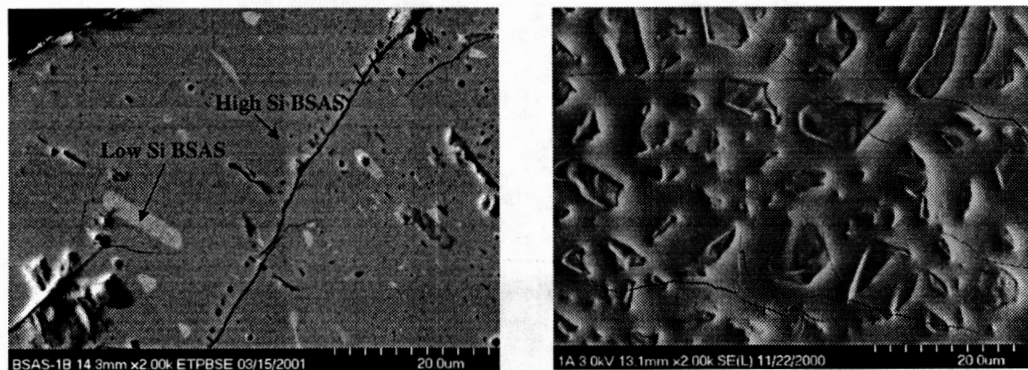
Fig. 1 (a) The BSAS coating was decomposed into low Si (bright second) and high Si (dark matrix) phases during initial laser thermal cyclic testing. (b) The higher Si phase became the glass phase and surface cracks were formed after 100 hour cyclic testing at the surface temperature of $1482^\circ C$.

Fig. 1 shows SEM microstructures of the BSAS/Si environmental barrier coating after laser thermal gradient cyclic testing. It can be seen from Fig. 1 (a) that the BSAS coating was first decomposed and precipitated a lower silicon (Si) containing phase, with the matrix being a high Si containing BSAS. As the coating was further cyclically tested at the surface temperature of $1482^\circ C$, the BSAS matrix was melted because of the formation of the higher Si and lower melting point BSAS. The surface cracking was also observed after coating melting and glass phase formation.

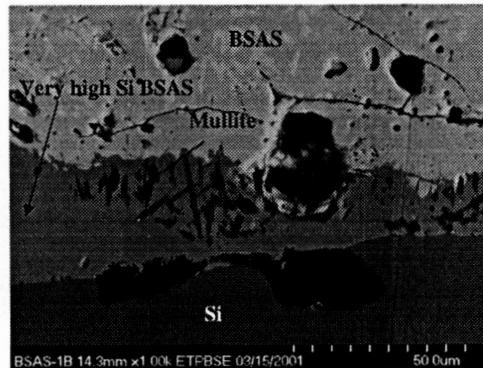
Fig. 2 SEM cross-section micrograph of the BSAS coating after 100 hour laser thermal gradient cycling test. The interface reactions resulted in a dark reaction BSAS layer with high Si concentrations. The mullite phase (very dark needle-shaped phase) precipitation was also found within the high Si reaction BSAS region.

Fig. 2 shows a SEM cross-section micrograph of the BSAS coating after 100 hour laser thermal gradient cycling test. The interface reactions between the Si bond coat and BSAS coating resulted in a dark reaction layer with the layer thickness of 30-40 microns. The EDS analysis has shown that this BSAS region has very high Si concentrations due to the Si diffusion from the Si bond coat into the BSAS. The high Si concentration BSAS phase was also decomposed into mullite phase (very dark needle-shaped phase) within the high Si BSAS reaction region. Although the coating interface melting was not observed under the 1300°C interface temperature of the thermal gradient testing for 100 hours, the high Si concentration BSAS reaction layer has been reported to facilitate the coating melting and the glass phase formation under the uniform temperature furnace testing in a water vapor environment at higher temperatures [5].

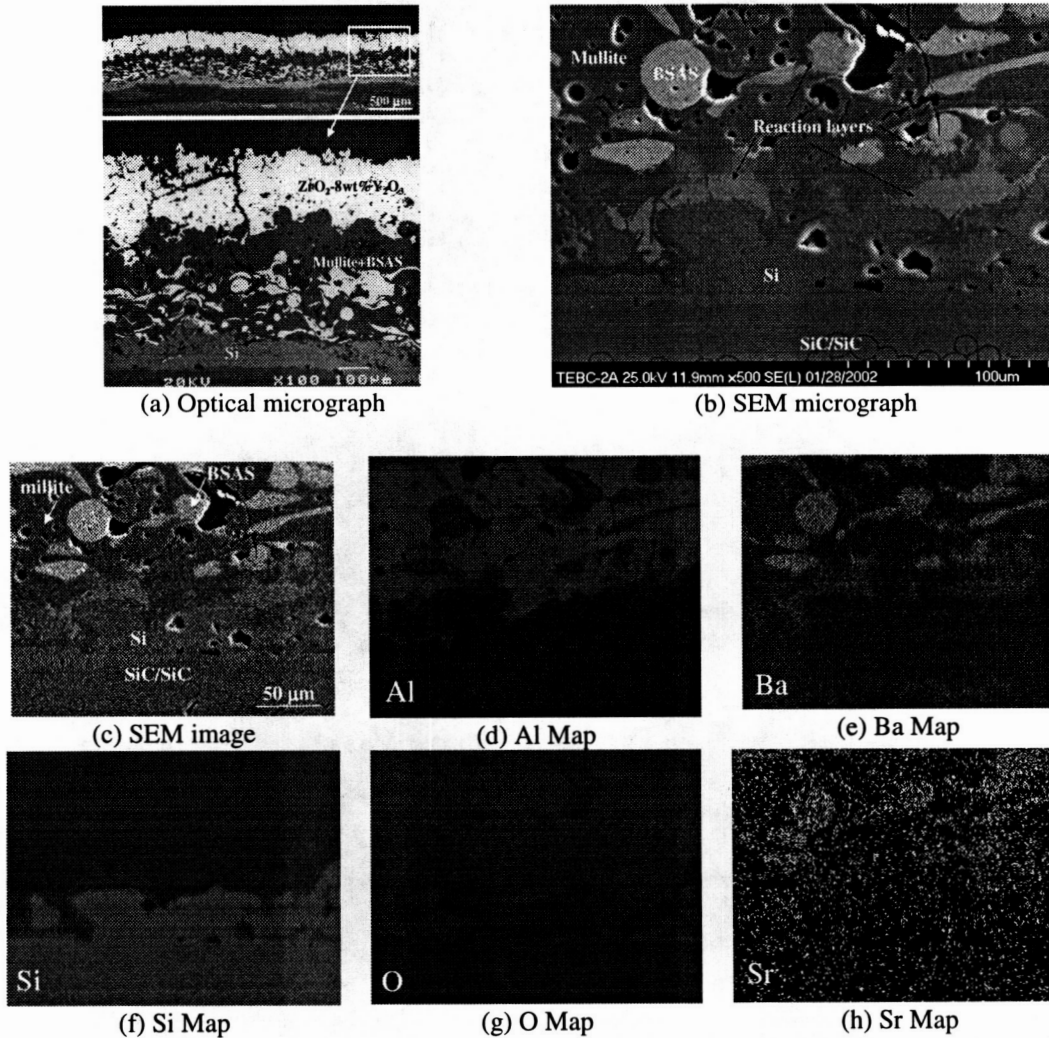
Fig. 3 SEM images and EDS element composition maps of the ZrO_2 -8wt% Y_2O_3 /BSAS+mullite mixture/Si on SiC/SiC ceramic matrix composite substrates after laser testing, showing significant interface reactions between BSAS and bond coat Si layer, and the BSAS and mullite. (a) and (b) Optical and SEM micrographs of the coating after 100 hours testing, showing the surface cracking and interface reactions; and (c) to (h) SEM cross-section

micrograph and the corresponding EDS elemental maps for the coating systems near the interface.

Fig. 3 shows cross-section micrographs and compositional maps of the ZrO_2 -8wt% Y_2O_3 /BSAS+mullite mixture/Si on a SiC/SiC ceramic matrix composite substrate, after 100 hours testing in a combined alternating laser thermal gradient cyclic and furnace water vapor exposure cyclic testing. It can be seen that substantial thermal gradient induced coating surface wedge-shape cracking has occurred and the resulting delamination was observed for the coating specimen. As shown in Fig. 3, significant interface reactions within the mullite+BSAS EBC layer occurred. The reaction affected zone can be as thick as 30 to 40 microns, especially near the interface and the BSAS phase (bright phase) regions. The reactions between mullite and BSAS phases were also noticed with a typical reaction layer thickness of 2-5 microns. However, the interdiffusion of Ba and Al between the mullite and BSAS can occur at a much greater distance, as indicated by the EDS composition maps in Fig. 3 (d) and (e). The reactions were further enhanced by the surface crack penetrations into the EBC layer which allowed the water vapor fast access to the coating at the EBC/Si interface. The accelerated coating damage under the thermal gradient cyclic testing combined with the furnace water vapor testing was attributed to the increased delamination driving force under the thermal gradient cyclic loading and the reduced interface adhesion due to the detrimental interface reactions [4, 6].

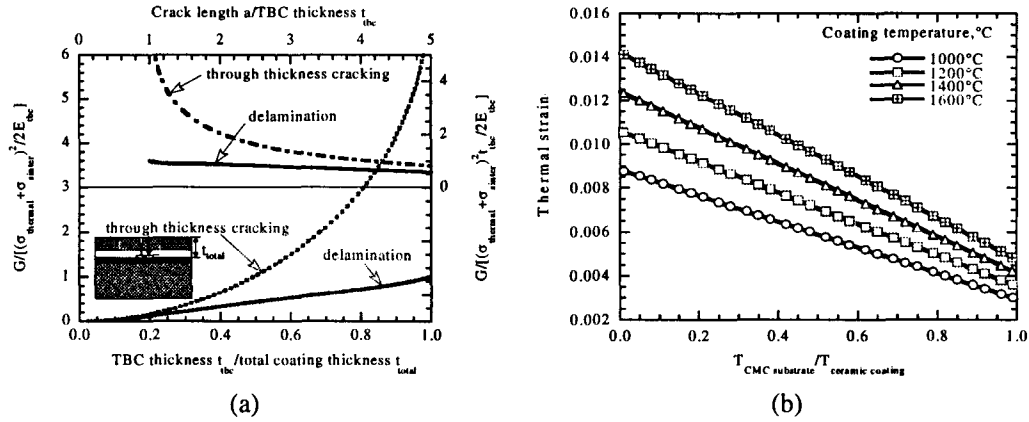
Fig. 4 (a) ZrO_2 - Y_2O_3 TBC layer on mullite-BSAS EBC and CMC substrates, the coating surface cracking and delamination energy release rates can increase significantly with a relatively thick, and larger thermal expansion ZrO_2 - Y_2O_3 TBC layer on mullite-BSAS EBC on CMC substrates. (b) The significantly larger thermal stresses/strains will be generated with increasing the thermal gradients (the temperature difference between the ceramic coating and the substrates).

The coating surface cracking is largely due to ceramic top coat sintering and thermal expansion mismatch, especially under the large thermal gradient conditions. As can be seen in Fig. 4, with a relatively thick, higher thermal expansion ZrO_2 - Y_2O_3 TBC layer on mullite-BSAS EBC and CMC substrates, the coating surface cracking and delamination driving force can increase significantly, based on a thermal gradient testing delamination model proposed in the literature [7]. The significantly larger thermal stresses generated under thermal gradients will also accelerate the coating delamination under the thermal cyclic conditions.

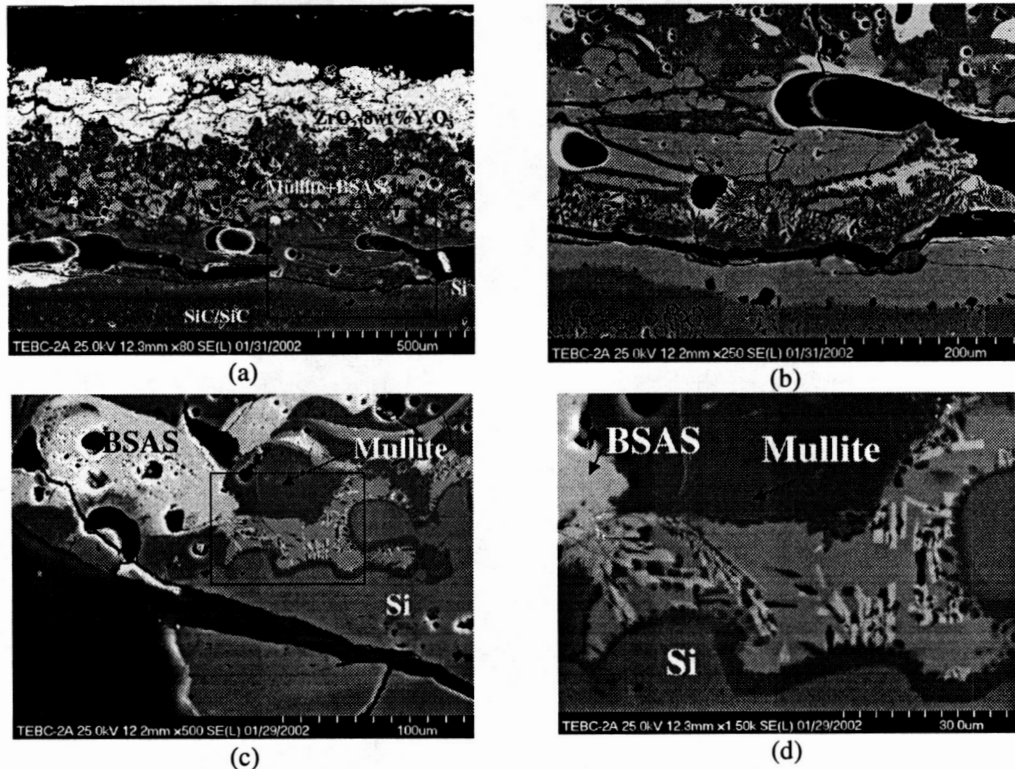
Fig. 5 SEM cross-section micrographs of the $ZrO_2-8wt\%Y_2O_3/BSAS+mullite/Si$ on a SiC/SiC ceramic matrix composite substrate, after total 400 hours testing in the combined laser gradient thermal furnace water vapor through cyclic conditions. (a) Significant interfacial pore formation due to the water vapor attack through the vertical cracks under the thermal gradient cycling conditions. (b) Low melting eutectic phase was also observed near the BSAS-mullite-Si interfaces after the testing.

Fig. 5 shows the SEM cross-section micrographs of the ZrO_2 -8wt% Y_2O_3 /BSAS+mullite mixture/Si on a SiC/SiC ceramic matrix composite substrate, after 400 hours of testing in the combined laser thermal gradient and furnace water vapor cyclic testing. Extensive coating delamination and some ~~spallation~~ spallation were observed during the testing. From Fig 5 (a) and (b), it can be seen that, in addition to the more significant reactions between the EBC mullite, BSAS and Si bond coat, large interfacial pores developed due to the water vapor attack through the vertical cracks in the EBC coatings. From Fig. 5 (c) and (d), it can also be seen that a low melting point eutectic phase around the BSAS, Si, and mullite interfaces formed. For the top ZrO_2 - Y_2O_3 coating side, no obvious reactions were found between mullite and ZrO_2 -8wt% Y_2O_3 coatings after the 400 hours combined laser and furnace water vapor thermal cycling test.
