Surface Cracking and Interface Reaction Associated Delamination Failure of Thermal and Environmental Barrier Coatings

9. SPONSORING/MONITORING AGENCY NAME(S) AND ADDRESS(ES) National Aeronautics and Space Administration Washington, DC 20546-0001 and U.S. Army Research Laboratory Adelphi, Maryland 20783-1145		10. SPONSORING/MONITORING AGENCY REPORT NUMBER NASA TM-2003-212318 ARL-TR-2969

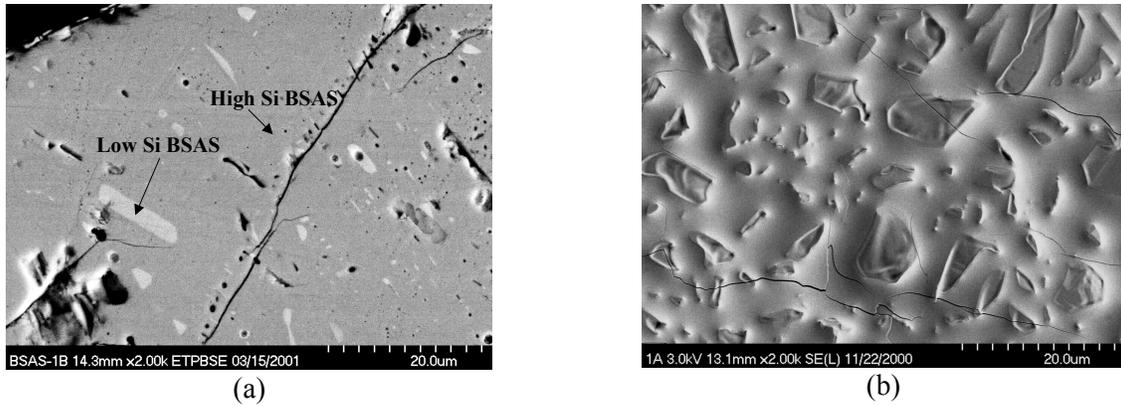
Figure 1.—(a) The BSAS coating was decomposed into low Si (bright second phase) and high Si (dark matrix) phases during initial laser thermal cyclic testing. (b) The higher Si phase became the glass phase and surface cracks were formed after 100 hour cyclic testing at the surface temperature of 1482 °C.

Figure 1 shows SEM microstructures of the BSAS/Si environmental barrier coating after laser thermal gradient cyclic testing. It can be seen from Figure 1 (a) that the BSAS coating was first decomposed and precipitated a lower silicon (Si) containing phase, with the matrix being a high Si containing BSAS. As the coating was further cyclically tested at a surface temperature of 1482 °C, the BSAS matrix was melted because of the formation of the higher Si and lower melting point BSAS. The surface cracking was also observed after coating melting and glass phase formation.

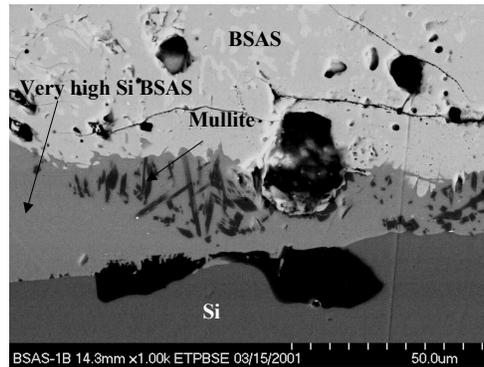
Figure 2.—SEM cross-section micrograph of the BSAS coating after 100 hour laser thermal gradient cycling test. The interface reactions resulted in a dark reaction BSAS layer with high Si concentrations. The mullite phase (very dark needle-shaped phase) precipitation was also found within the high Si reaction BSAS region.

Figure 2 shows a SEM cross-section micrograph of the BSAS coating after 100 hour laser thermal gradient cycling test. The interface reactions between the Si bond coat and BSAS coating resulted in a dark reaction layer with the layer thickness of 30 to 40 microns. The EDS analysis has shown that this BSAS region has very high Si concentrations due to the Si diffusion from the Si bond coat into the BSAS. The high Si concentration BSAS phase was also decomposed into mullite phase (very dark needle-shaped phase) within the high Si BSAS reaction region. Although the coating interface melting was not observed under the 1300 °C interface temperature of the thermal gradient testing for 100 hours, the high Si concentration BSAS reaction layer has been reported to facilitate the coating melting and the glass phase formation under the uniform temperature furnace testing in a water vapor environment at higher temperatures (ref. 5).

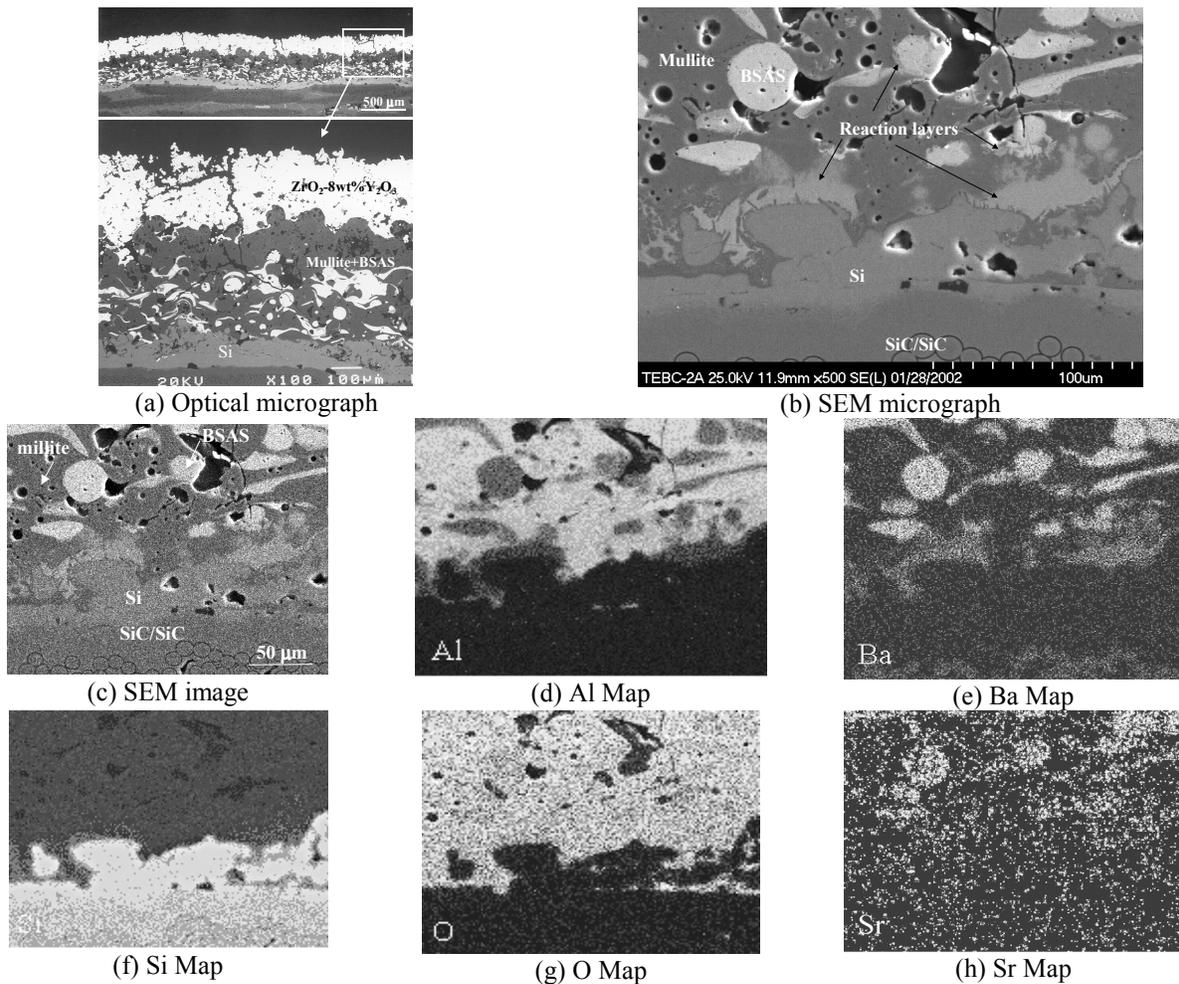
Figure 3.—SEM images and EDS element composition maps of the $ZrO_2-8wt\%Y_2O_3/BSAS+mullite$ mixture/Si on SiC/SiC ceramic matrix composite substrates after laser testing, showing significant interface reactions between BSAS and bond coat Si layer, and the BSAS and mullite. (a) and (b) Optical and SEM micrographs of the coating after 100 hours testing, showing the surface cracking and interface reactions; and (c) to (h) SEM cross-section micrograph and the corresponding EDS elemental maps for the coating systems near the interface.

Figure 3 shows cross-section micrographs and compositional maps of the ZrO₂-8wt%Y₂O₃/BSAS+mullite mixture/Si on a SiC/SiC ceramic matrix composite substrate, after 100 hours testing in a combined alternating laser thermal gradient cyclic and furnace water vapor exposure cyclic

testing. It can be seen that substantial thermal gradient induced coating surface wedge-shape cracking has occurred and the resulting delamination was observed for the coating specimen. As shown in Figure 3, significant interface reactions within the mullite+BSAS EBC layer occurred. The reaction affected zone can be as thick as 30 to 40 microns, especially near the interface and the BSAS phase (bright phase) regions. The reactions between mullite and BSAS phases were also noticed with a typical reaction layer thickness of 2 to 5 microns. However, the inter-diffusion of Ba and Al between the mullite and BSAS can occur at a much greater distance, as indicated by the EDS composition maps in Figure 3 (d) and (e). The reactions were further enhanced by the surface crack penetrations into the EBC layer which allowed the water vapor fast access to the coating at the EBC/Si interface. The accelerated coating damage under the thermal gradient cyclic testing combined with the furnace water vapor testing was attributed to the increased delamination driving force under the thermal gradient cyclic loading and the reduced interface adhesion due to the detrimental interface reactions (refs. 4, 6).

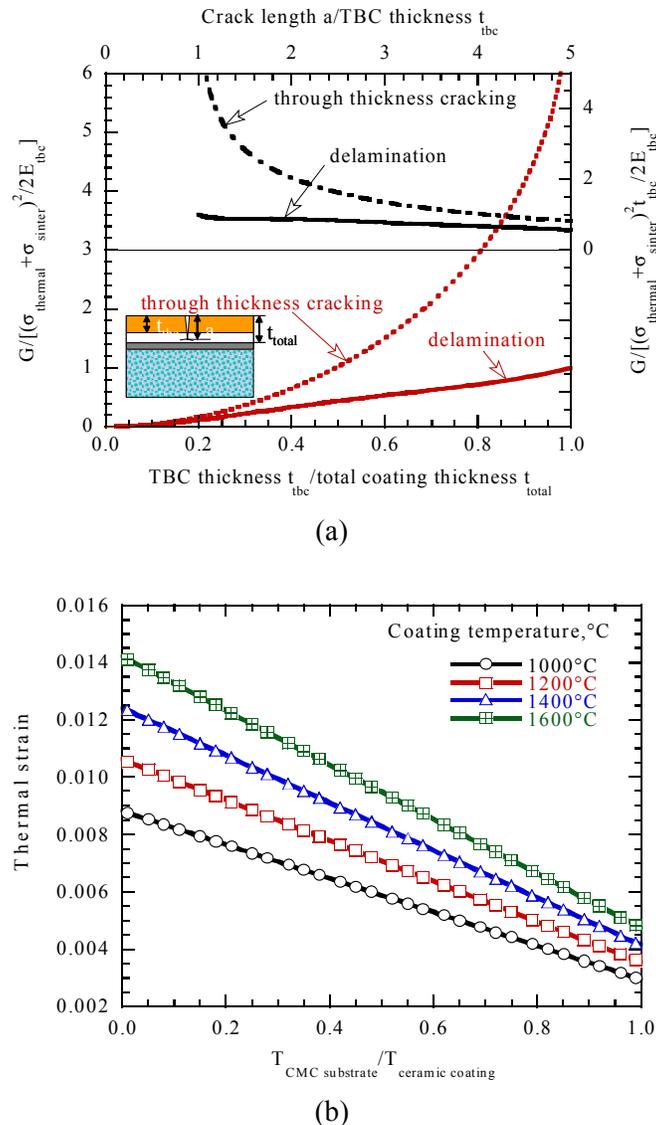
Figure 4.—(a) $ZrO_2\text{-}Y_2O_3$ TBC layer on mullite-BSAS EBC and CMC substrates, the coating surface cracking and delamination energy release rates can increase significantly with a relatively thick, and larger thermal expansion $ZrO_2\text{-}Y_2O_3$ TBC layer on mullite-BSAS EBC on CMC substrates. (b) The significantly larger thermal stresses/strains will be generated with increasing the thermal gradients (the temperature difference between the ceramic coating and the substrates).

The coating surface cracking is largely due to ceramic top coat sintering and thermal expansion mismatch, especially under the large thermal gradient conditions. As can be seen in Figure 4, with a relatively thick, higher thermal expansion $ZrO_2\text{-}Y_2O_3$ TBC layer on mullite-BSAS EBC and CMC substrates, the coating surface cracking and delamination driving force can increase significantly, based on a thermal gradient testing delamination model proposed in the literature (ref. 7). The significantly larger thermal stresses generated under thermal gradients will also accelerate the coating delamination under the thermal cyclic conditions.

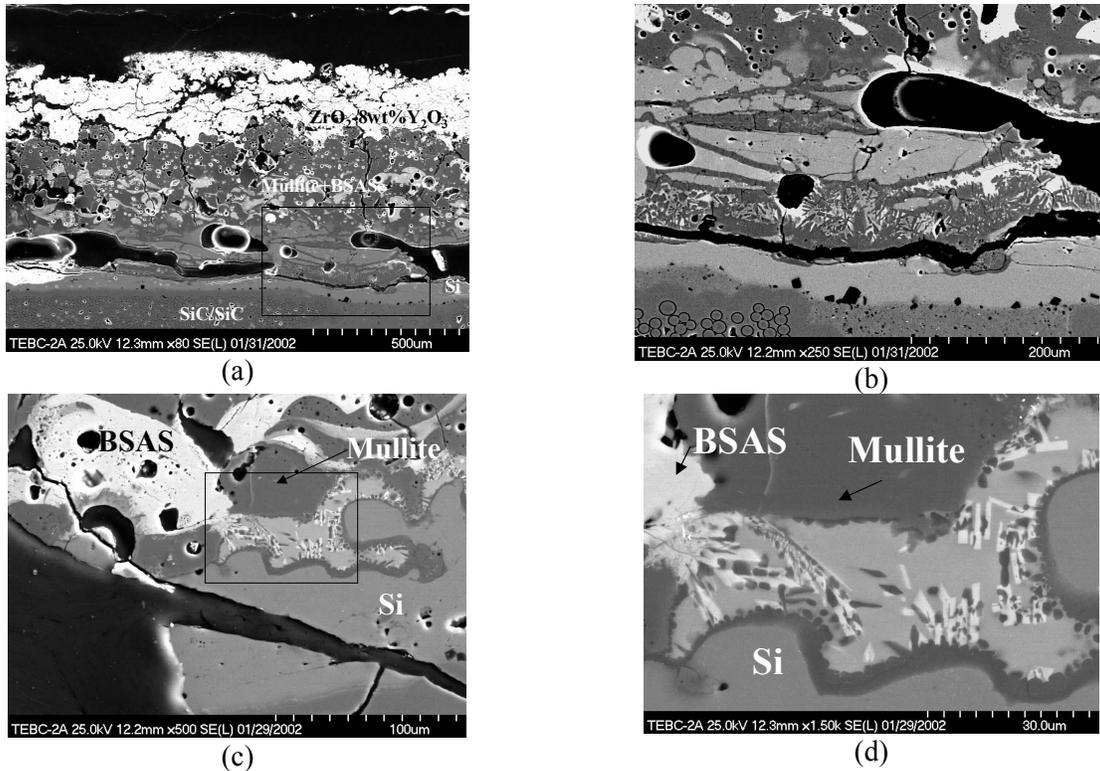
Figure 5.—SEM cross-section micrographs of the $ZrO_2-8wt\%Y_2O_3/BSAS+mullite$ mixture/Si on a SiC/SiC ceramic matrix composite substrate, after total 400 hours testing in the combined laser thermal gradient and furnace water vapor cyclic testing. (a) Significant interfacial pore formation due to the water vapor attack through the vertical cracks under the thermal gradient cycling conditions. (b) Low melting eutectic phase was also observed near the BSAS-mullite-Si interfaces after the testing.

Figure 5 shows the SEM cross-section micrographs of the $ZrO_2-8wt\%Y_2O_3/BSAS+mullite$ mixture/Si on a SiC/SiC ceramic matrix composite substrate, after 400 hours of testing in the combined laser thermal gradient and furnace water vapor cyclic testing. Extensive coating delamination and some spallation were observed during the testing. From Figure 5 (a) and (b), it can be seen that, in addition to the more significant reactions between the EBC mullite, BSAS and Si bond coat, large interfacial pores developed due to the water vapor attack through the vertical cracks in the EBC coatings. From Figure 5 (c) and (d), it can also be seen that a low melting point eutectic phase around the BSAS, Si, and mullite interfaces formed. For the top $ZrO_2-Y_2O_3$ coating side, no obvious reactions were found between mullite and $ZrO_2-8wt\%Y_2O_3$ coatings after the 400 hours combined laser and furnace water vapor thermal cycling test.
