Thermal-Mechanical Cyclic Test of a Composite Cryogenic Tank for Reusable Launch Vehicles

Ross Messinger and John Pulley
The Boeing Company
Huntington Beach, California

For
44th AIAA/ASME/ASCE/AHS/ASC
Structure, Structural Dynamics, and Material Conference
Special Session: Cryogenic Propellant Tanks and Integrated
Structures for a Next Generation Reusable Launch Vehicle

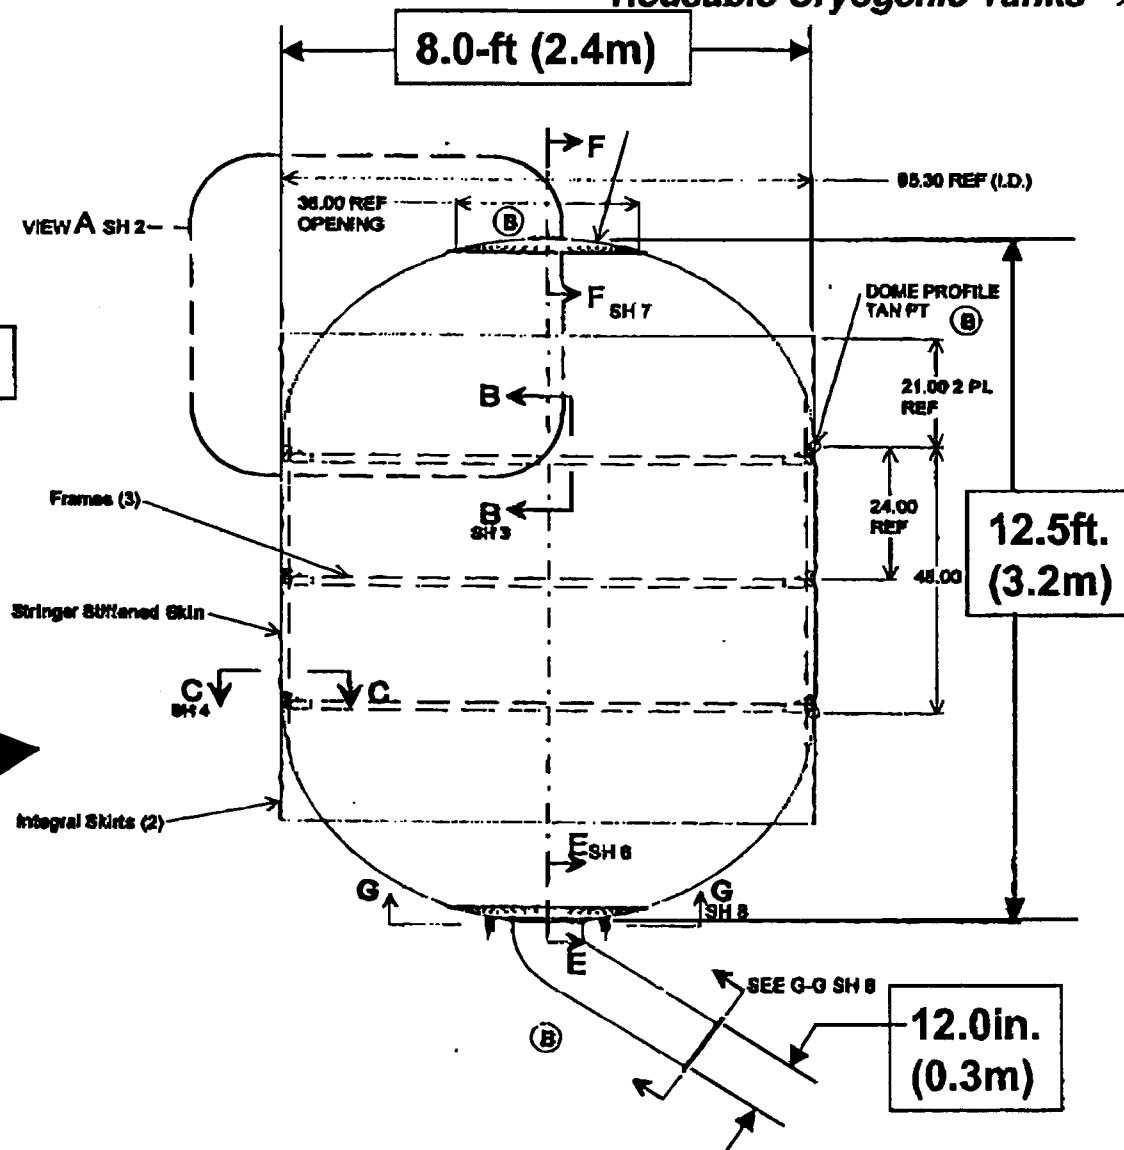
Tank Structural Configuration

Heritage Rockwell SSTO

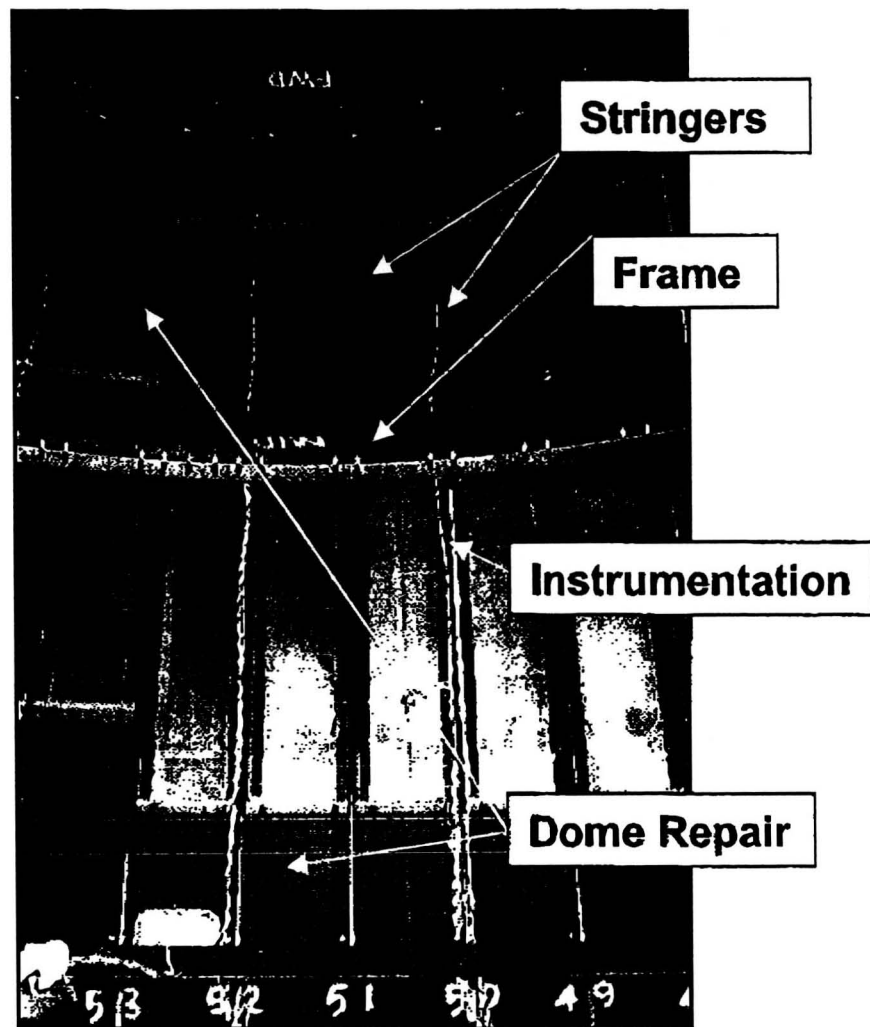
Visual Inspection Of Tank Interior After 5 Cycles

- With the sump cover off, an inspection of the inside of tank was performed
- No visually apparent anomalies were observed in the tank skin
- A "tap test" of the bond of each of the 60 stringers from the lower end to the mid frame revealed no obvious soft areas or disbonds
- Visual inspection of each of the tension and shear clips common to the lower frame showed no clip or fastener failures or apparent movement
- While not conclusive of tank health, no change in tank appearance was evident through 5 cycles

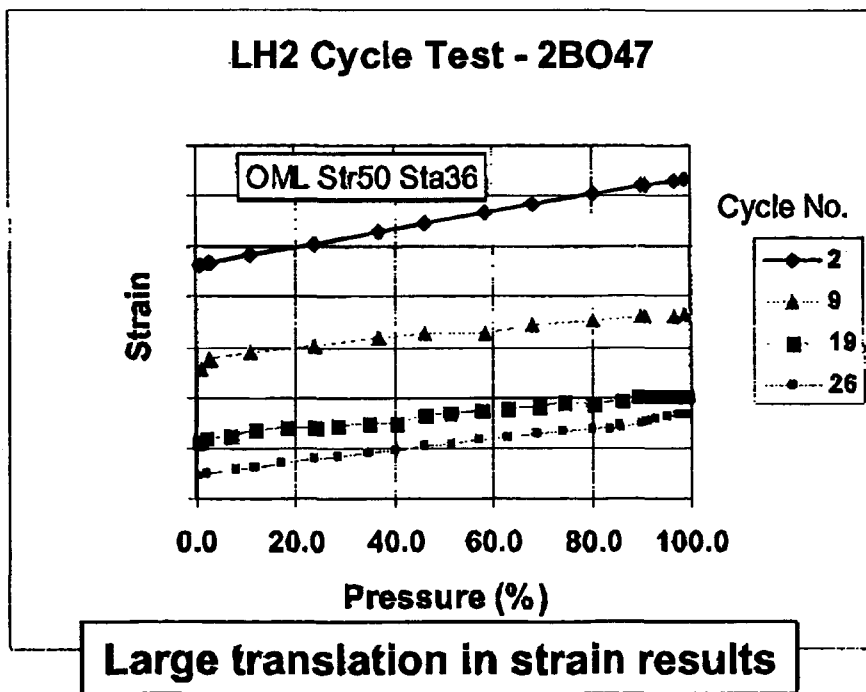
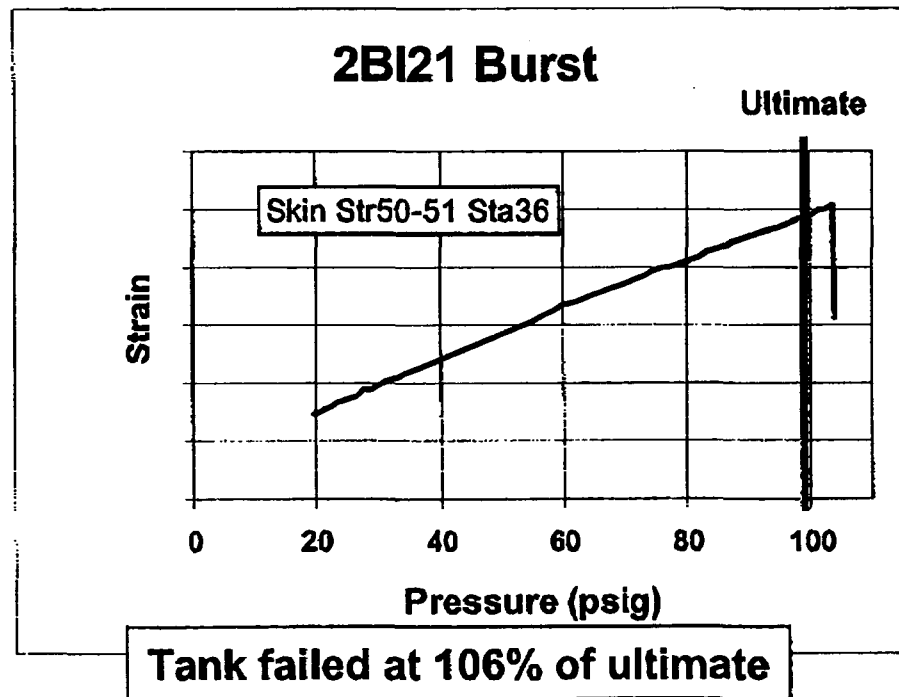
Strain Data

- Large translation of the strain data was observed from some gages but not others, but since the data was linear, the behavior was concluded to be a gage or calibration issue rather than a structural problem
- Only four gages survived through all 26 LH2 cycles and burst test

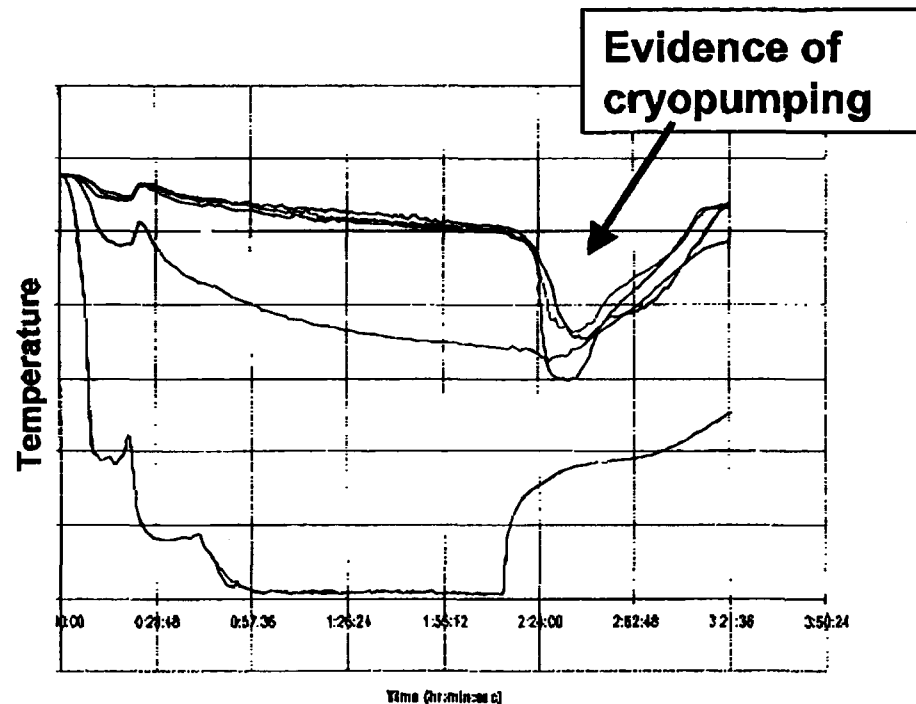
TPS Temperature Data

- Thermal data obtained on wall, within TPS, within insulation, and at all interfaces
- Adhesive bondline temperatures generally remained within established maximum and minimum limits
- Cryopumping, caused by liquid air evaporating away from the tank wall surface and blowing through the insulation, was evident locally

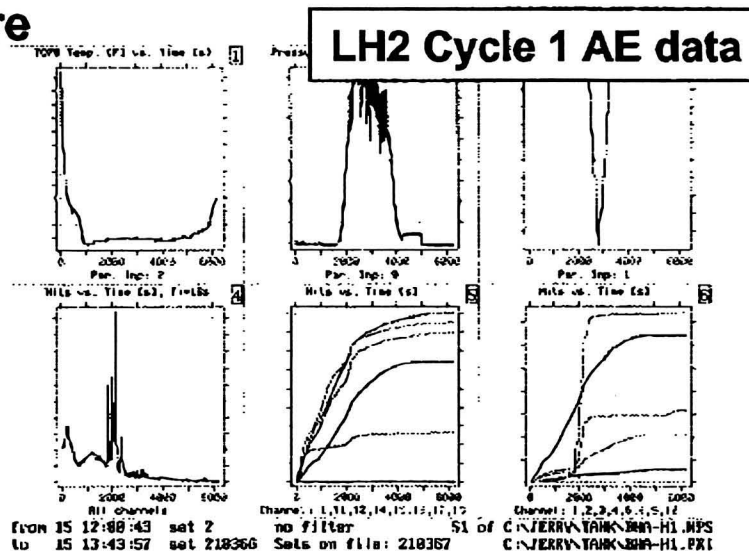
Acoustic Emission Data

- Significant number of AE signals recorded during each LH2 or LN2 filling due to cold shock induced thermal stresses
- Tank pressurization (tension membrane load) caused a large number of AE hits
- Matrix cracking or crazing monitored at the beginning of the test series, with no structural integrity damage
- Fewer AE signals were detected during each subsequent equivalent cycle (Kaiser effect)
- A distinct peak of AE hits occurred when the pressure increased from the cyclic test pressure to burst pressure

Sensor and installation in cryoinsulation

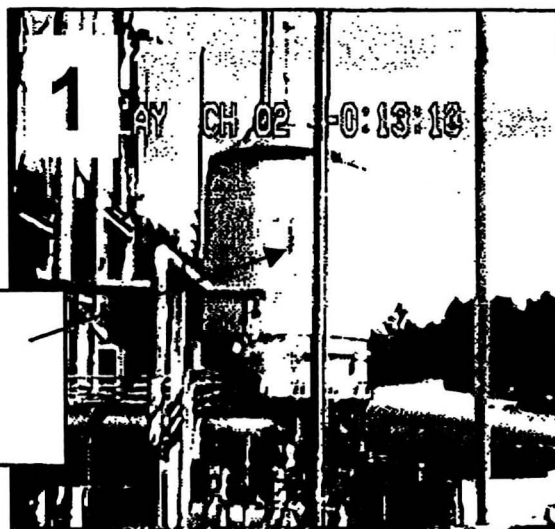
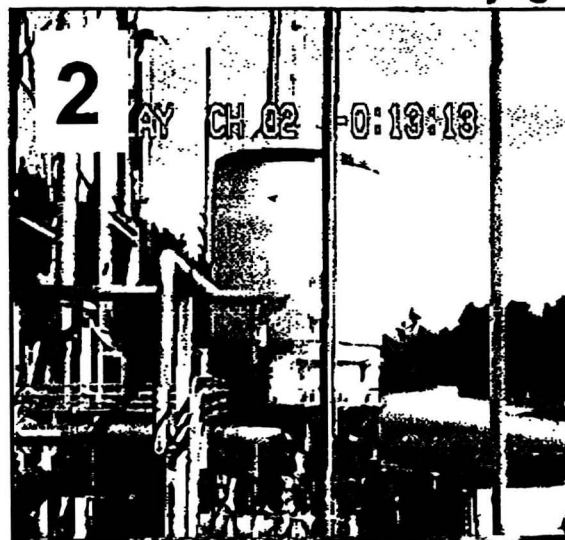
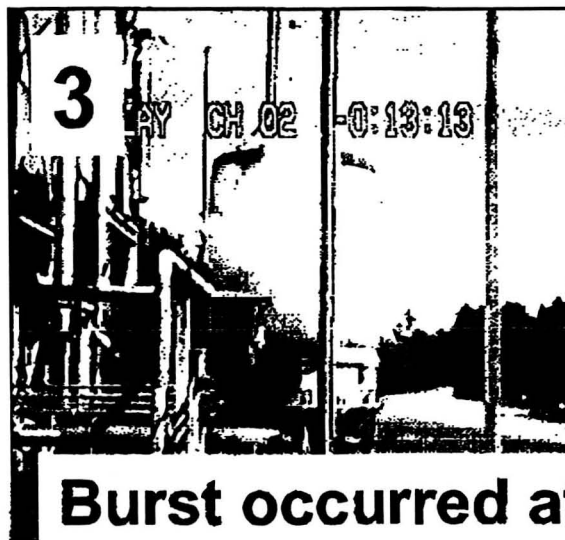
LN2 Pressure Load Burst Test

Burst
location at
stringer 51

Expanding
Nitrogen
Cloud

Burst occurred at 106% of ultimate)

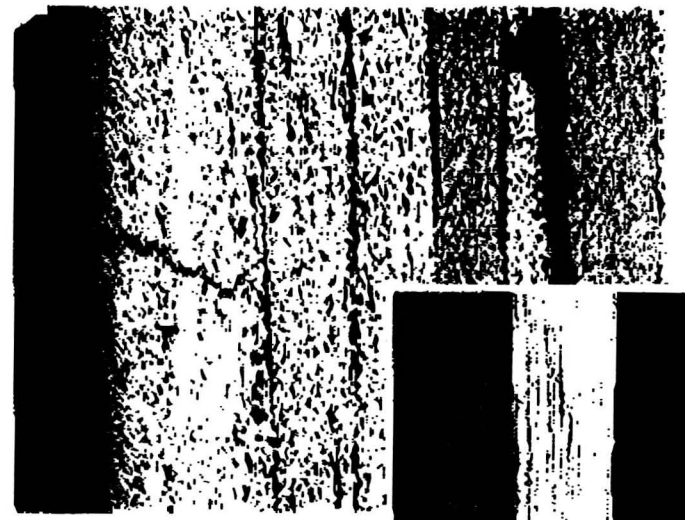
Post-test Evaluation

- Microscopy and C-scans revealed good tank wall consolidation
- Minimal microcracking (max. 2-ply depth) in the tank wall were found
- Blade-stringers were cracked in noodle area (probably due to thermal stresses)
- Some stringer flanges dis-bonded from the tank wall (probably due to burst test)
