Foreign Object Damage in Disks of Two Gas-Turbine-Grade Silicon Nitrides by Steel Ball Projectiles at Ambient Temperature

Sung R. Choi
Ohio Aerospace Institute, Brook Park, Ohio

J. Michael Pereira, Lesley A. Janosik, and Ramakrishna T. Bhatt
Glenn Research Center, Cleveland, Ohio

Foreign object damage (FOD) behavior of two commercial gas-turbine-grade silicon nitrides, AS800 and SN282, was determined at ambient temperature through postimpact strength testing of disks impacted by steel ball projectiles with a diameter of 1.59 mm in a velocity range from 115 to 440 m/s. AS800 silicon nitride exhibited a greater FOD resistance than SN282, primarily due to its greater value of fracture toughness (K_{Ic}). The critical impact velocity V_c for which the corresponding postimpact strength was the lowest was $V_c \approx 440$ and 300 m/s for AS800 and SN282, respectively. A unique lower strength regime was typified for both silicon nitrides depending on impact velocity and was attributed to significant radial cracking. The damage generated by projectile impact was typically in the form of ring, radial, and cone cracks with their severity and combination being dependent on impact velocity

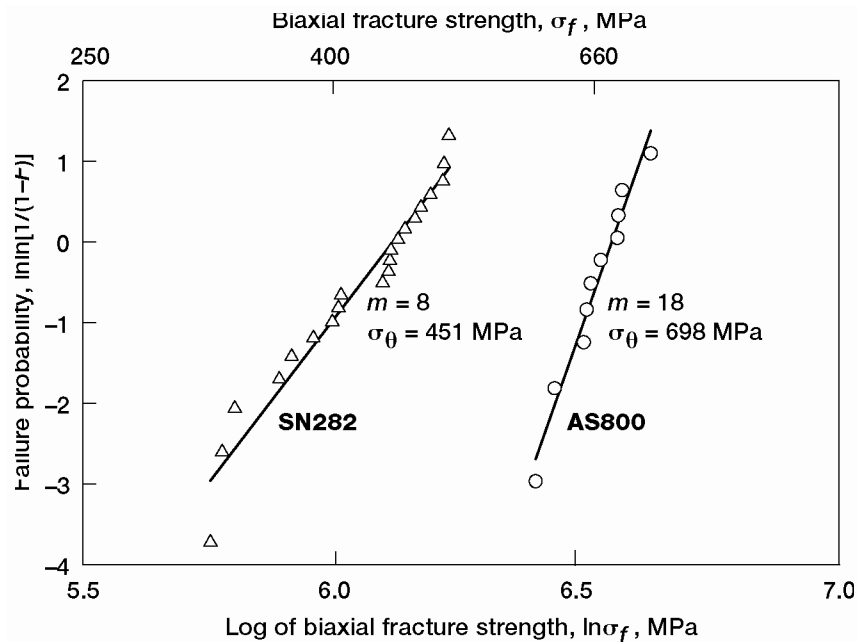
Figure 3.—Weibull distributions of biaxial strength of as-received AS800 and SN282 silicon nitride disks determined in ring-on-ring biaxial flexure at ambient temperature. Weibull modulus and characteristic strength are represented by m and σ_0 , respectively. Lines represent best fit.

As-received biaxial fracture strength.—The two-parameter Weibull plots of as-received biaxial fracture strengths of both AS800 and SN282 silicon nitrides are shown in figure 3, where $\ln\ln[1/(1-F)]$ was plotted as a function of $\ln\sigma_f$ with F and σ_f being failure probability and biaxial fracture strength, respectively. Note that the postimpact biaxial strengths of the specimens where failure was not initiated at the impact sites were included as as-received biaxial fracture strength data in the figure. The number of specimens used in the biaxial fracture strength data was 10 and 21, respectively, for AS800 and SN282. Weibull modulus m and characteristic strength σ_0 were $m = 18$ and $\sigma_0 = 698$ MPa for AS800. For SN282, $m = 8$ and $\sigma_0 = 451$ MPa. The mean strength was 678 ± 45 MPa for AS800 and 426 ± 60 MPa for SN282. The Weibull modulus for AS800 and SN282 ($m = 18$ and 8 , respectively) in biaxial configuration compares well with the values determined previously ($m = 21$ and 11 , respectively, see table I) for AS800 and SN282 in uniaxial four-point configuration (ref. 12), although the number of AS800 specimens (10) tested in the biaxial configuration might not be considered to be enough to give reliable Weibull parameters. Failure origins of both silicon nitrides, in many cases, were associated with surface-related defects such as machining flaws, pores, and elongated grains.

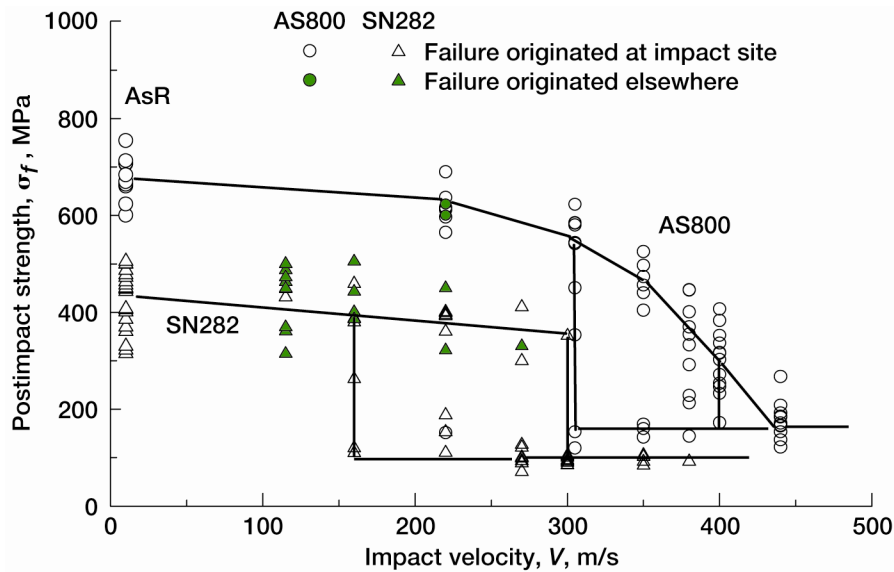
Figure 4.—Postimpact biaxial strength as function of impact velocity determined for AS800 and SN282 silicon nitride disks impacted by 1.59-mm-diameter steel ball projectiles at ambient temperature. “AsR” indicates as-received biaxial fracture strength of each material.

Postimpact strength.—The results of strength testing for impacted target specimens are shown in figure 4, where postimpact biaxial fracture strength was plotted as a function of impact velocity for both silicon nitrides. The biaxial fracture strength of both as-received materials was also included for comparison. Frequently, the specimens impacted at low velocities did not incur fractures originating from the impact sites and were indicated with closed symbols in the figure. For AS800, 2 specimens out of 10 did not obtain fractures originating from the impact sites when impacted at 220 m/s. For SN282, 1, 2, 4, and 9 (each out of 10) specimens did not fail from the impact at 270, 220, 160, and 115 m/s, respectively. Those specimens not failing from fractures initiating at the impact sites were equivalent in strength to the corresponding as-received specimens and thus were used to provide valid data in estimating the overall as-received biaxial fracture strength for each material.

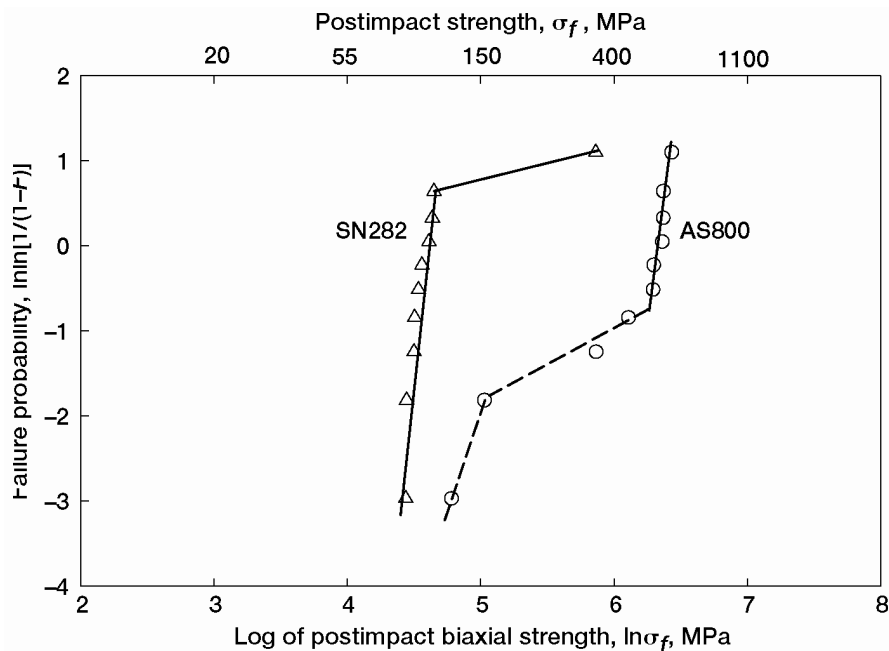
Figure 5.—Weibull postimpact biaxial strength distributions for AS800 and SN282 silicon nitride disks impacted at 300 m/s by 1.59-mm-diameter steel ball projectiles at ambient temperature.

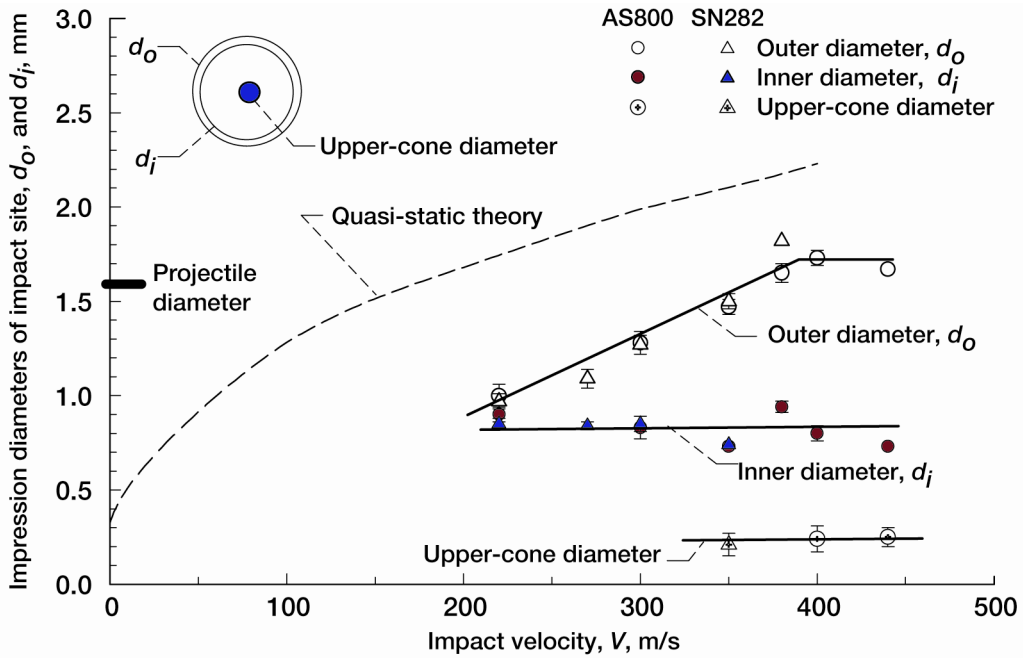
Figure 9.—Impression size generated on impact sites of target specimens as function of impact velocity for AS800 and SN282 silicon nitride disks impacted by 1.59-mm-diameter steel ball projectiles at ambient temperature. The contact-area diameter estimated by the quasi-static contact theory (2a, eq. (2)) is included for comparison. Upper-cone size data are also shown.

with ν being Poisson's ratio and the primes denoting variables associated with the projectile. As shown in figure 9, the calculated contact area $2a$ based on equation (2) was significantly greater than the impression sizes observed. However, it should be noted that a direct comparison should not be made between the calculated and the observed values since the calculated impression size was unrealistically large, indicating that the calculated values were in the range of significant plastic deformation. As a consequence, the impact events in this work can be characterized as plastic (in projectile)-elastic (in target material) rather than elastic-elastic impact that is the case for ceramic balls versus ceramic target. It is interesting to note from the figure that a consistent size (0.23-mm diameter) of upper cone was observed regardless of impact velocity. This phenomenon contradicts the Hertzian theory, which states that the contact area increases with increasing impact velocity and that the tensile principal stress occurs just outside contact area, in which a cone crack initiates and propagates through the locus of maximum tensile stress (refs. 5 and 9). The discrepancy is believed again to be due to the significant plastic deformation, which may make Hertzian contact theory inapplicable.

U_{KP} was calculated using equation (10) with d_o determined (fig. 9) for a given impact velocity. The resulting plots of kinetic energy evaluated with both U_K and U_{KP} are shown in figure 23. The discrepancy between the two approaches was small at lower impact velocity but was amplified with increasing impact velocity ($V \geq 300$ m/s). The discrepancy occurring at higher impact velocity could be due to the volume

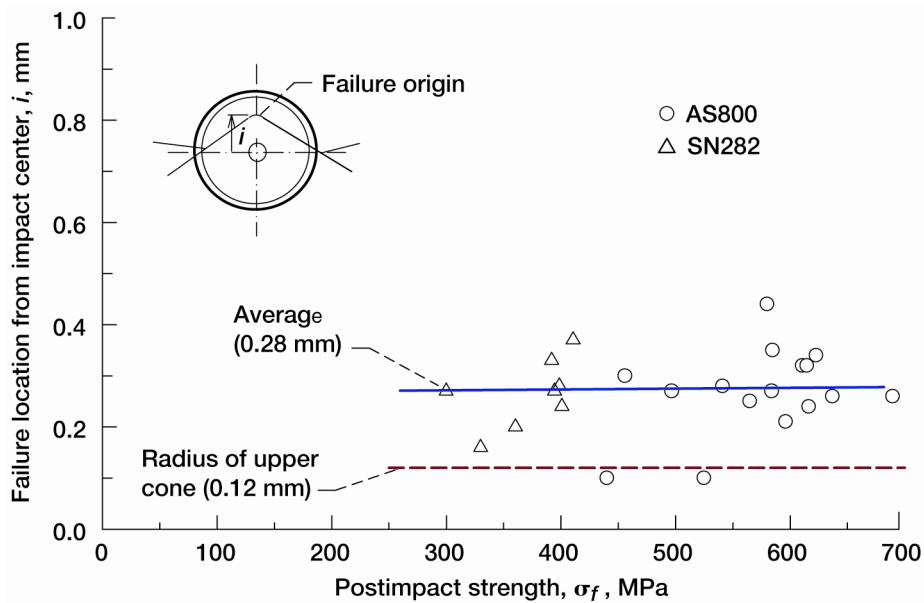
Figure 11.—Failure location distance from impact center as function of postimpact strength for silicon nitride disks that failed from ring cracks, which impart overall medium to high postimpact strength. Average radius of upper cone is also indicated as dashed straight line for comparison.

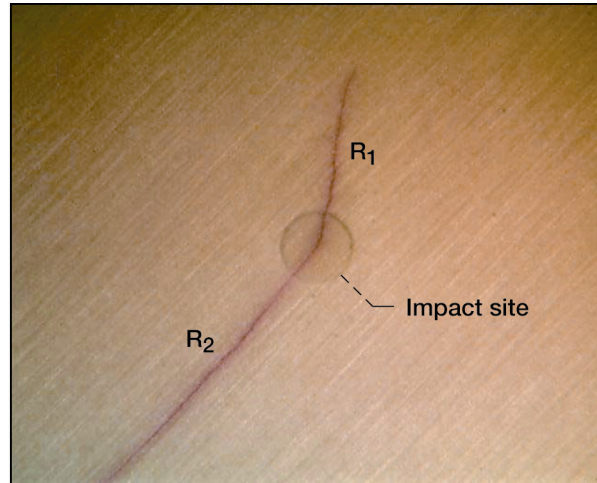
Figure 12.—Example showing significant radial cracks (R_1 and R_2) in AS800 silicon nitride disk impacted at 220 m/s by 1.59-mm-diameter steel ball projectile. Resulting postimpact strength of this specimen, controlled by the 4.7-mm crack R_2 , was 151 MPa.

exclusively with well-developed radial cracks ranging in size from 3 to 5 mm, emanating from the impact sites, as shown in figure 12. These well-developed radial cracks resulted in the lower strength regime around 150 and 100 MPa, respectively, for AS800 and SN282. Hence, it is important to note that the existence of lower strength regime was due to the occurrence of these significant radial cracks.

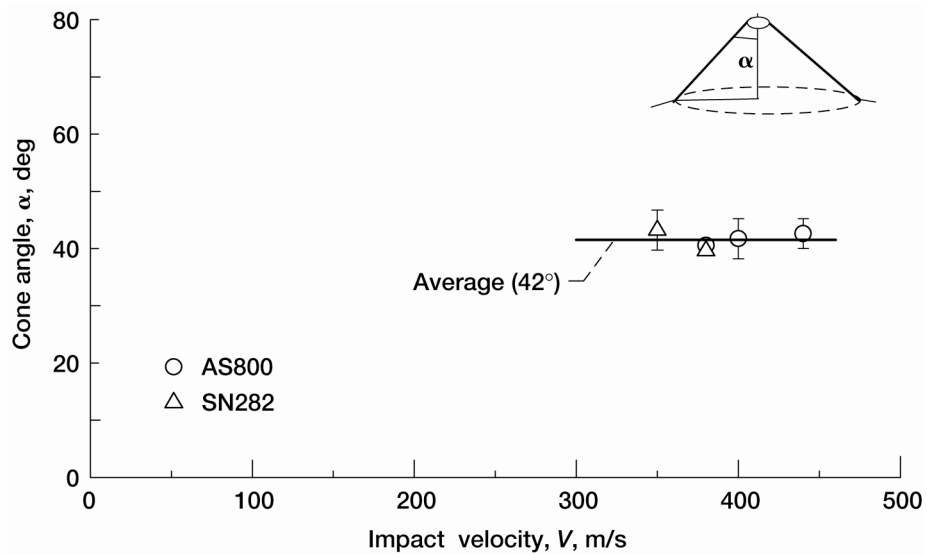
Figure 14.—Cone angle as function of impact velocity for AS800 and SN282 silicon nitride disks impacted by 1.59-mm-diameter steel ball projectiles at ambient temperature. Note that cones developed mainly at higher impact velocities. Error bars indicate ± 1.0 standard deviation.

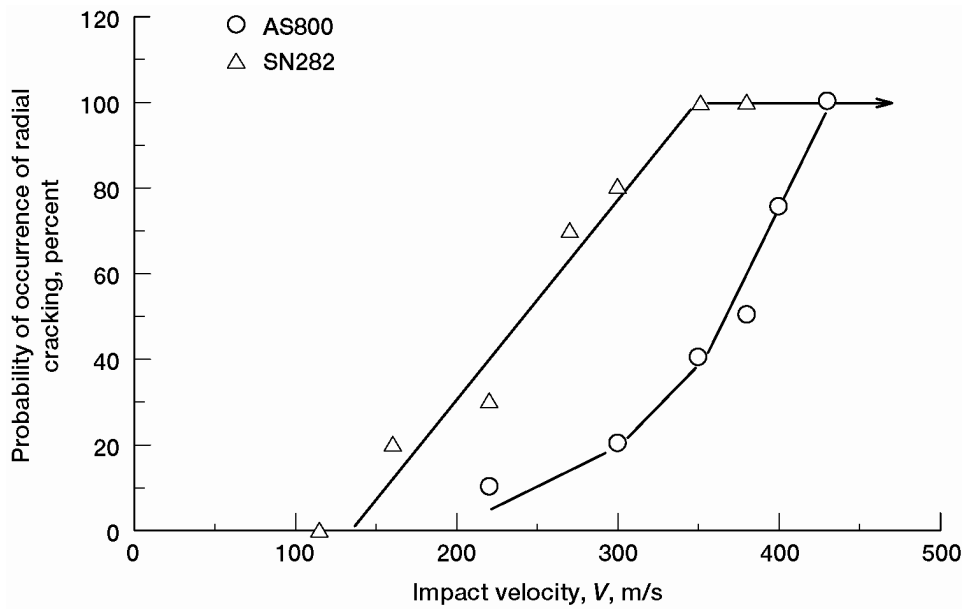
Figure 15.—Probability of occurrence of radial cracking as function of impact velocity for AS800 and SN282 silicon nitride disks impacted by 1.59-mm-diameter steel ball projectiles at ambient temperature.

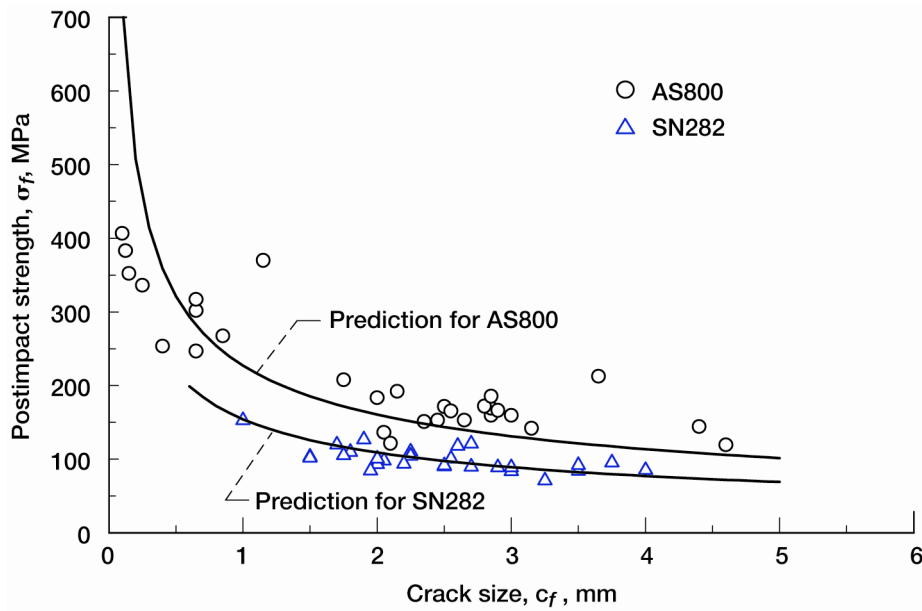
Figure 16.—Postimpact strength as function of radial crack size for AS800 and SN282 silicon nitride disks impacted by 1.59-mm-steel ball projectiles at ambient temperature. Solid lines represent predictions based on semi-circular crack assumption.

prediction is in good agreement with the experimental data, possibly eliminating or minimizing the need for experimental data to determine the postimpact strength.

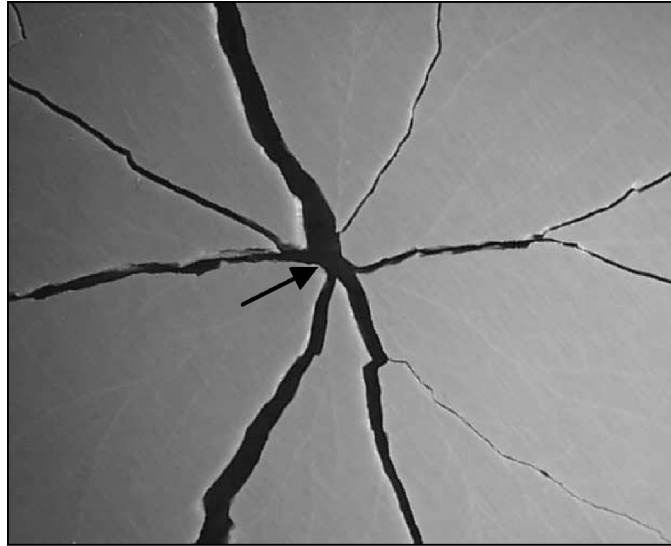
Figure 19.—Typical pattern of crack branching for AS800 silicon nitride disk impacted by 1.59-mm-diameter steel ball projectile. Arrow indicates failure origin.

Crack branching: A typical crack branching pattern of a target specimen in strength testing is shown in figure 19, as also inferred from figure 10(a). The empirical relation between biaxial fracture strength σ_f (in MPa) and crack branching length has been shown as (e.g., ref. 24)

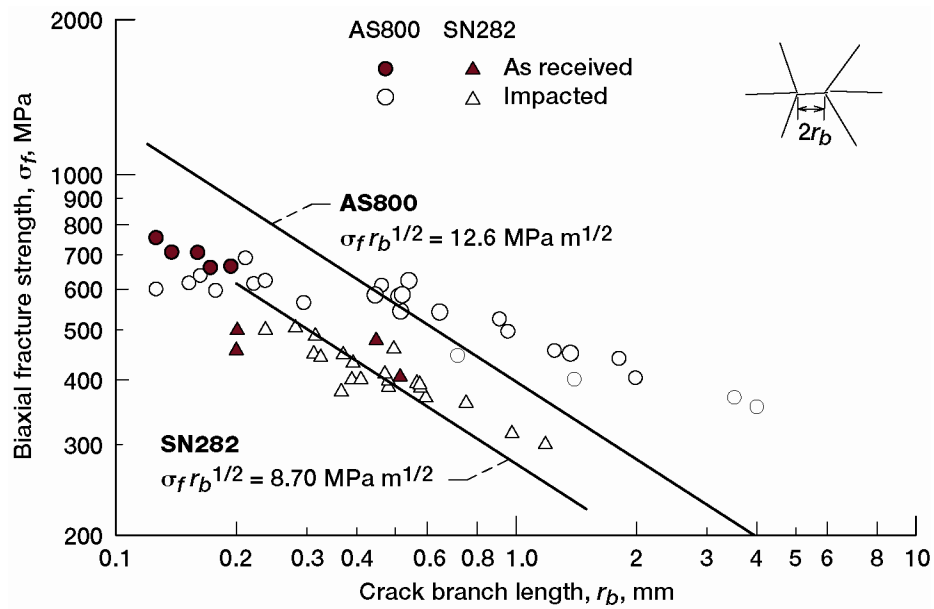
Figure 20.—Biaxial strength as function of crack branch length for as-received and impacted disks of AS800 and SN282 silicon nitrides at ambient temperature. Solid lines represent best-fit lines based on equation (4).

where r_b is the crack branching length in meters, assumed to be straight, and A_b is the branching constant in $\text{MPam}^{1/2}$. Figure 20 shows the results of postimpact strength as a function of crack branching length determined for both silicon nitrides. A good correlation between strength and branching length was observed in SN282 with a branching constant of $A_b = 8.7 \pm 1.0 \text{ MPam}^{1/2}$. By contrast, AS800 did not exhibit a reasonable correlation because of significant scatter. The crack branching constant for AS800 was $A_b = 12.6 \pm 4.2 \text{ MPam}^{1/2}$. This branching constant, however, is in reasonable agreement with the branching constant ($A_b = 14.9 \pm 1.9 \text{ MPam}^{1/2}$) of the same material ('99 vintage) determined previously in uniaxial flexure (20/40 mm spans, ASTM B type specimens) (Choi, S.R.: Fracture Mirror Constant Versus Fracture Toughness for Various Advanced Structural Ceramics. Presented at the American Ceramic Society Annual Meeting, April 28, 2002, St. Louis, MO.). The ratio of crack branching constant to fracture toughness was $A_b/K_{Ic} = 1.56$ and 1.58, respectively, for AS800 and SN282. Although 3 has long

been regarded as the value of A_b/K_{Ic} for brittle materials and ceramics (e.g., ref. 24), a recent study on the fracture branching constant for various advanced ceramics (ref. 25) has shown that the value is actually closer to 2. Hence, the determined A_b/K_{Ic} ratio for both AS800 and SN282 in biaxial flexure is said to be within the range generally found in many recent advanced ceramics.

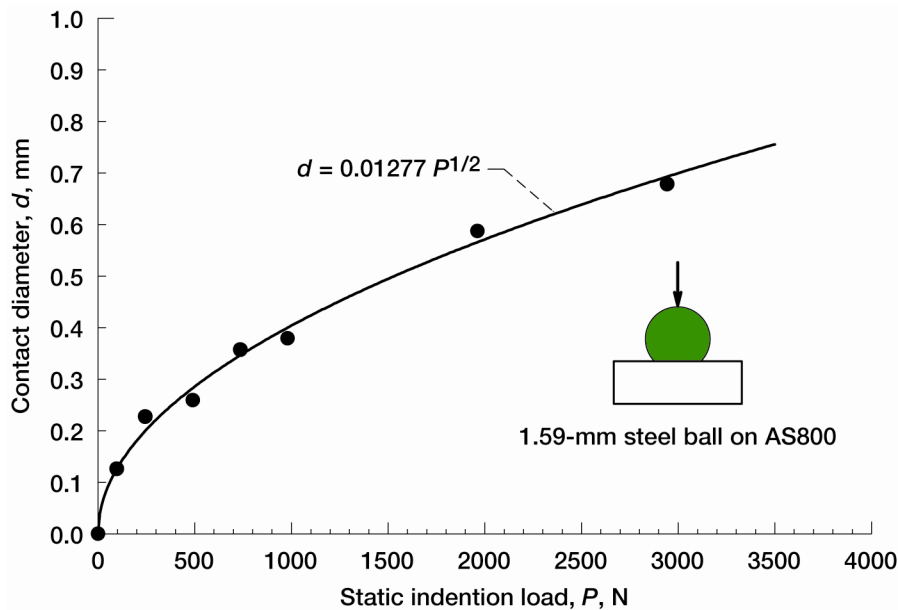
Figure 21.—Contact diameter as function of static indentation load determined with AS800 silicon nitride disk and 1.59-mm-diameter steel ball indenter. Line represents best fit.

Experimental results.—The static indentation experiments with projectile ball indenters on an AS800 silicon nitride disk showed that a flattened circular area of contact—a sign of significant plastic deformation—was well developed on each ball indenter, and as expected its size (or diameter) depended on applied indent load. There was no visible sign of damage in contact area in the AS800 disk. The experimental results are shown in figure 21 where contact diameter d was plotted against applied static indent load P_s . The best-fit line was represented as follows:

The average compressive contact pressure cp calculated from the slope of the best-fit line based on a relationship of $cp = 4P_s/(\pi d^2)$ was found to be 7815 ± 1063 MPa (with a coefficient of variation of 13.6 percent) in the range of indent loads applied from 0 to 2943 N. This contact pressure was surprisingly consistent regardless of indent load, indicating that the plastic flow stress occurring in the steel ball projectile upon indent loading is almost constant. Because of the negligible elastic strain compared with plastic strain involved, it could be reasonable to take the average contact pressure as compressive plastic flow stress of the ball projectile; thus it could be possible to use a rigid-perfectly plastic assumption. Therefore, the plastic flow stress of the ball projectile in compression, σ_p , is

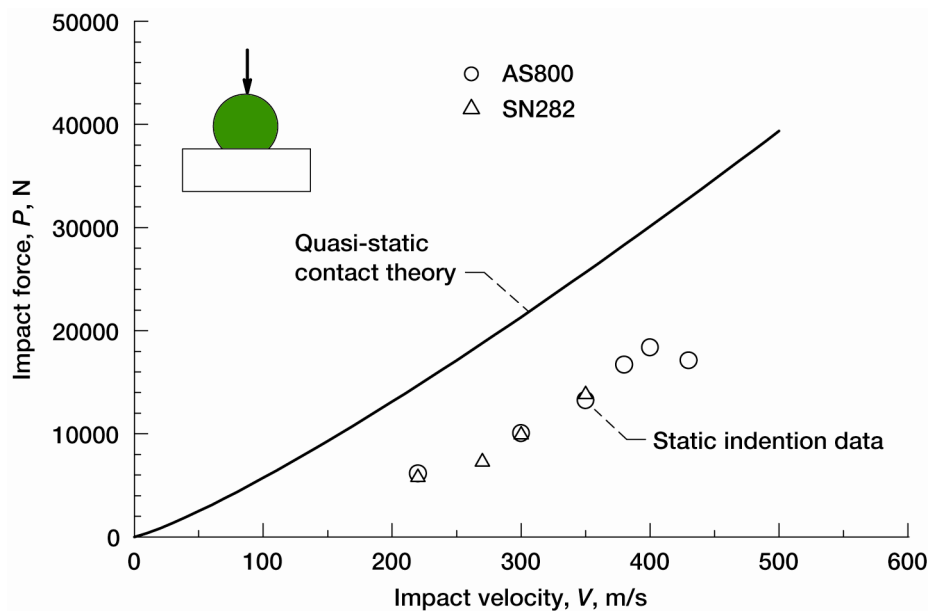
Figure 22.—Impact force as function of impact velocity estimated from results of static indentation experiments. Impact force evaluated by quasi-static contact theory, equation (8), is also included for comparison.

The quasi-static contact theory predicted the impact force 50 to 100 percent greater than the static indentation approach based on plasticity. Although it is unknown as to which approach would yield a better estimation, it is manifest that the quasi-static contact theory, which assumed the impact event as an idealized elastic (in projectile)-elastic (target) phenomenon, would overestimate the impact force. Although the discrepancy is significant between the two approaches, the result shown in the figure gives an insight regarding the magnitude of impact force, even reaching two to three metric tons (!) at a high impact velocity of 400 m/s. Note that appropriate instrumentation should be utilized to better describe the evolution and magnitude of force during the impact.

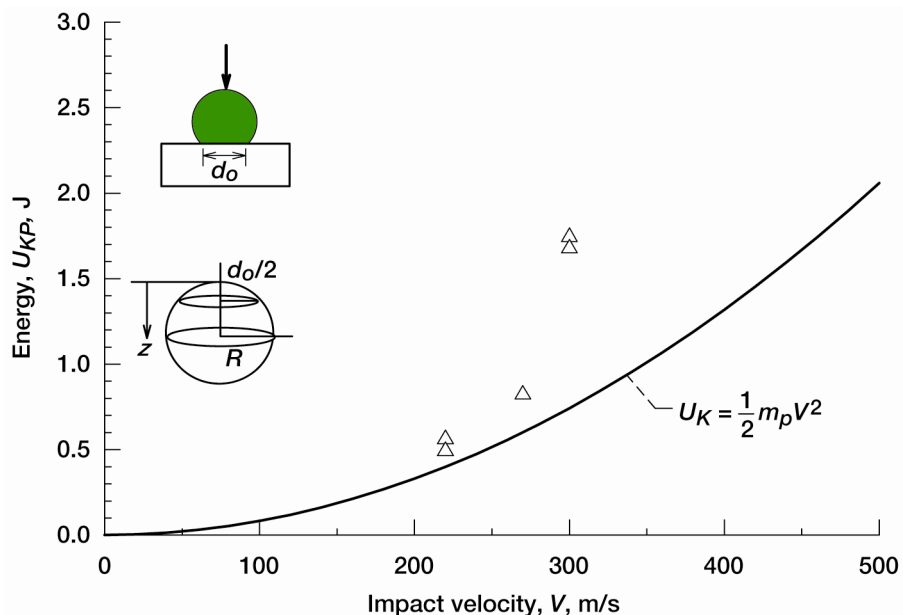
Figure 23.—Impact kinetic energy U_{KP} as function of impact velocity V estimated with equation (8) from results of static indentation experiments on silicon nitride. Line showing impact kinetic energy U_K estimated by equation (7) is also included for comparison, where m_p is mass of the projectile.

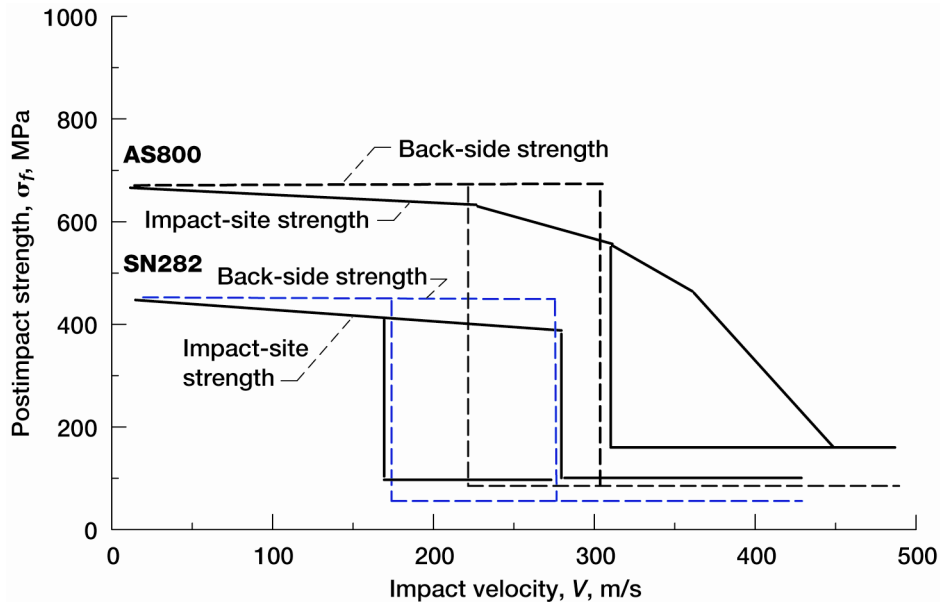
Figure 25.—Postimpact strength as function of impact velocity determined by considering postimpact and back-side strengths of AS800 and SN282 silicon nitrides disks impacted by 1.59-mm-diameter steel ball projectiles at ambient temperature. Solid line represents regular postimpact strength; dashed line, back-side strength.

relatively high, exhibiting significant back-side cracking. Some additional AS800 specimens were flipped over for strength testing so that the back-side cracking was now subjected to tension. The resulting strength was found to be around 120 MPa. If the specimens were regarded as actual structural components under service with unexpected, varying load conditions, the strength and/or reliability of the components, as a consequence, should be based on the degree of severity of back-side cracking. The strength of each of AS800 and SN282 disks containing back-side cracks with an average size of 6 mm, called back-side strength, was estimated to be about 130 and 90 MPa, respectively, using the semicircular assumption. Figure 25 compares strength at the impact site with back-side strength for both silicon nitrides. Back-side cracking initiates with a low probability of occurrence at 160 and 220 m/s for SN282 and AS800, respectively, and it reaches to a 100 percent probability at a velocity of $V \geq 300$ m/s for both silicon nitrides (as already seen in fig. 18). From a structural design point of view, the lower limit of impact velocities should be decreased to 220 m/s for AS800 because of the influence of back-side cracking, whereas it remains unchanged for SN282. Also, the critical impact velocity, where target specimens would exhibit 100 percent back-side cracking, should be decreased from 440 to 300 m/s for AS800.

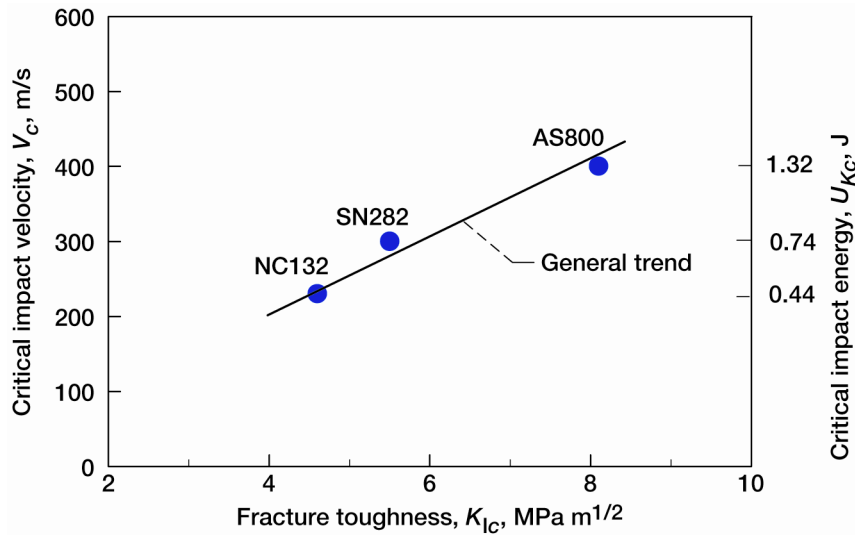
Figure 28.—General trend of critical impact velocity as function of fracture toughness for AS800 and SN282 and one equiaxed fine-grained NC132 (ref. 12) silicon nitride flexure bar specimens.

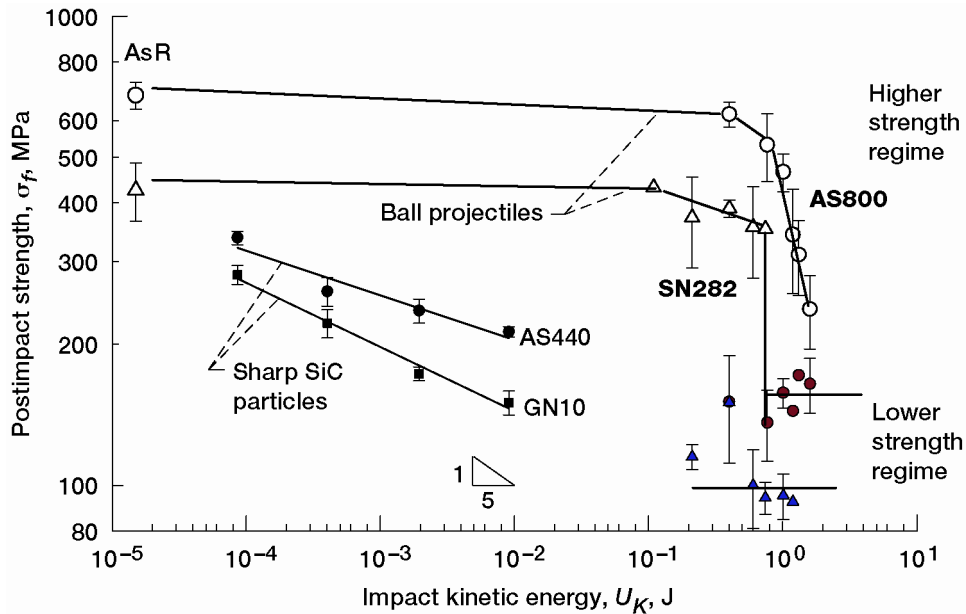
Figure 29.—Comparison of postimpact biaxial strength as function of impact kinetic energy between sharp SiC particle impact for AS440 and GN10 silicon nitride disks (refs. 3 and Choi, S.R.; Ritter, J.E.; and Jakus, K.: Erosion and Impact Behavior of Various Advanced Ceramics at Ambient and Elevated Temperatures. Unpublished work, University of Massachusetts, Amherst, MA, 1988) and blunt steel ball projectile impact (present study) at ambient temperature. “AsR” indicates as-received biaxial fracture strength of both AS800 and SN282 silicon nitride disks. Error bars indicate ± 1.0 standard deviation.

A comparison of postimpact biaxial strength of silicon nitrides between blunt steel ball impact (this study) and sharp SiC-particle (16 and 46 grit) impact (ref. 3 and Choi, S.R.; Ritter, J.E.; and Jakus, K.: Erosion and Impact Behavior of Various Advanced Ceramics at Ambient and Elevated Temperatures. Unpublished work, University of Massachusetts, Amherst, MA, 1988) is shown in figure 29. Note a considerable strength degradation for the case of sharp particle impact occurring even at much lower

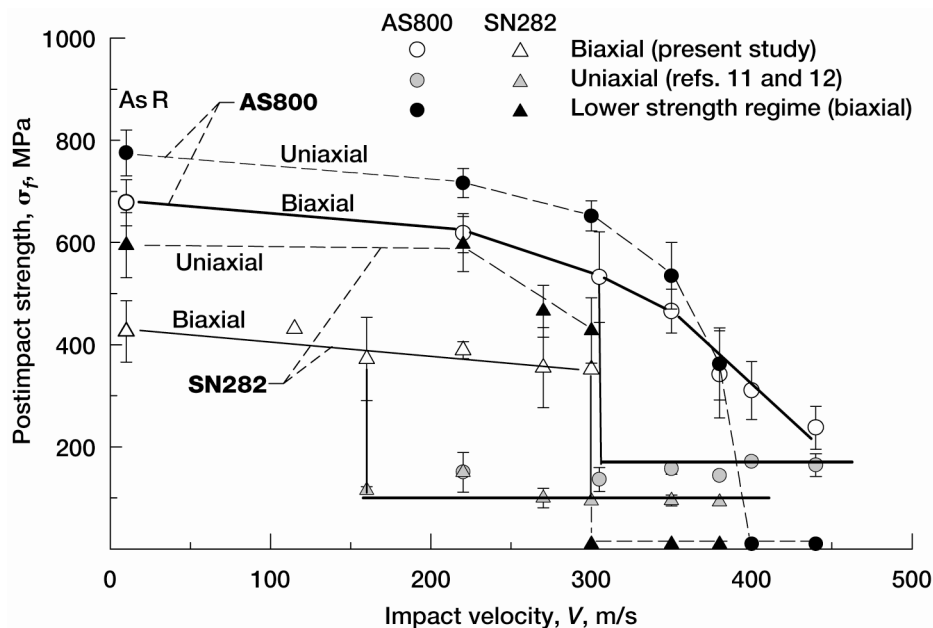
Figure 30.—Comparison of postimpact strength as function of impact velocity between flexure bars (refs. 11 and 12) and biaxial disks (present study) of AS800 and SN282 silicon nitrides impacted by 1.59-mm-diameter steel ball projectiles at ambient temperature. “AsR” indicates as-received fracture strength. Error bars indicate ± 1.0 standard deviation.

Figure 30 shows a comparison of postimpact strength behaviors between the biaxial disks (2-mm thickness and 45-mm diameter) in this work and the uniaxial flexure bars (4 by 3 by 45 mm in width, depth, and length, respectively) in the previous work (refs. 11 and 12). Both disks and flexure bars were rigidly supported, and the same steel ball projectiles were used. The overall postimpact strength was higher for uniaxial flexure bars than for biaxial disks because of the size effect.³ The critical impact
