# **Proof-of-Concept Application of Impedance-Based Health Monitoring on Space Shuttle Ground Structures**

Daniel M. Peairs, Benjamin Grisso, and Daniel J. Inman  
Virginia Polytechnic Institute and State University, Blacksburg, Virginia

Kenneth R. Page and Robert Athman  
United Space Alliance, Kennedy Space Center, Florida

Ravi N. Margasahayam  
NASA, Kennedy Space Center, Florida

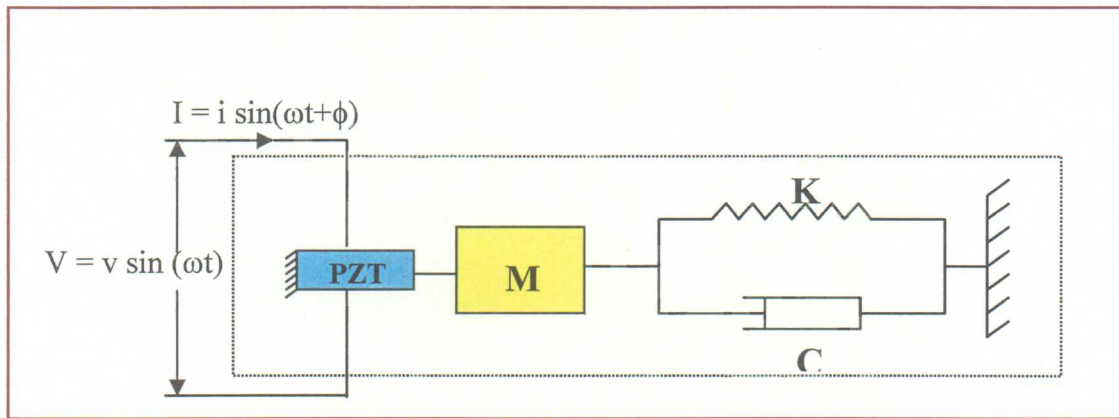
Figure 1. 1-D model used to represent a PZT-driven dynamic structural system.

The electromechanical modeling which quantitatively describes the process is presented in Figure 1. The PZT is normally bonded directly to the surface of the structure by a high-strength adhesive to ensure a better electromechanical coupling. The surface-bonded PZT is considered to be a thin bar in axial vibration due to an applied alternating voltage. One end of the bar is considered fixed, whereas the other end is connected to the external structure. This assumption regarding the interaction at two discrete points is consistent with the mechanism of force transfer from the bonded PZT transducer to the structure.

The solution of the wave equation for the PZT bar connected to the structure leads to the following equation for a frequency-dependent electrical admittance [2]:

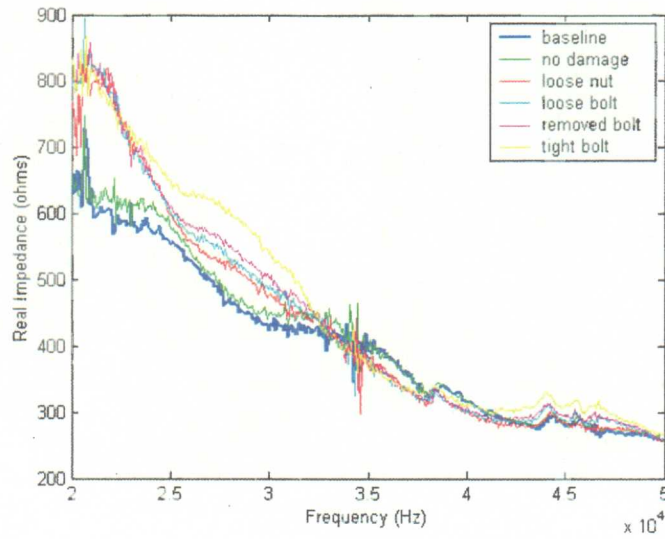
Figure 5. Impedance measurements of white room joint with changing damage level.

With an acceptable frequency range determined, a baseline measurement was made along with a measurement of the structure in an unmodified state. Next, the nut on a bolt adjacent to the sensor was completely loosened, but not removed, and another impedance measurement was recorded. A third measurement was made with the bolt broken loose from the paint. The fourth measurement was with the bolt completely removed. The final measurement was made with the bolt retightened in the joint, although no measurement of the torque applied was made. The measurements are shown in Figure 5. It should be noted that due to the use of double sided tape, rather than cyanoacrylate or epoxy, and the high humidity of the test location, the sensor had to be repressed to the tape on several occasions due to peeling. However, the location of the sensor was never changed. In order to quantify the changes in the shape of the measurements with the implementation of damage, a damage

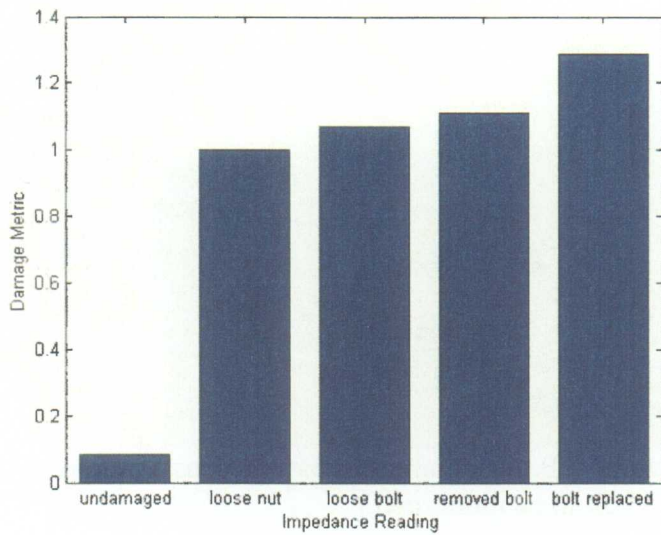
Figure 6. Damage metric for white room joint with changing damage level.

metric was made using the formula given in equation (4). The damage metric was calculated and then scaled by the damage metric at the first damage case. The results are shown in Figure 6. It is clear from the damage metric that an event such as the loosening of a bolt on the white room structure can be detected.

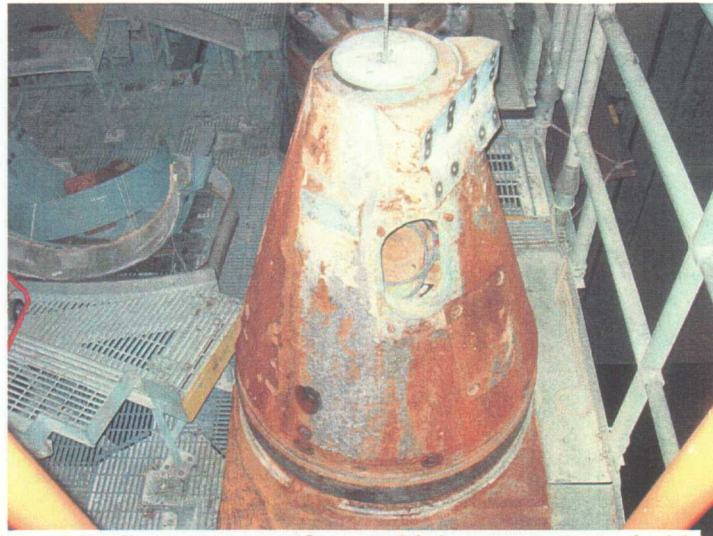
Figure 7. Support post four, which connects to hold-down post four on the SRB.

The next sets of tests were performed on SRB Hold-down Post number 4 of the MLP as seen in Figure 7. Four Hold-down Posts per SRB are responsible for attaching the shuttle to the MLP. Explosive bolts disconnect the SRBs from the MLP at launch. The Hold-down Posts experience tremendous vibrations and blast from the solid rocket motors during lift off. The Hold-down Posts are connected to the MLP via several large bolts. A monitoring system for these joints is desired since the structure has been in use longer than its design life and there is potential for a very large cost of failure, including the possible loss of human life.

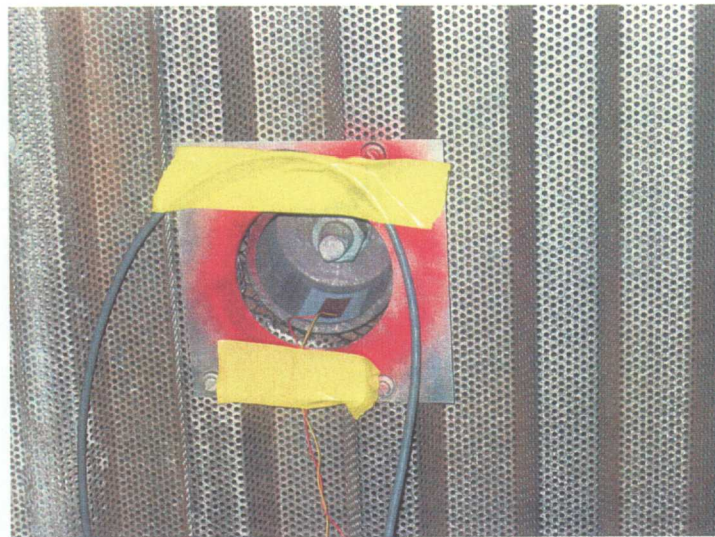
Figure 10. Bolted connection of heat shield pin with MFC sensor installed.

The same MFC sensor was used as in the previous tests, as well as the same type of double sided tape used to bond the sensor to the structure. Since it was impossible to determine the properties such as size and mass of the structure being tested, it was difficult to predict if the test would be successful at showing structural data. Impedance measurements were initially made at frequency ranges of 10 kHz to 20 kHz as seen in Figure 11. In this frequency range, the impedance decreases significantly as the frequency increases. This trend masks most of the structural peaks since the amplitude of the real impedance at low frequencies, even where
