Fatigue Crack and Porosity Measurement in Composite Materials by Thermographic and Ultrasonic Methods

Detect thermo-mechanically induced intra-ply fatigue microcracking and manufactured porosity in unlined composite pressure vessels

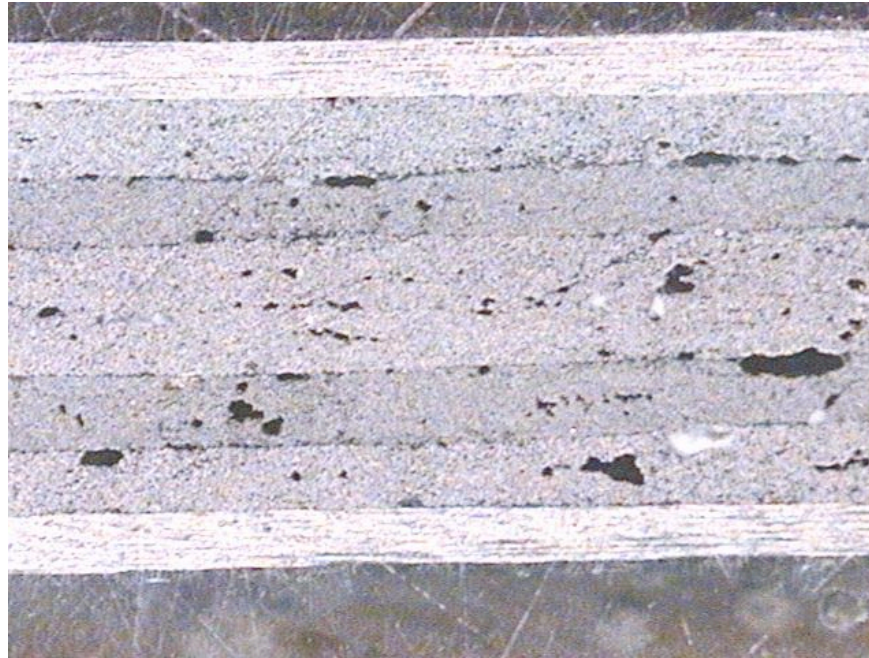
DEFECT DESCRIPTIONS (Porosity)

Cause/Definition: Voids trapped within a laminate during the curing process due to off-gassing of the resin, air trapped between plies, improper cure schedule, etc.

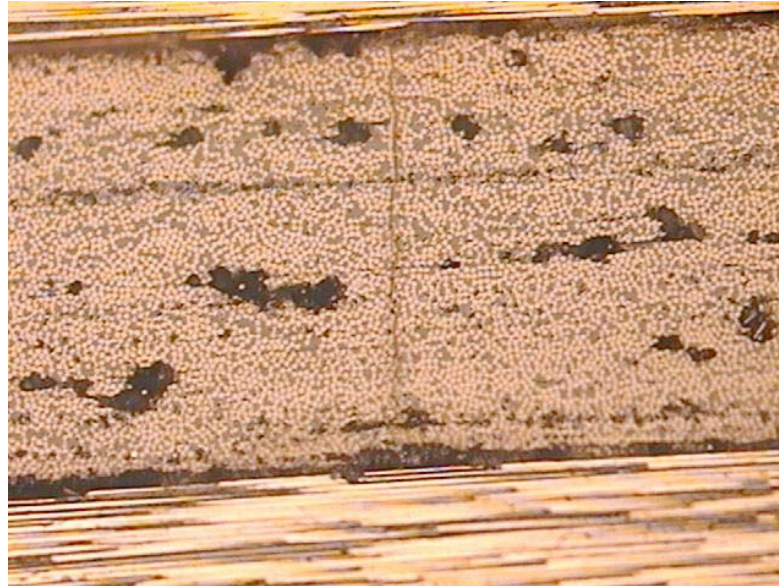
DEFECT DESCRIPTIONS (Microcracking)

Cause/Definition: Cracking of the resin used to support the fibers in the laminate due to combined thermal “cryogenic” and mechanical loading.

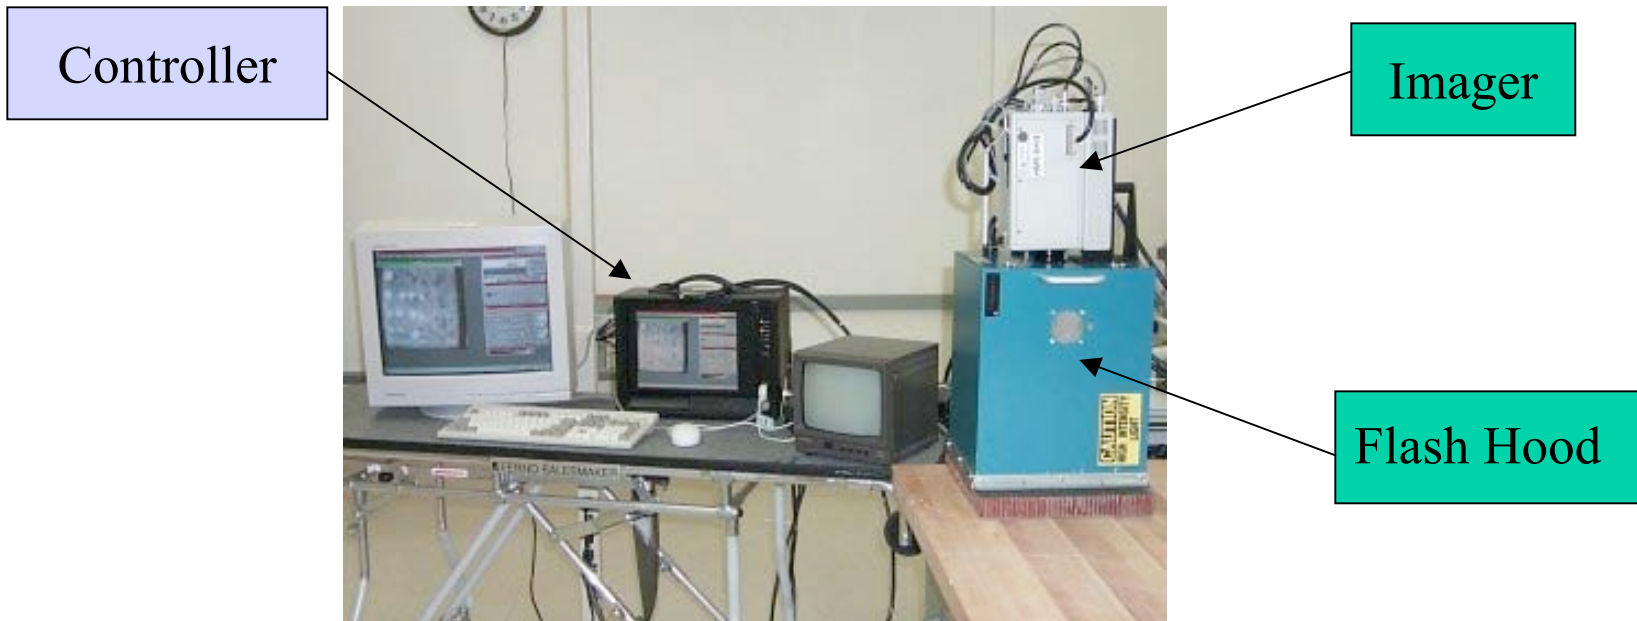
THERMOGRAPHIC INSPECTION SYSTEM

- **Imager: Indigo Merlin Mid**
- **Detector => Indium Antimonide**
- **Detector resolution => 256 x 312**
- **Spectral Response => 3 - 5 μm**
- **Sensitivity => 0.025 $^{\circ}\text{C}$ NE ΔT**
- **Software: ECHOTHERM[®] 32 (Thermal Wave Imaging, Inc.)**
- **Lens => 13 mm**

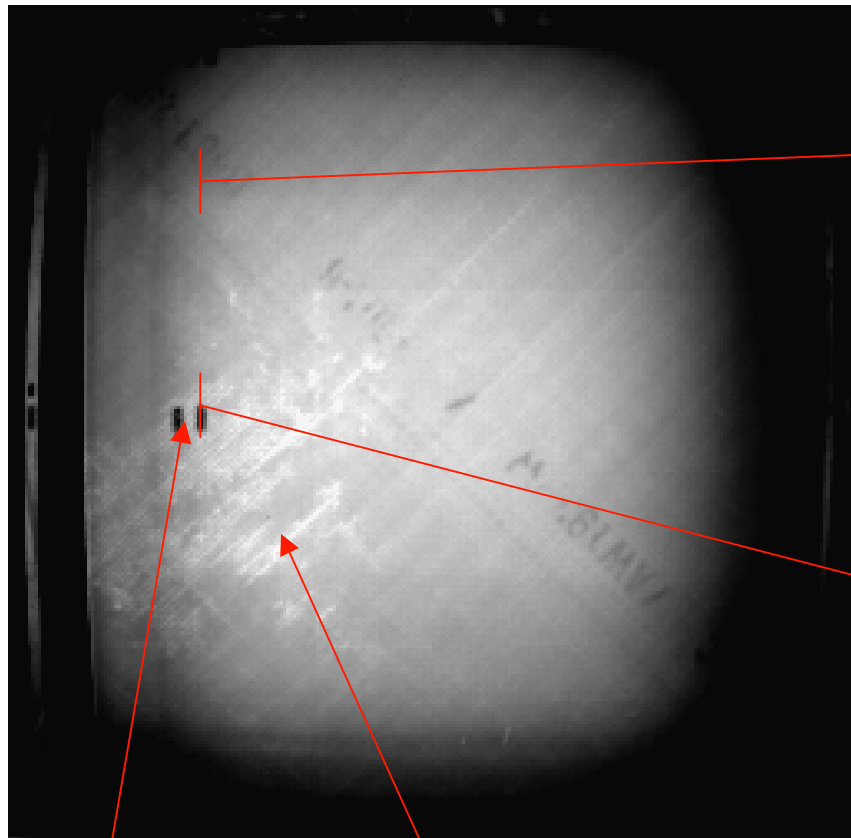
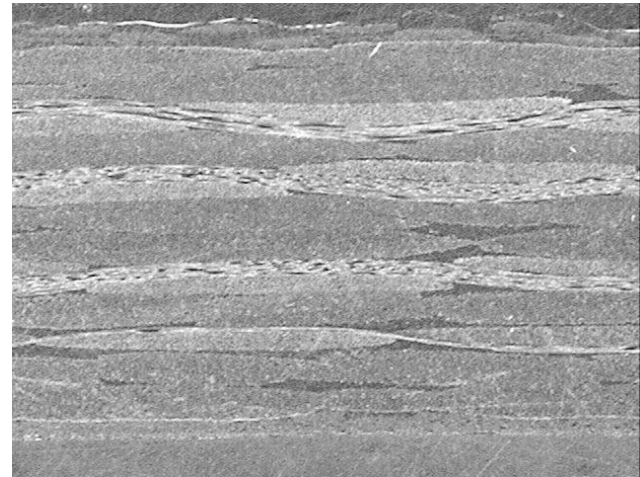
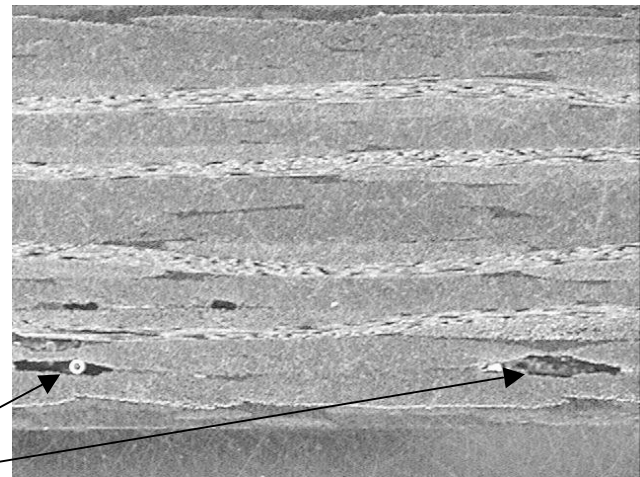
Clustered Porosity Detected Thermographically

8 inches

Lead foil markers

Porosity

Thermography has been shown to be capable of detecting clustered porosity and shows promise for quantifying general porosity level

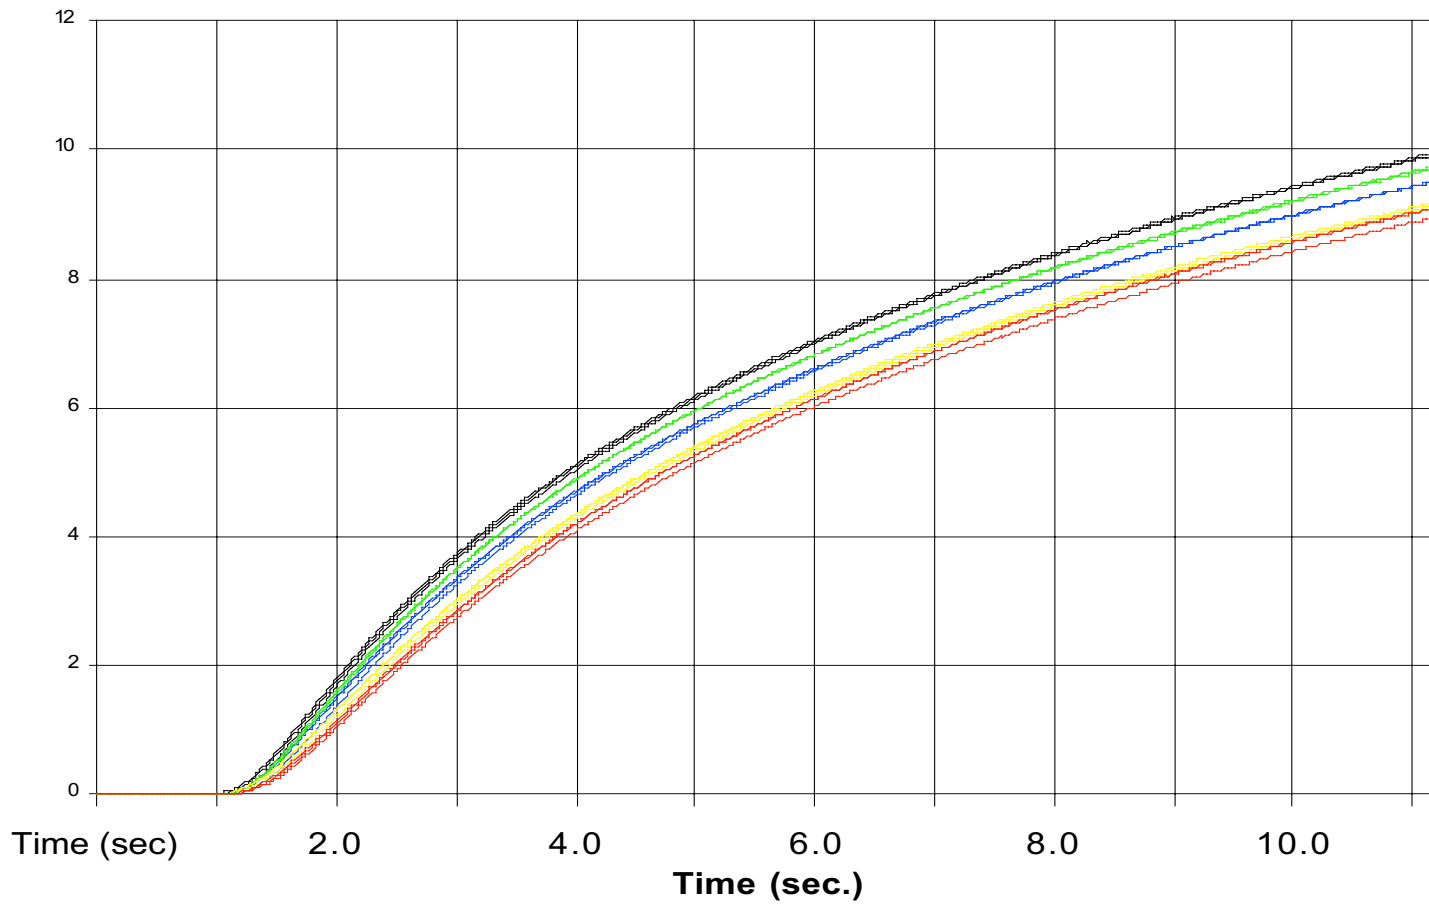
THERMOGRAPHY TREND

POROSITY IN GRAPHITE EPOXY

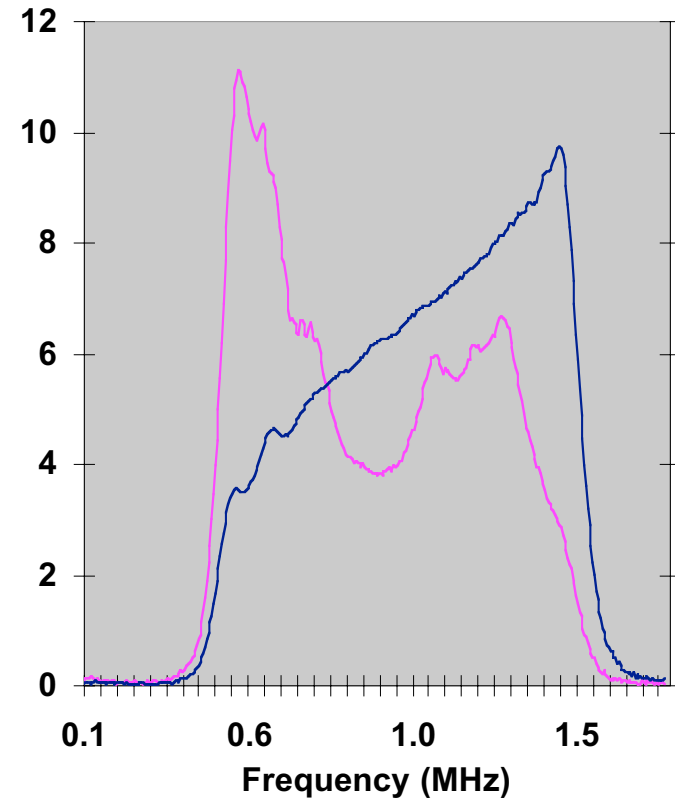
Typical Power Spectra

Pulser
Receiver

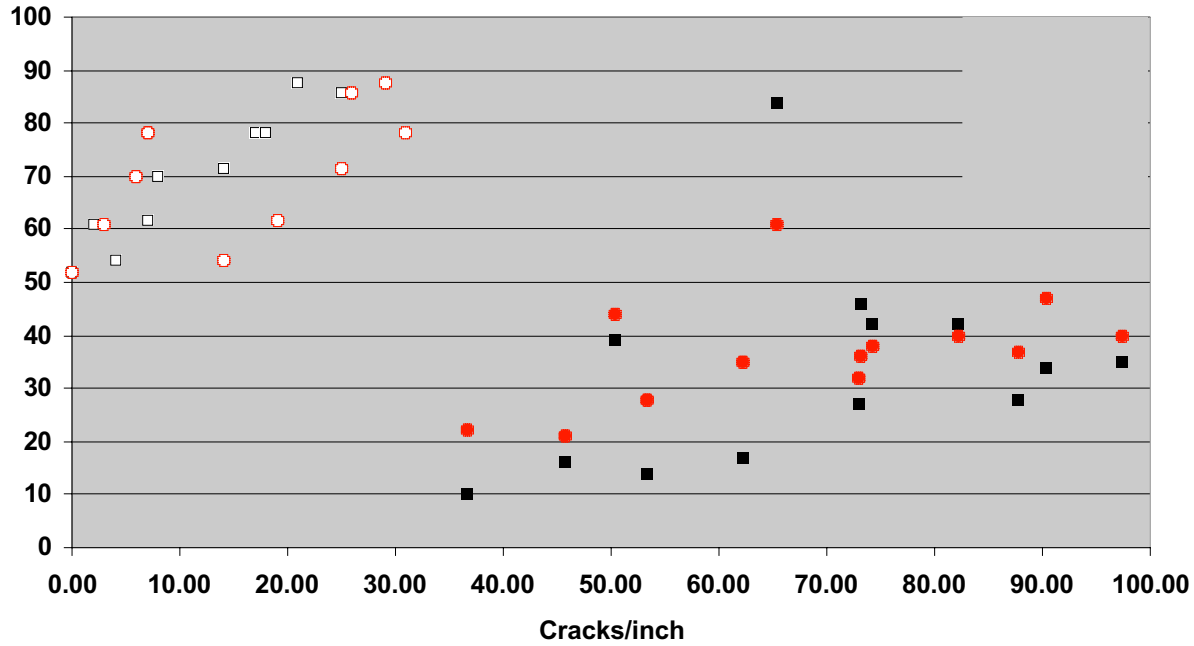
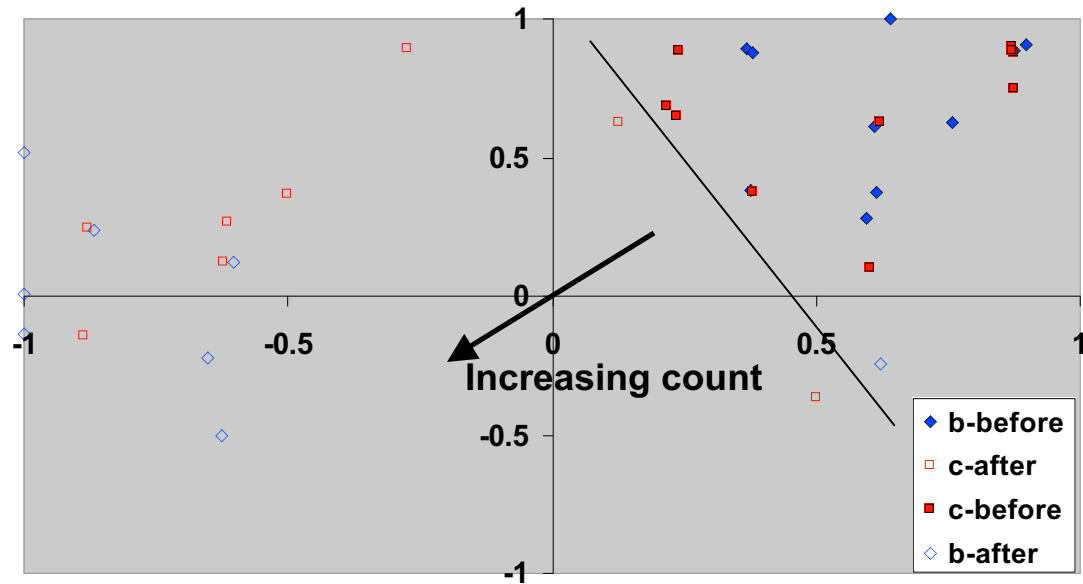
(0, 90, 0, 90)s SAMPLES

Microcrack Trend

Kohonen Map

Resonance ultrasound has been shown capable of detecting the presence of microcracking

The ability to detect microcracking with resonance ultrasound is dependent upon the number of cracks present

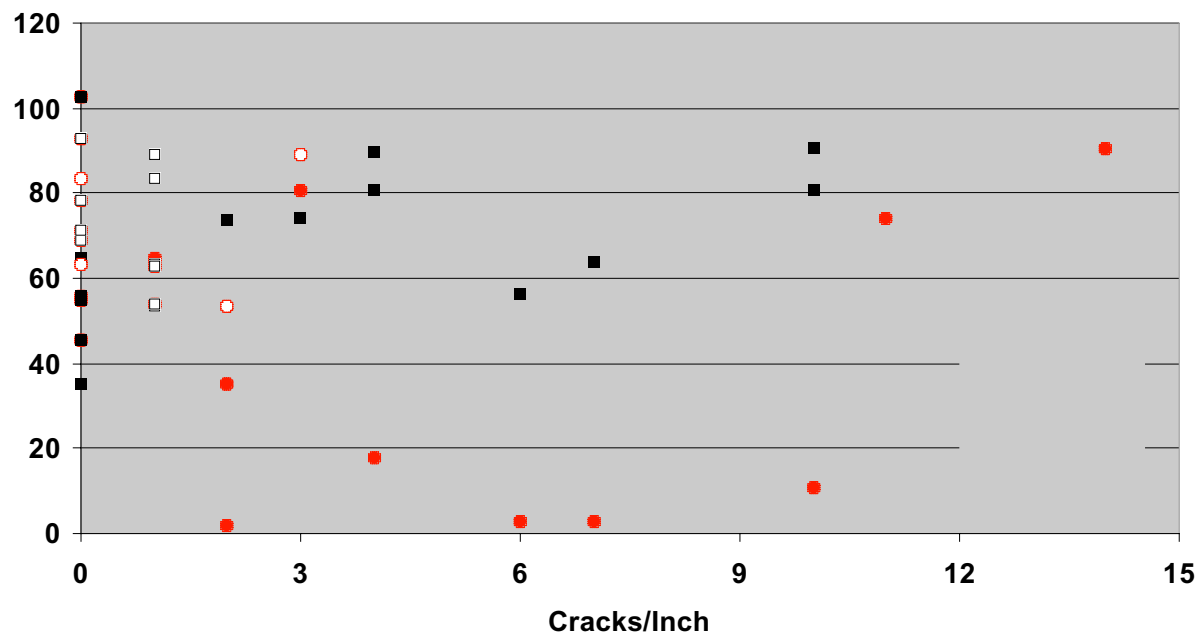
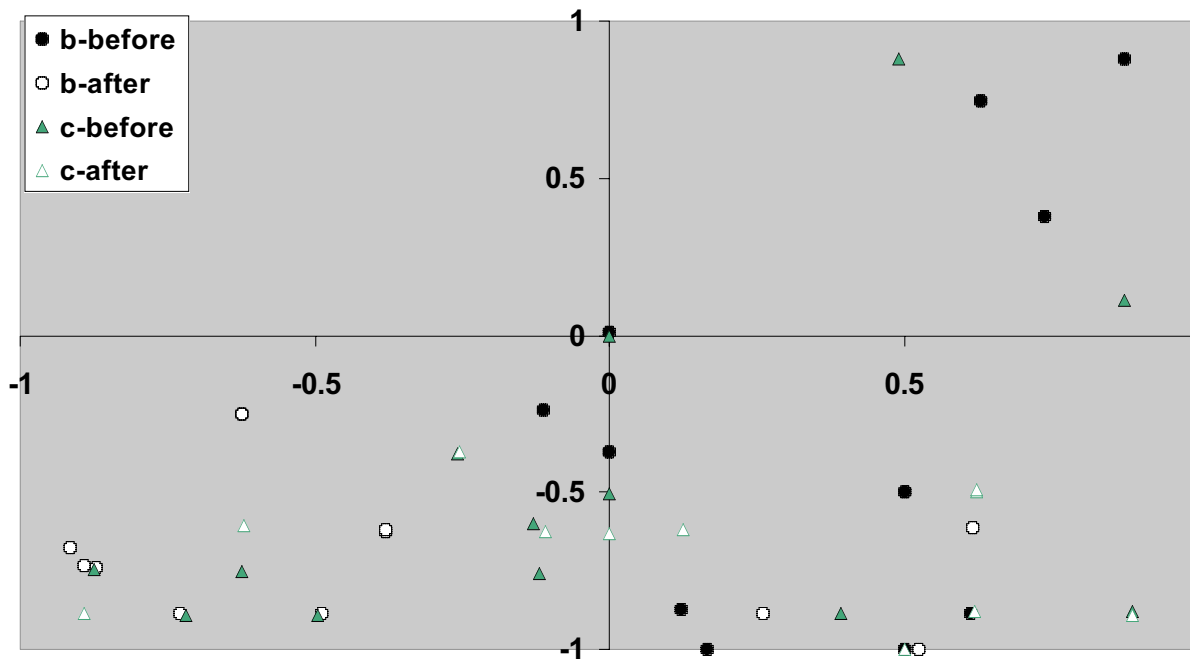
(0, 45, 0, -45)s SAMPLES

Microcrack Trend

Kohonen Map
